Walshaw Hall Care Home, Bury

Daytime Bat Survey

Client Capstone Care Limited  
Project Title Walshaw Hall Care Home  
Project Reference RHE.3670.01  
Project Leader Hollie Ainley  
Contact Details [hollie@rachelhackingecology.co.uk](mailto:hollie@rachelhackingecology.co.uk)

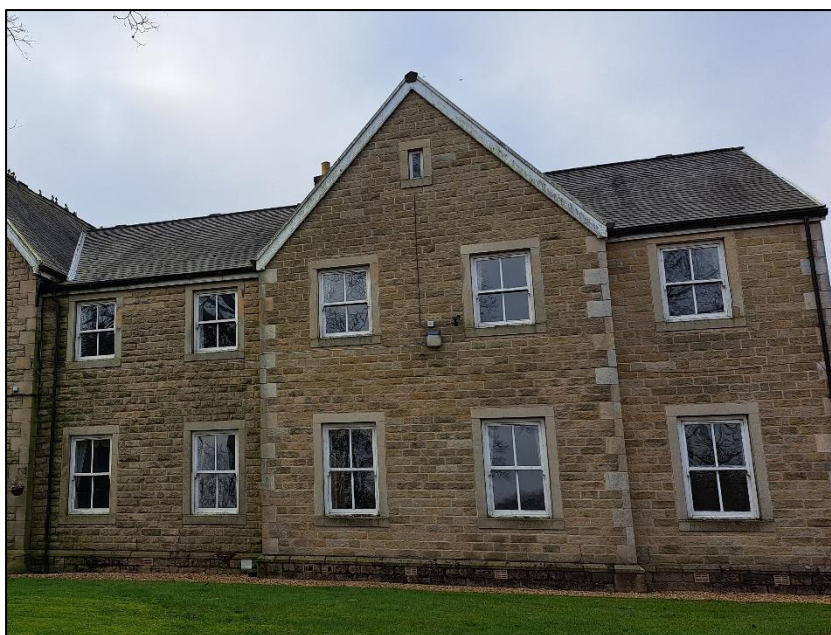
- 3.3.1 The site comprises an 18<sup>th</sup> Century mansion with various extensions comprising a number of interconnected buildings. The main building is constructed from stone with wall dormers and some parapet walls on the southern elevation. The roofs have a gable and valley structure and are covered with slate tiles. Soffits and eaves appear to be of uPVC. The roof appears to have been replaced in the last 20 years.
- 3.3.2 The external stonework is in good condition with only minor areas of missing mortar around the lintels (see Photographs 1, 2 and 3). The brick chimney stacks are complete and intact. The uPVC door and window frames are all intact and are flush with the surrounding masonry.

*Photograph 1 showing the eastern elevation*

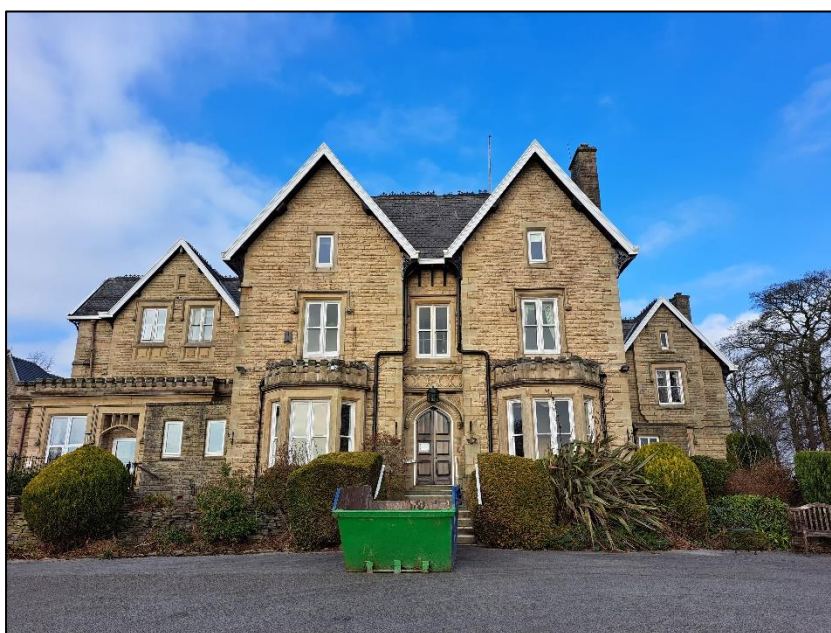
*Photograph 2 showing the southern elevation*

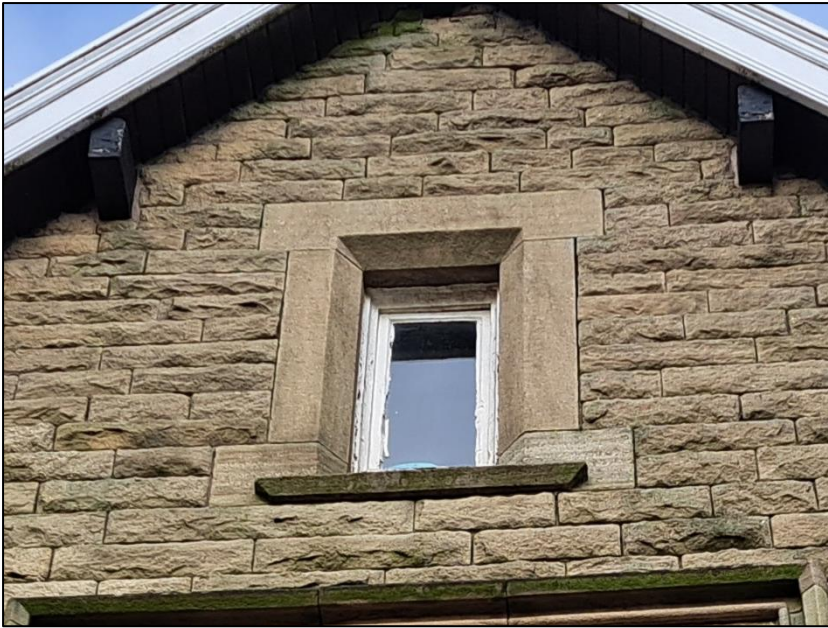
*Photograph 3 showing missing mortar*

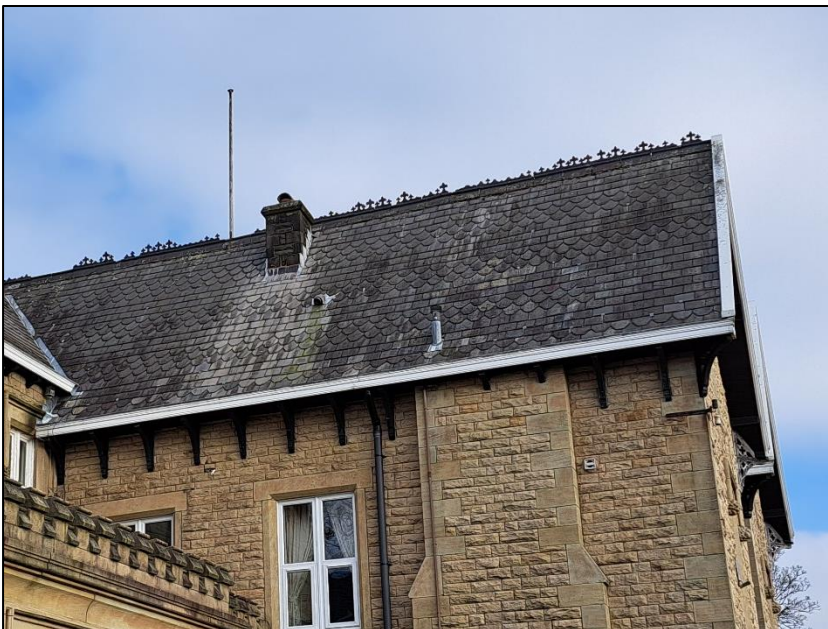
- 3.3.3 The roof of the building has a gable and valley structure covered with slate tiles (see Photograph 4). A small number of roof and ridge tiles are raised or missing (see Photograph 5). Lead flashing is present in-between pitches, this is flat and sits flush to the surrounding tiles.

*Photograph 4 showing a section of the roof*

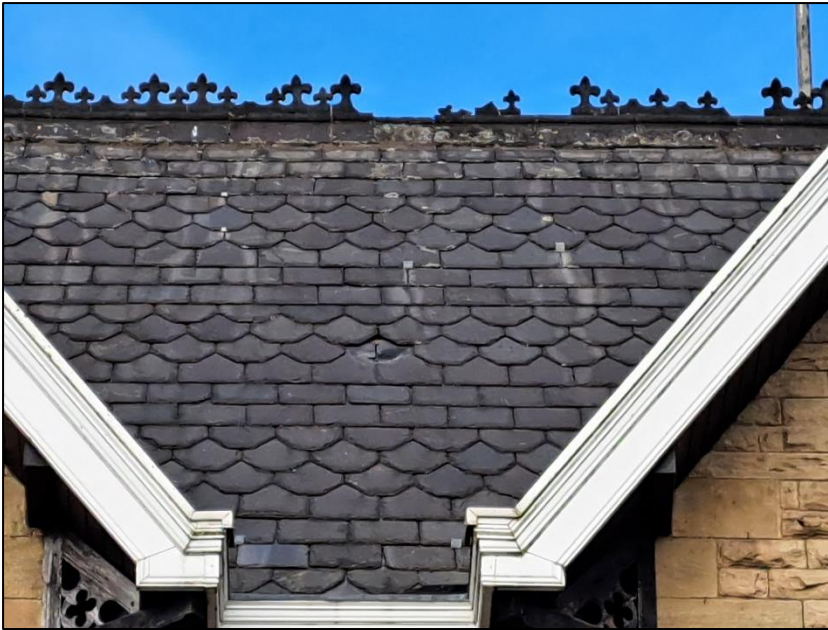
*Photograph 5 showing some of the missing roof and ridge tiles*

- 4.1.1 The site contains features which could be used by individual or small numbers of crevice dwelling bat species such as underneath the raised tiles. Potential access into the roof voids was also located underneath the soffits. Furthermore, the site is located in a rural area with good quality bat foraging and commuting habitat. It is assessed as offering low potential to support roosting bats.

- 5.1.1 Further detailed survey is required in order to determine the status of roosting bats at the site. A single bat activity survey is required at an optimal time of year (between May and September).

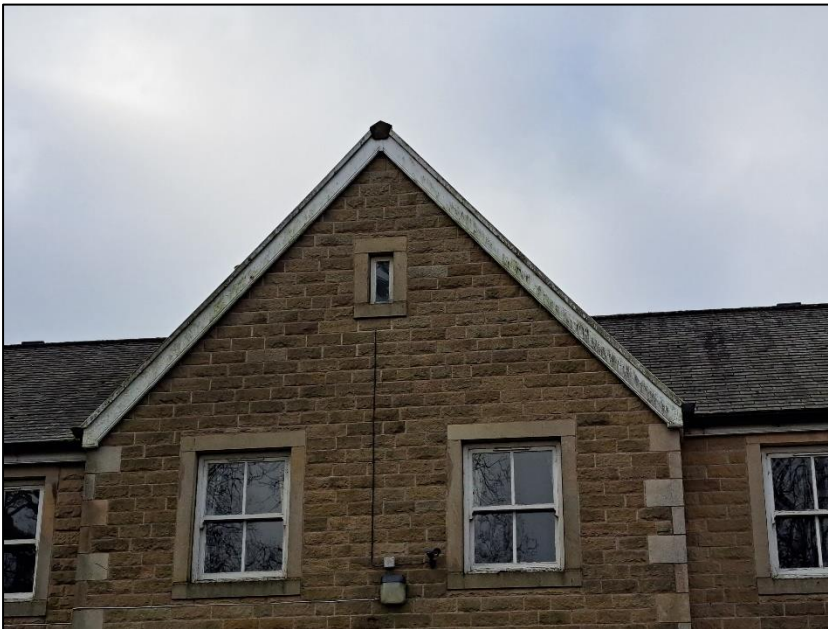
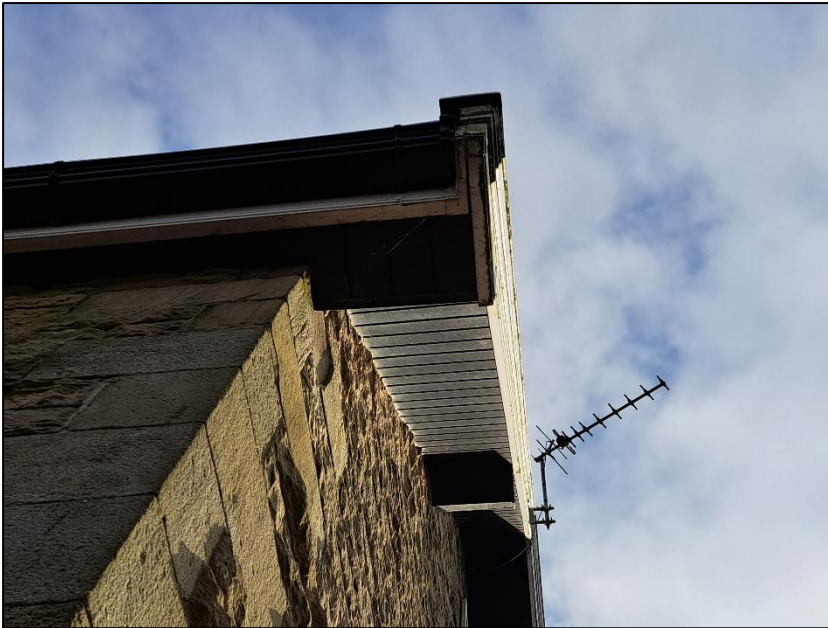
- 3.3.4 The buildings have uPVC soffits and barge boards (see Photographs 6 and 7). These are in good condition; however they do not lie flush to the stonework creating gaps which could be used as potential entry points into the roof voids for bats (see Photograph 8)

*Photograph 6 showing the uPVC barge boards*

*Photograph 7 showing the uPVC soffits*

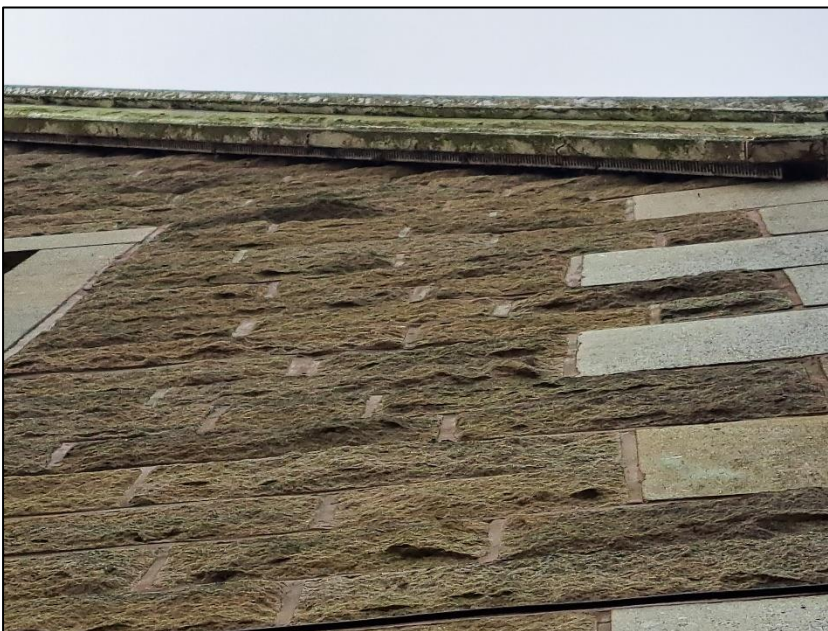
*Photograph 8 showing the gaps beneath the barge boards*

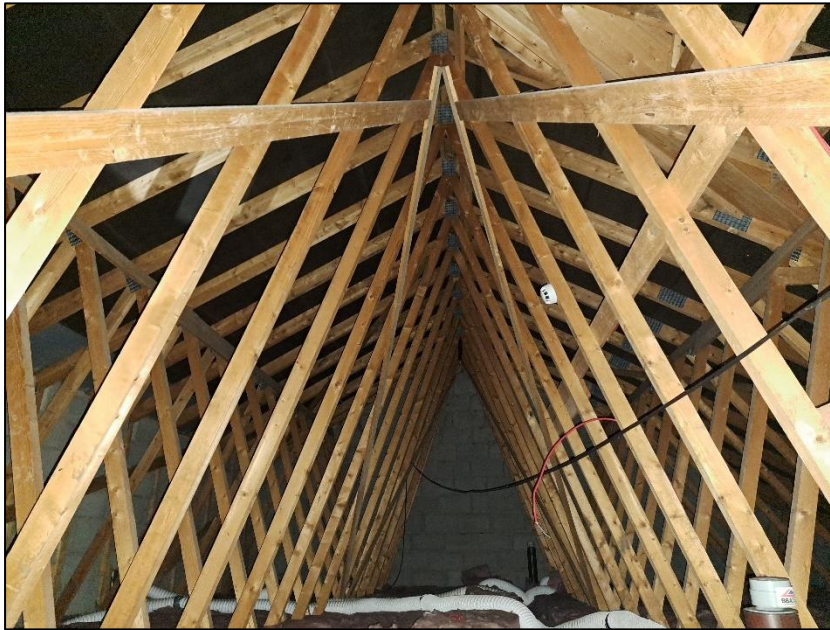
- 3.4.1 The living spaces are not currently in use. The former living spaces are well-lit with natural light from the windows and do not provide suitable bat roosting habitat. The property has multiple roof voids present. The roof voids in the north-western wing of the building are newer in construction and separated by a fire break. The voids in this wing have a trussed roof structure and the timbers are all

intact, without gaps or cracks for bats to use (see Photographs 9 and 10). The roof is lined throughout with bitumen underfelt, and this is mostly complete with no significant tears or rips.

*Photograph 9 showing the roof void*

*Photograph 10 showing the roof trusses and lining*

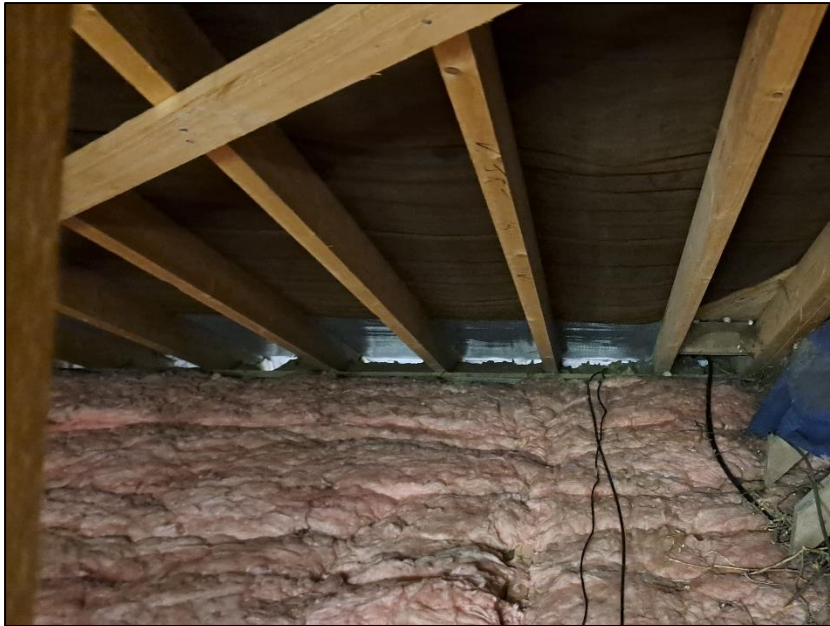
- 3.4.2 The voids are insulated to the floor throughout. The internal masonry is complete, with no damaged bricks or missing mortar. A small window is present on the wall dormer allowing a small amount of light into the roof void. Daylight can be seen at the roof edges (see Photograph 11). No evidence of bat activity, such as bat droppings, could be found inside the roof void.

*Photograph 11 showing daylight at the roof edges*

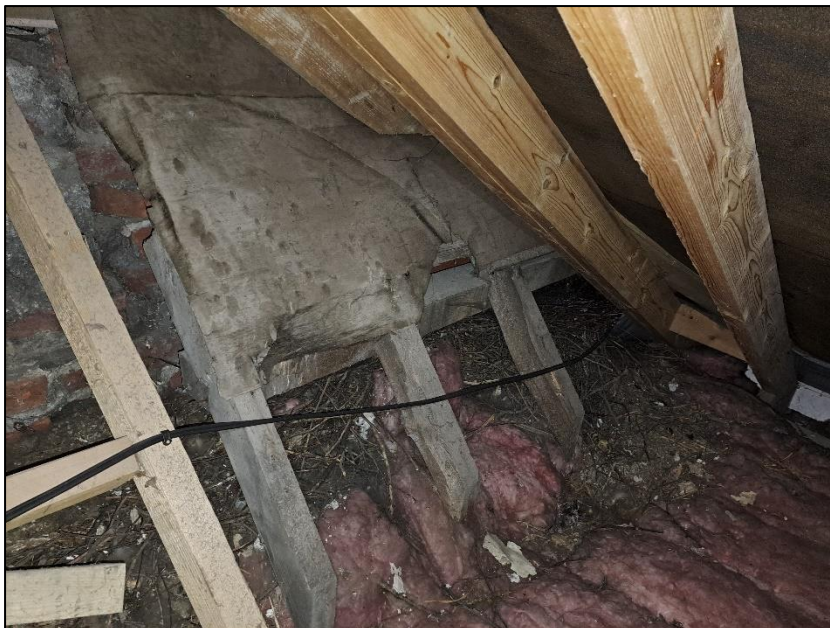
- 3.4.3 Evidence of nesting birds was located within the roof void (see Photograph 12).

*Photograph 12 showing the evidence of nesting birds*

- 5.1.4 Evidence of nesting birds was identified within one of the roof voids, therefore, it is recommended that any works take place outside of the bird nesting season (the nesting season is generally March to August), or a bird nest check be undertaken prior to work commencing.

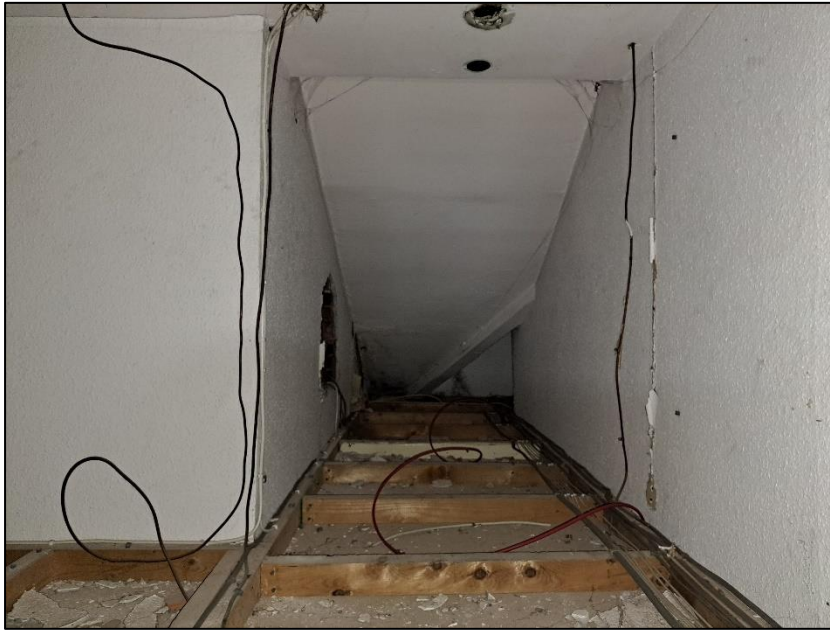
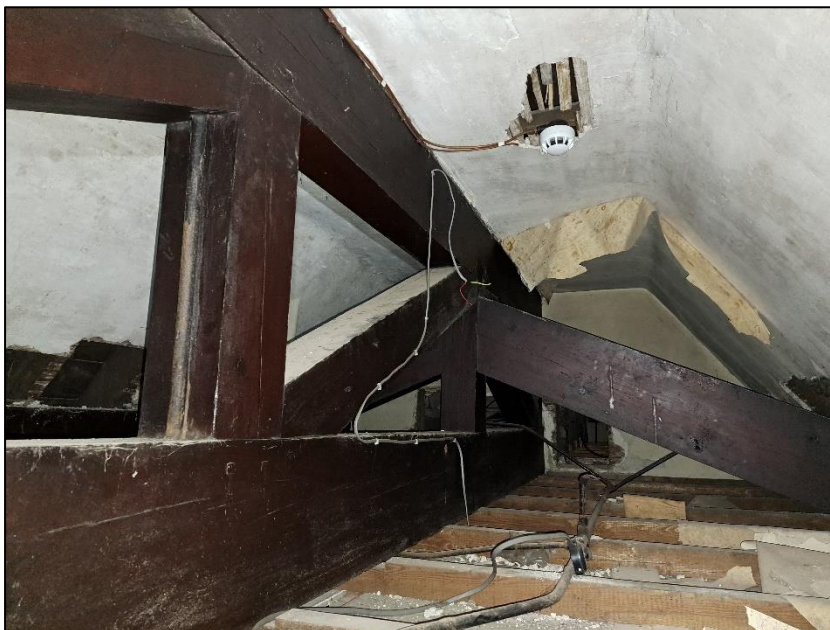
- 3.4.4 Several smaller roof voids are located in the older areas of the building. False ceilings with voids above are situated beneath the original roof voids (see Photographs 13 and 14). The roof timbers are in good condition, without gaps or cracks for bats to use. The voids are plastered throughout, and this is damaged in places. No evidence of bat activity, such as bat droppings, could be found inside the roof void.

*Photograph 13 showing the space above the false ceiling*

*Photograph 14 showing one of the original roof voids*

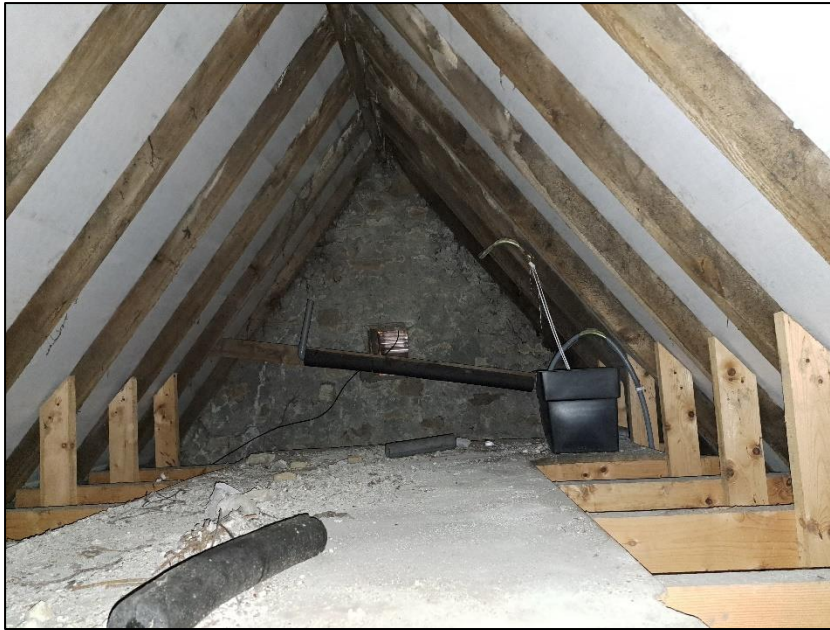
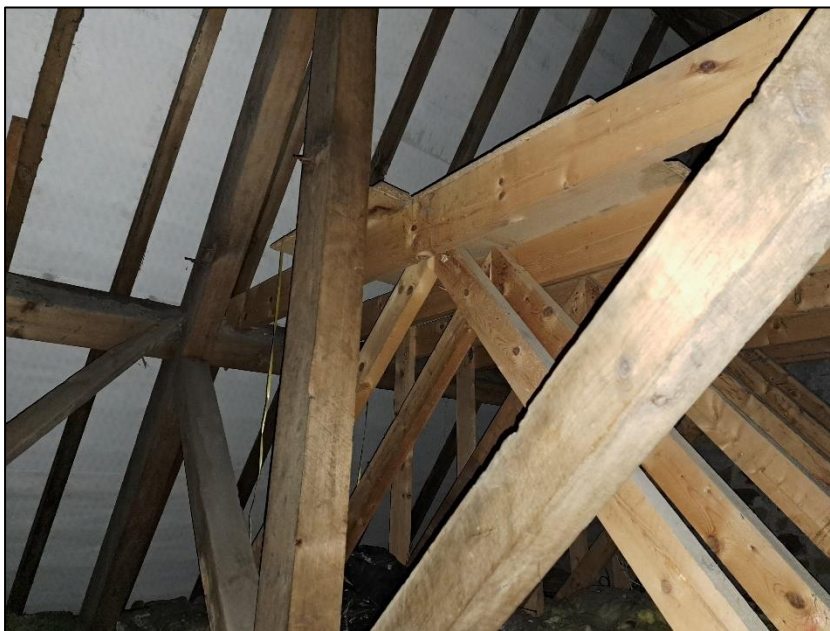
- 3.4.5 A roof void is present within the extension to the north of the site. The roof timbers are all intact, without gaps or cracks for bats to use (see Photographs 15 and 16). The roof is lined throughout with breathable membrane and this is complete with no significant tears or rips.

*Photograph 15 showing roof void*

*Photograph 16 showing the timber and the lining*

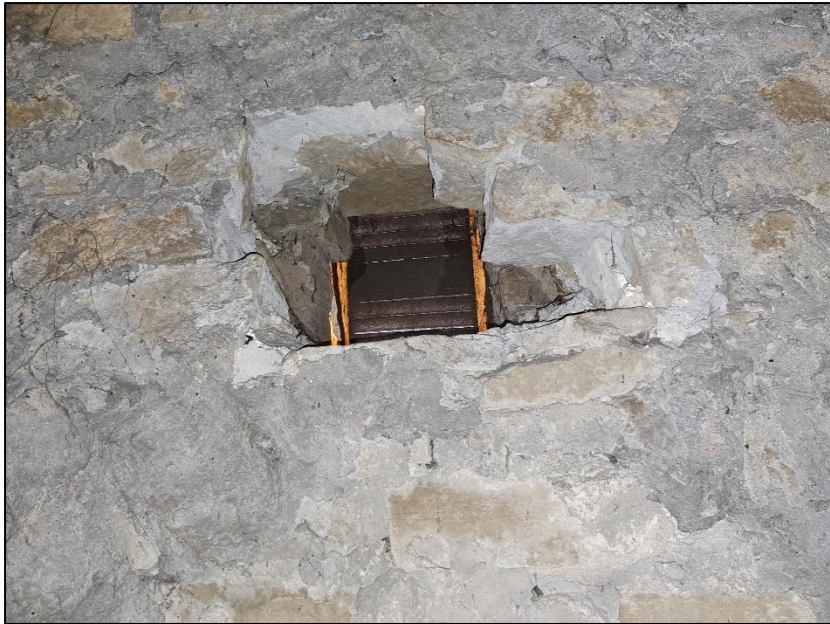
- 3.4.6 The void is insulated to the floor throughout. The internal masonry is complete, with no damaged bricks or missing mortar. Small louvre windows are present on the gable ends allowing a small amount of light into the roof void (see Photograph 17). No daylight could be seen at the roof edges. No evidence of bat activity, such as bat droppings, could be found inside the roof void.

*Photograph 17 showing one of the louvre windows*

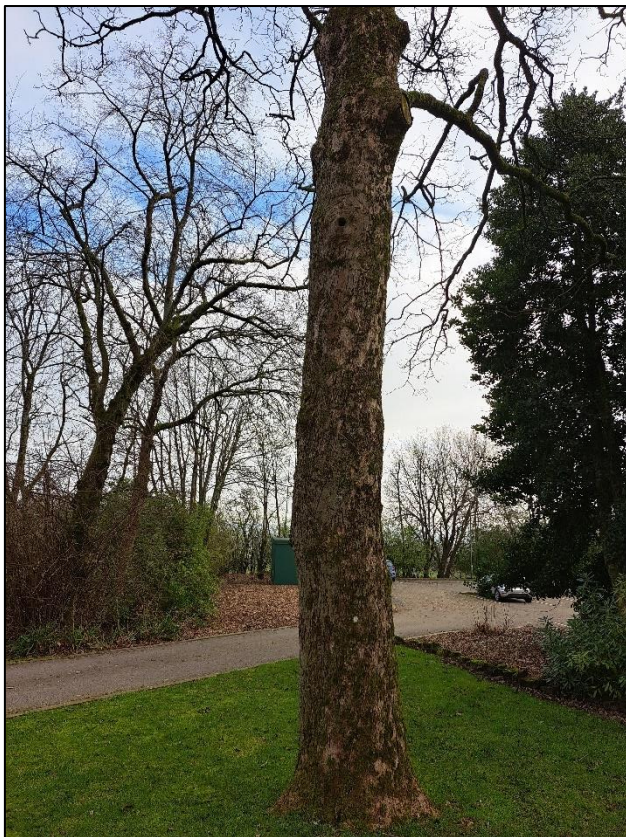
- 3.4.7 One tree on site to the east of the site has a woodpecker hole, which is a Potential Roosting Feature (PRF) (see Photograph 18).

*Photograph 18 showing the woodpecker hole*

- 5.1.3 If the tree with the PRF requires removal or treatment in the future, an aerial inspection should be undertaken by a suitably licensed and trained ecologist, to survey the PRF for evidence of bat activity.
