## **GROUND INVESTIGATION REPORT**

**FOR  
LAND AT  
BILLBERRY CLOSE  
AND ALBERT ROAD,  
WHITEFIELD,  
GREATER MANCHESTER**

**PREPARED FOR  
THOMPSON CONTRACTS  
(BLACKPOOL) LIMITED**

**REPORT NO. 8130A  
MARCH 2025**

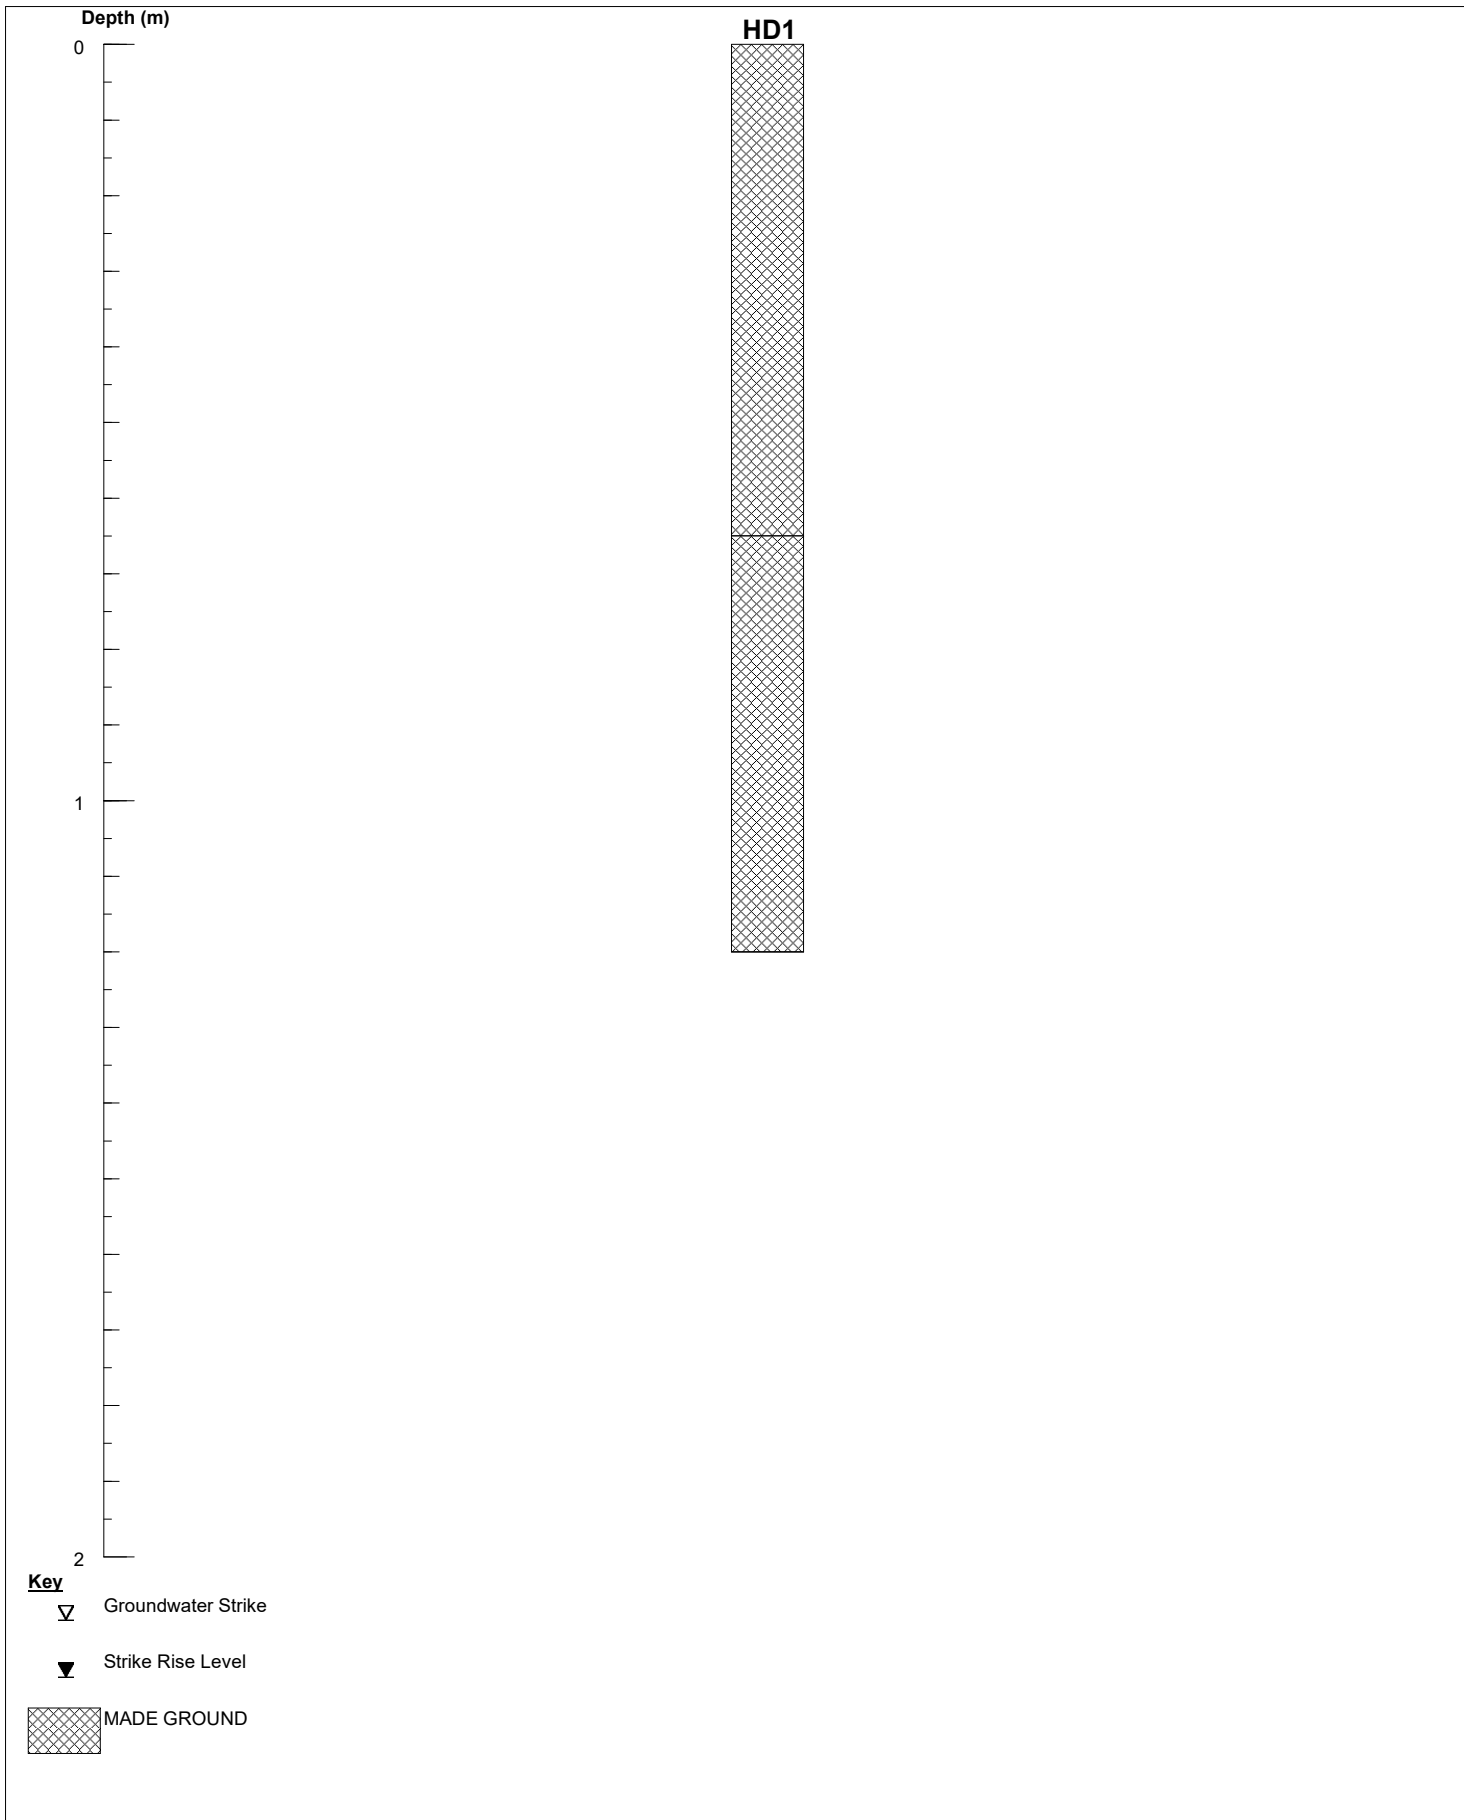
8130A.HD1

Underlying the above in HD1 were brown sandy gravel and cobble sized fragments of stone to the base of the trial pit at a depth of 1.20m.

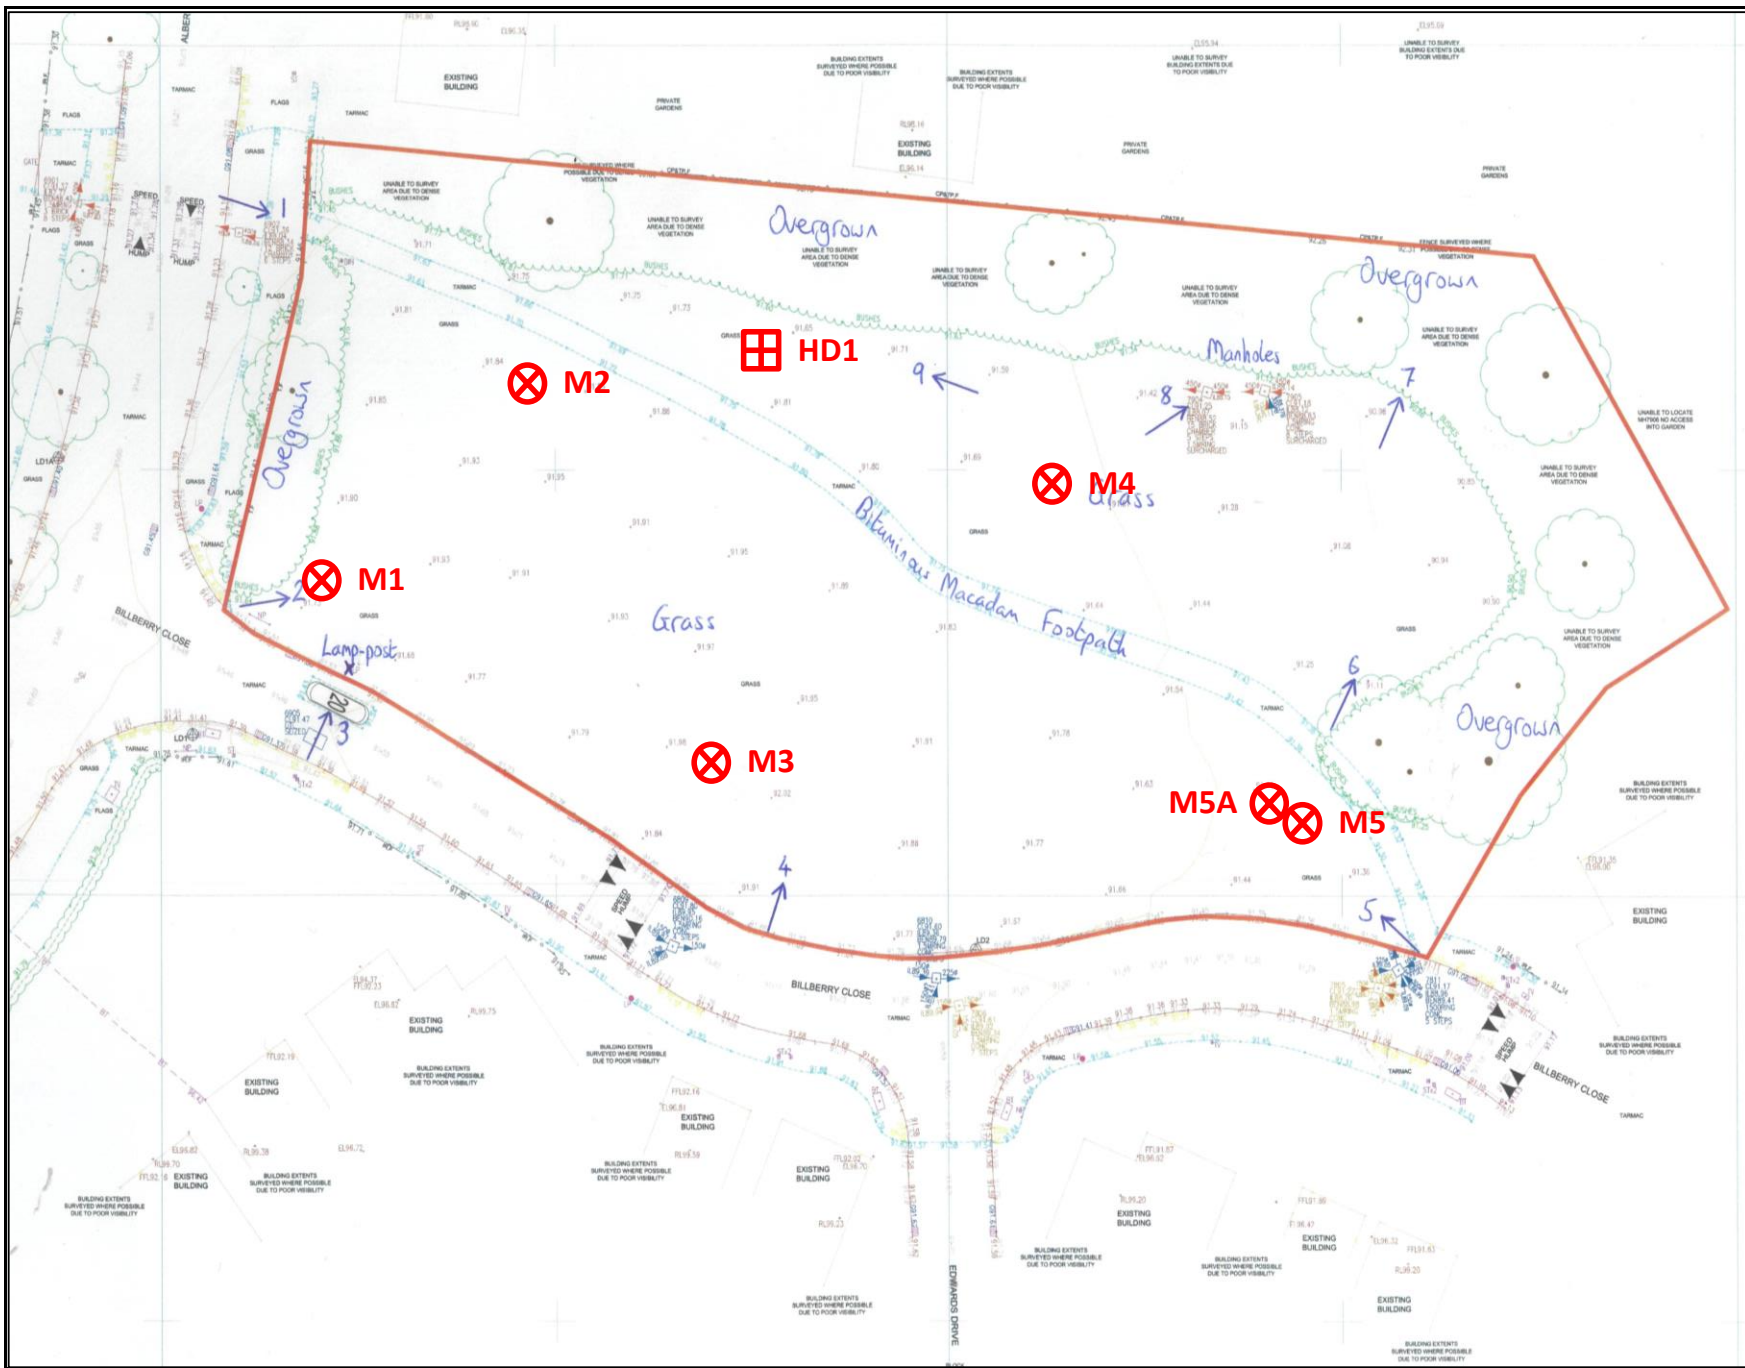
# Site Plan / Walkover Photo Locations

As shown in Figure 2, the site comprises an irregular shaped plot of land of 0.3ha. At the time of the walkover carried out for the Phase I Report (27<sup>th</sup> November 2024), the site comprised a predominantly grassed area with overgrown areas in the north, east and west and a bituminous macadam surfaced footpath running from northwest to southeast. The site is bound by 8-16 and 38 Regal Close to the north, 31-35 Brook Drive to the northeast, 17-19 Billberry Close to the southeast, Billberry Close to the south, and Albert Road to the west.

One hand dug trial pit was taken out at the positions determined by the Client's Engineer and set out by Sub Surface North West Ltd, as shown on Figure 2. The hand dug trial pit was excavated to a depth of 1.20m. Samples were taken for logging, in accordance with BS.5930:2015+A1:2020, and testing. The resulting Hand Dug Trial Pit Records are appended. On completion the hand dug trial pit was backfilled with arisings.

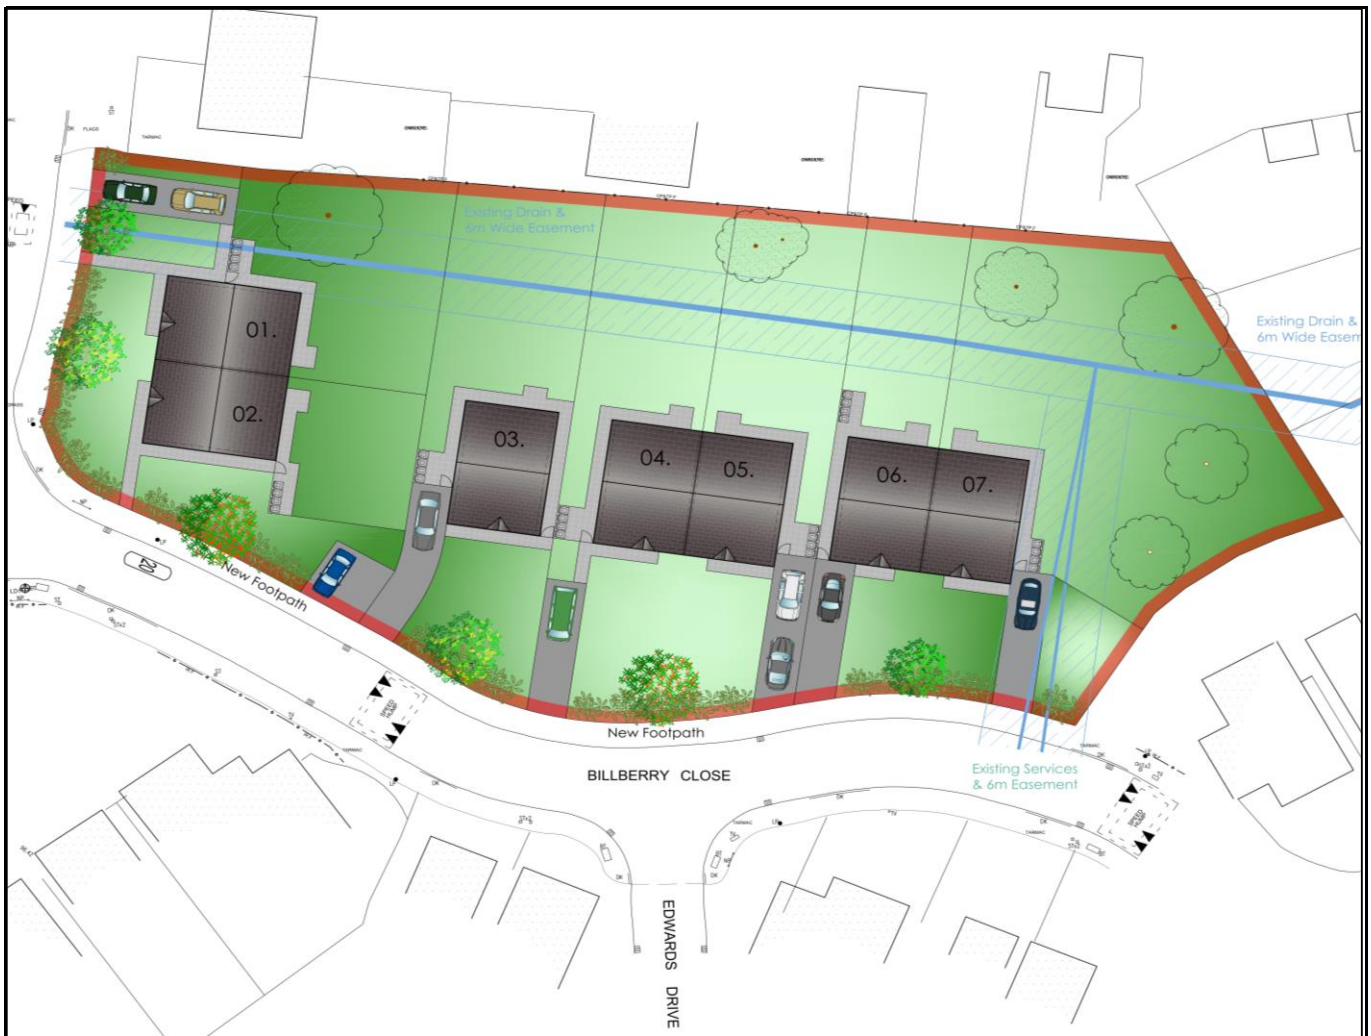
Street Scene Elevation Along Billberry Close  
(Scale 1:100)

We understand that it is proposed to erect seven residential bungalows (three pairs of semi-detached and one detached), with driveways, gardens and landscaped areas, as shown in Figure 3.

We understand that it is proposed to erect seven residential bungalows (three pairs of semi-detached and one detached), with driveways, gardens and landscaped areas, as shown in Figure 3. However, at the time of writing this report no specific details regarding any design loadings were available and consequently the recommendations given are in general terms only.
