# VICTORIA COURT, BURY

Site Investigation and Ground Assessment

| Report No | BEK-25152-1 |

1.1.1 BEK Enviro Limited (BEK) has been commissioned by JN Building Contactors Ltd to carry out a site investigation and ground assessment for the land located at Victoria Court, Tottington, Bury (hereafter referred to as 'the site'). The investigation will inform a quantitative risk assessment with respect to contamination and ground gas at the site considering the change of use to residential and to provide recommendations for foundation design.

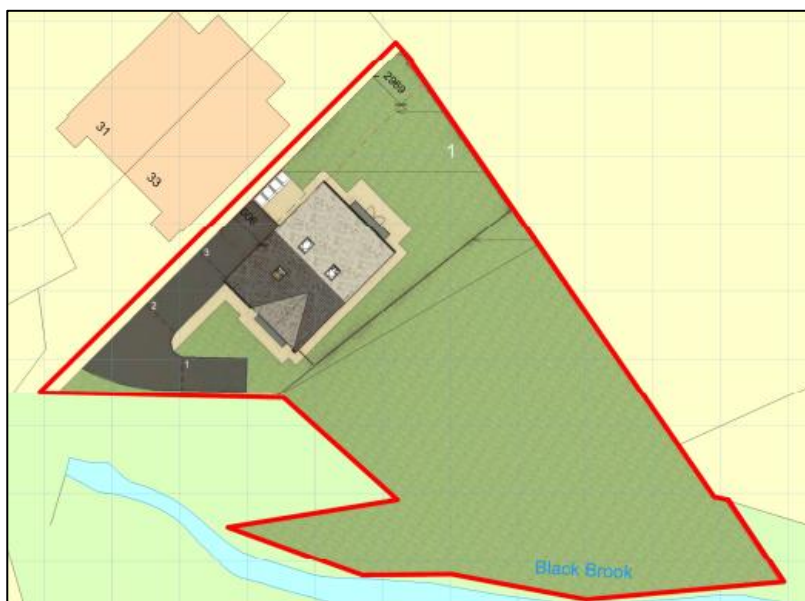
**Figure 1:** Proposed Site Plan, Taken from the Phase 1 Desk Study

1.3.2 At present, no proposed site plan has been made available to BEK, however the following proposed plans are presented in the Phase 1 Desk Study:

1.3.1 It is proposed to construct a residential dwelling with private garden and driveway.
