Our Ref: BEK-25152-260310-JNBC

**Land at Victoria Court, Bury - Additional Site Investigation Report**

### **BEK Site Investigation October 2025**

### **Additional Site Investigation February 2026**

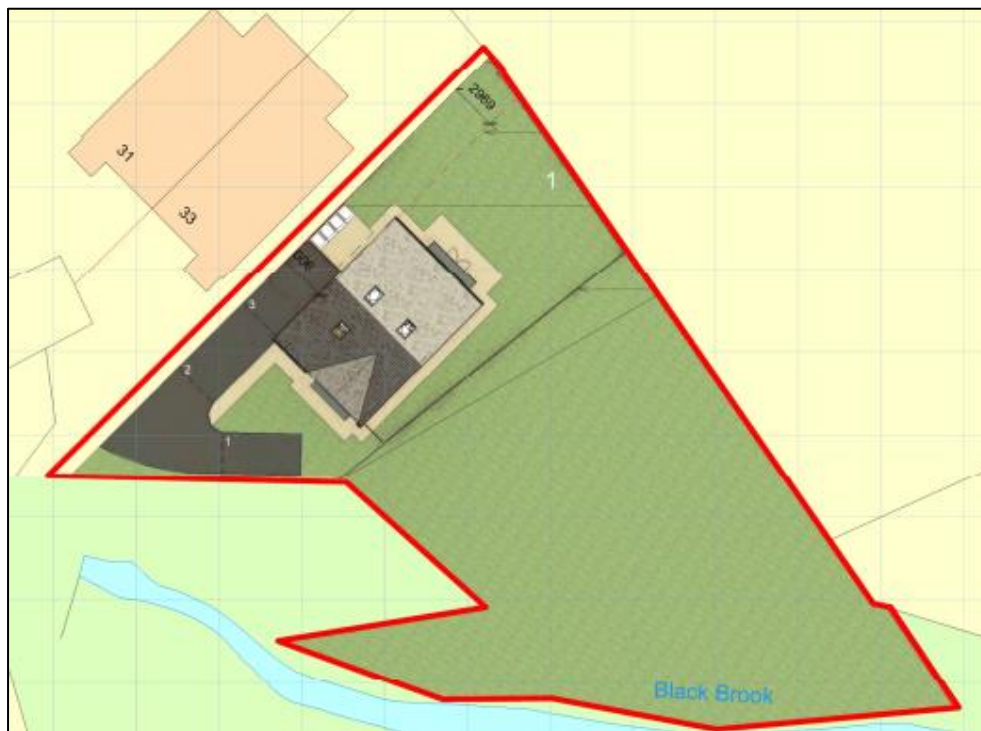
**Figure 1:** Proposed Site Layout, Taken from the Phase 1 Desk Study

BEK Enviro (BEK) has been commissioned by JN Building Contractors Ltd to carry out additional site investigation works for the proposed residential development at the land located at Victoria Street, Bury (National Grid Reference 377809, 412801). The works are required to support a controlled waters risk assessment to support the construction of a residential dwelling with private garden and driveway. the proposed development layout is presented in the Phase 1 Desk Study:
