# HERITAGE APPRAISAL TO INFORM PLANNING PROPOSAL

## AT NORCOT, MOORBOTTOM ROAD, HOLCOMBE, RAMSBOTTOM

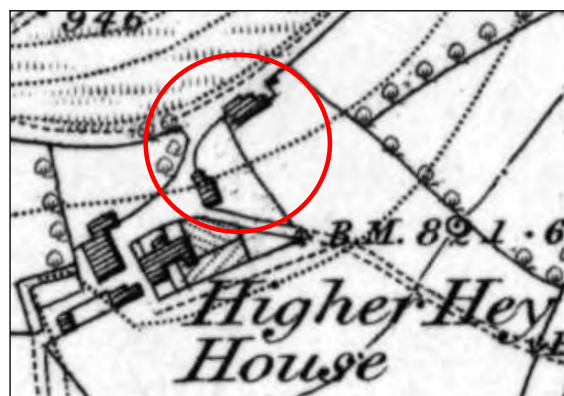
- 3.1 Historic Ordnance Survey maps assist to a small degree in an understanding of the site's development from the mid nineteenth century.
- 3.2 House and barn are both shown on the first edition 1:10560 map of 1850 (figure 1<sup>3</sup>), but the site is not named, and access at that date seems to have been from Moorbottom Road to the north. The south side of the house faced onto a large enclosure, and the barn was set within its own smaller field. These aspects suggest that the house was then still of modest status, most likely attached to a working farm.

Figure 1: OS 1:10560 map, 1850

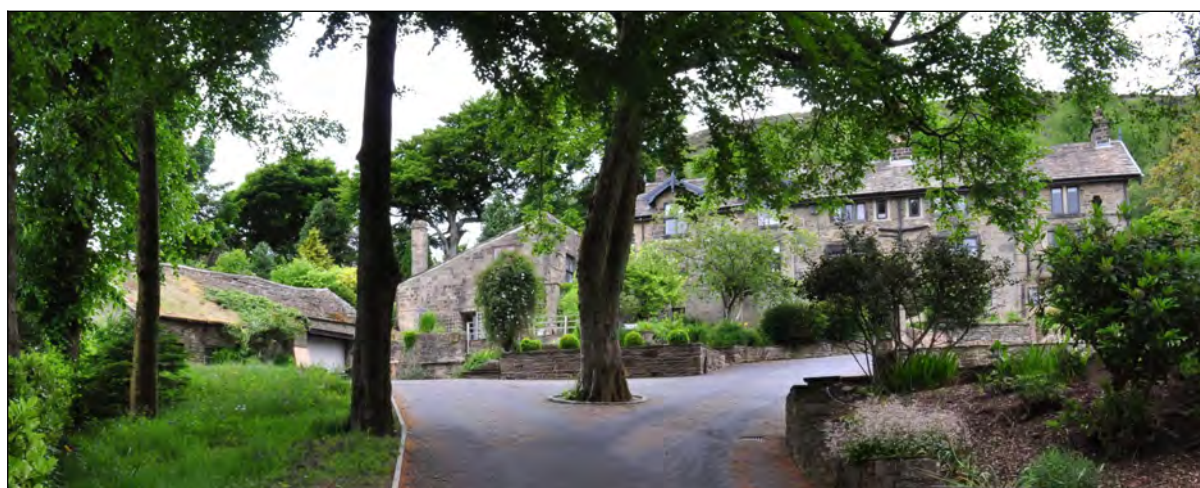
- 5.1 Norcot appears to have originated as a vernacular farmhouse with historic origins, perhaps associated in some way with the nearby Hey House, but during the later part of the nineteenth century it was gentrified, a process which involved enlargement and rebuilding, albeit to an unknown extent. The overall appearance of Norcot today is that of a villa with a strong arts and crafts theme, dating from around the turn of the twentieth century, but containing a core which may be up to a century earlier, ie of about 1800. It should be noted that the inspection was confined to the exterior only.

Photo 1: Norcot, and its barn (left), viewed from the drive to the south

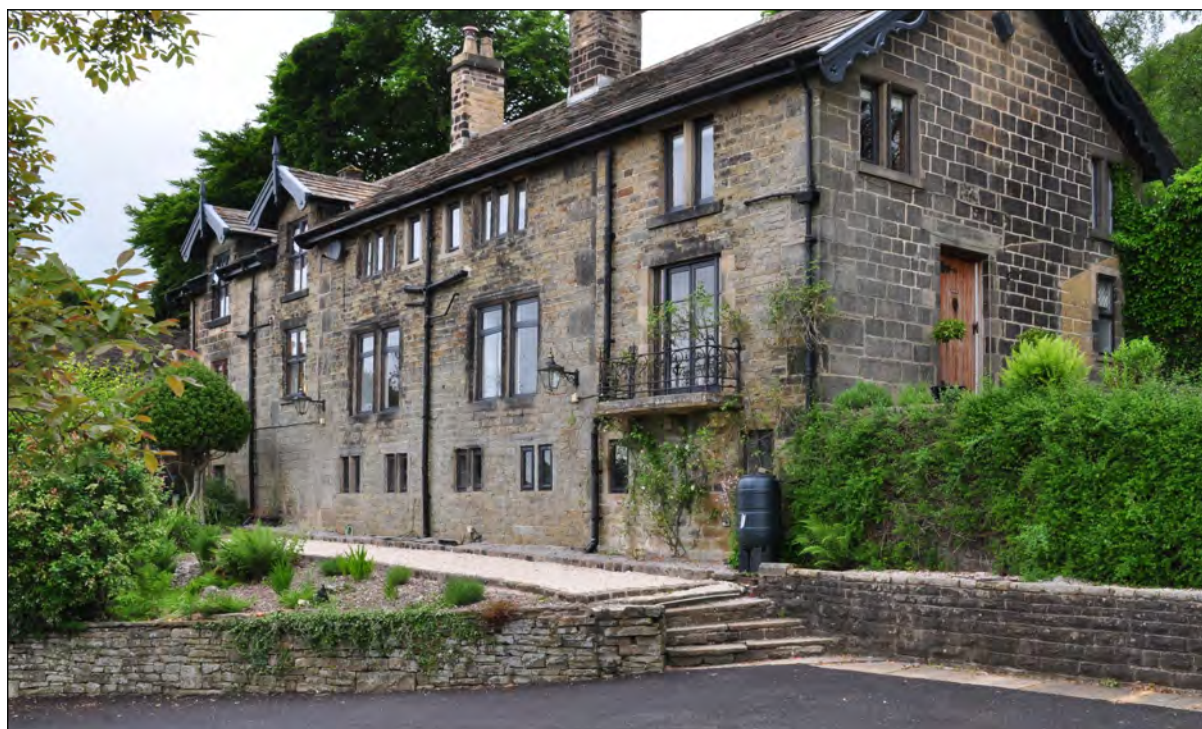
- 5.3 The earliest part of the house appears to be represented by two bays lying towards its east end, defined by deep, edge-laid quoins at either end, but extended to both east and west. These two bays have a symmetrical fenestration on all three floors, with traditional two-light windows with flush mullions on the lower ground floor, but much larger two-light openings with chamfered surrounds to the main, ground floor. Although these latter appear much later in date, there is nothing within the stonework to suggest that they are not original to it, which suggests that substantial or even wholesale rebuilding took place in the late nineteenth century.

Photo 2: The south front

- 5.4 The additions to these two bays include a single bay to the east, containing cantilevered balcony, and two bays of different date to the west, both with gabled dormers to the first floor. Elaborate bargeboards of Edwardian character are fitted to all the gables. West of the house is a domestic outbuilding block, linked to the main house by the rear boundary wall and now by a glazed porch on the south side.

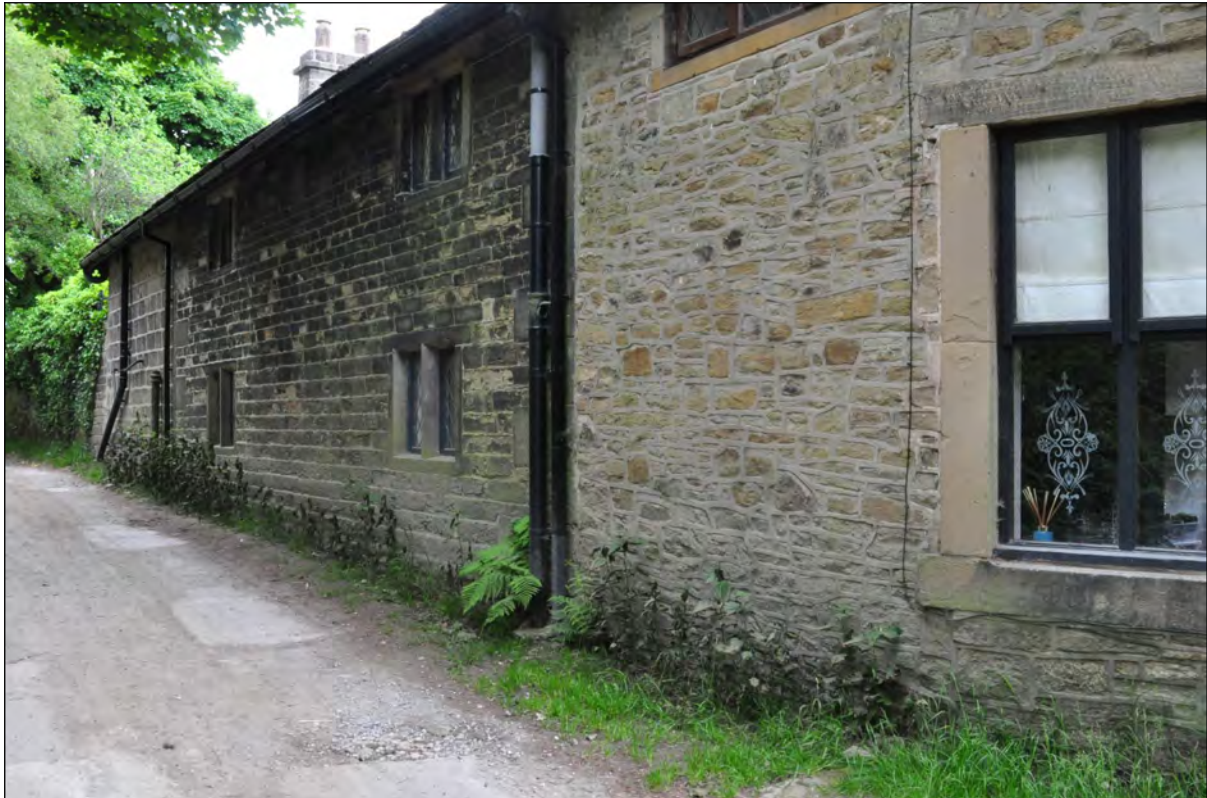
- 5.5 An unusual aspect of the house is the relegation of the entrances to the gables, and the east doorway is currently the principal one, though it appears to have been inserted in its present position within the extension here, to judge from the surrounding stonework, which raises the question of where the main entrance was previously. This gable faces onto a terrace which has evidently been the site of former outbuildings. Its deep courses of ashlar stonework are a strong element, as are the first floor windows and bargeboards.

Photo 3: Rear of house, looking east along Moorbottom Road

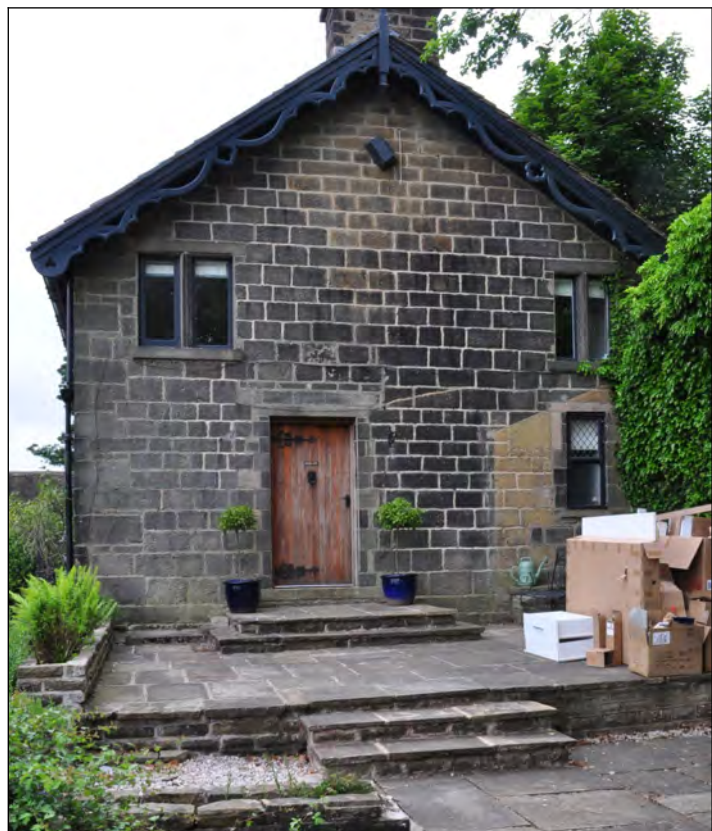
Photo 4: East gable

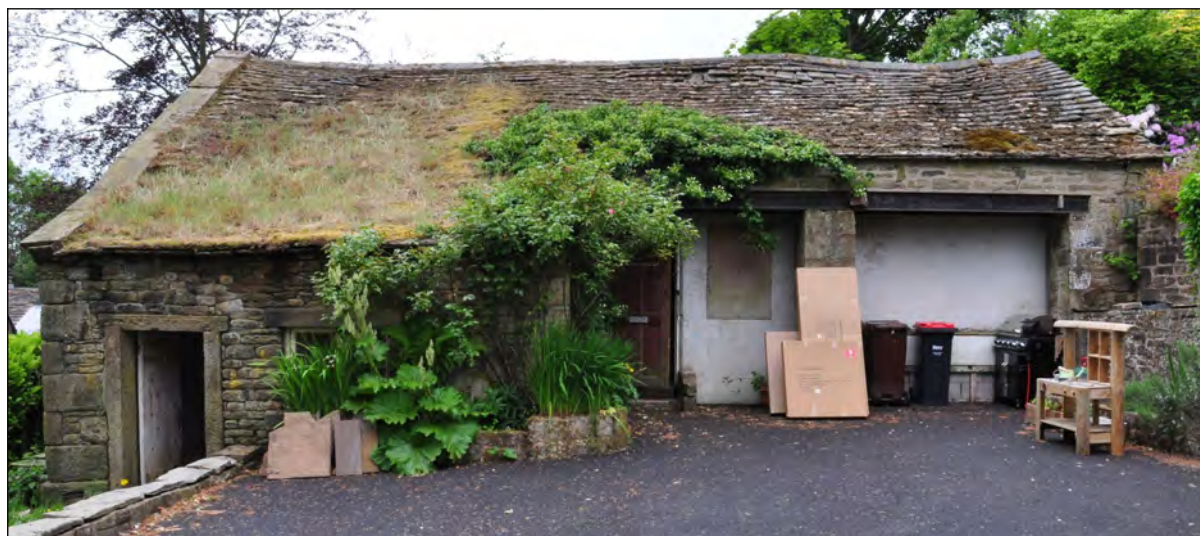
- 6.1 The barn is a three-bay, detached structure, likely to date from the early eighteenth century, and originally of a form very much in keeping with the small combination barns of the west Pennines. However in the late nineteenth or early twentieth century, as part of the gentrification of the property, and when its agricultural function was no longer required, it was altered to accommodate stables and the householder's horse-drawn vehicles, which seems to have given rise to its becoming known as the "carriage house".

Photo 5: Barn: east elevation

- 6.3 The east side has been altered by the insertion of two steel beams to create a pair of wide entrances for vehicular access, the southern one of which no doubt replaced the original doorway to the threshing bay. A full-height cart doorway under a timber lintel, but now blocked up, can be seen in the west side, although it is largely hidden by vegetation. There are also pedestrian doorways in either end of the former shippon, and a modern, inserted doorway in the north gable.

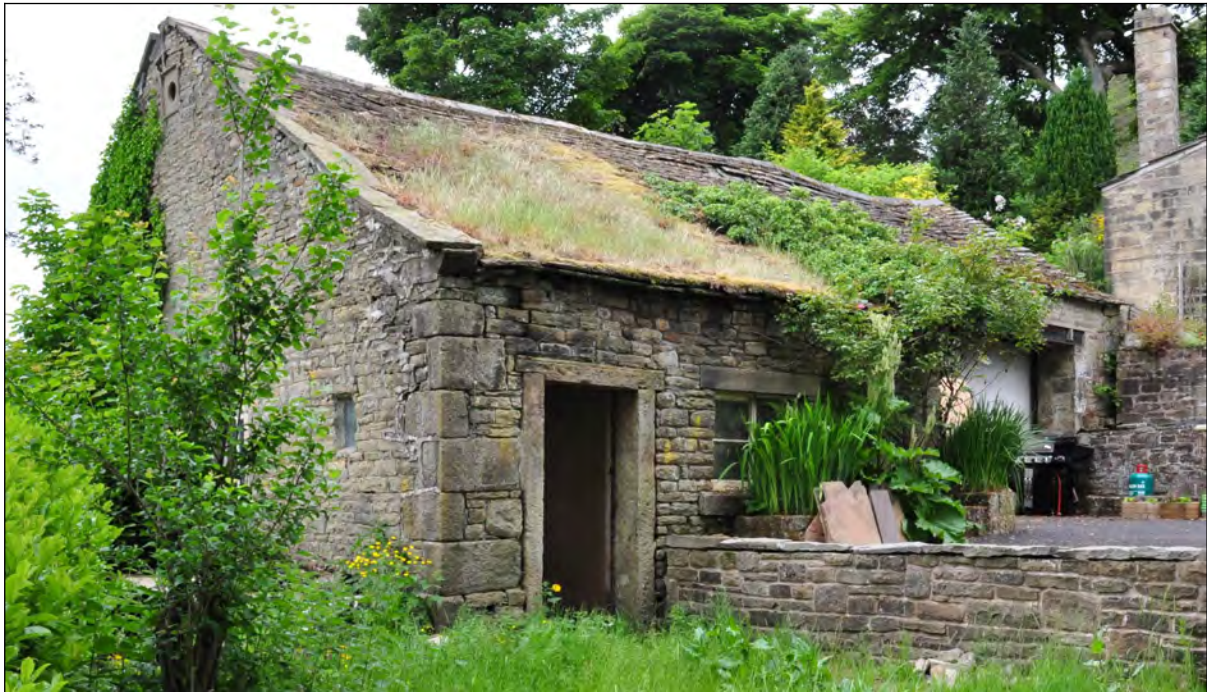
- 6.2 The building has an L-shaped plan and was constructed down the slope, with its wider south end, originally containing the shippon, at a lower level than the central threshing bay. Its walls are of loosely coursed rubble, with monolithic jambs to the doorways, and the roof is stone slate.

Photo 6: Barn, looking north-west

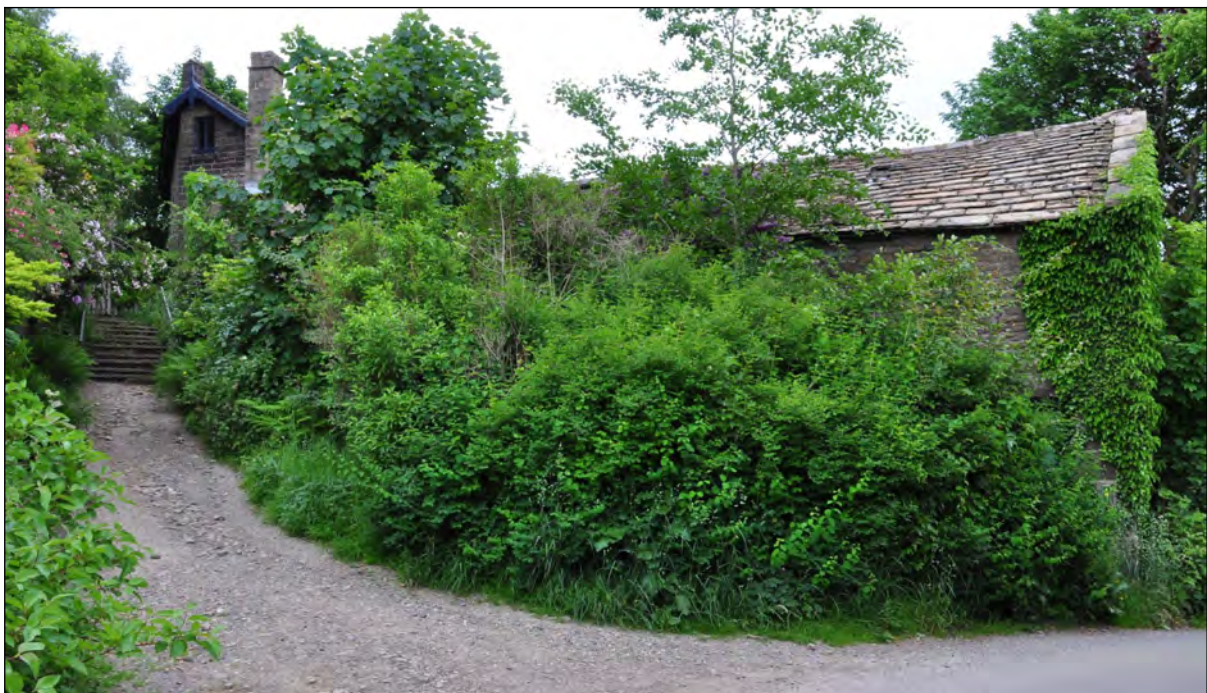
Photo 7: Barn, viewed from the west

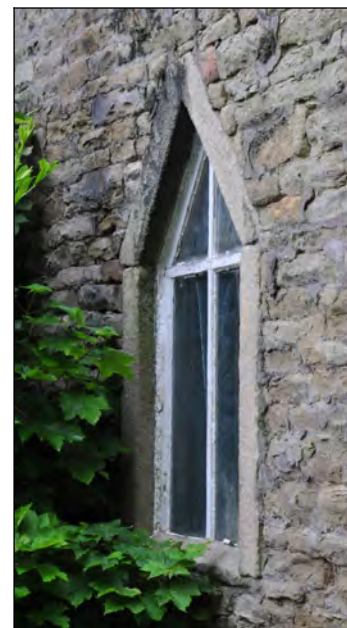
Photo 8: Arched window in south side of barn

- 6.4 A distinctive feature in the south gable is the window with a simple triangular arch, no doubt inserted when the building was converted to stables. (There is an identical arch on the lower ground floor of the house, in the south front.) Over it is a circular owl hole, cut into an edge-laid flag, and likely to be original to the building.

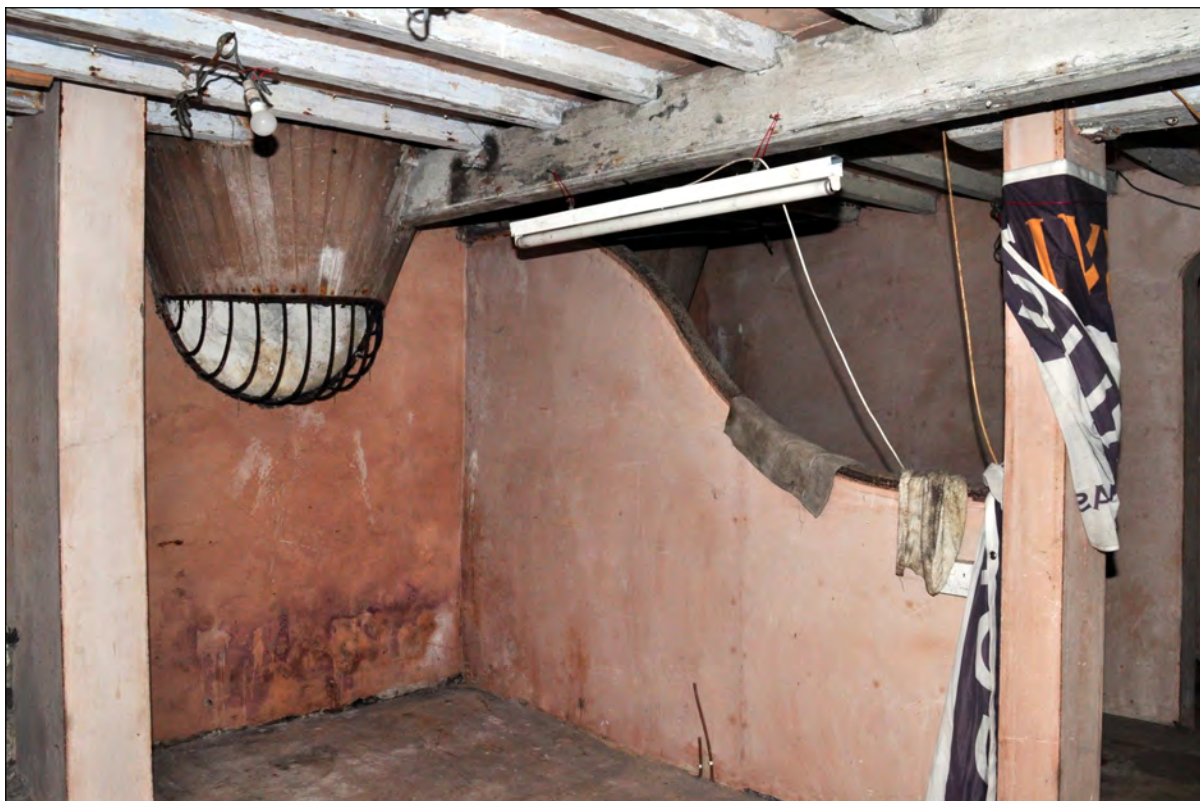
- 6.5 The barn interior has undergone various alterations through its life. The stable within the former shippon contains a single, ramped stall divider, partly concealed but likely to date from about 1900, and cast iron hay racks fastened to the wall to either side of it suggest that two horses were housed here. More recent work has involved new partitions and the insertion of a modern staircase, creating a domestic character. The wall faces of the barn's two other bays to the north have been plastered and a new ceiling inserted, so that this area, perhaps formerly used for threshing and storing hay, is entirely modern in appearance. However the roof structure is very largely intact, and comprises two principal rafter trusses fashioned from pegged oak. The tie-beam of the south truss is a good example of a re-used, whole-tree cruck, with the characteristic halvings for tie and collar. The north tie-beam is not visible.

Photo 9: Stable (former shippon) in south end of barn

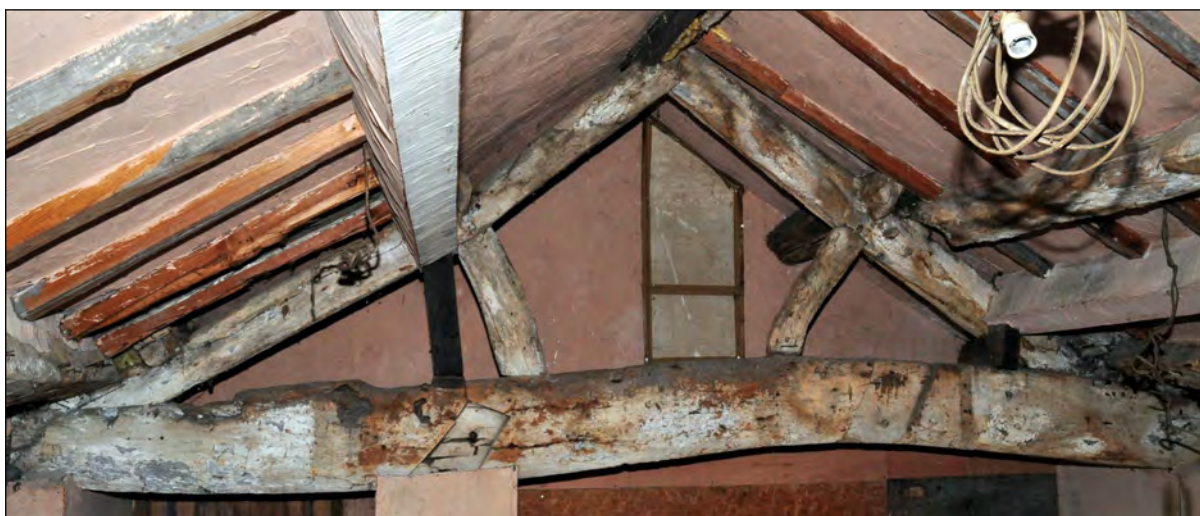
Photo 10: South roof truss in barn. Tie-beam is re-used cruck
