**GEOENVIRONMENTAL SITE INVESTIGATION  
REPORT  
PHASE II SITE INVESTIGATION  
OF LAND AT  
LOWERCROFT ROAD  
BURY**

**October 2023  
GSI 1923 LR PII Report V1**

| Quality Assurance | |
|---|---|
| Project Name | Lowercroft Road, Bury |
| Report Type | Ground Investigation |

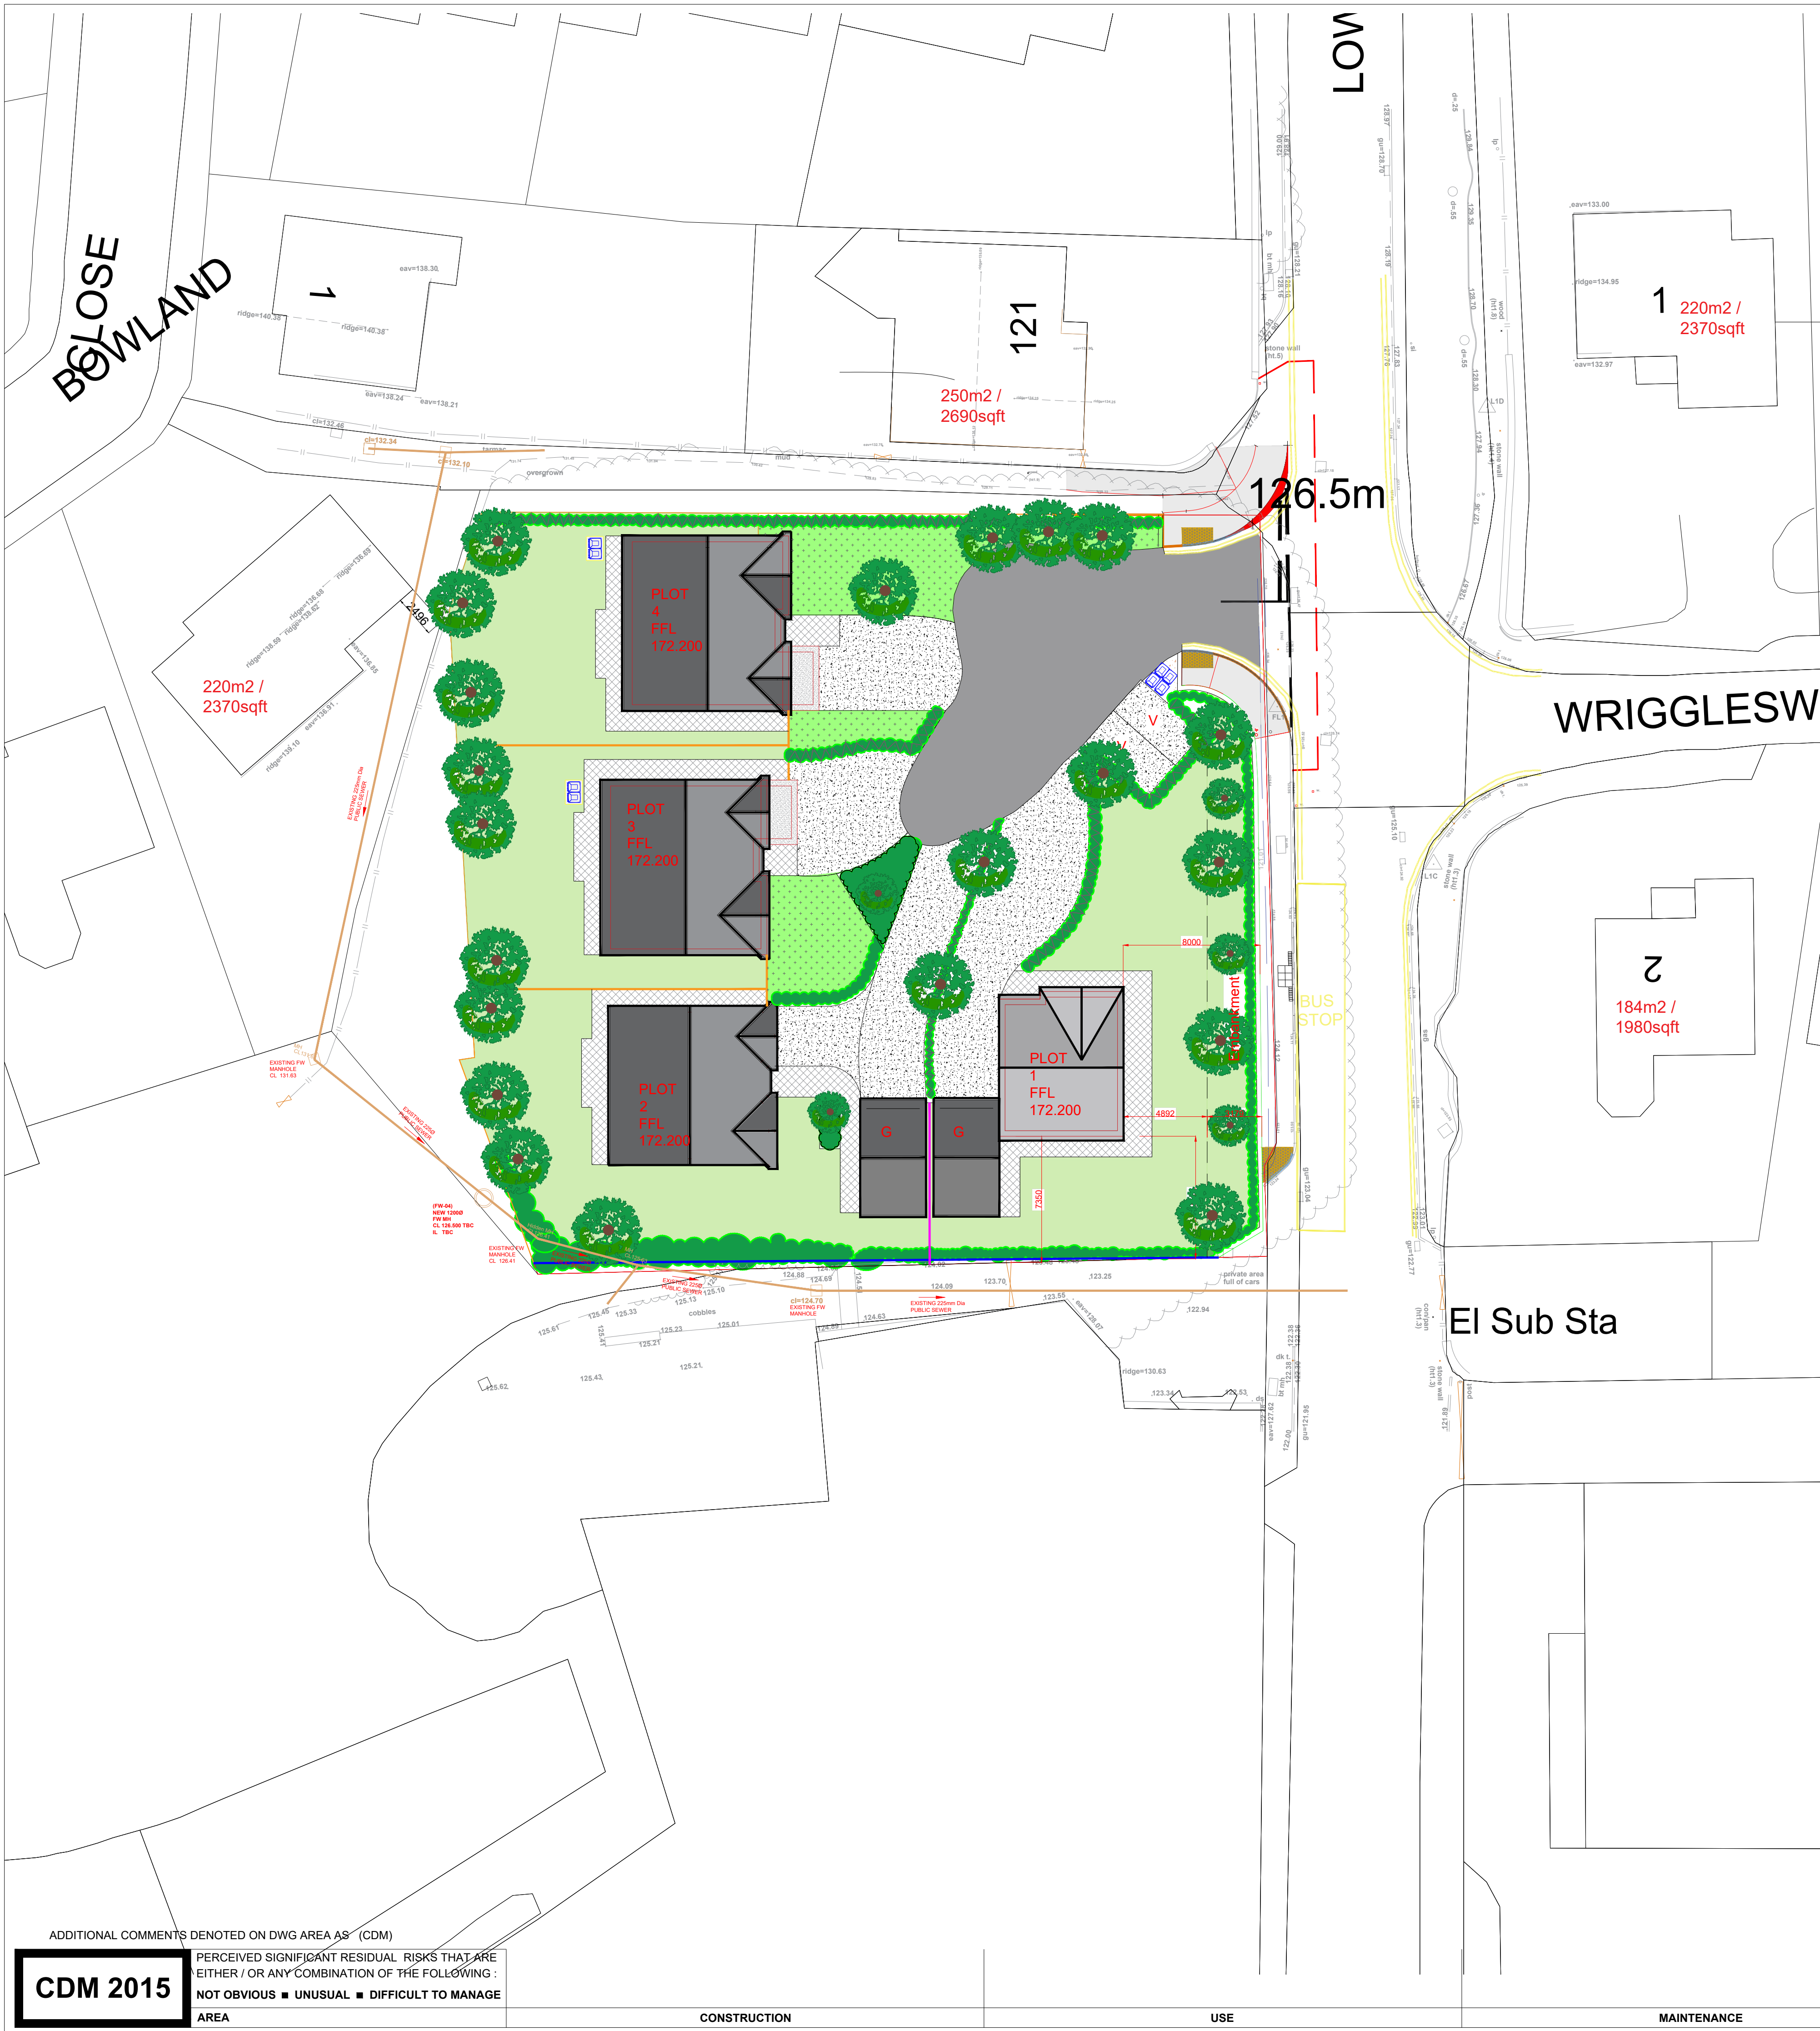
| TITLE | Site Plan |

Boundary Treatments : Scale @1:50 A1

| 1 | Plot 1 size reduced, added boundary dims | A.H | H.K | 26/06/23 |
