# Millwood School Extension

## Factual Report

Probing, Locating, Drilling and Treatment for Shallow  
Mine Workings

| <b>Summary Table</b> | |
|---|---|
| <b>Factual Report for the probing and treatment of shallow workings beneath new proposed development at the Former Roseberry College Site.</b> | |

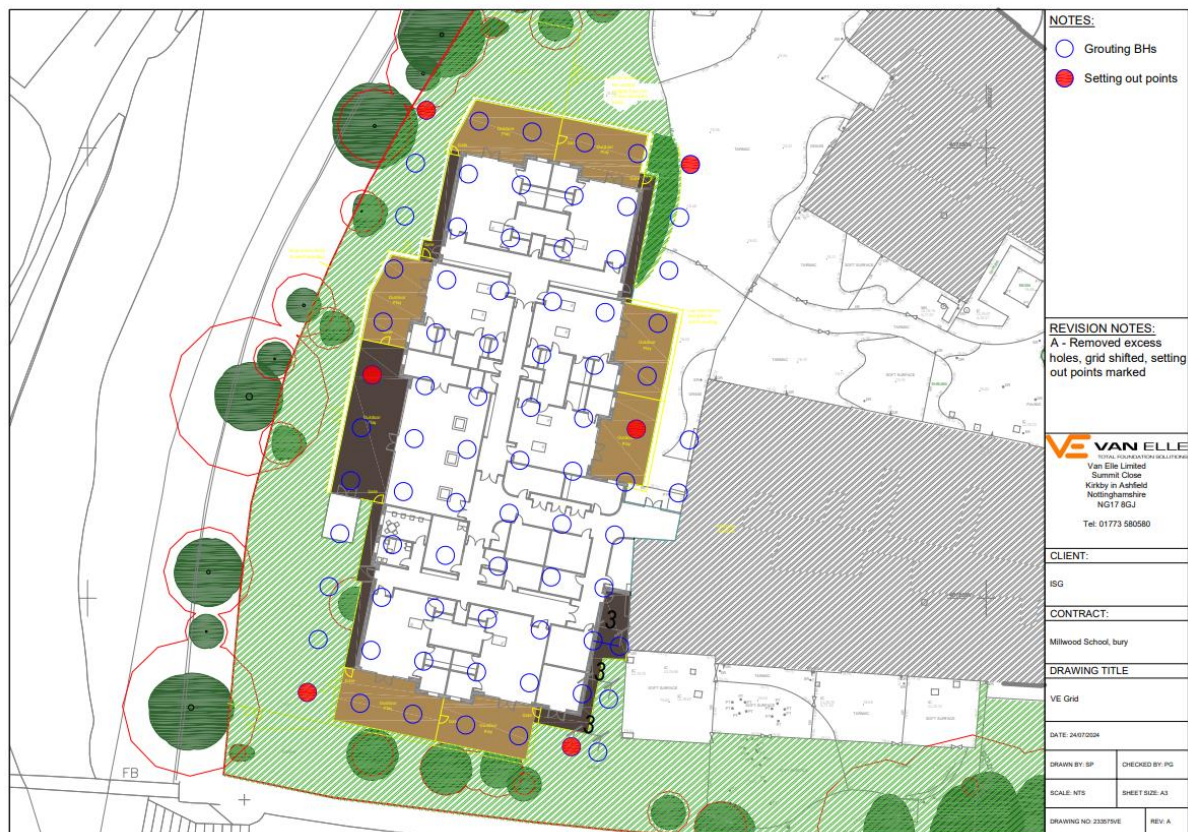
Figure 1 – Stabilisation plan.

Figure 1 shows the area to be treated within the footprint of the development.

A 6m x 6m grid has been superimposed on the footprint of the proposed building. The treatment boreholes will be drilled to an average depth of 50m below existing ground level (or 1m below seam) to intercept the target seam(s). If any workings are encountered then the grid will be closed to a 4.25m grid.
