**Spurr House, Bury**

**Arboricultural Impact Assessment**

**Bury Council**

Project No.: GAR001-003

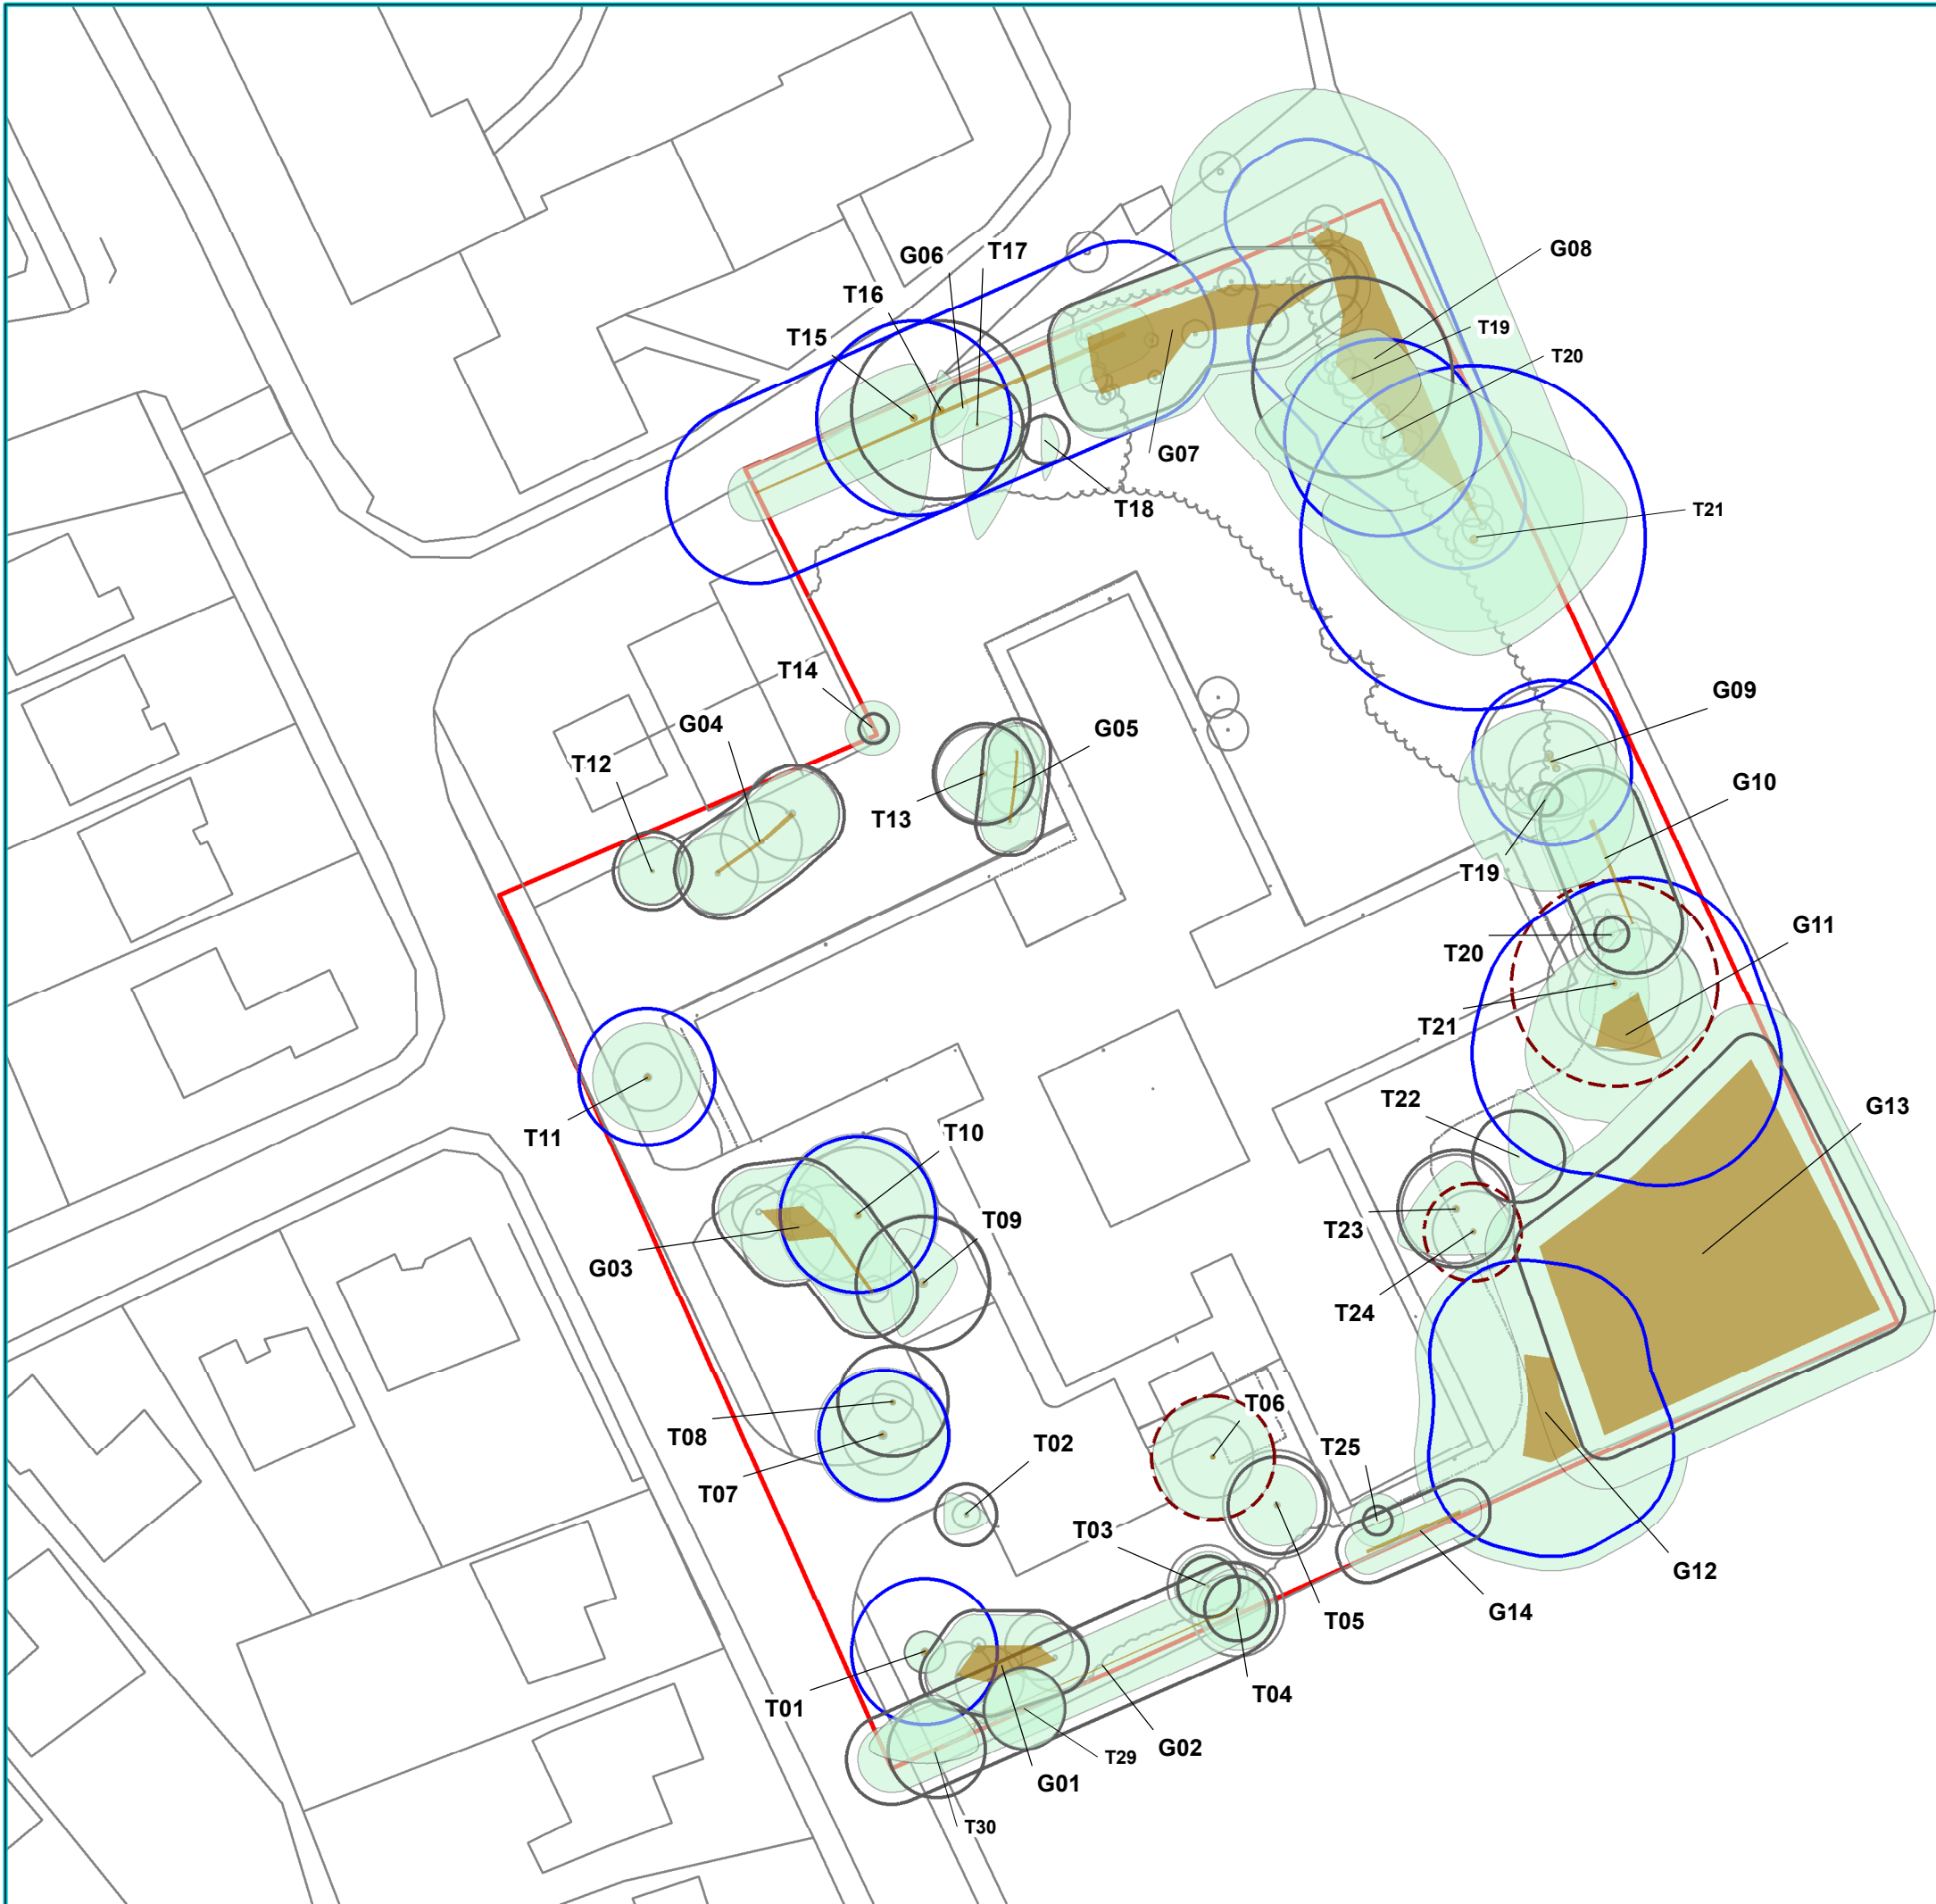
Figure Number  
2

- 1.1.5 A total of 30 individual trees and 14 groups of trees were recorded during the survey, details of which are listed in the Tree Schedule. The surveyor recorded 0 Category A tree features, 7 Category B individual trees, 5 Category B groups of trees, 20 Category C individual trees, 9 Category C groups of trees and 3 Category U individual trees located within or adjacent to the site (see Figure 2).

Figure Title  
Tree Constraints Plan  
(TCP01)

| Originator | Reference No. | Title |
|---|---|---|
| Thomson EC Ltd | Fig 2 | Tree Constraints Plan |

Installation of fence should avoid tree removal in this area. Fence to be re-aligned to avoid tree stems as necessary

Figure Title  
Tree Retention and  
Removal Plan  
(TRRP)

- 1.1.6 The development proposals directly require the removal of T01, G01, T02, T03, T05, T06, T07, T08, T09, T10, G03, T12, G04, T13, G05, T14 and T25.

**2.2.1** The development proposals require the removal of T01, G01, T02, T03, T05, T06, T07, T08, T09, T10, G03, T12, G04, T13, G05, T14 and T25 which are marked on the attached Tree Retention and Removal Plan.
