**Job title:** New Office Block, Bury

**Report type:** Preliminary Risk Assessment

| Document Control Form | |
|---|---|
| REPORT NAME | PRELIMINARY ENVIRONMENTAL RISK ASSESSMENT |
| REPORT REFERENCE | GRO-21438-3118 |

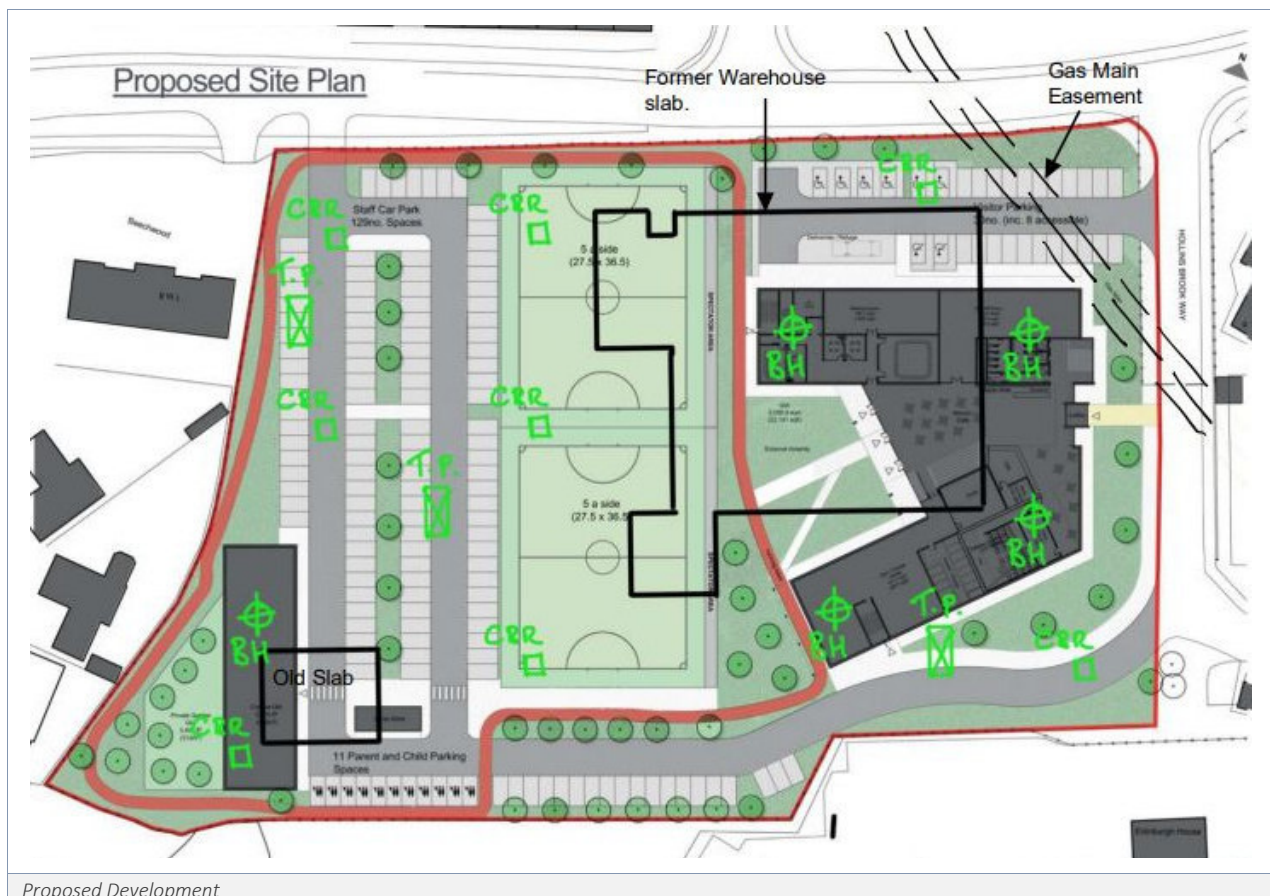
The proposed development is commercial end use comprising a new office block with associated hardsurfaced car park and staff facilities including two 5-a-side football pitches.
