**PROPOSED RESIDENTIAL DEVELOPMENT  
ON LAND AT DOVEHOUSE CLOSE  
WHITEFIELDS, BURY M45 7PE**

**MAY 2023**

**GEO-ENVIRONMENTAL DESK STUDY REPORT**

**2304/1921**

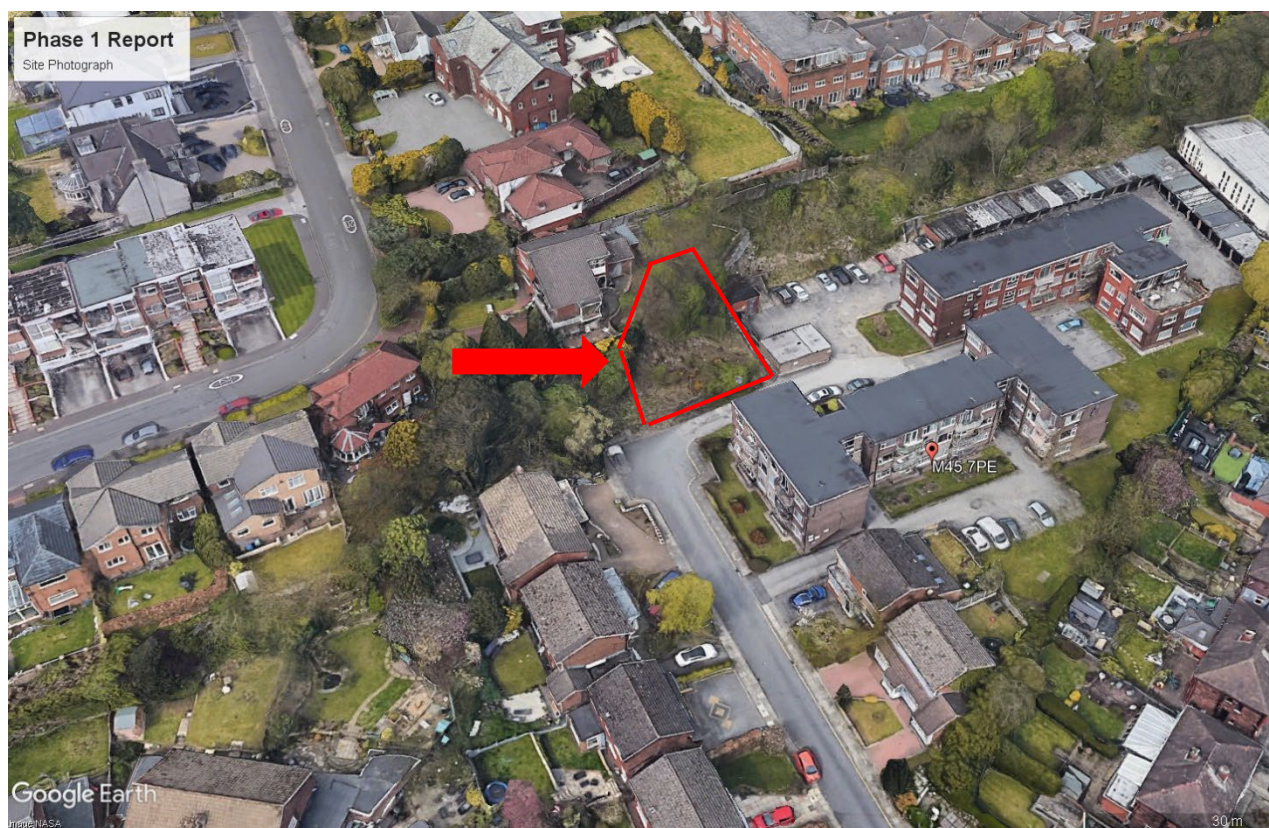
**Figure 2023-1 Site Location**

2.1.1 The site is roughly square in shape with the northwest corner cut off and is situated on the northern side of Dovehouse Close. The site is situated at approximate National Grid Reference SD 79973 05523 within a predominantly residential area. The site location is shown in figure 1 below.

- 2.3.2 Reference to the historical Ordnance Survey maps in appendix 7 from 1852 to 1967 have indicated that the site has remained as agricultural land and a sand pit up until the early 1930's, and once the quarry was worked out in the 1930's the base of the quarry has been used for development of apartments on Dovehouse Close, refer to figure 1.
