## **Phase 1 & Phase 2 Geoenvironmental Desk Study & Ground Stability Risk Assessment for East Lancashire Paper Mill Island Site, Rectory Lane, Radcliffe, M26 2QU**

**Project No: NX418**

**Report Reference:** NX418**Issue:** Rev 2**Date:** 16<sup>th</sup> June 2021**Written by:**Robbie Lee  
Geoenvironmental Engineer (For and on Behalf of NX Consulting Ltd).**Written & Approved by:**Mark Newton  
Director (For and on Behalf of NX Consulting Ltd).

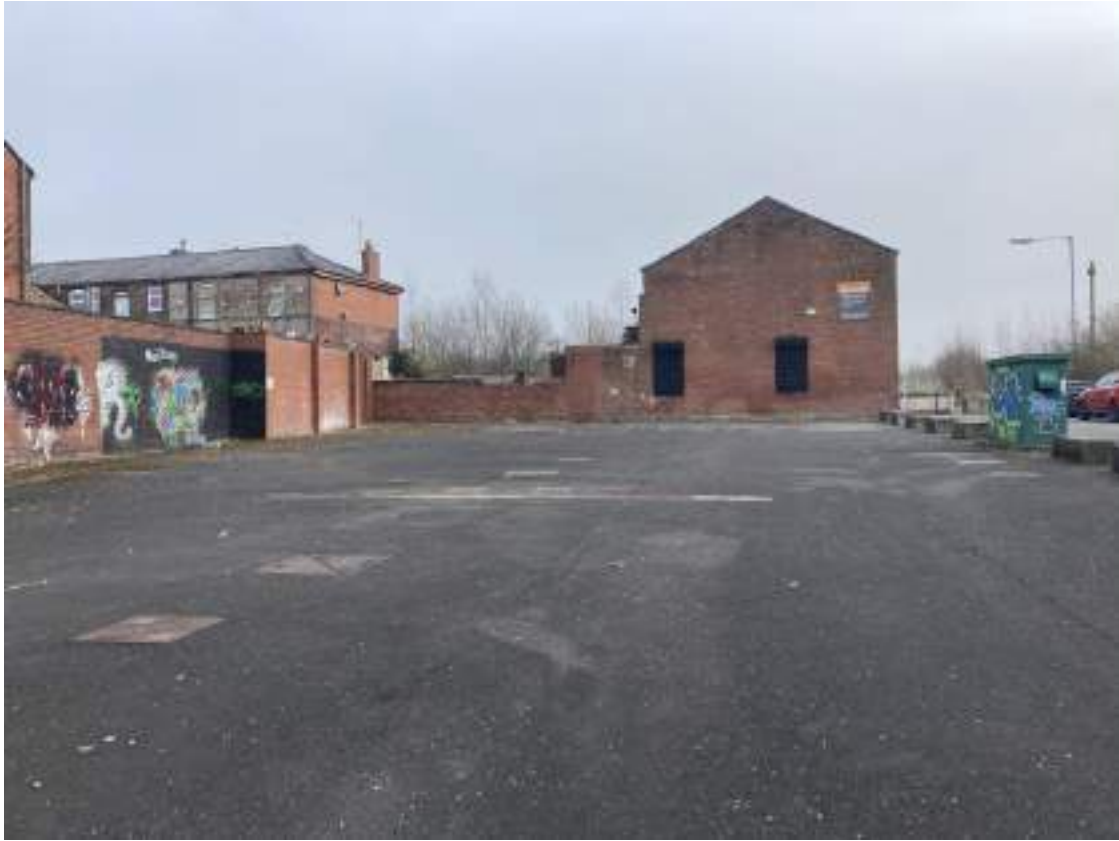
**Plate 1 – South-eastern corner of site looking east towards the former public house**

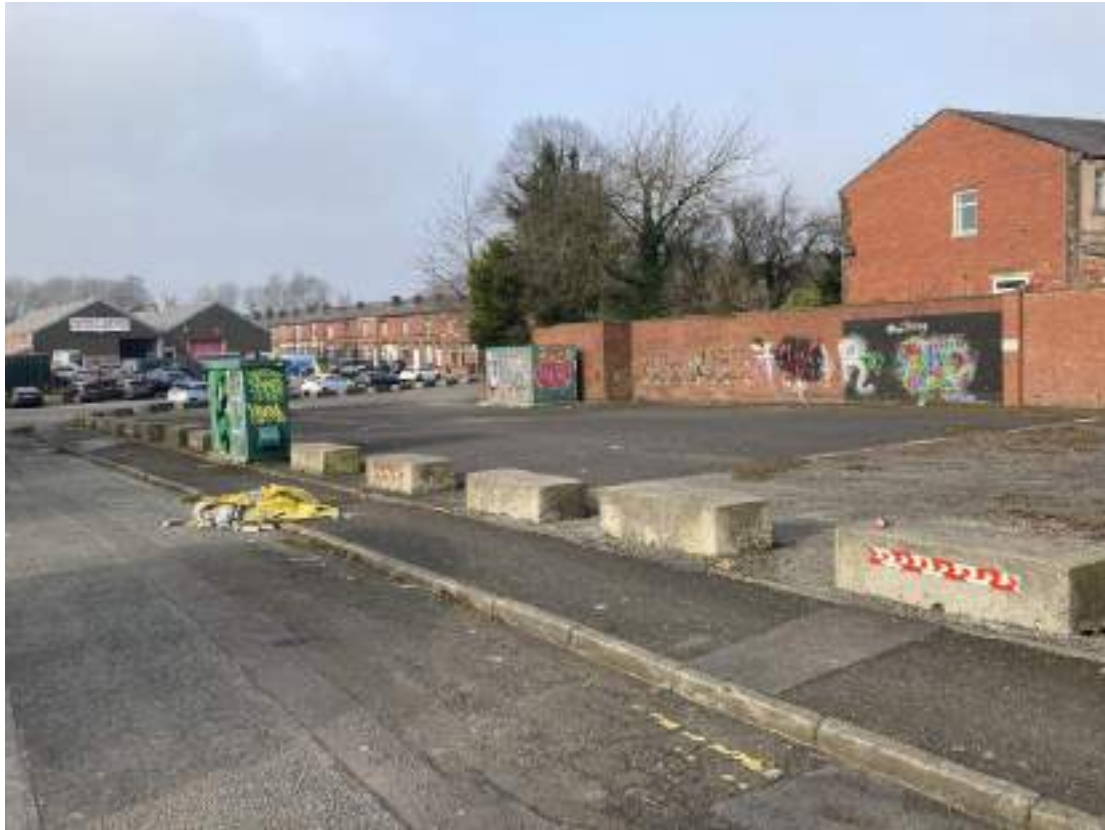
**Plate 3 – South east corner of site looking west. Concrete bollards represent the southern boundary curving round as the eastern boundary is the distance.**

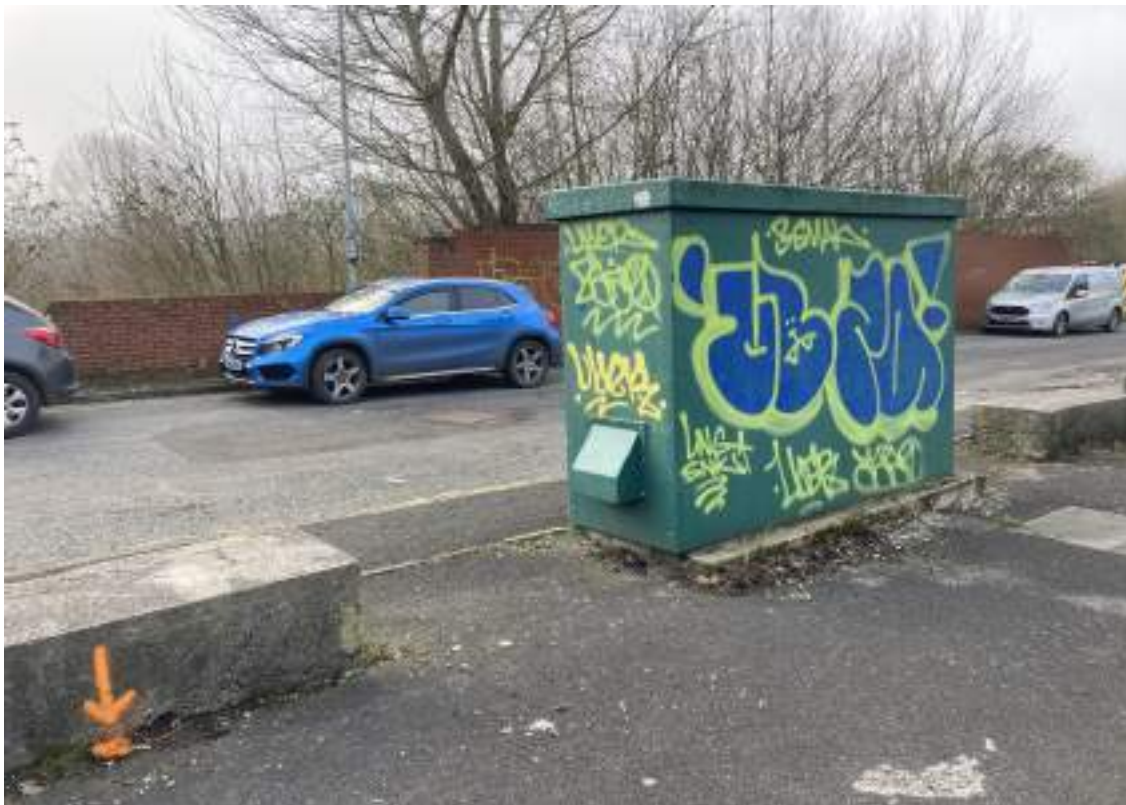
**Plate 4 – Container on southern boundary of site**

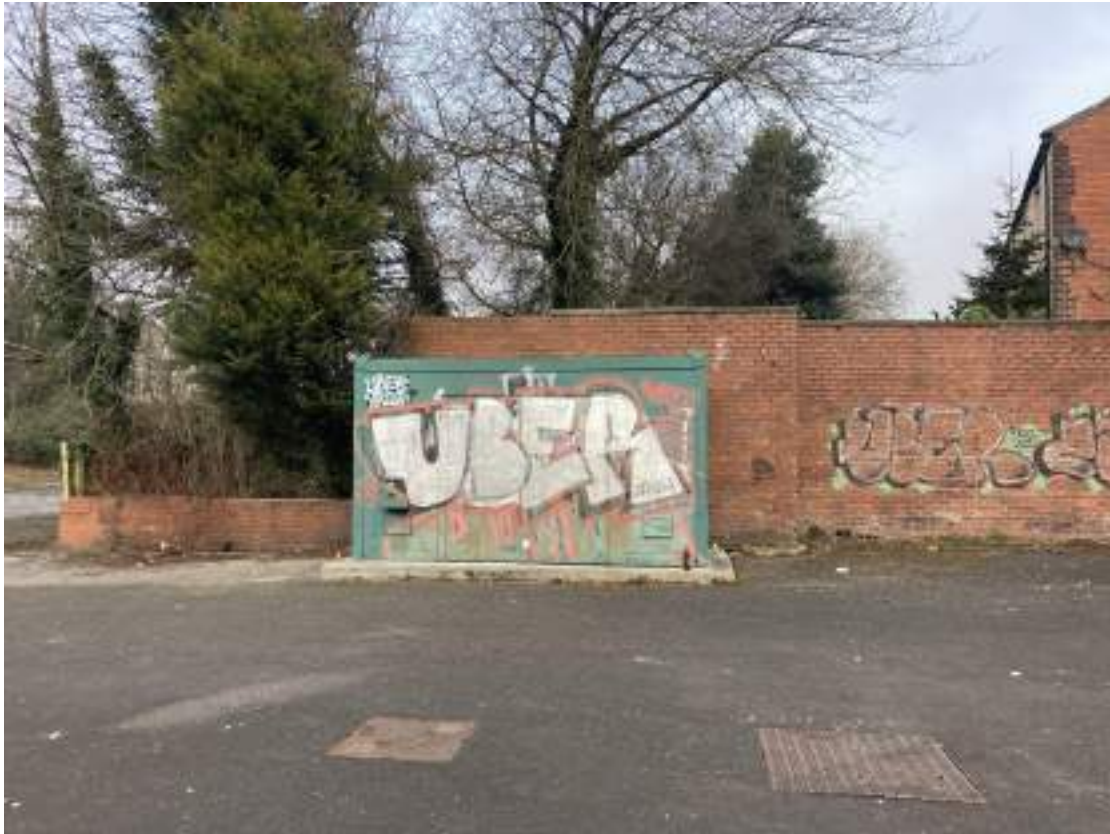
**Plate 5 – Container in the south east corner of site. Note Services**

There are several buried services including a culverted watercourse underneath the site, the foundation solution should allow for protection measures and ensure no damage to these services.

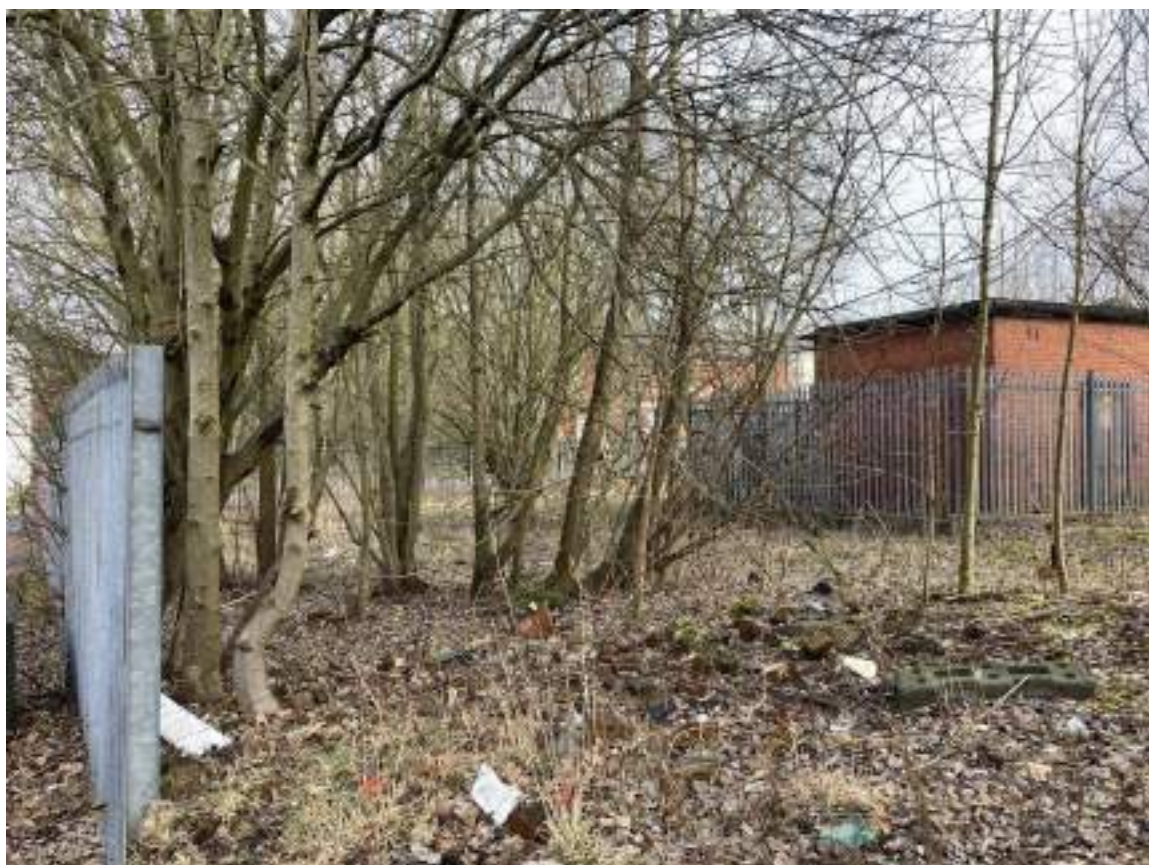
**Plate 13 – North west corner looking north with electrical substation**

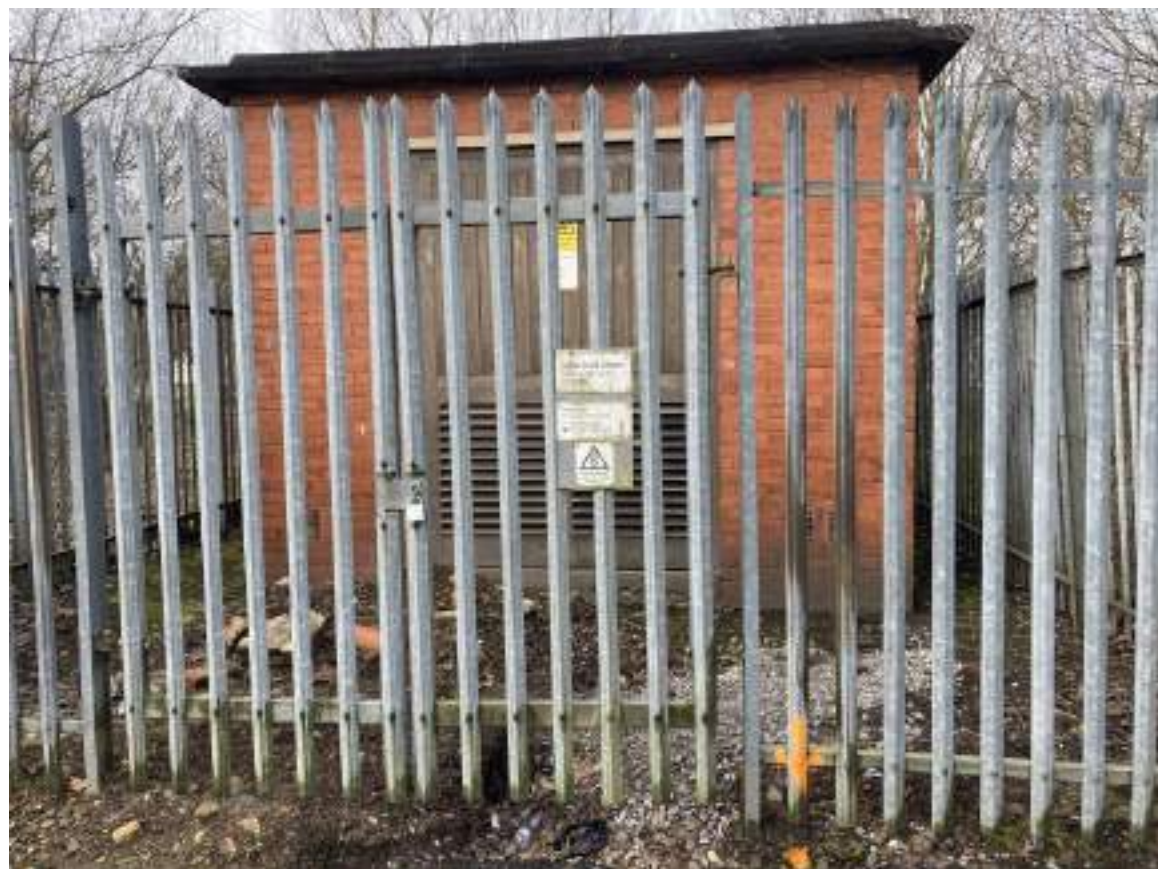
**Plate 15 – Electrical substation in north west corner**
