## Phase 3 Site Investigation Report

**Former Texaco Fuel Station  
Bury Old Road  
Prestwich, M25 0EY**

**Report Title:** Phase 3 Site Investigation Report  
Former Texaco Fuel Station, Bury Old Road,  
Prestwich, M25 0EY.

**Report Reference:** 649.00.01

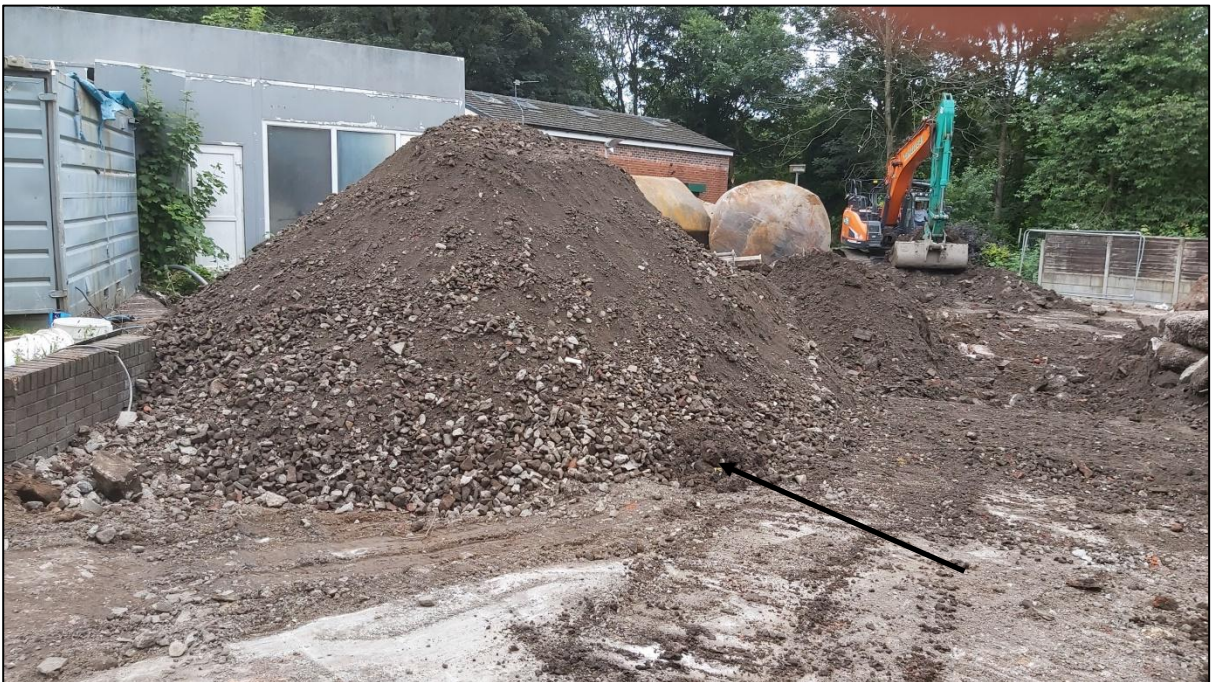
**Photograph 6 – Imported 6F2 Used to Backfill Tank Excavations**

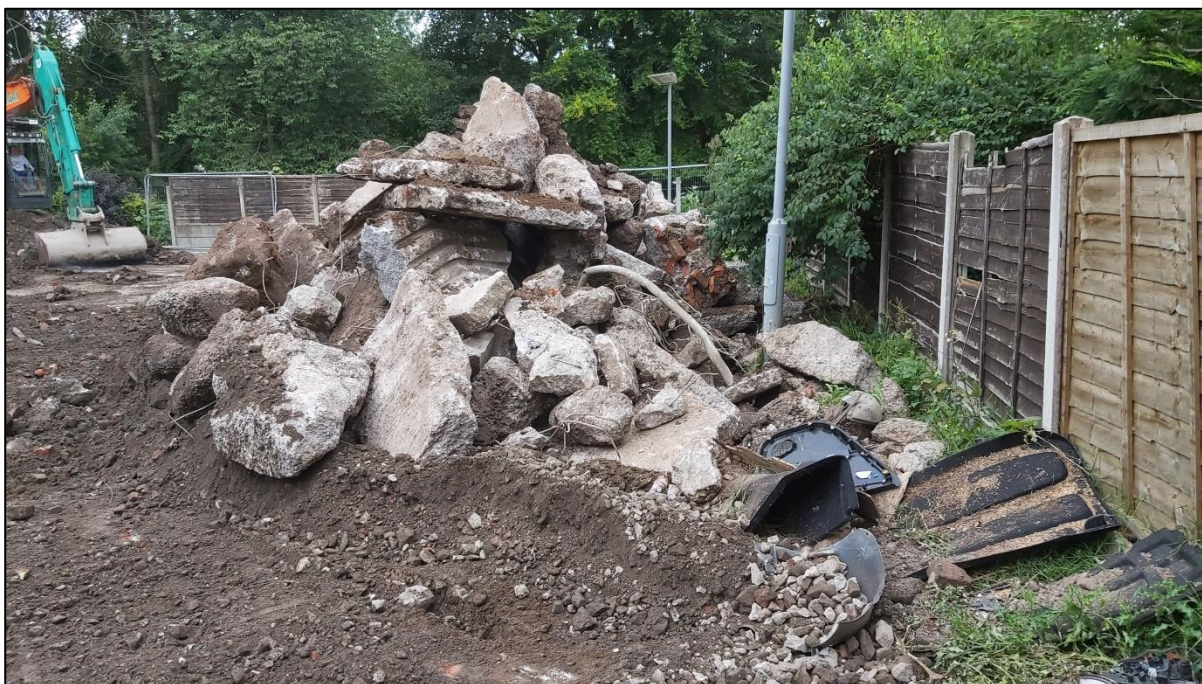
**Photograph 7 – Concrete Hardstanding to Be Taken Off Site for Recycling**

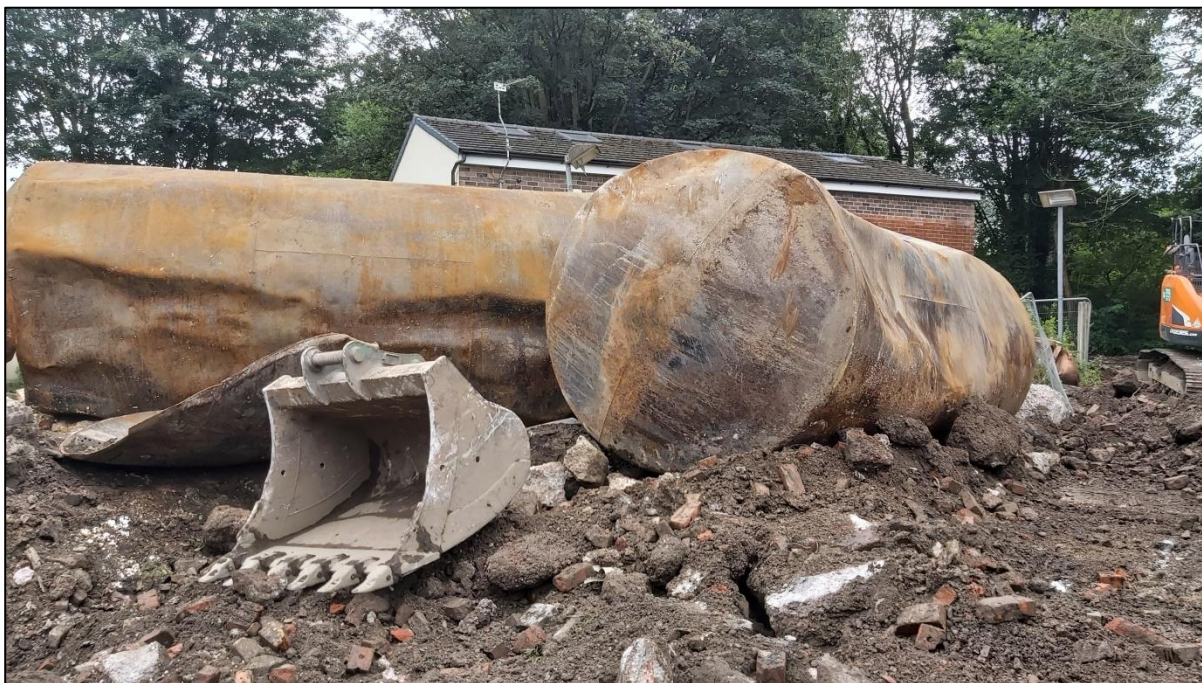
**Photograph 8 – Removed Tanks Waiting for Transport off Site**

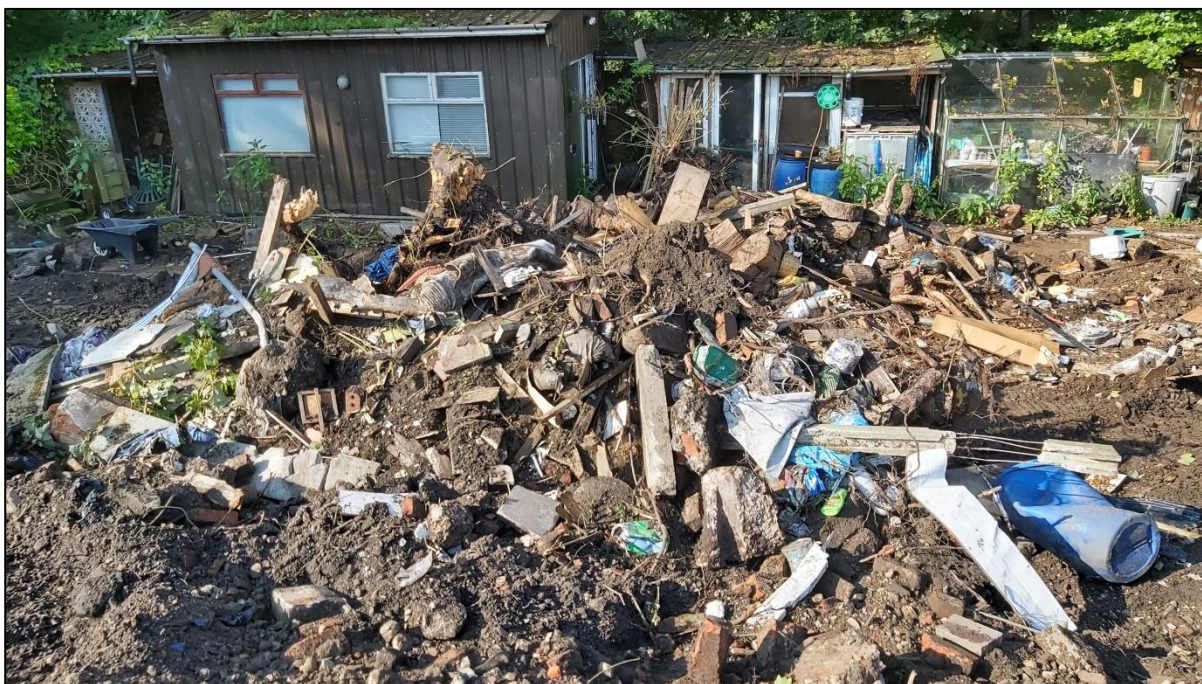
**Photograph 10 – Cleared General Waste, Wood, Plastic etc temporarily stored on adjacent site (this site also owned by the developer) prior to disposal off-site**

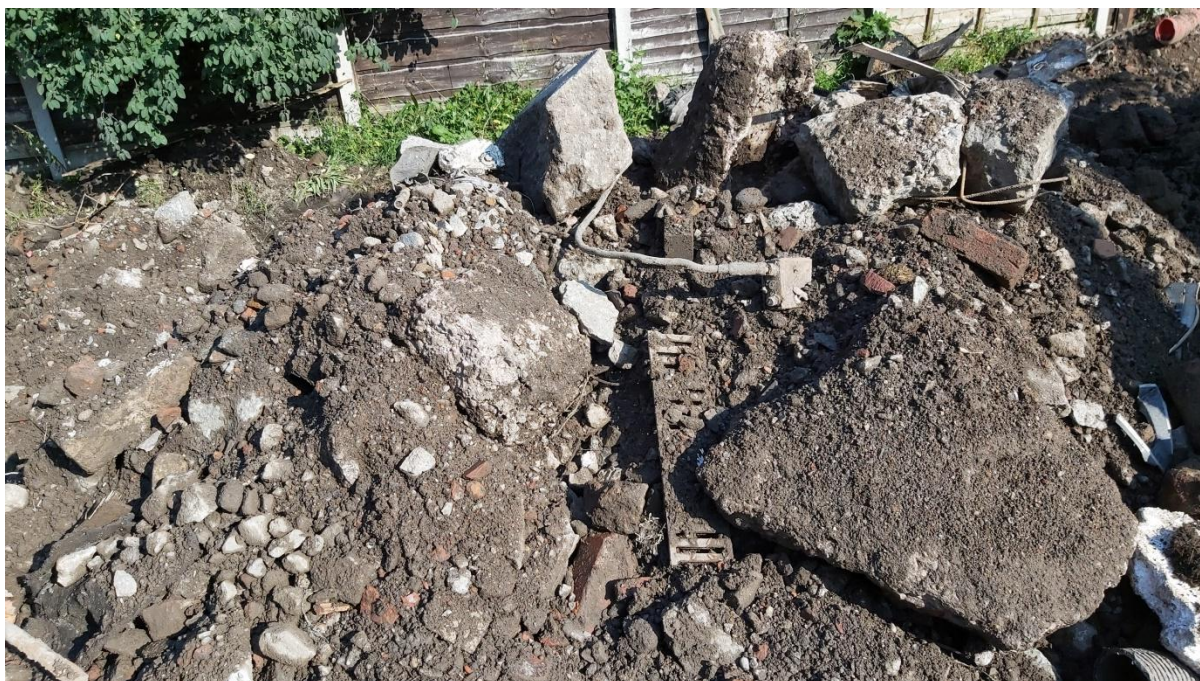
**Photograph 11 – Excavated Concrete Hardstanding Stockpiled Prior to be Taken Off Site for Recycling**

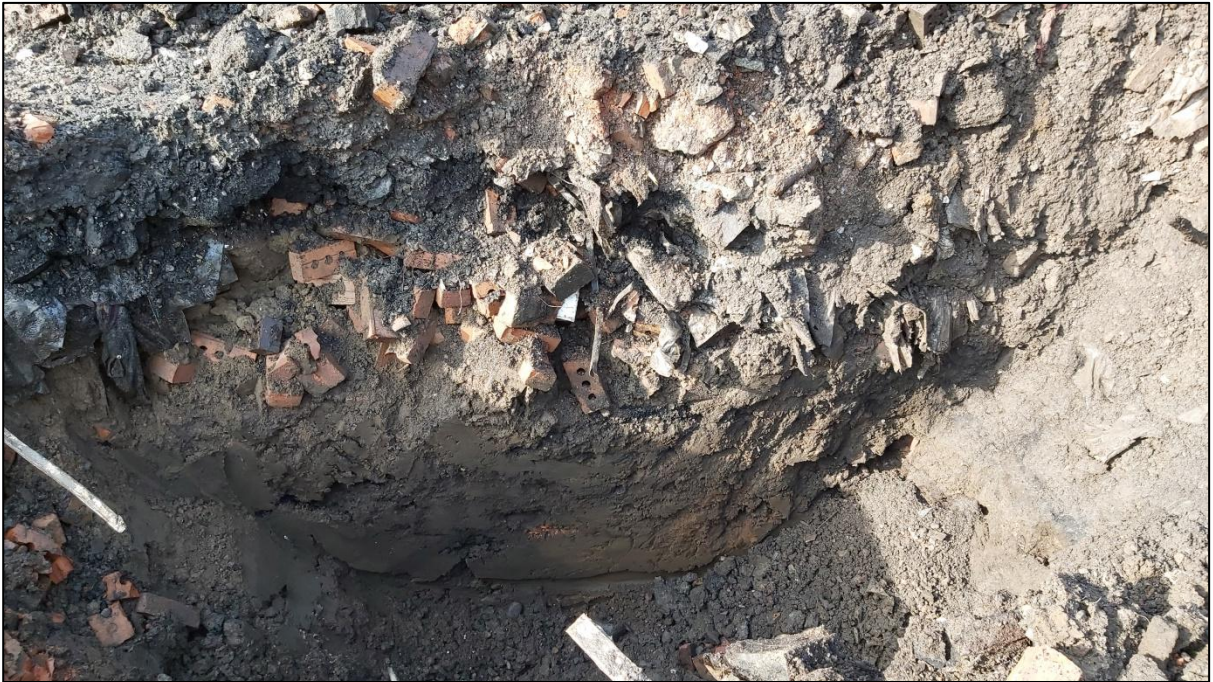
**Photograph 2 – TP1 Side of Pit**

A buried brick wall/foundation was encountered in the eastern end of TP1.

- 0.00 – 1.20 m Variable Demolition Material – Principally bricks and brick fragments and concrete with plastic sheet, piping, metal, wood, asphalt etc. (MADE GROUND)  
Brick foundation/wall in north eastern end of pit. Sample CS1 1.00 m
- 1.20 – 2.10 m Brown clayey very gravelly ashy SAND with a low cobble content. Gravel and cobbles of angular to subangular of brick and sandstone. (MADE GROUND)  
Sample CS2 1.75 m
- 2.10 - 3.10 m Brown silty fine SAND (GLACIOFLUVIAL DEPOSITS) Sample CS3 2.15 m

A buried wall/foundation was present at the eastern end of TP1. Other man-made obstructions may be present below the ground and these will require removal prior to piling and foundation construction.

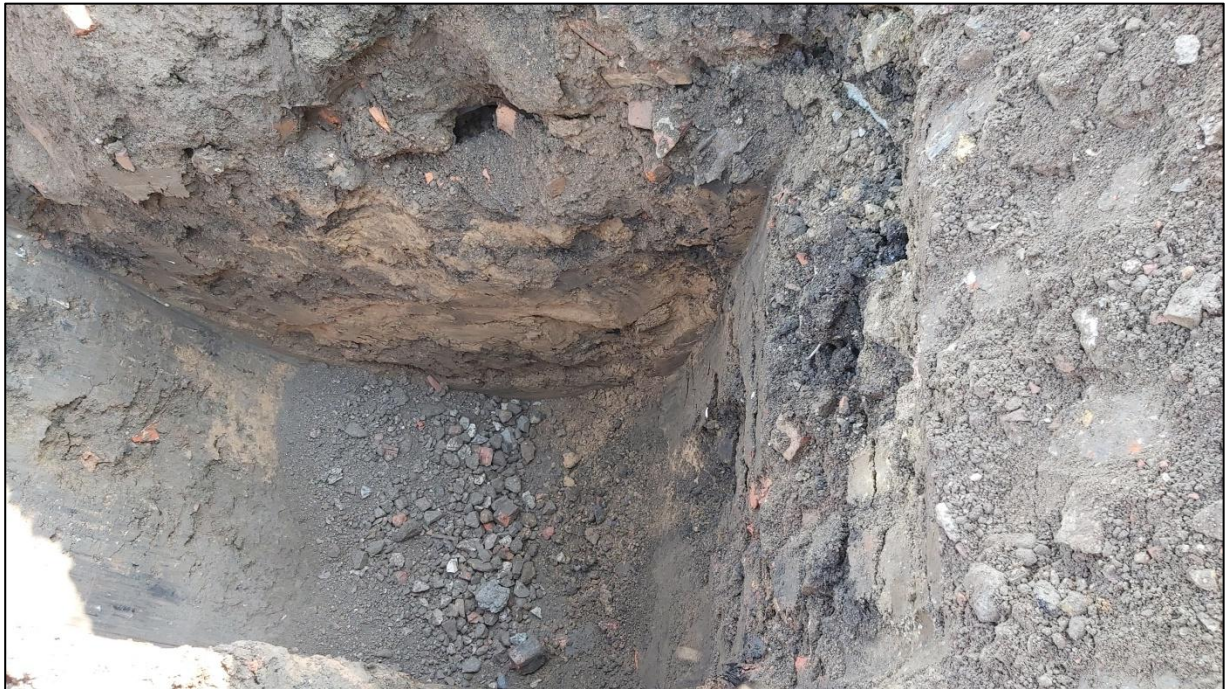
**Photograph 4 – TP2**

**1.55 – 2.40 m** Brown silty fine SAND (GLACIOFLUVIAL DEPOSITS) Sample CS3 2.30 m

**No groundwater encountered. No hydrocarbon odours**

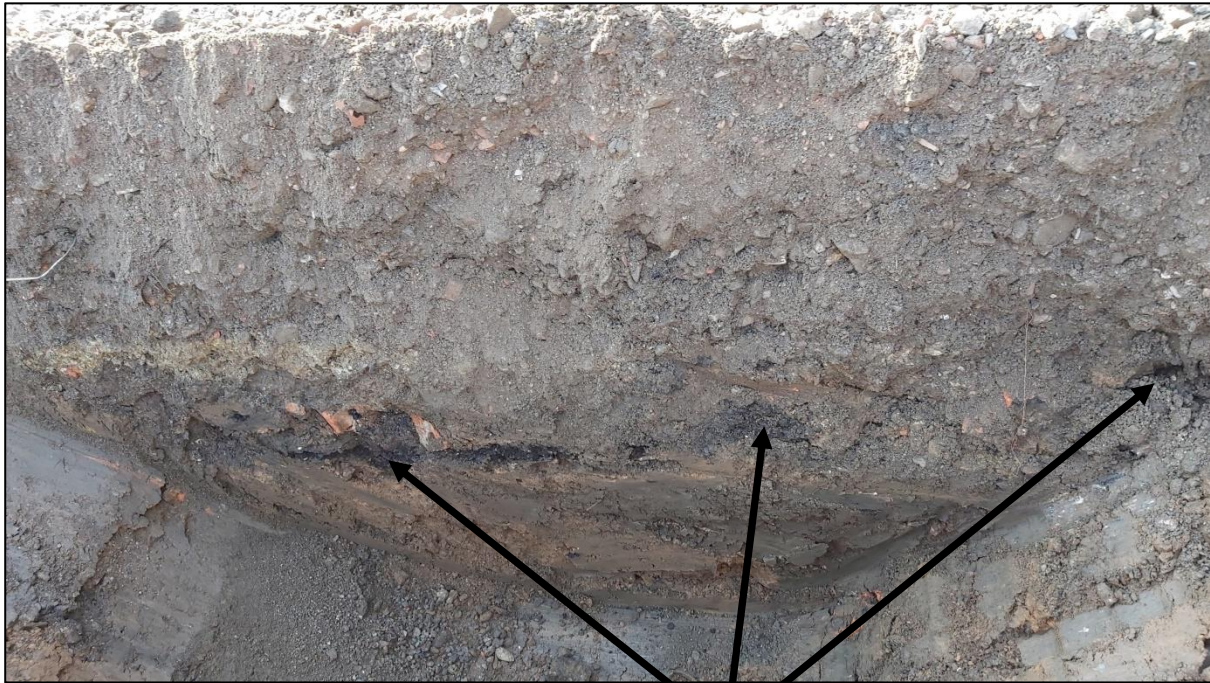
- 0.00 – 1.00 m Brown clayey very sandy GRAVEL with rare cobbles. Gravel angular to subangular of brick, clinker, asphalt and concrete with <1% wire & wood. Occasional pockets of black ash/clinker making up <1% of trial pit (MADE GROUND) Sample CS1 0.65 m from ash layer CS2 0.90 m
- 1.00 – 1.80 m Brown silty fine SAND (GLACIOFLUVIAL DEPOSITS) Sample CS3 1.80 m

Photograph 6 – TP3 Black ash layer/pockets

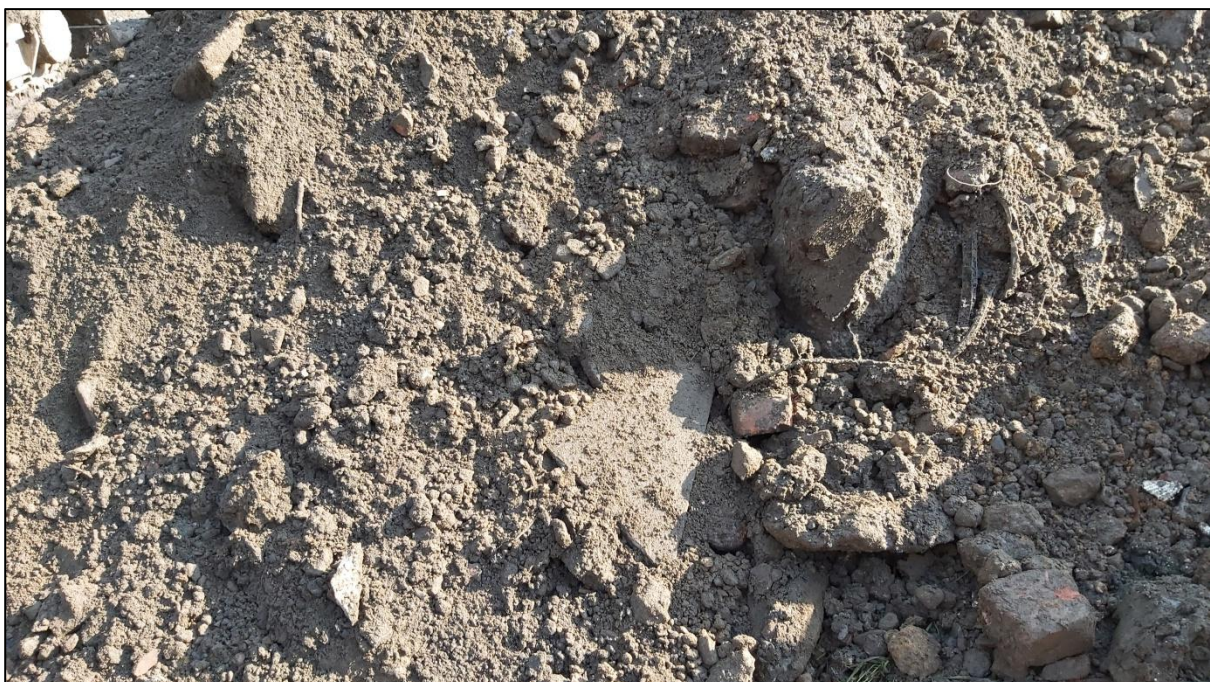
Photograph 7 – TP3 Spoil of Made Ground
