## Three Buildings & Chimney Former Mondi Site, Holcombe Mill Bridge Street Ramsbottom

Level 1-2 Historic Building Recording  
[Report No. 4556](#)

**Level 1-2 Historic Building Recording**

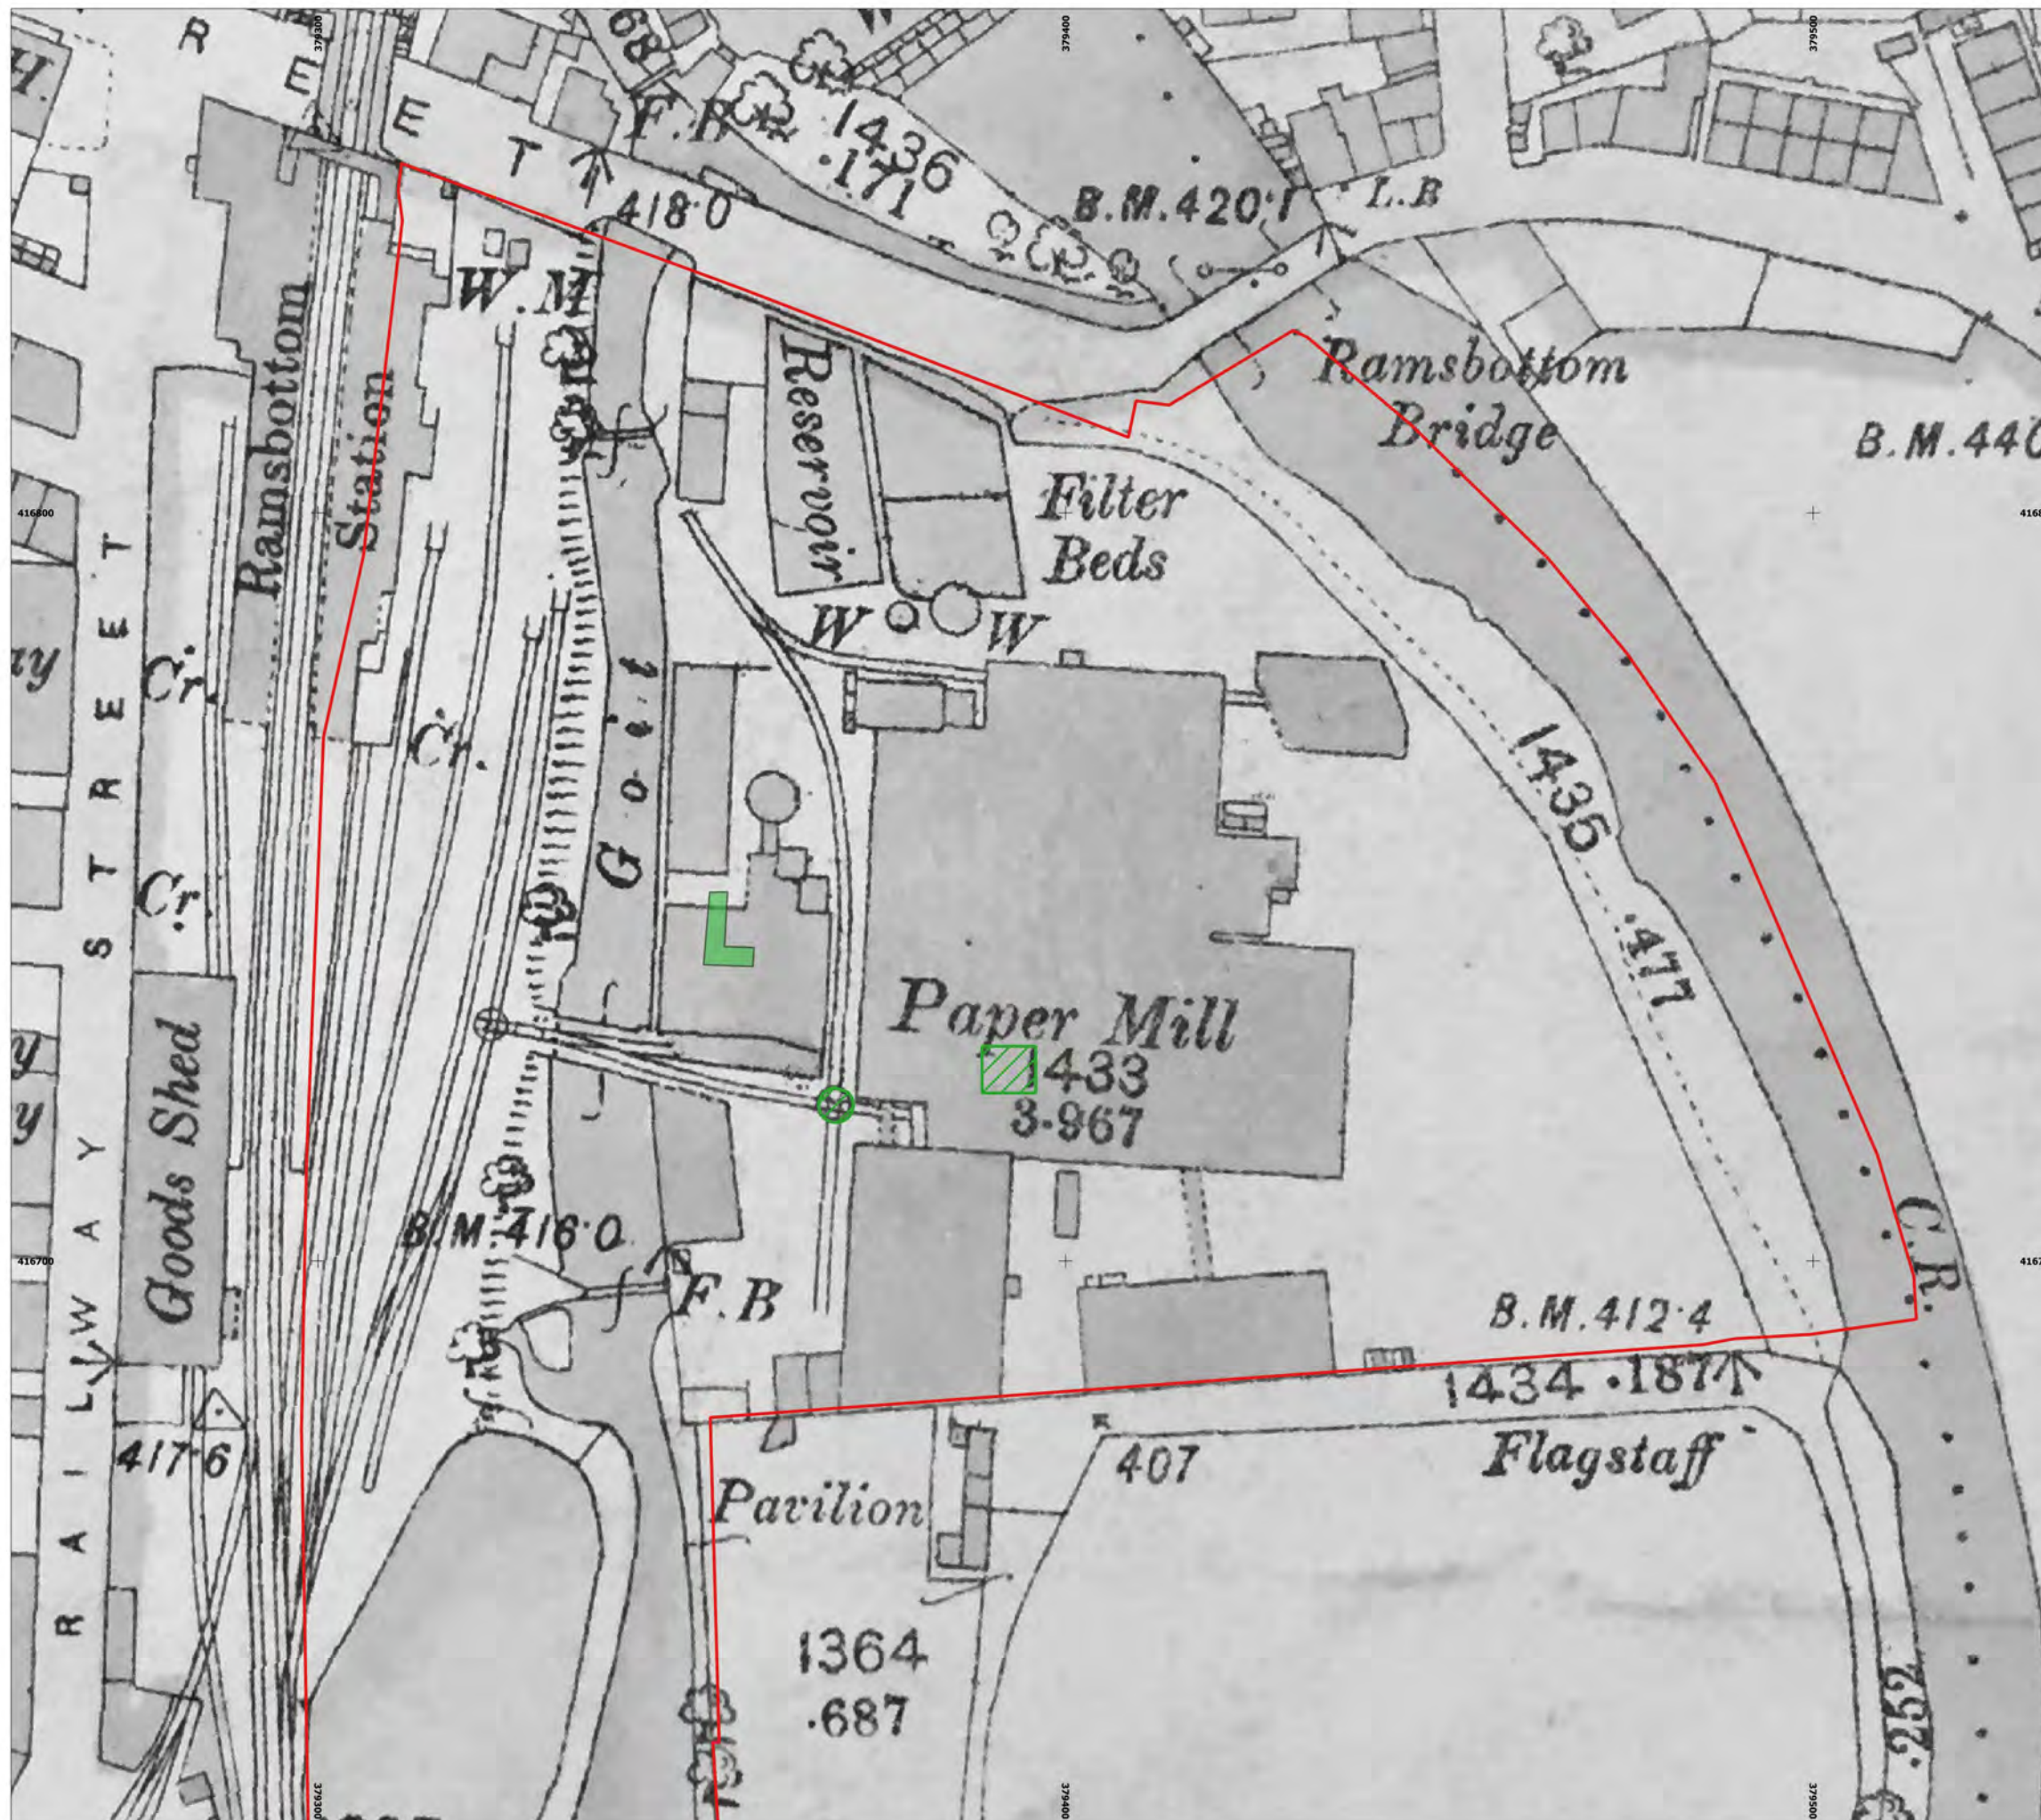
**Figure 3: Trench Location overlaid on 1892 Ordnance Survey Plan**

- Site Boundary
- Trench Plan
- Targeted Strip Map and Sample

4.1.2 The fieldwork will comprise of 1 trial trench and 2 areas subject to targeted strip map and sample. The extent of the site subject to targeted strip map and sample and evaluation is depicted on Figure 3, which comprises Trench 1 (49.554 m<sup>2</sup>), Old Engine House strip map and sample (93.980 m<sup>2</sup>) and Turntable strip map and sample (16.856 m<sup>2</sup>).

- ◆ A low-level photographic survey of the surviving chimney and goyt should be undertaken prior to their refurbishment.
- ◆ The archaeological evaluation trenching plan needs some slight revisions to target the most appropriate parts of the site, including: an L-shaped Trench 1 in the former boiler house (No.7 on the 1983 plan shown in Figure 6 of the DBA), instead of Trench 3 a targeted strip-map-sample area over the footprint of the 'Old Engine House' (No.14A on the 1983 plan shown in Figure 6 of the DBA), Removal of Trench 2 and replacement with a targeted strip-map-sample area over the turntable at the south-east corner of the boiler house/south-west corner of the main mill structure depicted on the 1892 OS plan (Figure 3 of the WSI)

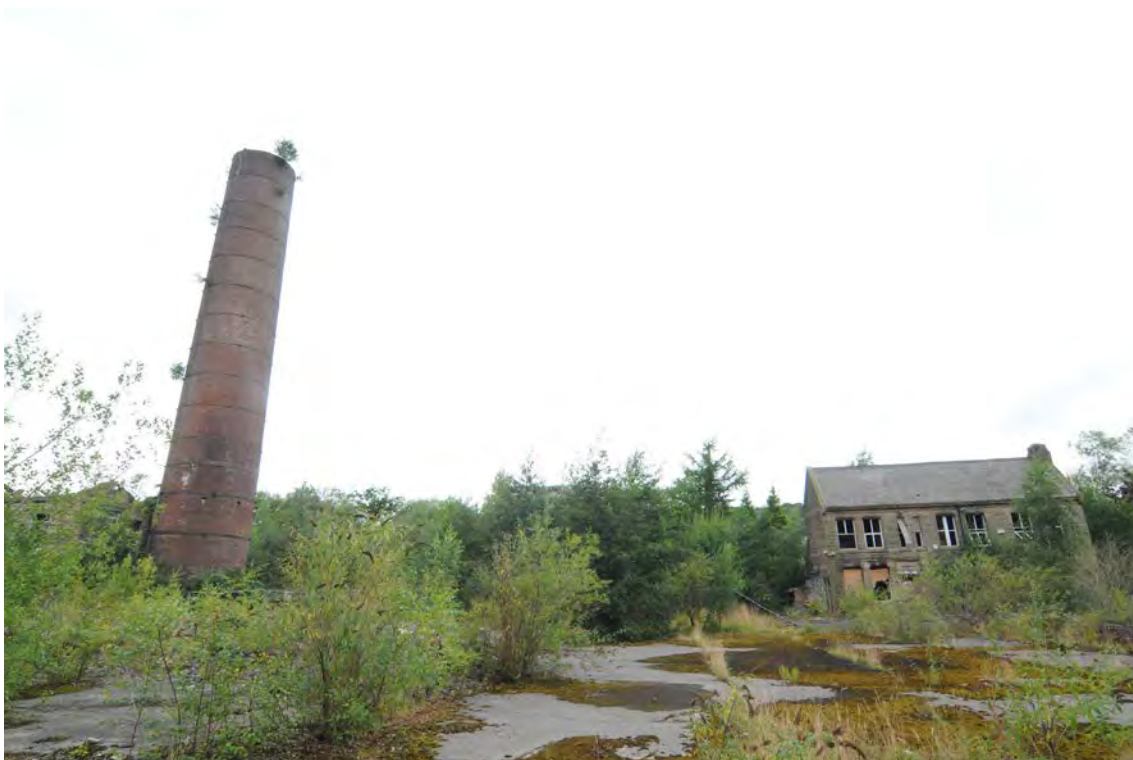
Photograph No : 1 Digital Ref: HOMI\_HBR\_0089 Direction: W  
Description: Westward view of site with Building A at north (right), Building B (centre, behind vegetation), Building C and Chimney at south (left)

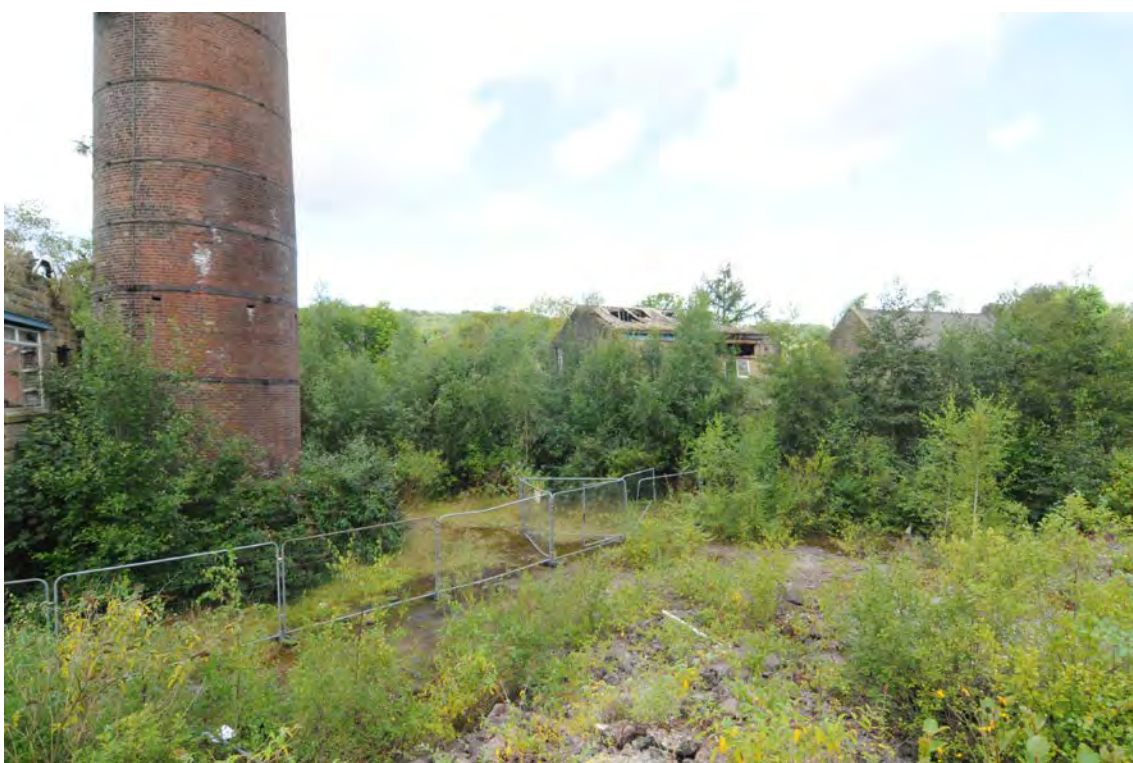
Photograph No : 2 Digital Ref: HOMI\_HBR\_0006 Direction: NW  
Description: NW view of site with Building A at north (right), Building B (centre), Building C and Chimney at south (left)

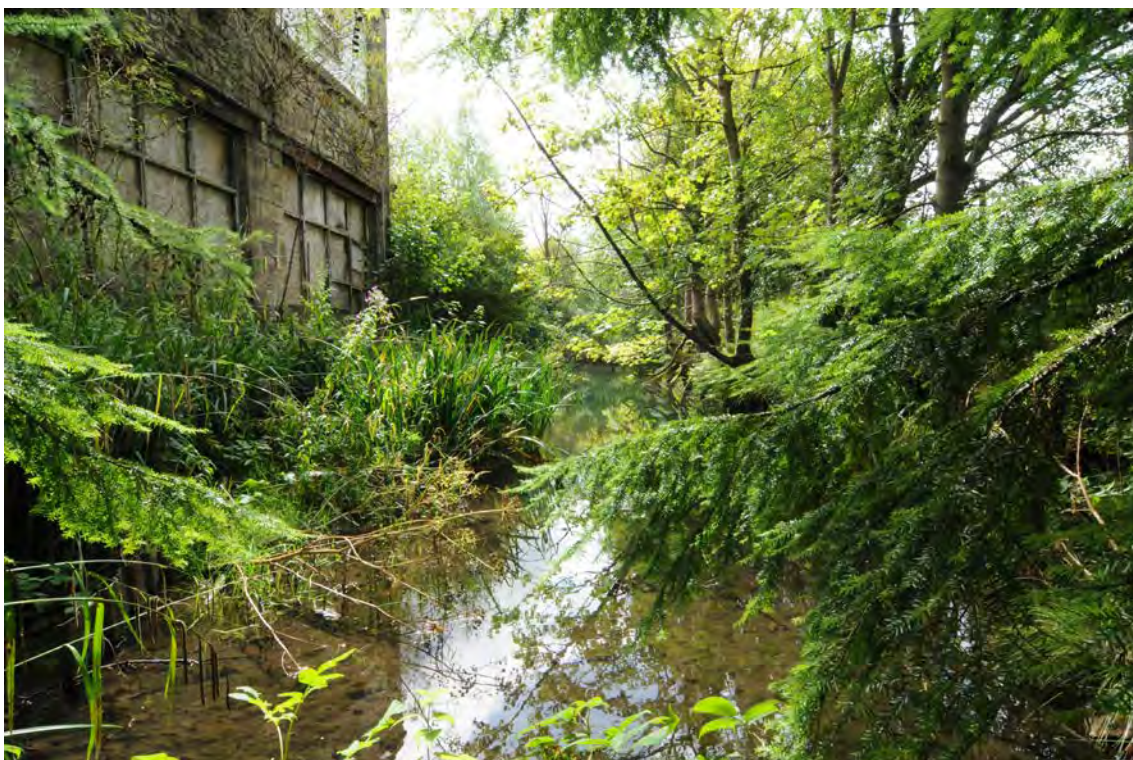
Photograph No : 3 Digital Ref: HOMI\_HBR\_0064 Direction: S  
Description: Remains of goit and west elevation of Building B

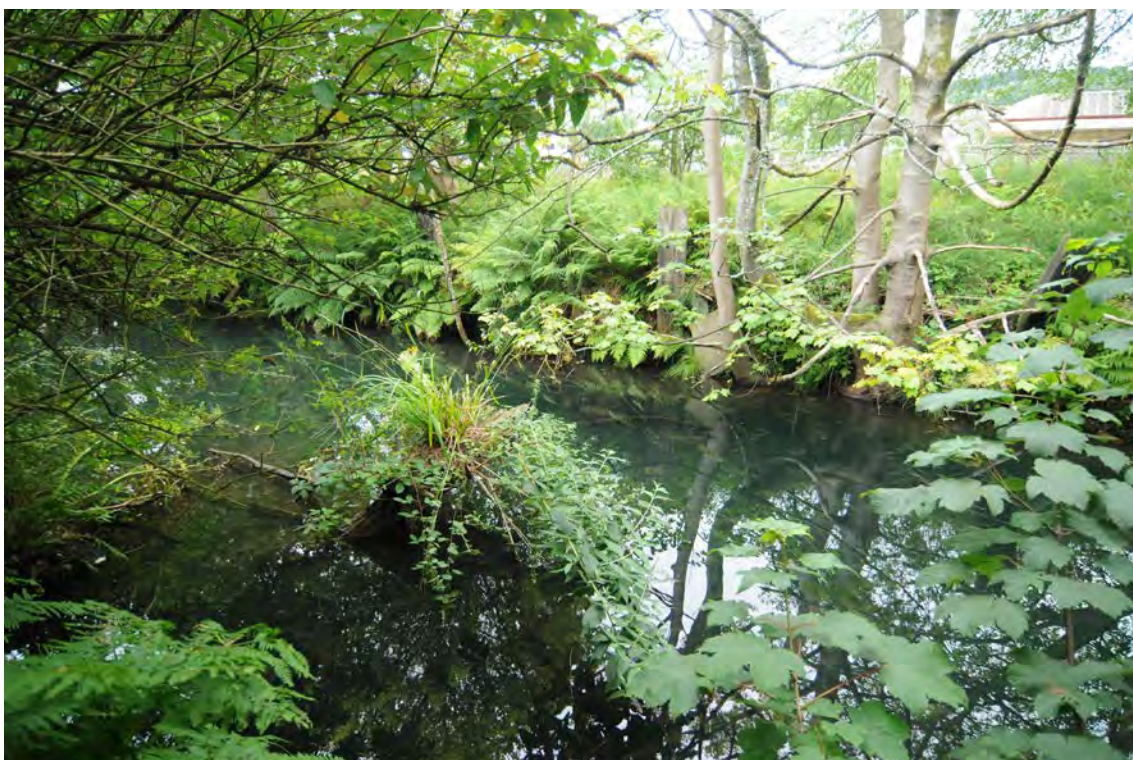
Photograph No : 4 Digital Ref: HOMI\_HBR\_0133 Direction: W  
Description: General view of goit with timber post on west bank

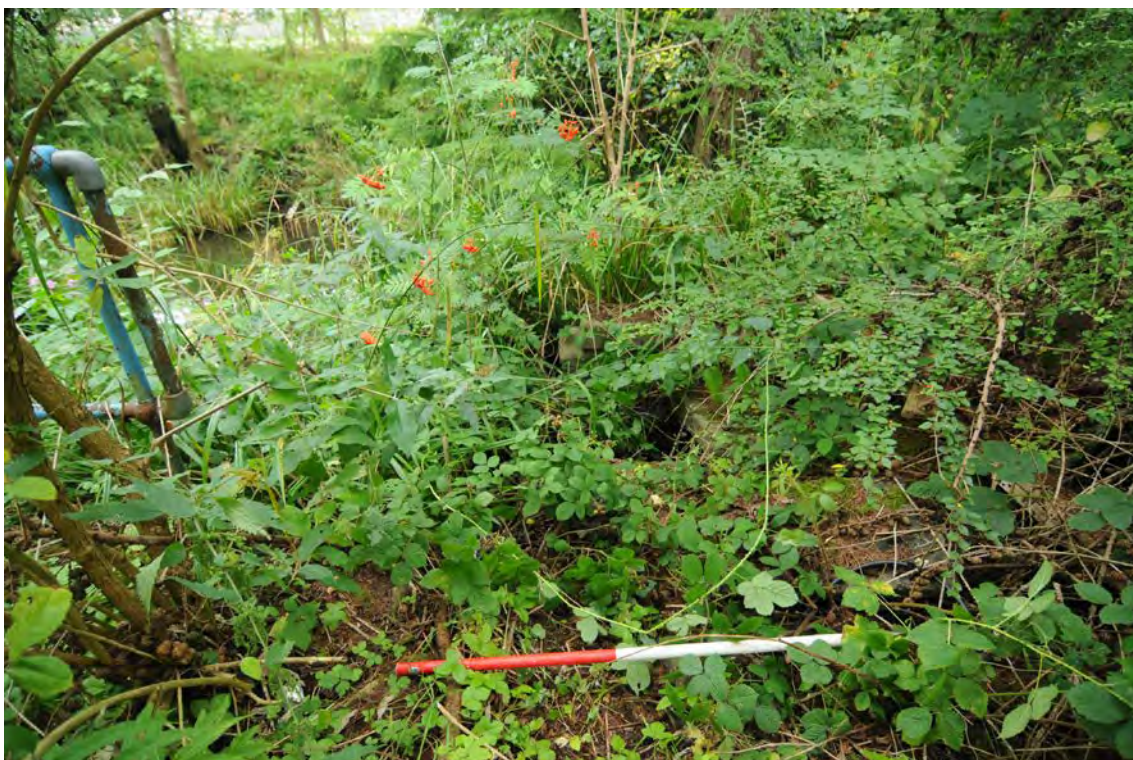
Photograph No : 5 Digital Ref: HOMI\_HBR\_0111 Direction: W  
Description: Sluice in goit

Paper mills used water both as a source of power and to treat fibres. According to the 1850 OS map, the Goit predated the paper mill and fed the reservoirs utilised by the quadrangle Print Works, later Square Works, building at the southwest (Section 4.1). The Goit appeared to have been adapted slightly between each map. Although a sluice is present on historic maps at the west of Building A, no direct relationship could be found between the buildings on site and the Goit, possibly suggesting and may have only been utilised for the Square Works. The surviving sluice appeared to be modern and had been relocated to just northwest of Building B (**Photograph 5**; Appendix 2).

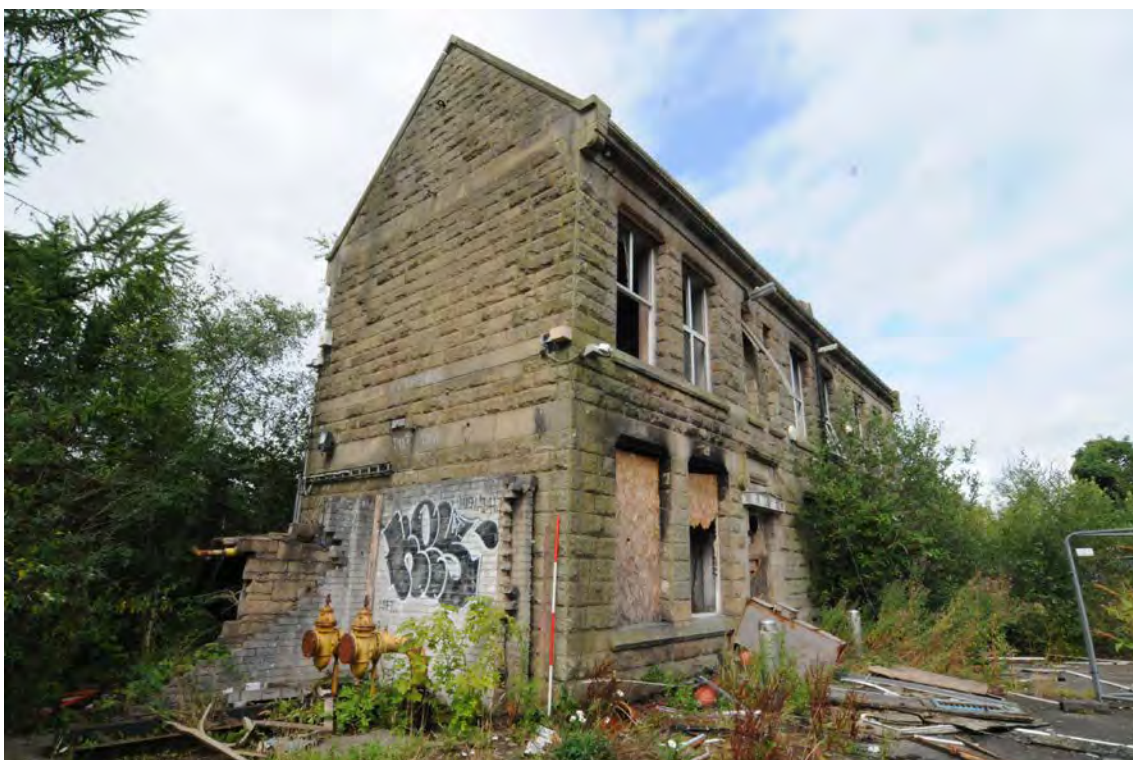
Photograph No : 6 Digital Ref: HOMI\_HBR\_0065 Direction: NW  
Description: South gable and east elevation of Building A

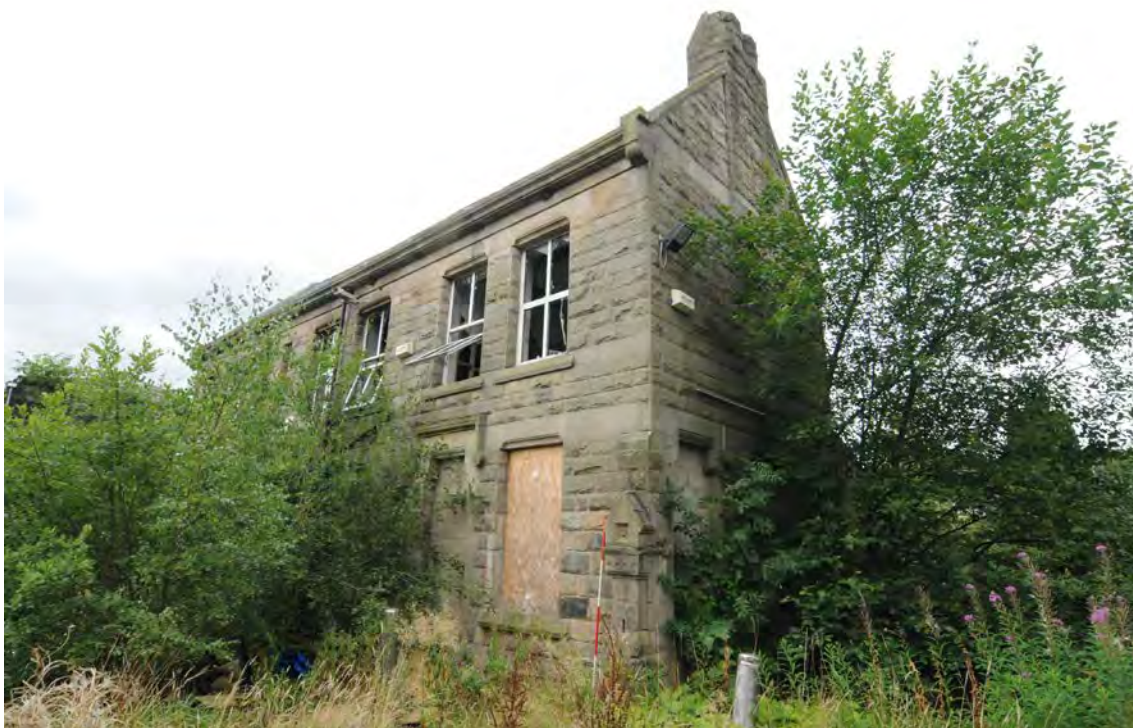
Photograph No : 7 Digital Ref: HOMI\_HBR\_0074 Direction: SW  
Description: East elevation and north gable of Building A

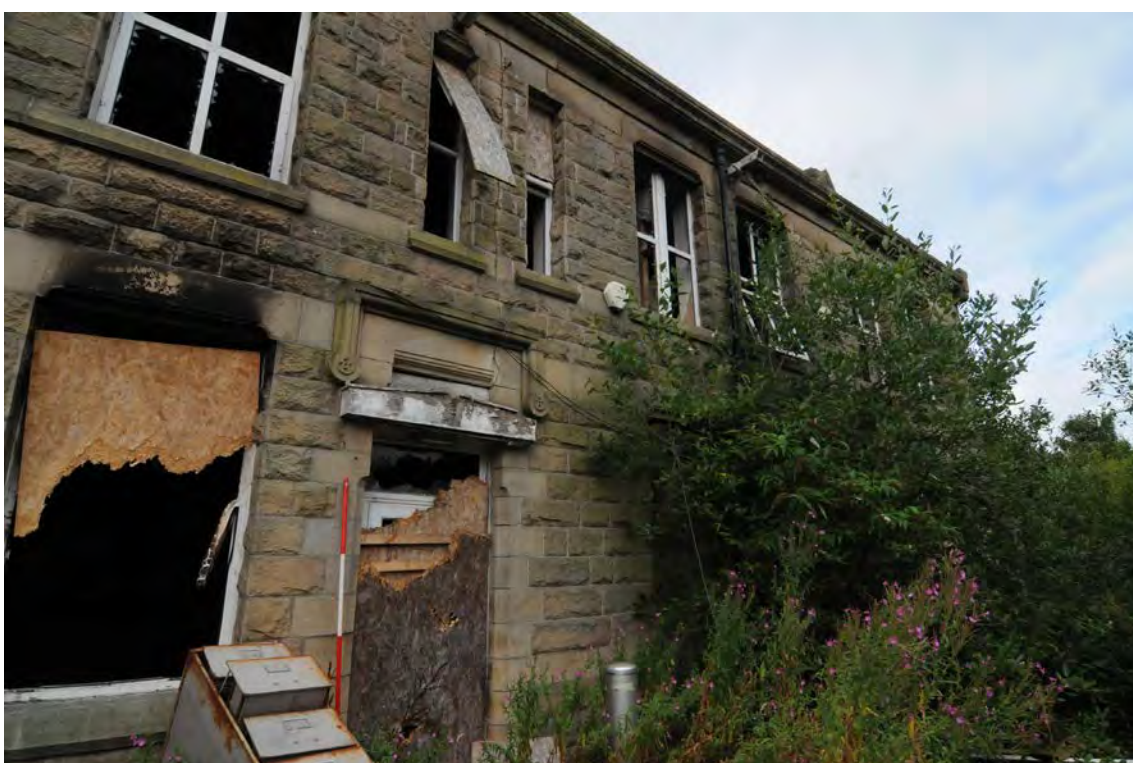
Photograph No : 8 Digital Ref: HOMI\_HBR\_0072 Direction: NW  
Description: East elevation of Building A

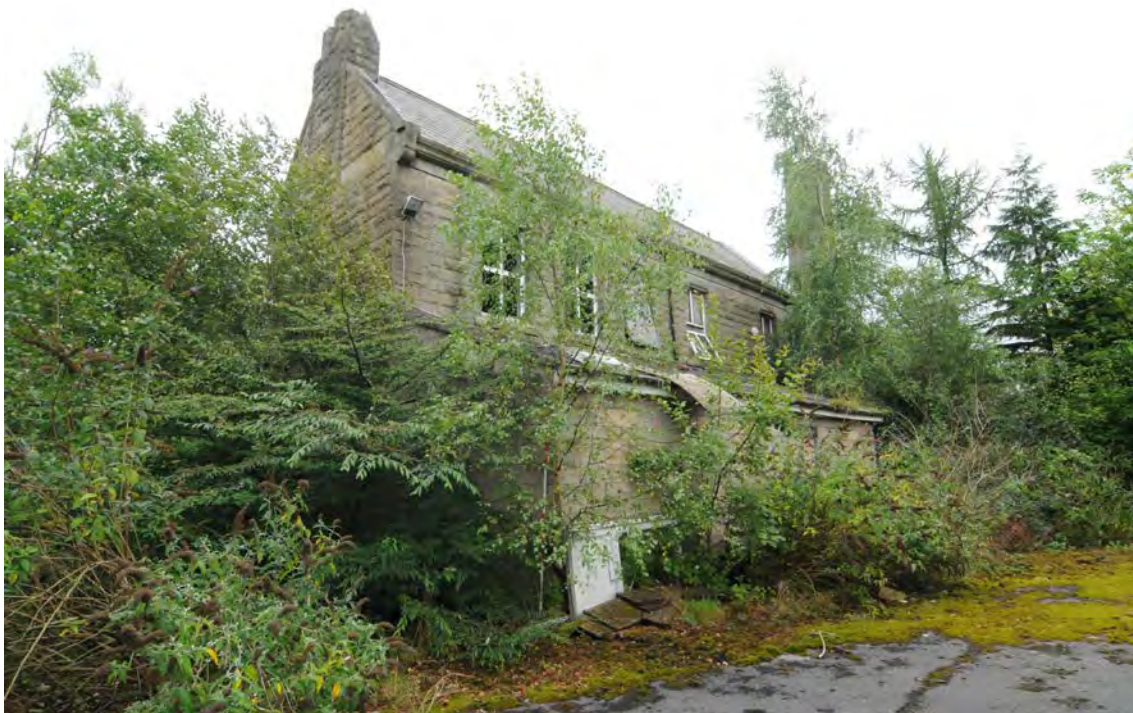
Photograph No : 9 Digital Ref: HOMI\_HBR\_0080 Direction: SE  
Description: West elevation and north gable of Building A with single storey addition

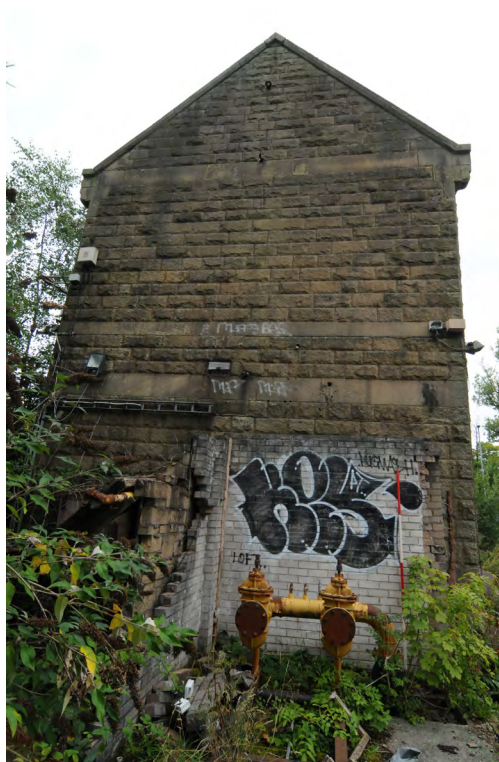
Photograph No : 10 Digital Ref: HOMI\_HBR\_0084 Direction: N  
Description: South gable of Building A with brick and stone addition around gas in foreground

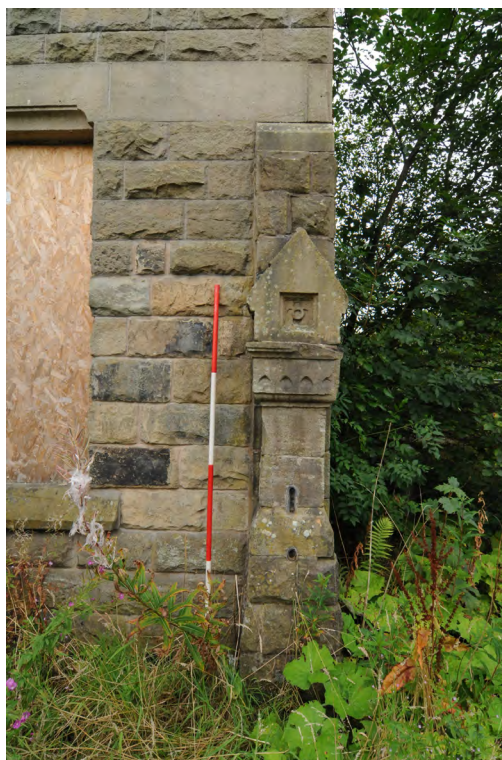
Photograph No : 11 Digital Ref: HOMI\_HBR\_0075 Direction: W  
Description: East face of gate post at north extent of east elevation of Building A

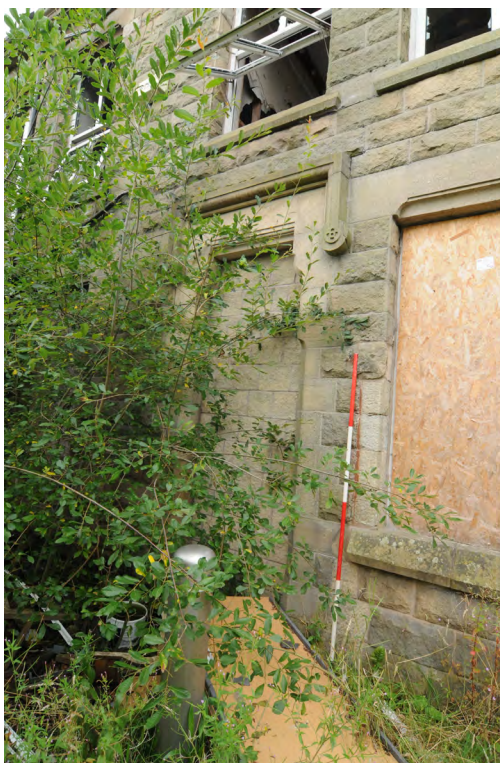
Photograph No : 13 Digital Ref: HOMI\_HBR\_0076 Direction: SW  
Description: Stone blocked doorway in east elevation of Building A

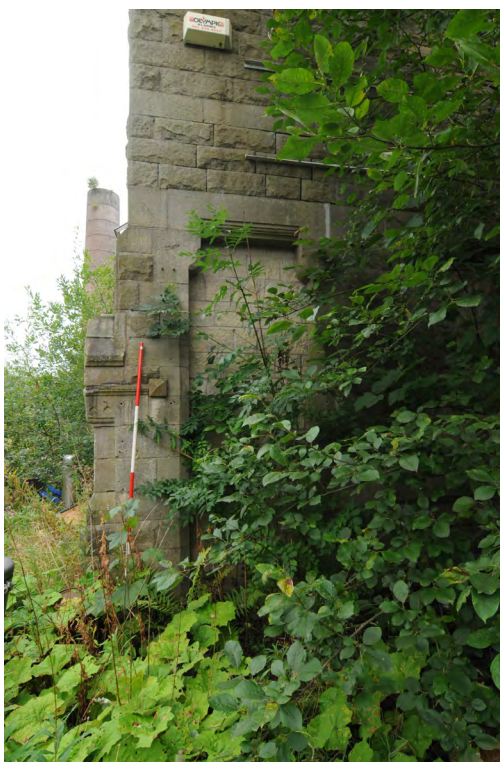
Photograph No : 14 Digital Ref: HOMI\_HBR\_0079 Direction: S  
Description: Stone blocked doorway at eastern side of north gable

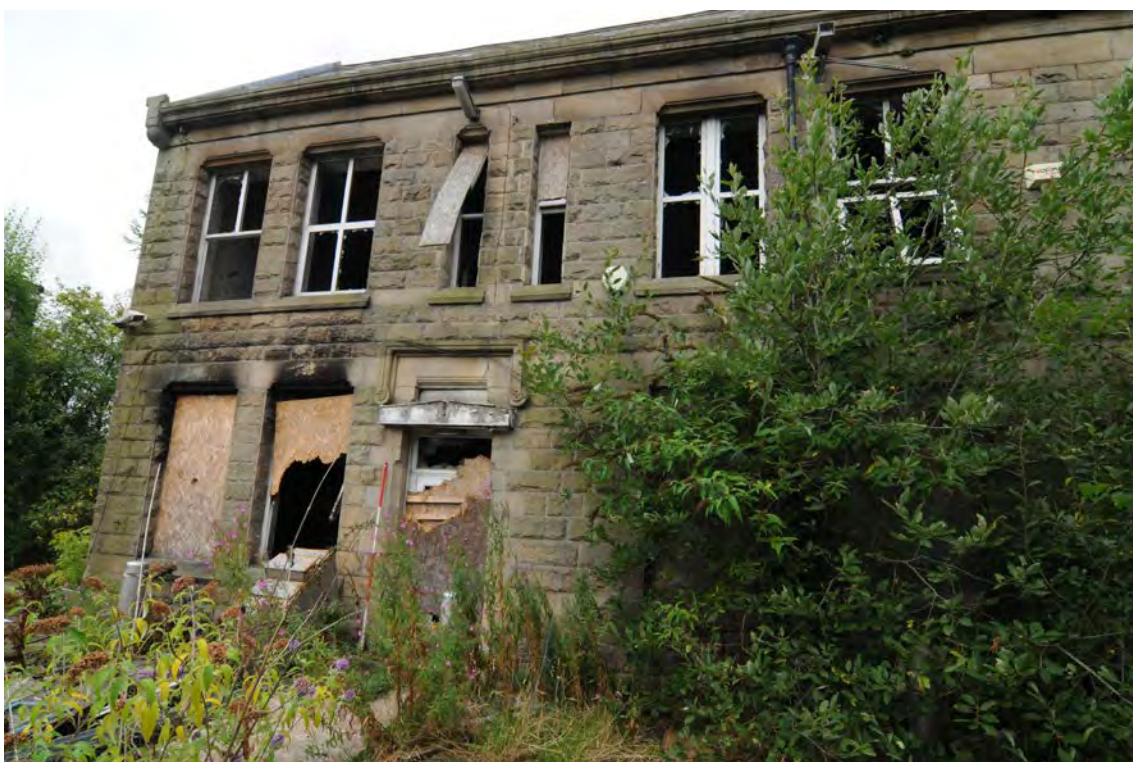
Photograph No : 15 Digital Ref: HOMI\_HBR\_0073 Direction: SW  
Description: Southern extent of east elevation of Building A

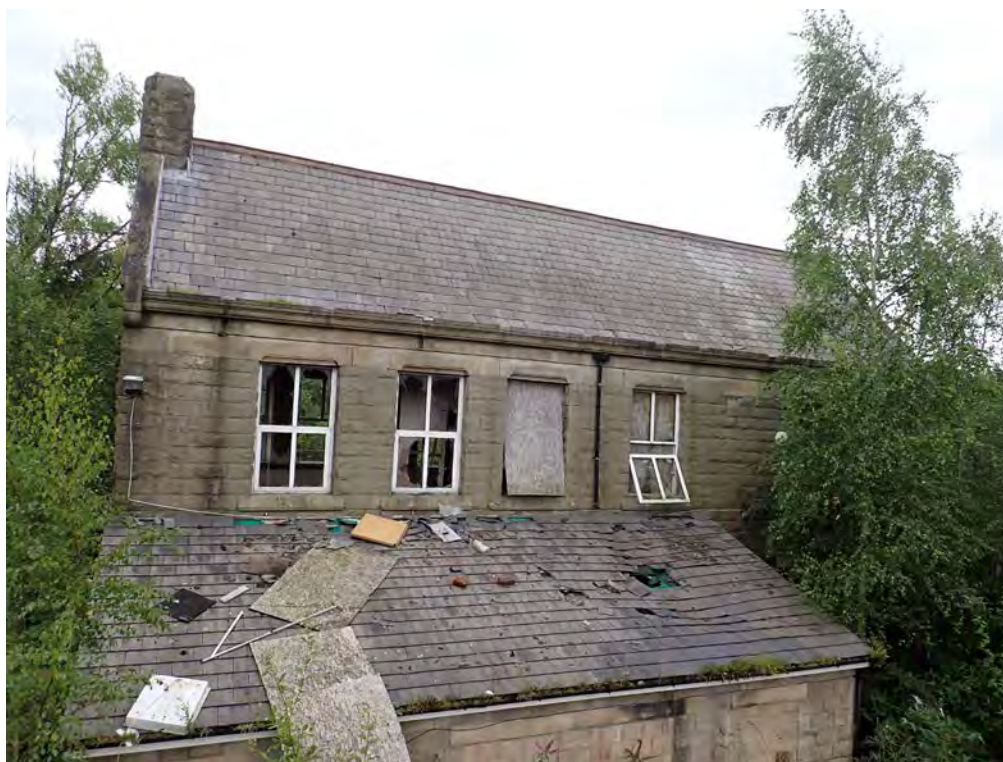
Photograph No : 16 Digital Ref: HOMI\_HBR\_0110 Direction: SE  
Description: Chimney, ridge, and first floor windows on west elevation of Building A

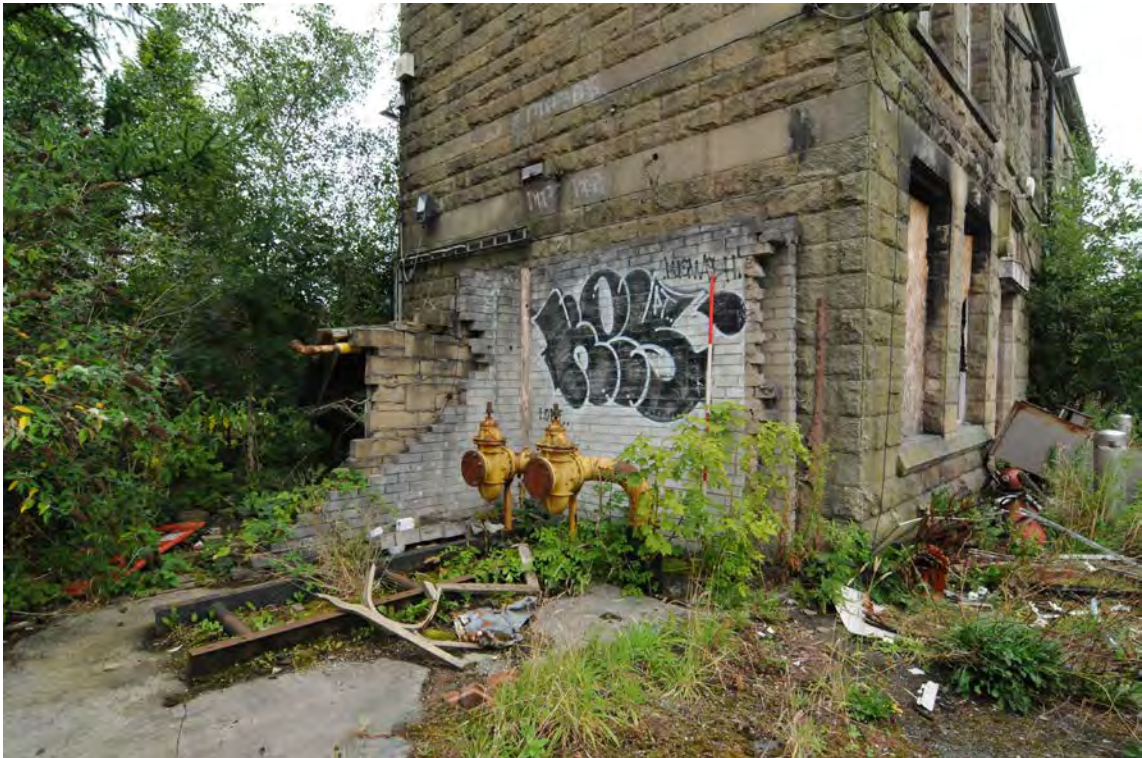
Photograph No : 18 Digital Ref: HOMI\_HBR\_0086 Direction: SW  
Description: Brick and stone addition at south gable of Building A with gas

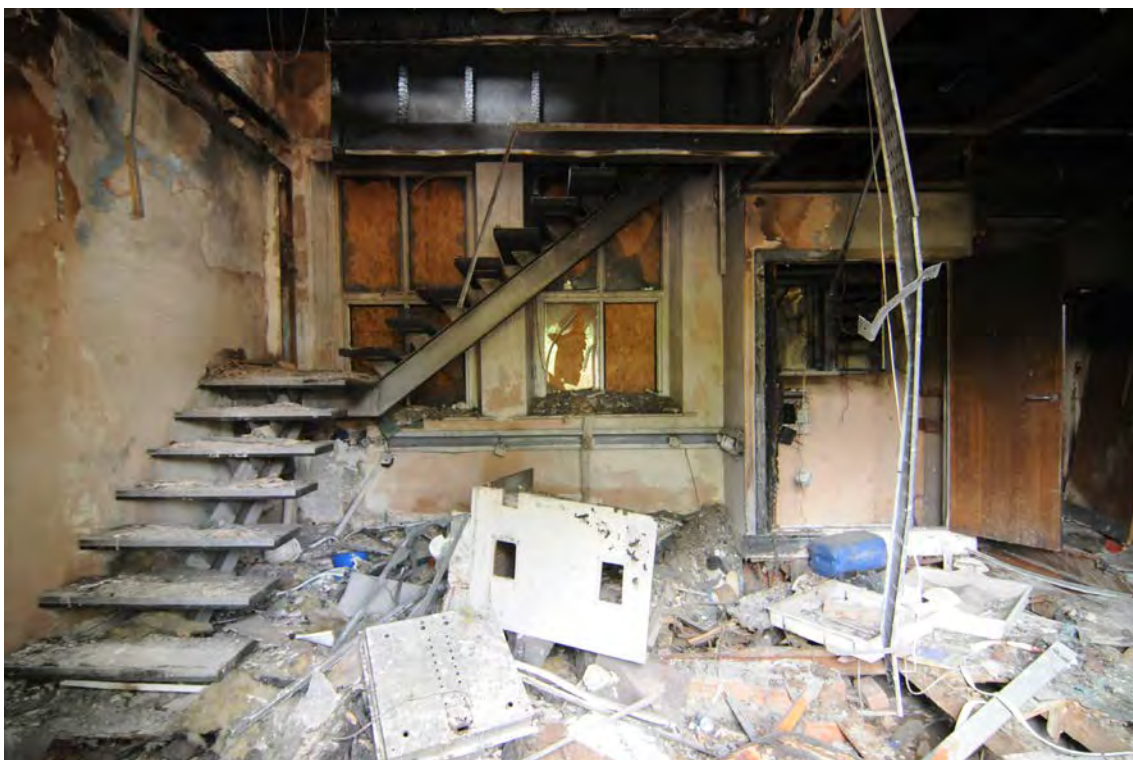
Photograph No : 19 Digital Ref: HOMI\_HBR\_0067 Direction: W  
Description: Internal ground floor of Building A with stairs in SW corner

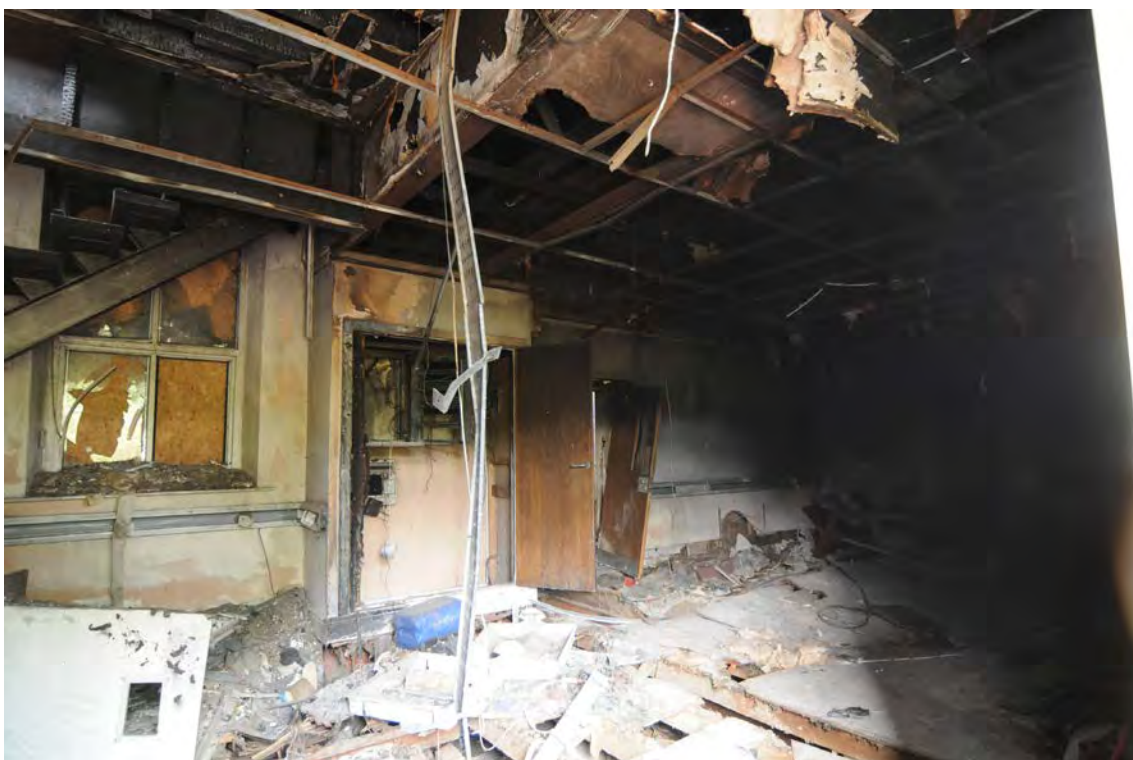
Photograph No : 20 Digital Ref: HOMI\_HBR\_0068 Direction: NW  
Description: General NW view of internal ground floor of Building A

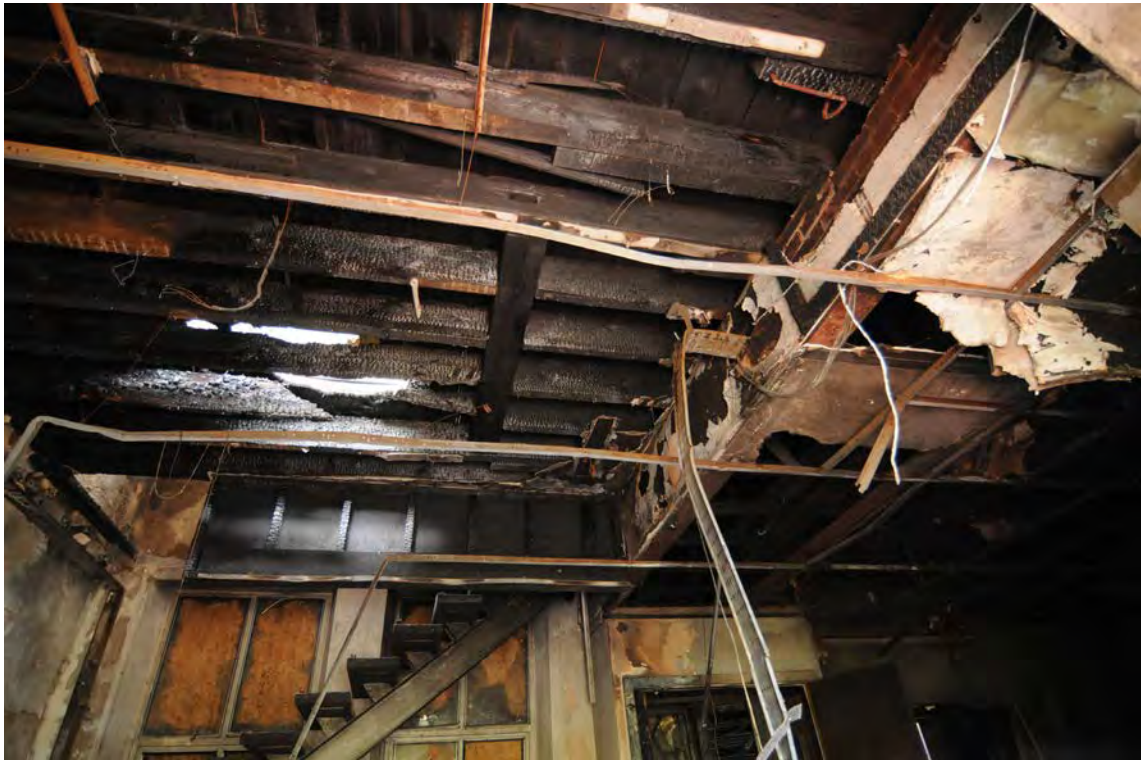
Photograph No : 21 Digital Ref: HOMI\_HBR\_0069 Direction: W  
Description: Ground floor ceiling timber beams in Building A

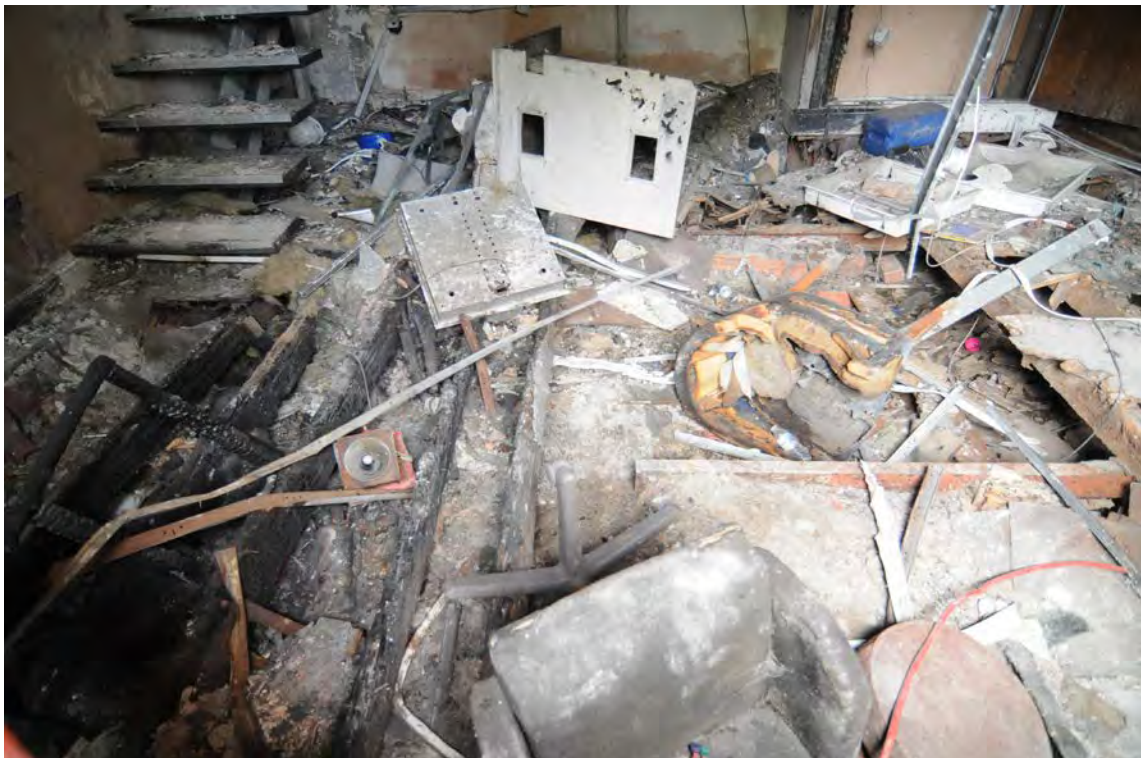
Photograph No : 22 Digital Ref: HOMI\_HBR\_0071 Direction: W  
Description: Ground in ground floor of Building A

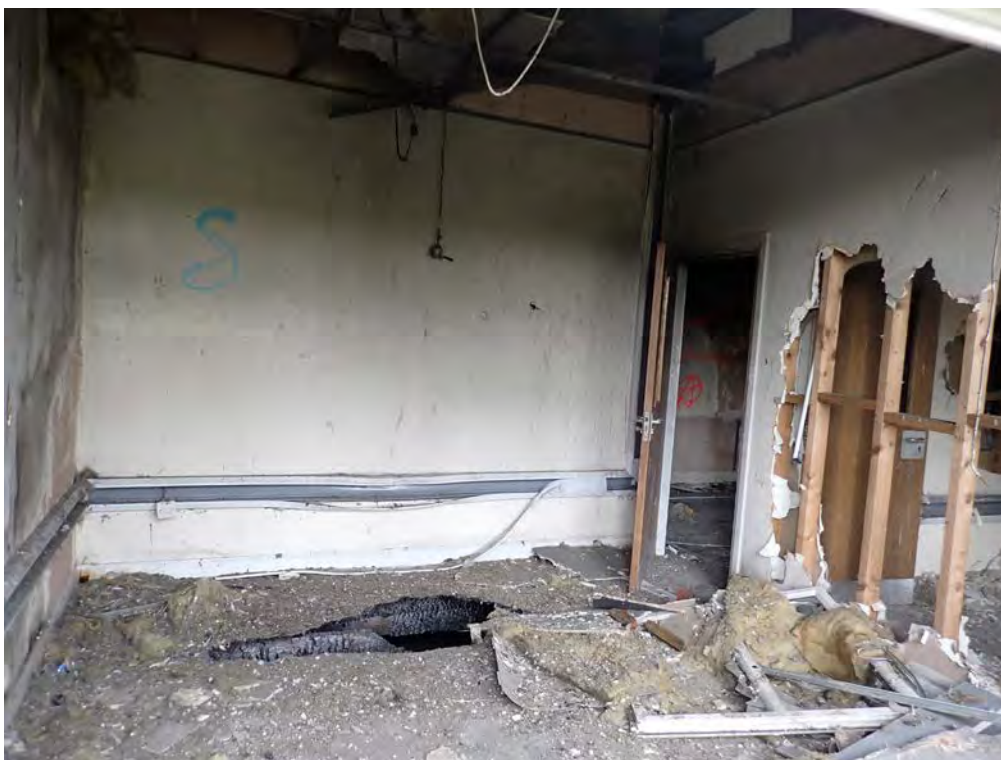
Photograph No : 23 Digital Ref: HOMI\_HBR\_0104 Direction: W  
Description: General view of first floor of Building A

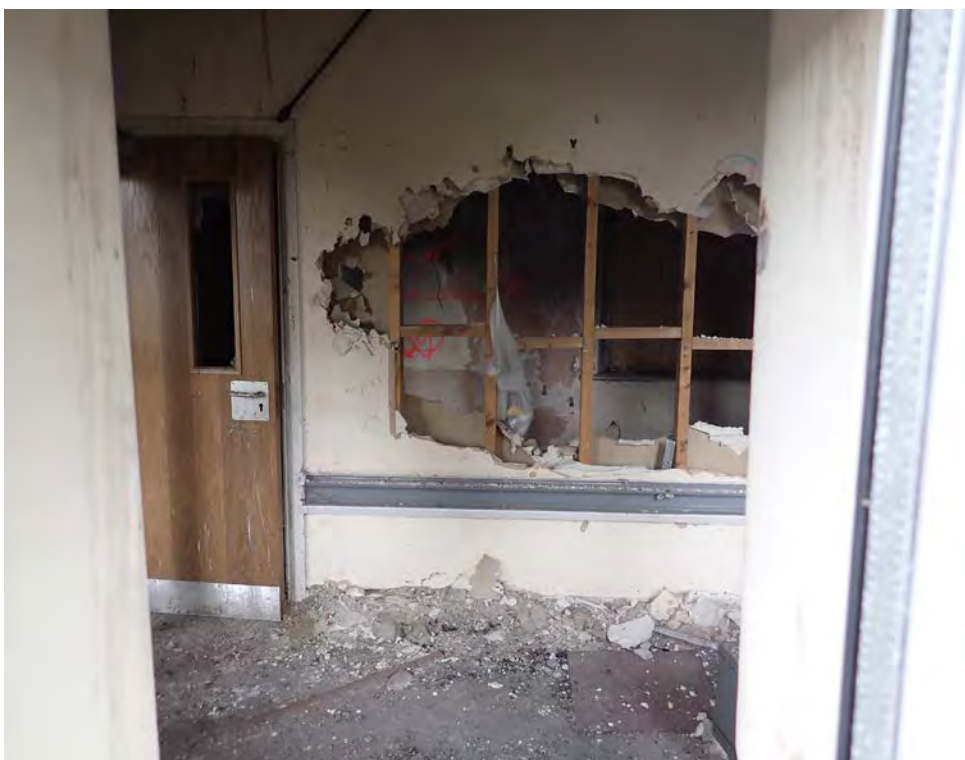
Photograph No : 24 Digital Ref: HOMI\_HBR\_0105 Direction: W  
Description: General view of first floor of Building A

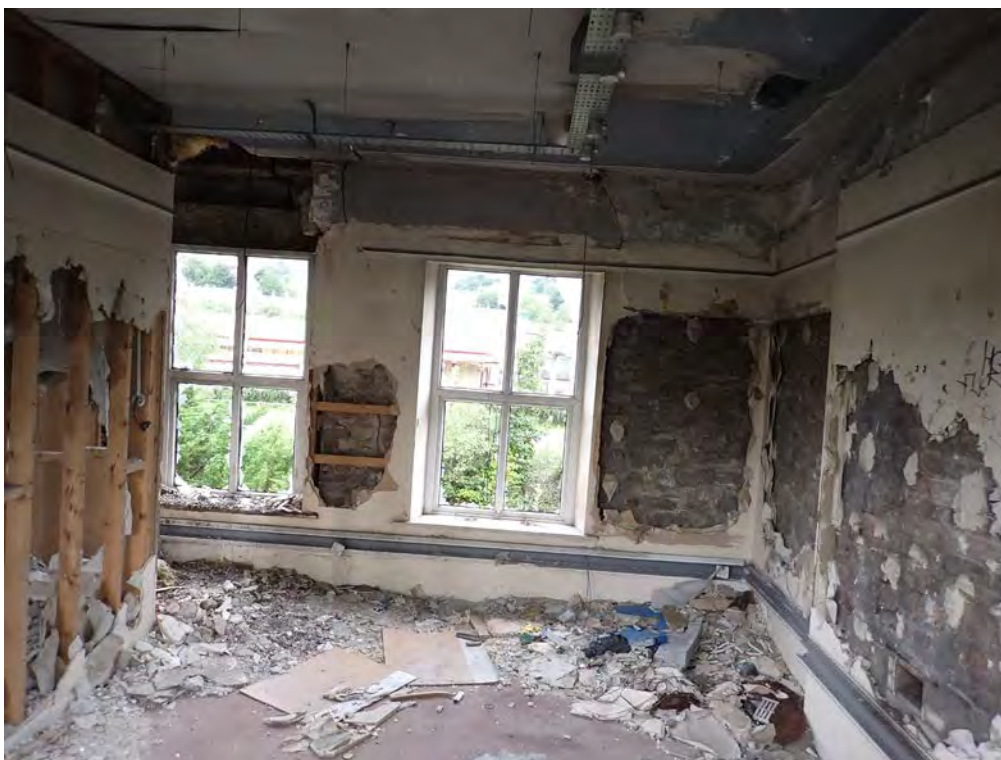
Photograph No : 25 Digital Ref: HOMI\_HBR\_0108 Direction: W  
Description: General view of first floor of Building A, blocked fireplace and chimney at the north (right)
