## Three Buildings & Chimney Former Mondi Site, Holcombe Mill Bridge Street Ramsbottom

Level 1-2 Historic Building Recording  
[Report No. 4556](#)

**Level 1-2 Historic Building Recording**

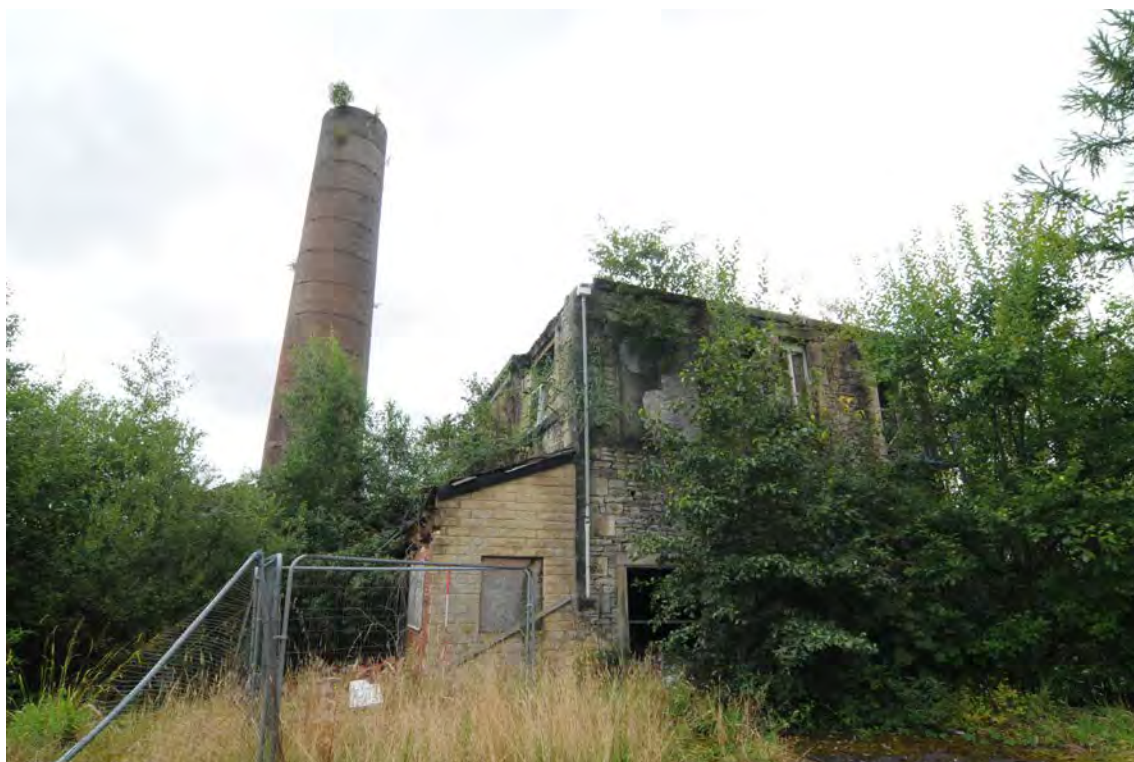
Photograph No : 26 Digital Ref: HOMI\_HBR\_0041 Direction: S  
Description: North elevation of Building B with Chimney in background

At the north elevation there was a wide door with an ashlar lintel and surrounds towards the east (fig. 4.6; **Photographs 26, 28, 41**). Directly above the first floor featured a brick blocked opening with a similar ashlar lintel and surrounds and a projecting cill. The centre of the first floor featured a two-light window with a wide ashlar mullion, flush ashlar lintel, projecting ashlar cill, and alternating jambs (**Photograph 42**). Metal stairs led to a door at the west (**Photograph 43**). The alternating jambs and ashlar lintel were smaller in size than those found elsewhere on the building, suggesting the door was not original.

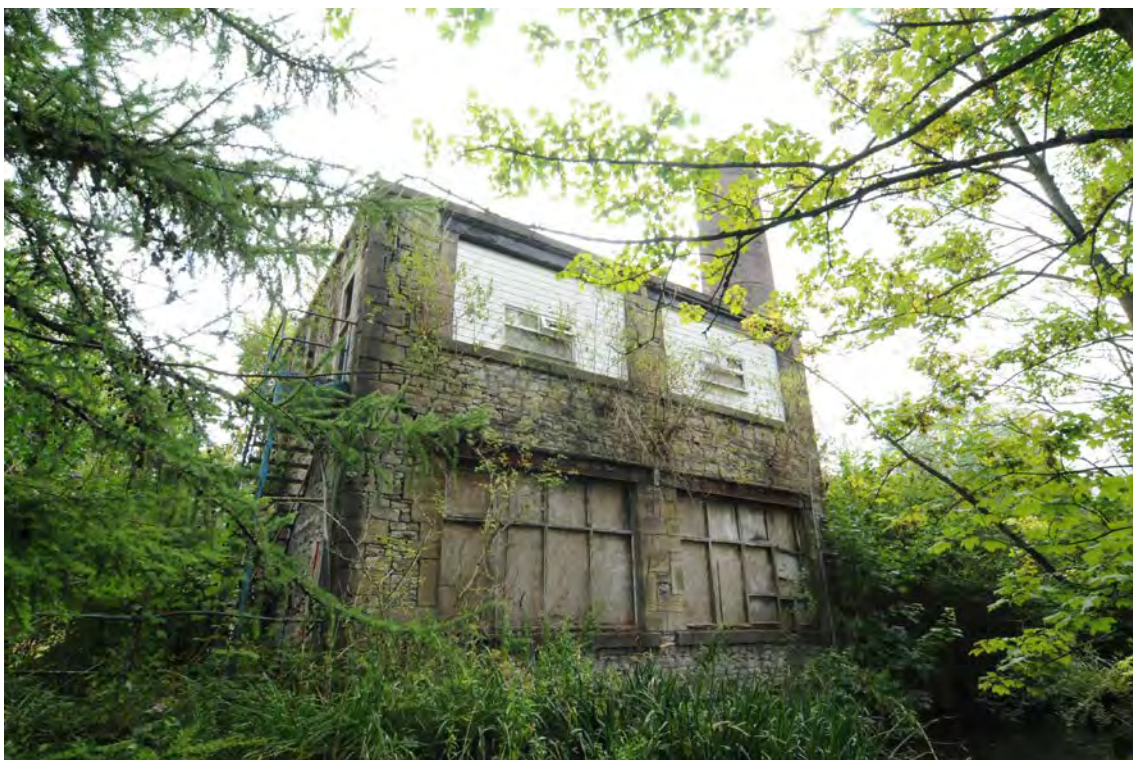
Photograph No : 27 Digital Ref: HOMI\_HBR\_0061 Direction: SE  
Description: West elevation of Building B with Chimney in background

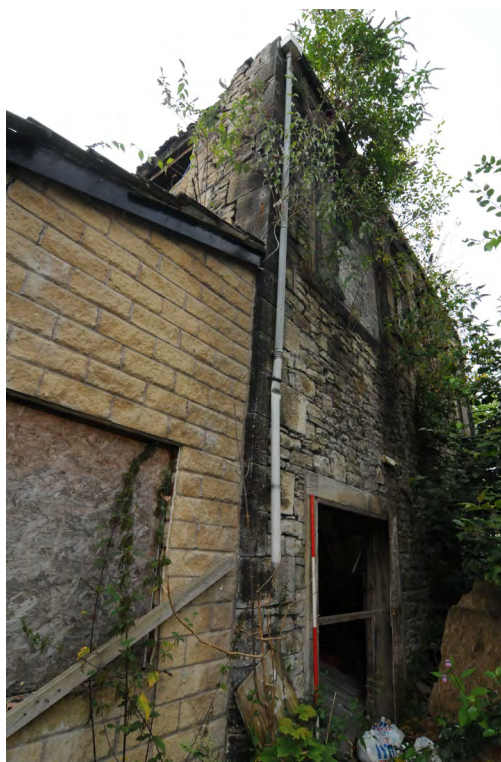
Photograph No : 28 Digital Ref: HOMI\_HBR\_0057 Direction: SW  
Description: Quoins at NE corner of Building B with extension in foreground

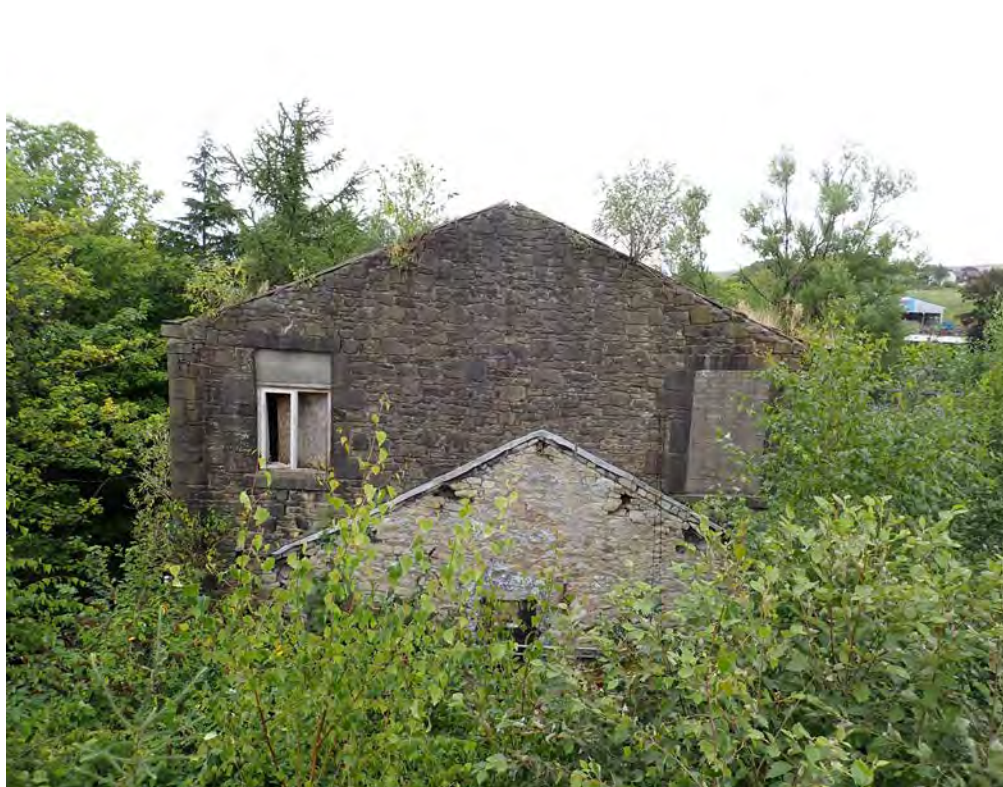
Photograph No : 32 Digital Ref: HOMI\_HBR\_0100 Direction: N  
Description: South gable of Building B with blocked fenestration at the first floor and gable scar of former building

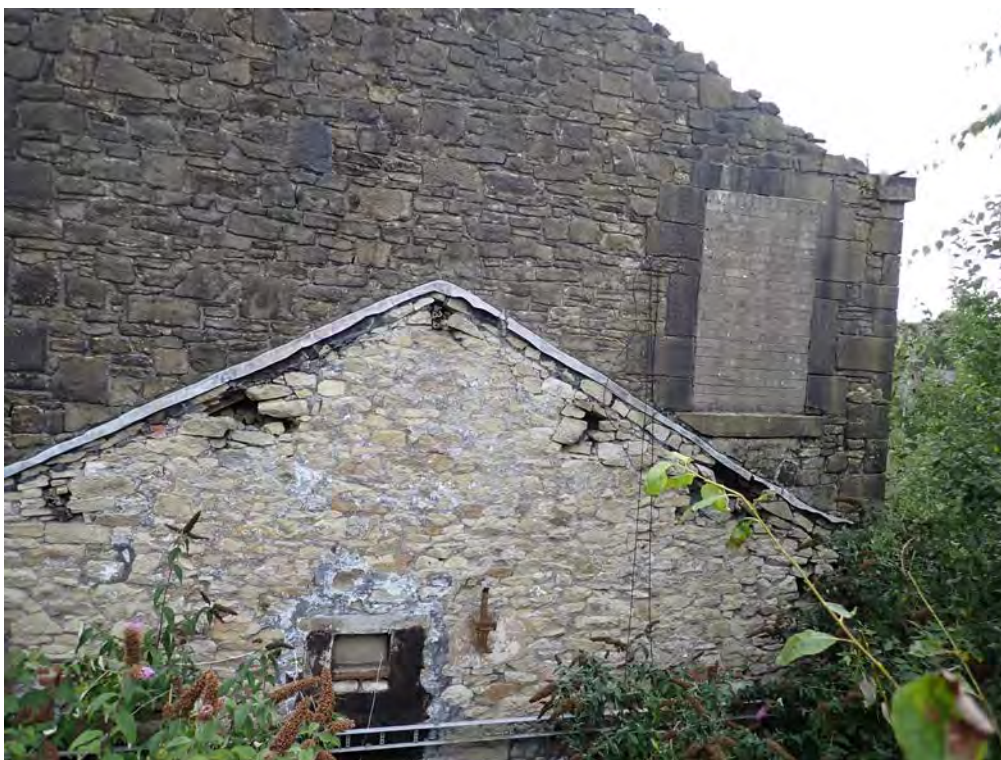
Photograph No : 33 Digital Ref: HOMI\_HBR\_0101 Direction: NE  
Description: South gable of Building B with blocked fenestration at the first floor, gable scar of former building, bearing box

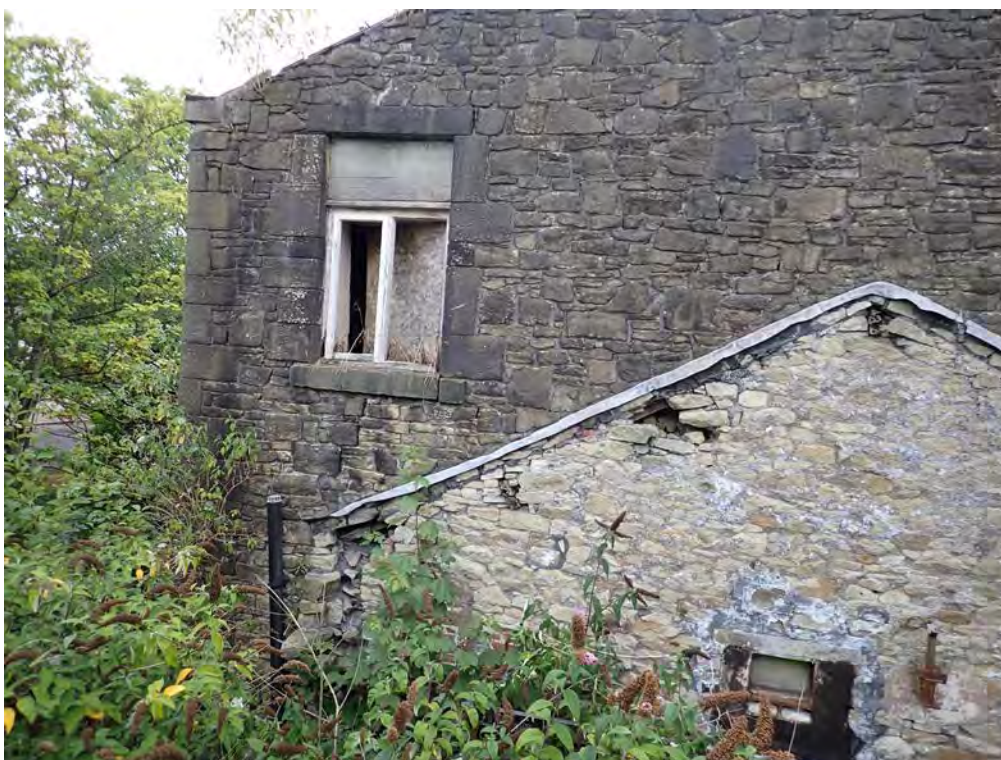
Photograph No : 34 Digital Ref: HOMI\_HBR\_0102 Direction: NW  
Description: South gable of Building B with blocked fenestration at the first floor, gable scar of former building, bearing box

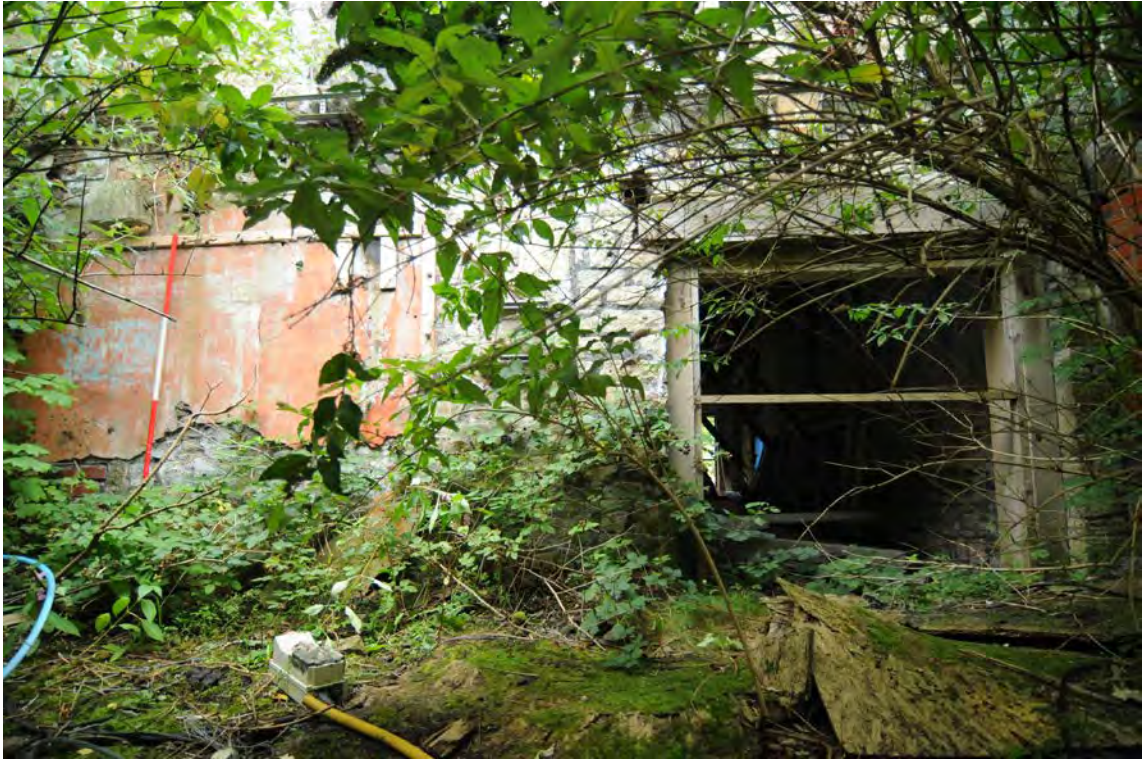
Photograph No : 37 Digital Ref: HOMI\_HBR\_0127 Direction: N  
Description: Fenestration in ground floor of south gable of Building B

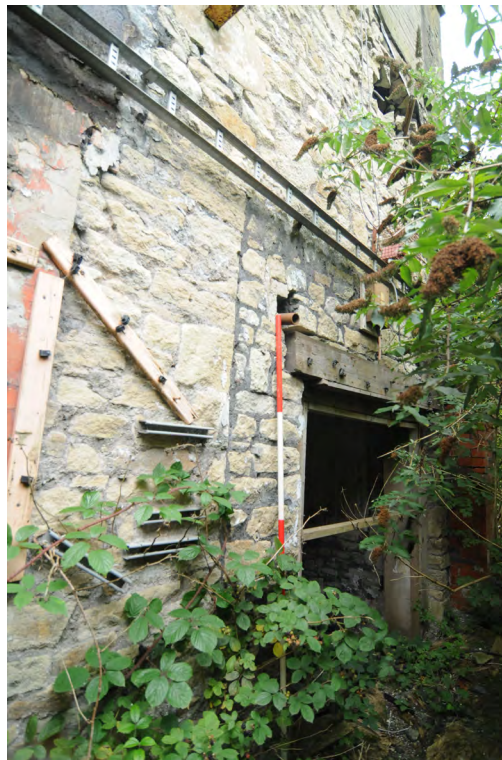
Photograph No : 38 Digital Ref: HOMI\_HBR\_0121 Direction: NE  
Description: Straight joint and change of stone at eastern side of south gable of Building B

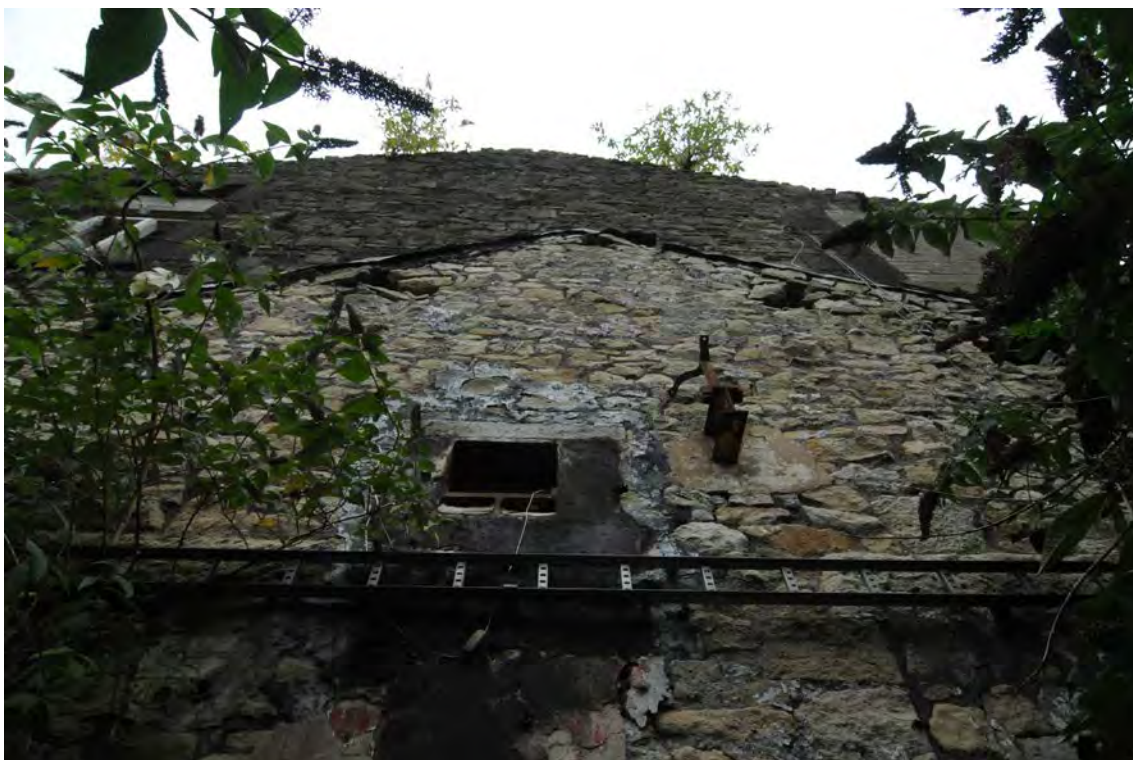
Photograph No : 39 Digital Ref: HOMI\_HBR\_0119 Direction: N  
Description: South gable of Building B with bearing box, steel I-beam, gable scar

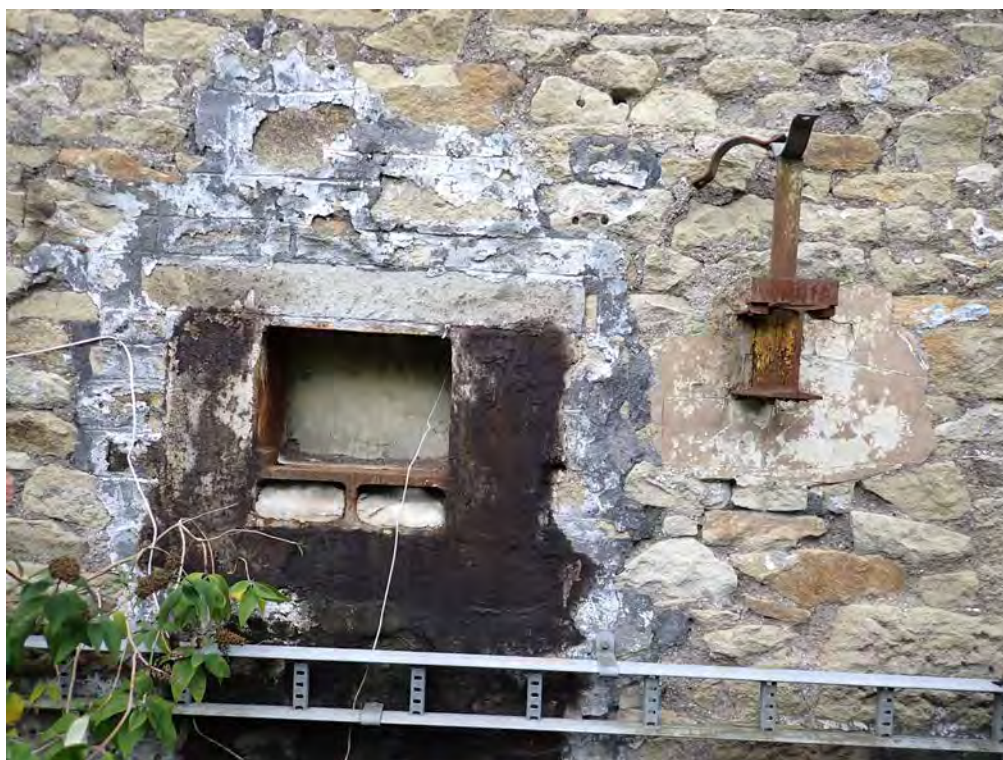
Photograph No : 40 Digital Ref: HOMI\_HBR\_0103 Direction: N  
Description: Detail of bearing box and steel I-beam in south gable of Building B

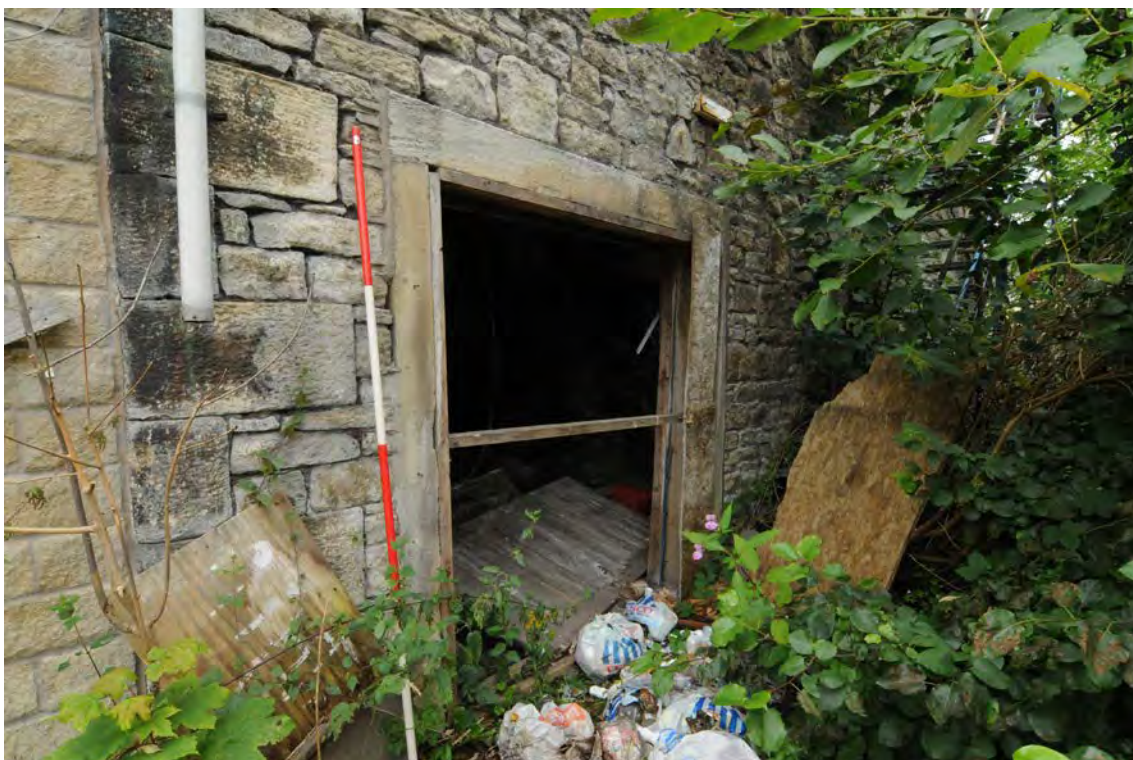
Photograph No : 41 Digital Ref: HOMI\_HBR\_0046 Direction: SW  
Description: Detail of ground floor fenestration in north elevation of Building B

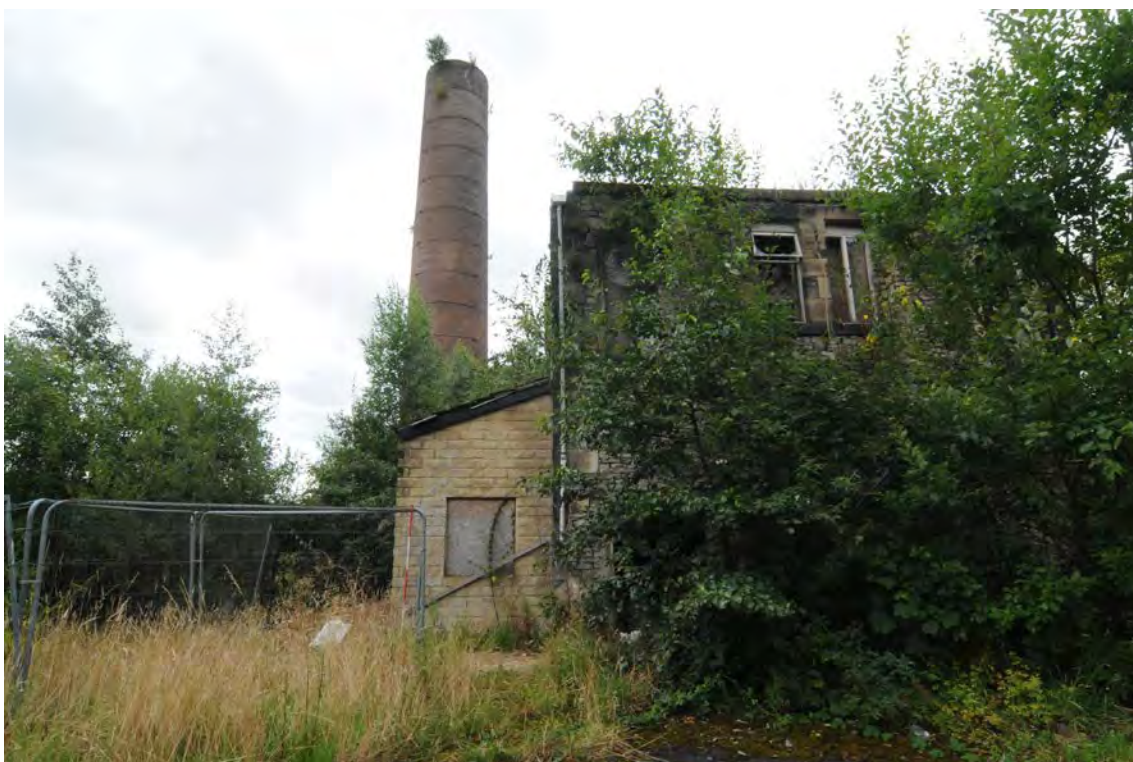
Photograph No : 42 Digital Ref: HOMI\_HBR\_0042 Direction: S  
Description: North elevation of Building B with Chimney in background

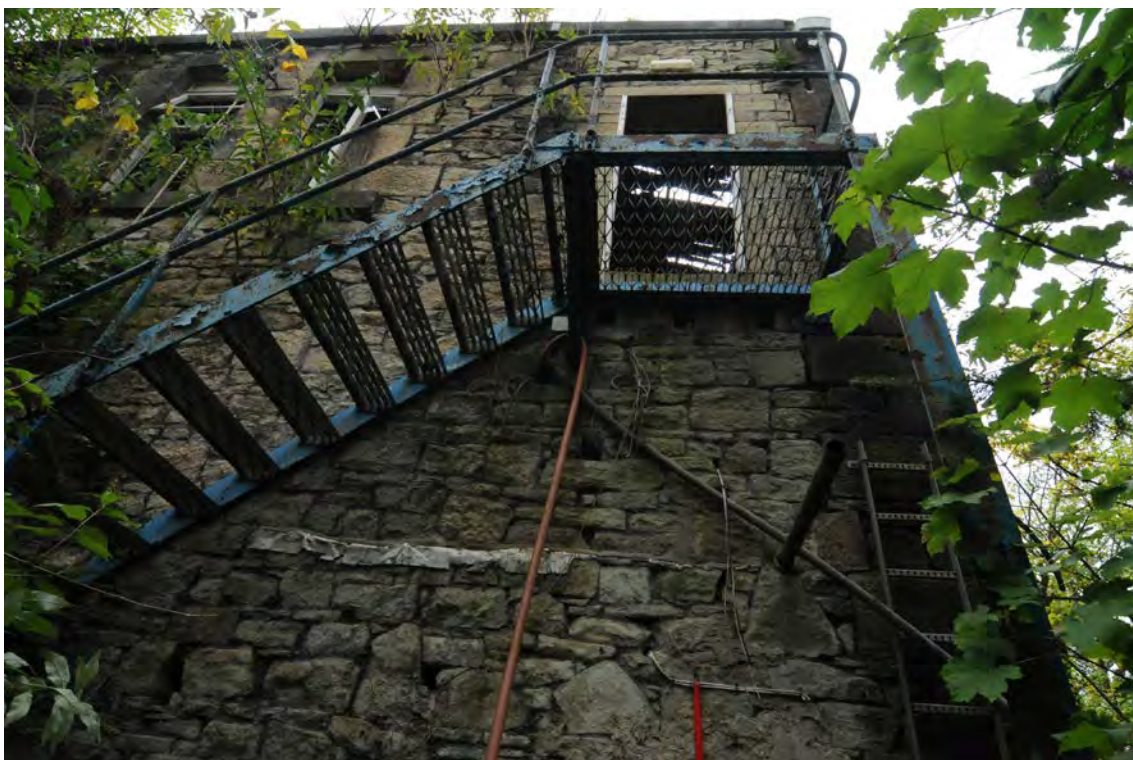
Photograph No : 43 Digital Ref: HOMI\_HBR\_0060 Direction: S  
Description: Ground and first floor of north elevation of Building B with fire escape

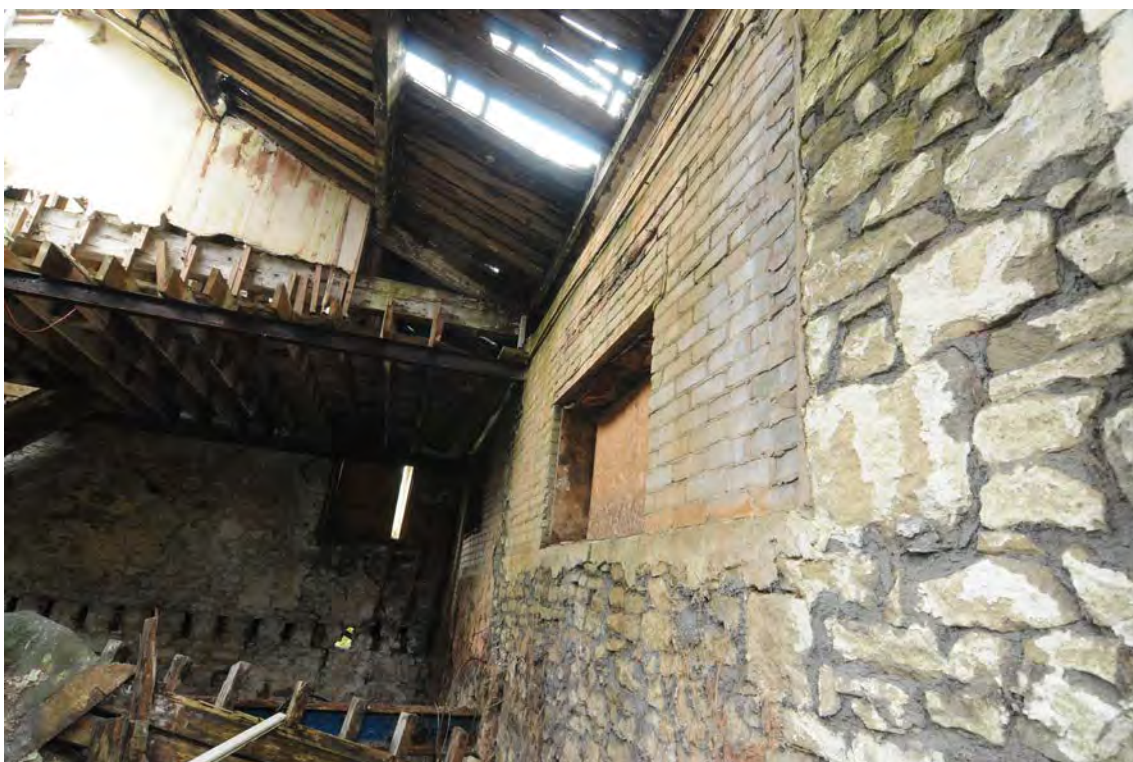
Photograph No : 44 Digital Ref: HOMI\_HBR\_0055 Direction: SW  
Description: Brick blocked fenestration at first floor in west wall of Building B

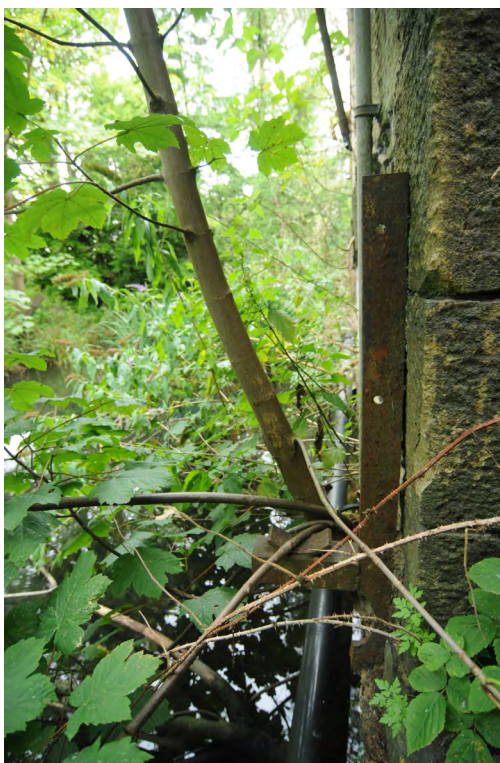
Photograph No : 45 Digital Ref: HOMI\_HBR\_0132 Direction: N  
Description: Metal fittings in southern extent of west wall of Building B

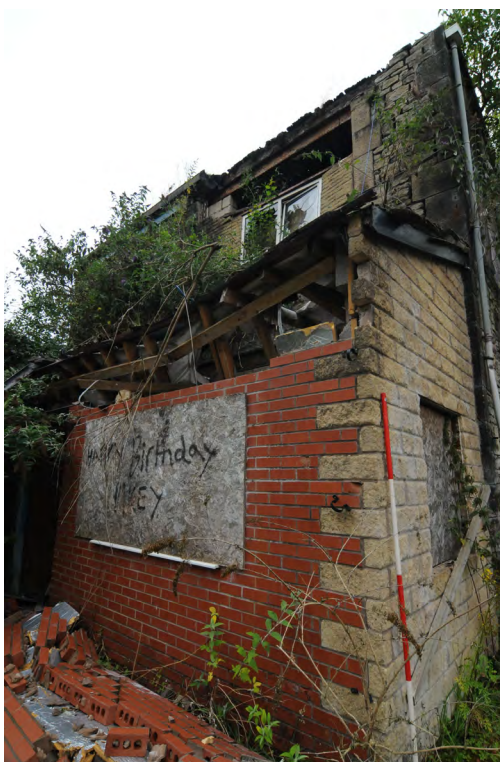
Photograph No : 46 Digital Ref: HOMI\_HBR\_0112 Direction: SW  
Description: Brick east elevation of single storey addition of Building B

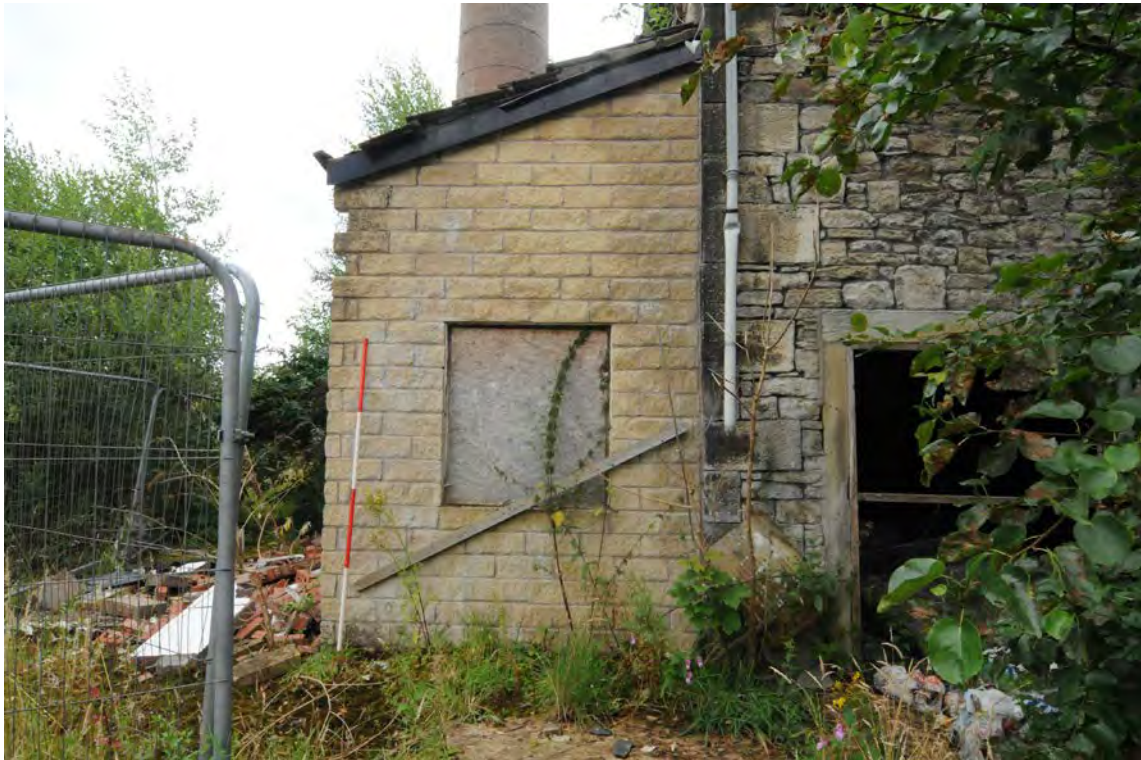
Photograph No : 47 Digital Ref: HOMI\_HBR\_0044 Direction: S  
Description: North elevation of addition of Building B with Chimney in background

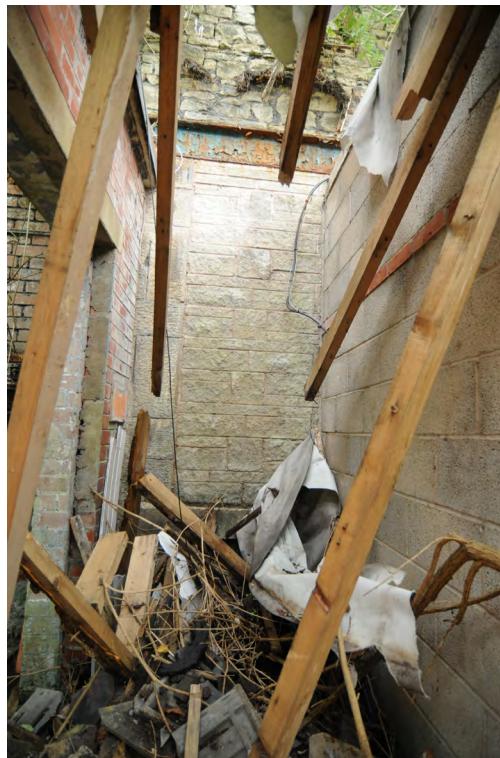
Photograph No : 48 Digital Ref: HOMI\_HBR\_0114 Direction: W  
Description: Blocked fenestration in west elevation of Building B and general internal view of ground floor area of addition

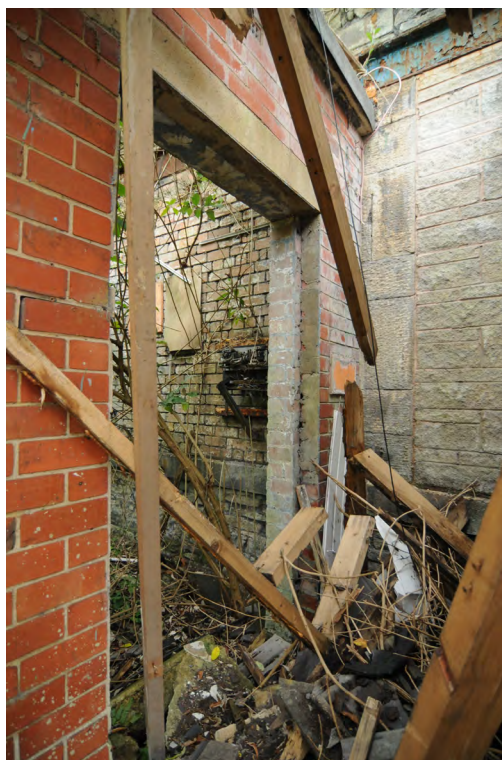
Photograph No : 49 Digital Ref: HOMI\_HBR\_0115 Direction: SW  
Description: Blocked fenestration in west elevation of Building B and general internal view of ground floor area of addition

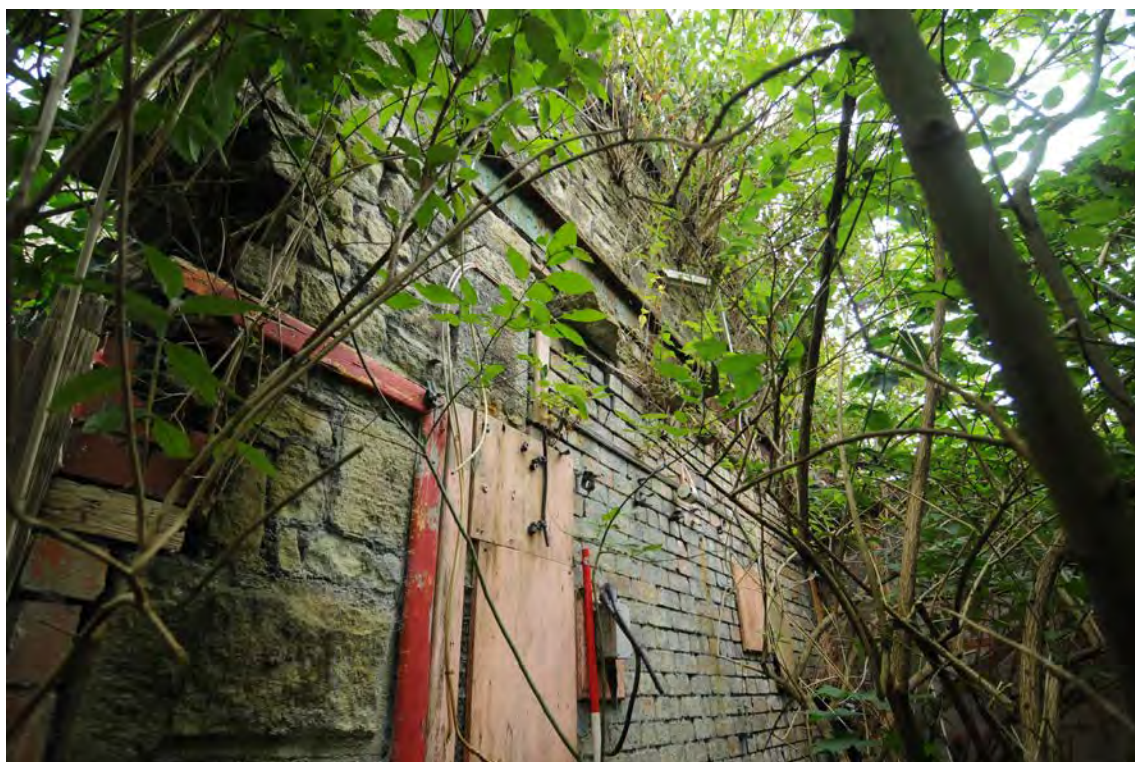
Photograph No : 50 Digital Ref: HOMI\_HBR\_0118 Direction: NW  
Description: Blocked fenestration in southern extent of east elevation of Building B with quoins at extent

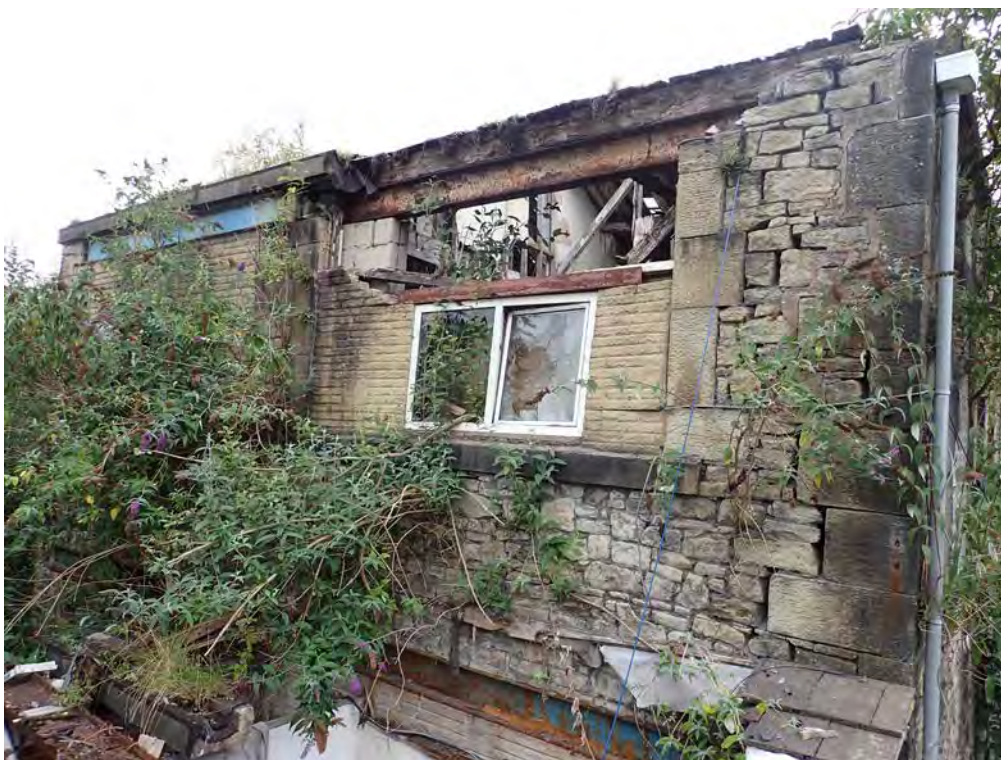
Photograph No : 51 Digital Ref: HOMI\_HBR\_0099 Direction: SW  
Description: Blocked window in first floor east elevation of Building B

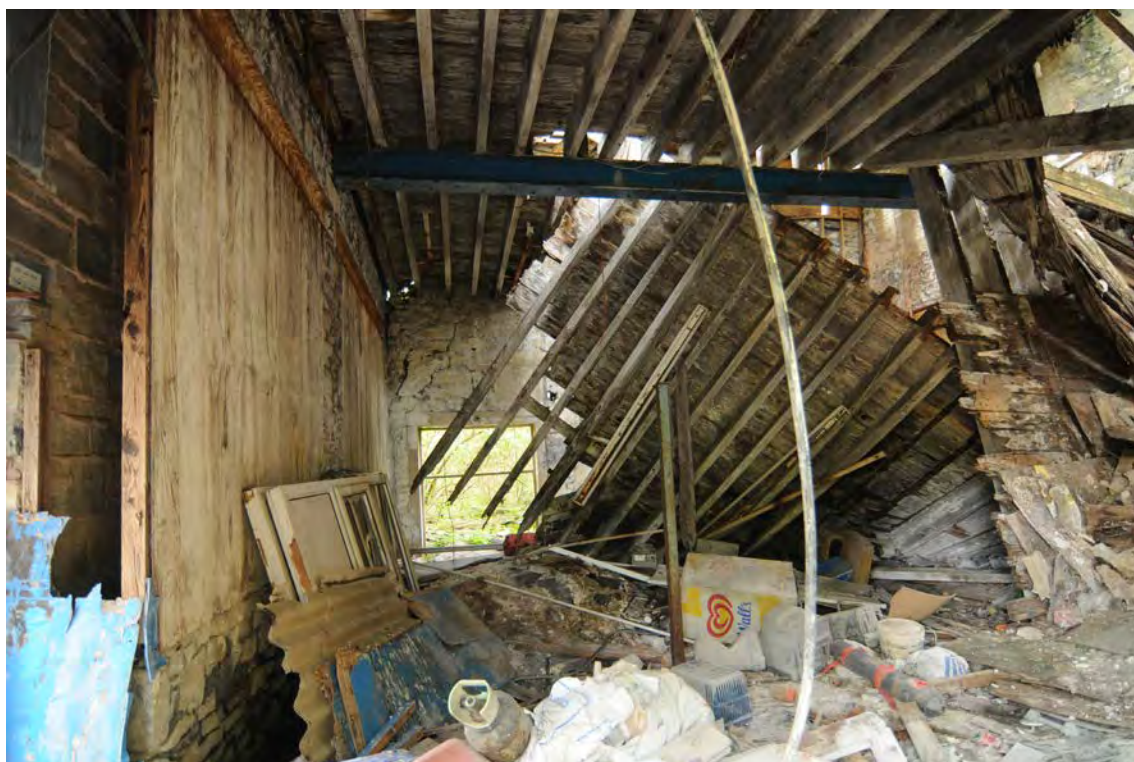
Photograph No : 52 Digital Ref: HOMI\_HBR\_0048 Direction: S  
Description: General southern view of internal area of Building B

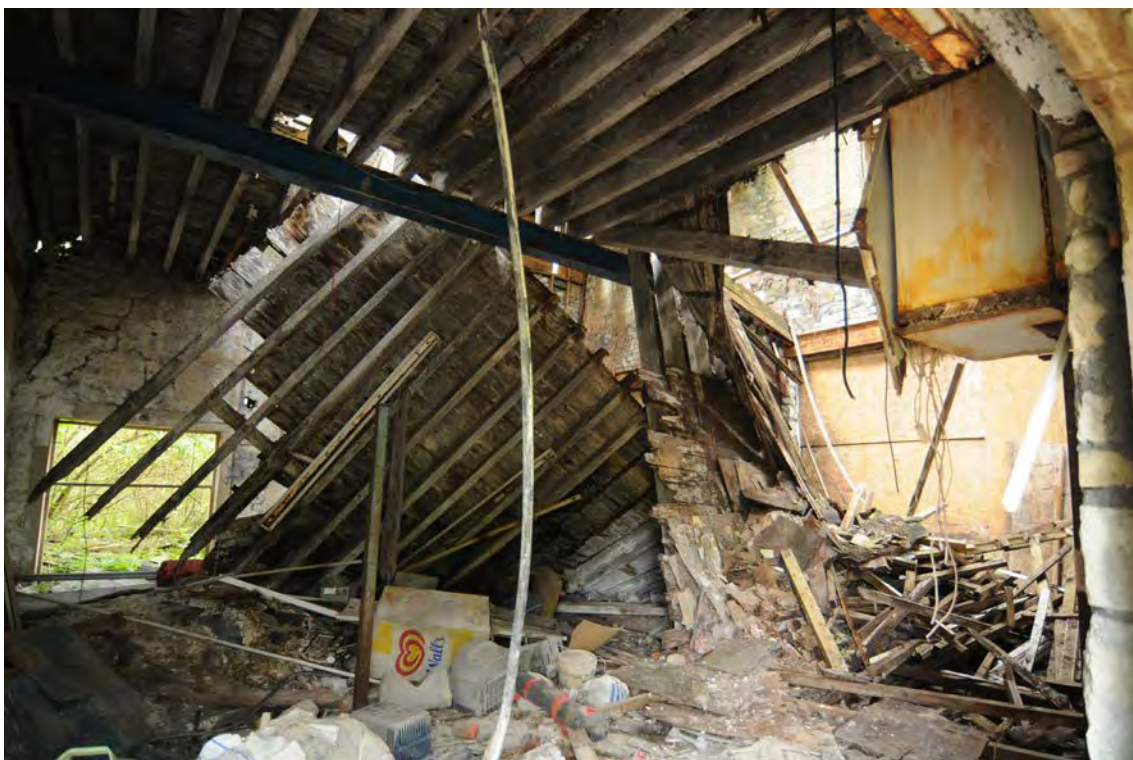
Photograph No : 53 Digital Ref: HOMI\_HBR\_0049 Direction: SW  
Description: General southern view of ground floor internal area of Building B

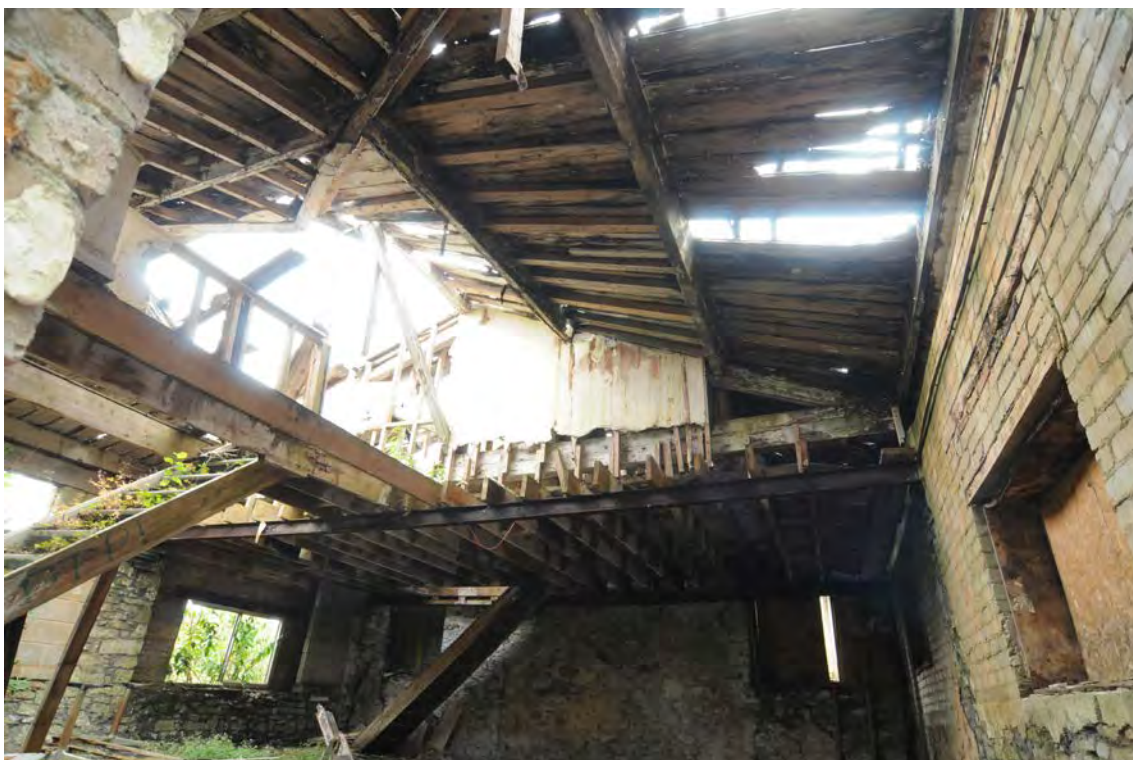
Photograph No : 55 Digital Ref: HOMI\_HBR\_0056 Direction: S  
Description: General southern view of first floor internal area of Building B

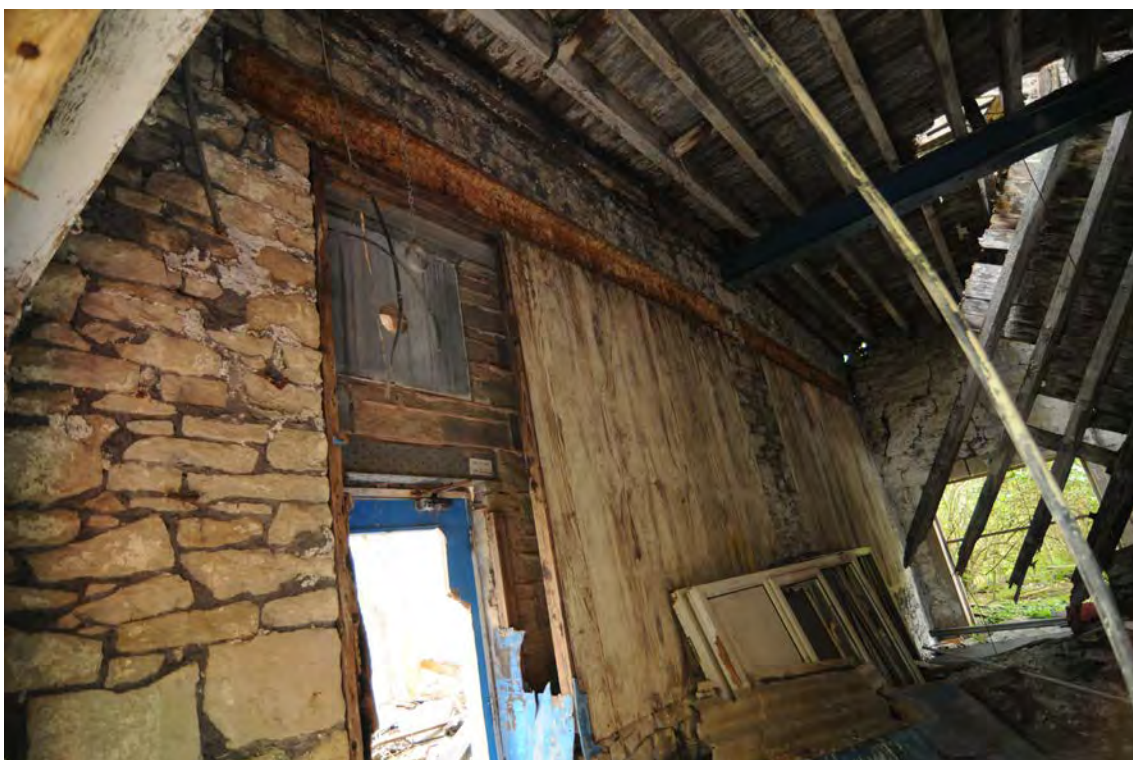
Photograph No : 56 Digital Ref: HOMI\_HBR\_0051 Direction: SE  
Description: Opening of east wall of Building B with façade wall beyond

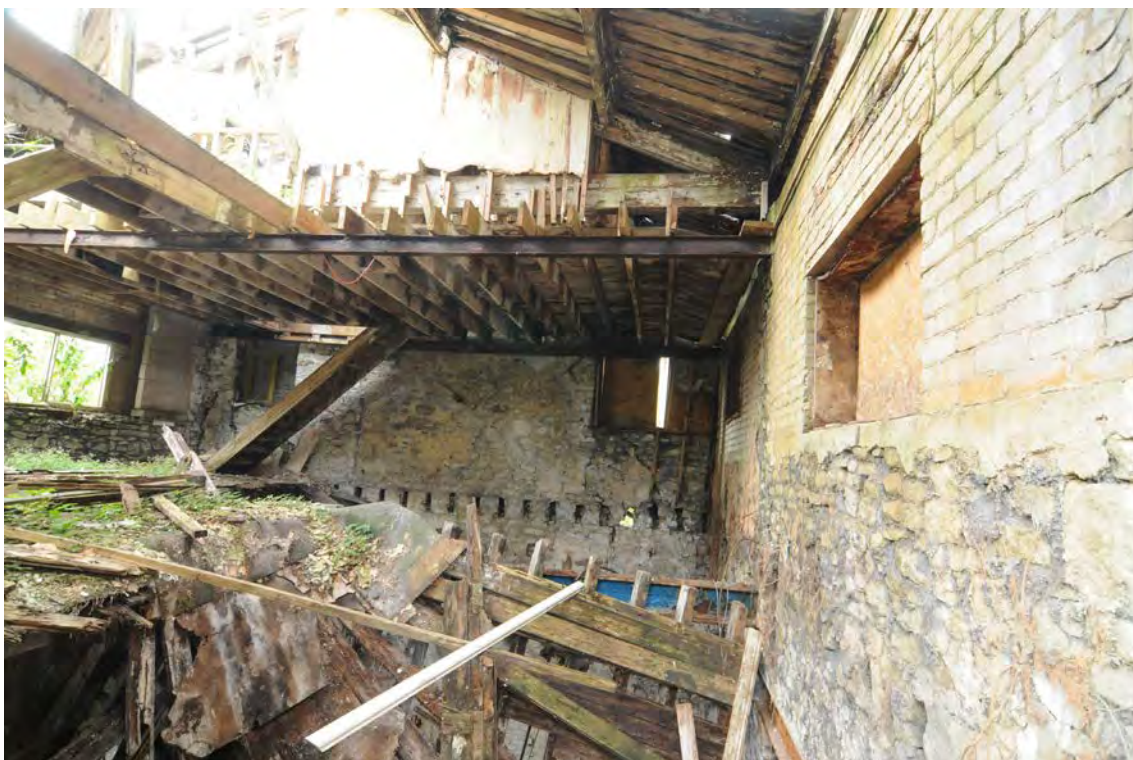
Photograph No : 57 Digital Ref: HOMI\_HBR\_0053 Direction: S  
Description: General southern view of first floor internal area of Building B

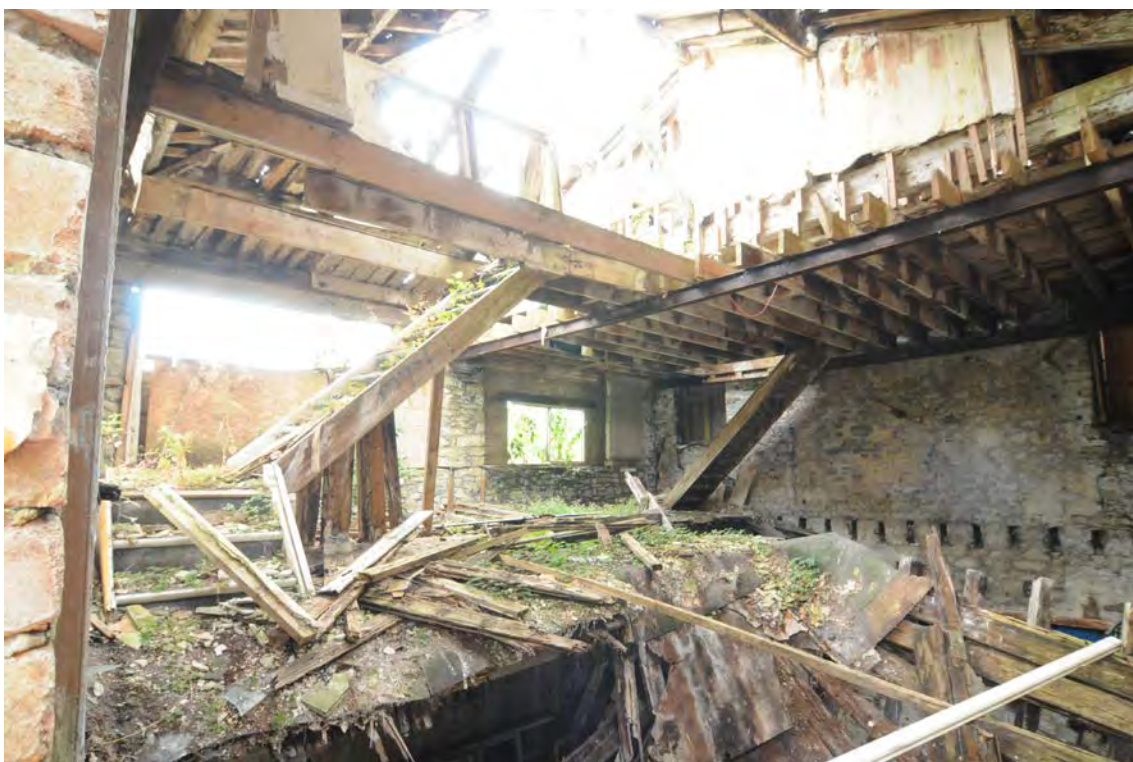
Photograph No : 58 Digital Ref: HOMI\_HBR\_0054 Direction: SE  
Description: General SE view of first floor internal area of Building B with stairs

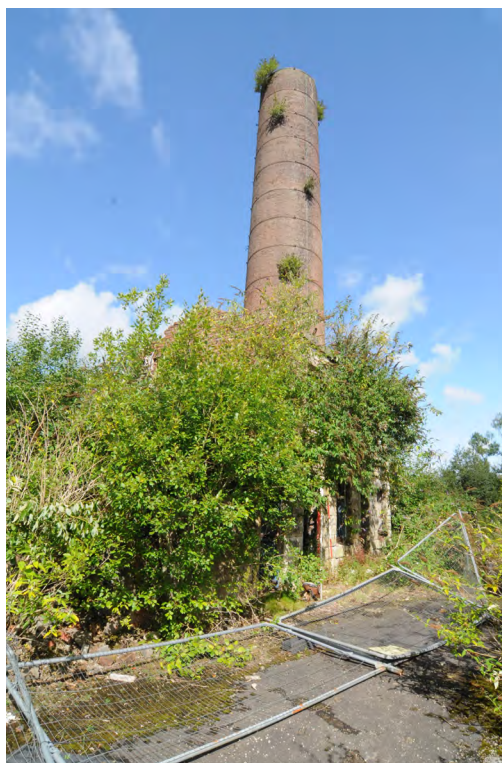
Photograph No : 59 Digital Ref: HOMI\_HBR\_0001 Direction: NW  
Description: East elevation of Building C and Chimney

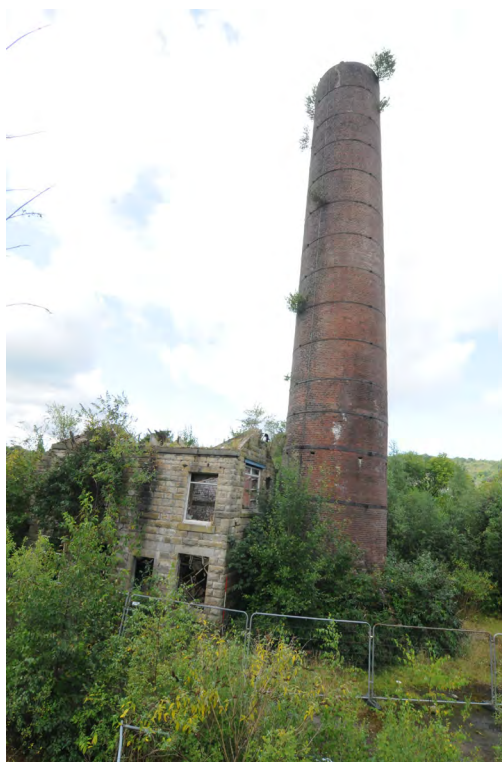
Photograph No : 60 Digital Ref: HOMI\_HBR\_0005 Direction: SW  
Description: East and north elevations of Building C and Chimney

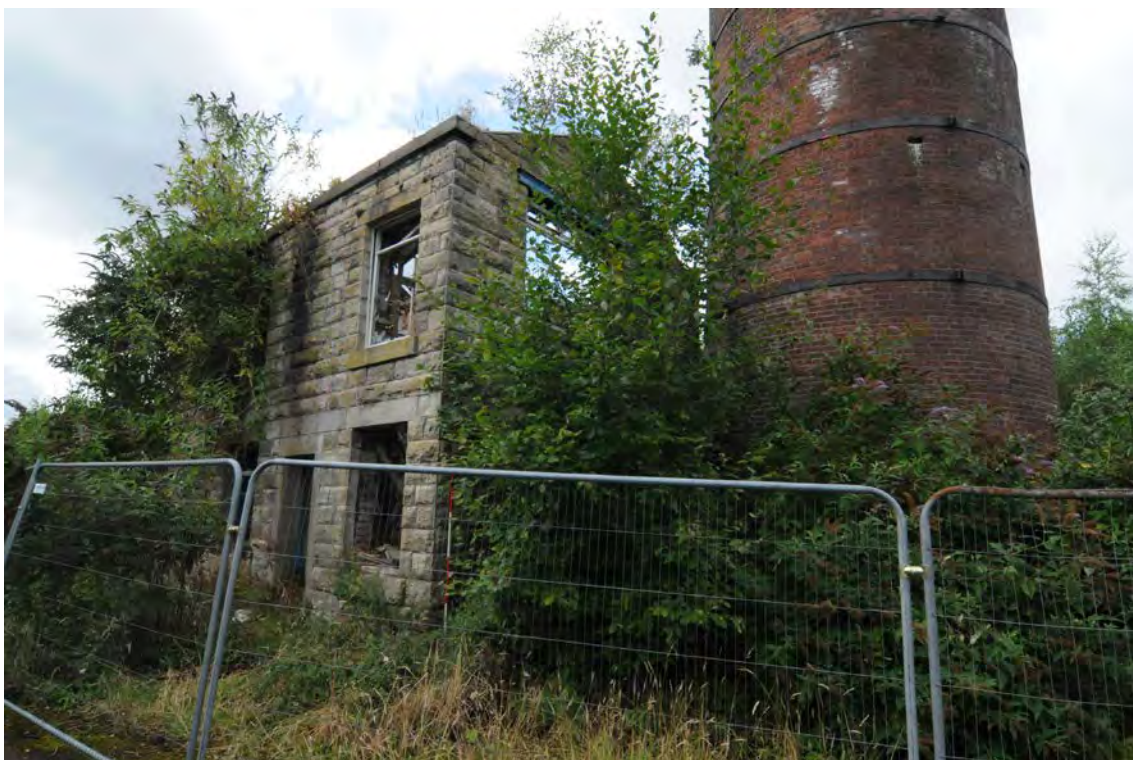
Photograph No : 61 Digital Ref: HOMI\_HBR\_0004 Direction: SW  
Description: East and north elevations of Building C and Chimney base
