## Three Buildings & Chimney Former Mondi Site, Holcombe Mill Bridge Street Ramsbottom

Level 1-2 Historic Building Recording  
[Report No. 4556](#)

**Level 1-2 Historic Building Recording**

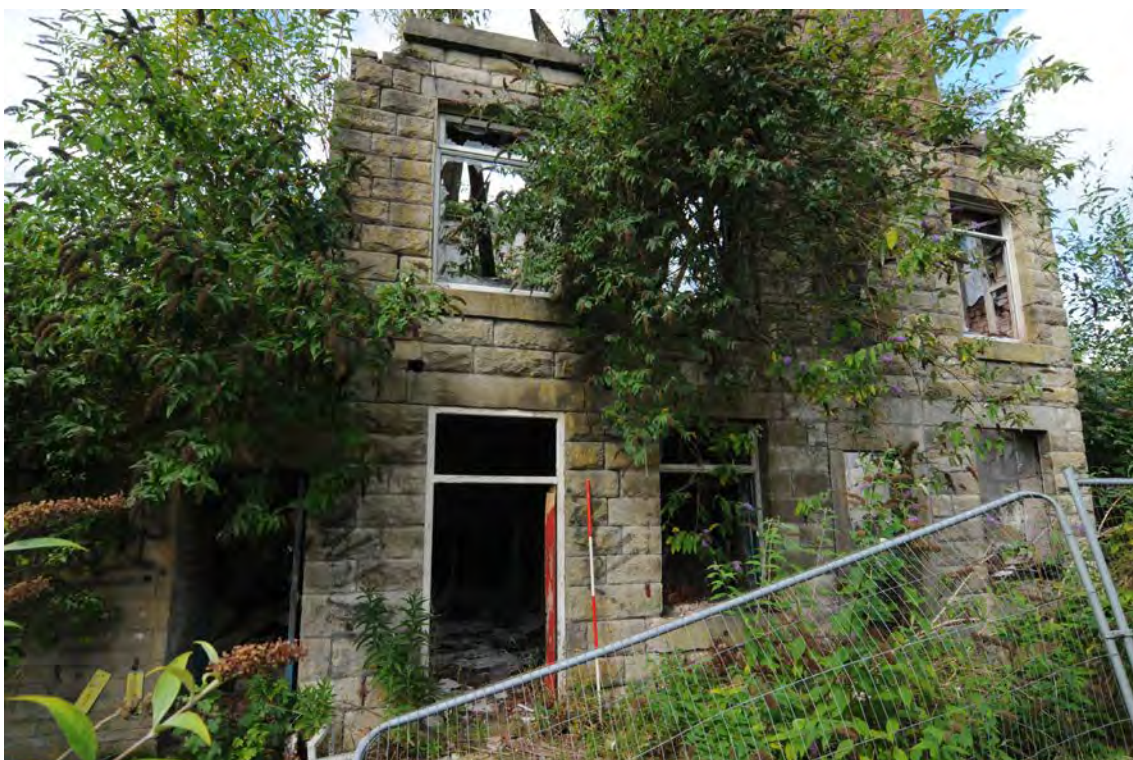
Building C was comprised of brick with coursed roughhewn grey sandstone façade at the principal east elevation and north elevation (**Photographs 62, 65 - 67**). Ashlar stones formed a band that continued from the ground floor fenestration to the north elevation, also found at the first-floor lintels, and at both floor fenestration cills (**Photographs 62, 66, 68 & 69**). The northern ground floor door had an ashlar architrave, whilst fenestration elsewhere had an ashlar margin at the surrounds (**Photograph 70**). The southern doorway appeared to have been opened at an earlier window as evident through cement infill at the former cill (**Photograph 71**). On the north elevation there was a door with an ashlar lintel at the west extent and a large window with a timber lintel and PVC framing towards the east (**Photograph 68**). At the ground floor level there was an area of cement appearing to block an earlier opening (**Photographs 72 & 73**). A steel I-beam was fitted below the door and joined to the chimney (**Photograph 74**). Two additional I-beams had been cut at the east (**Photograph 66**). Just above the ground level, the north elevation had a single small pipe opening (**Photograph 75**).

Photograph No : 62 Digital Ref: HOMI\_HBR\_0003 Direction: W  
Description: East elevation of Building C

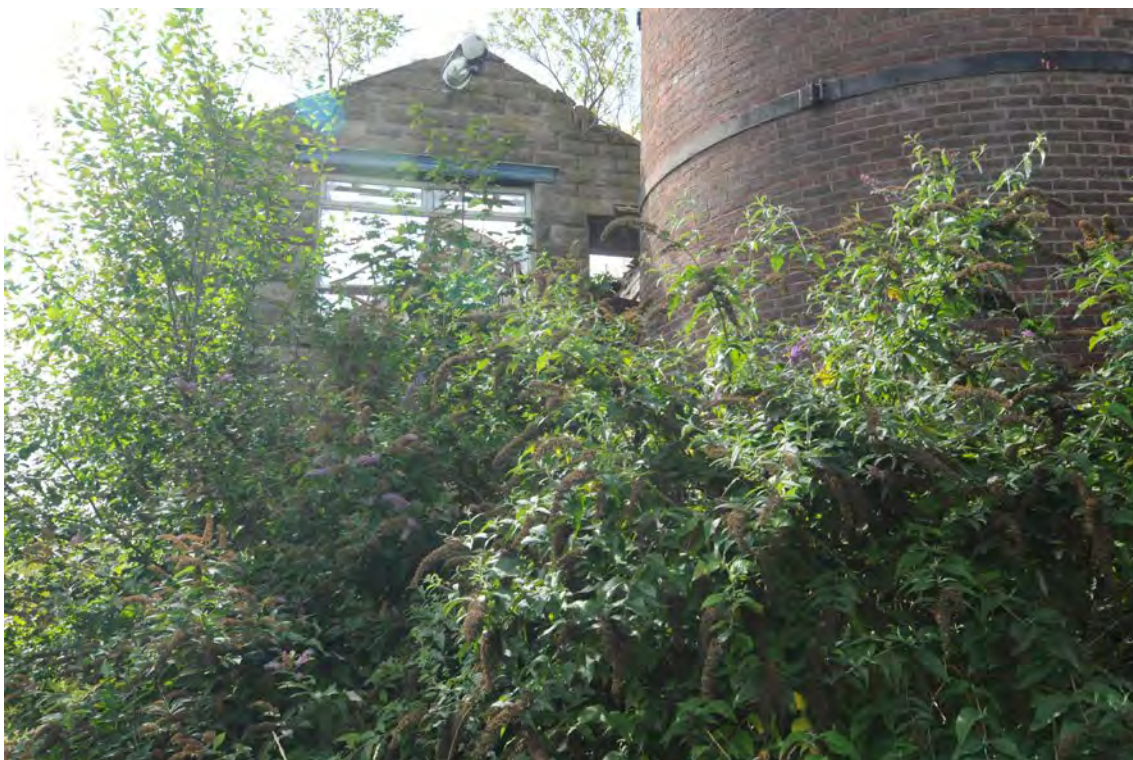
Photograph No : 63 Digital Ref: HOMI\_HBR\_0025 Direction: SW  
Description: North gable of Building C with Chimney base at NW (right)

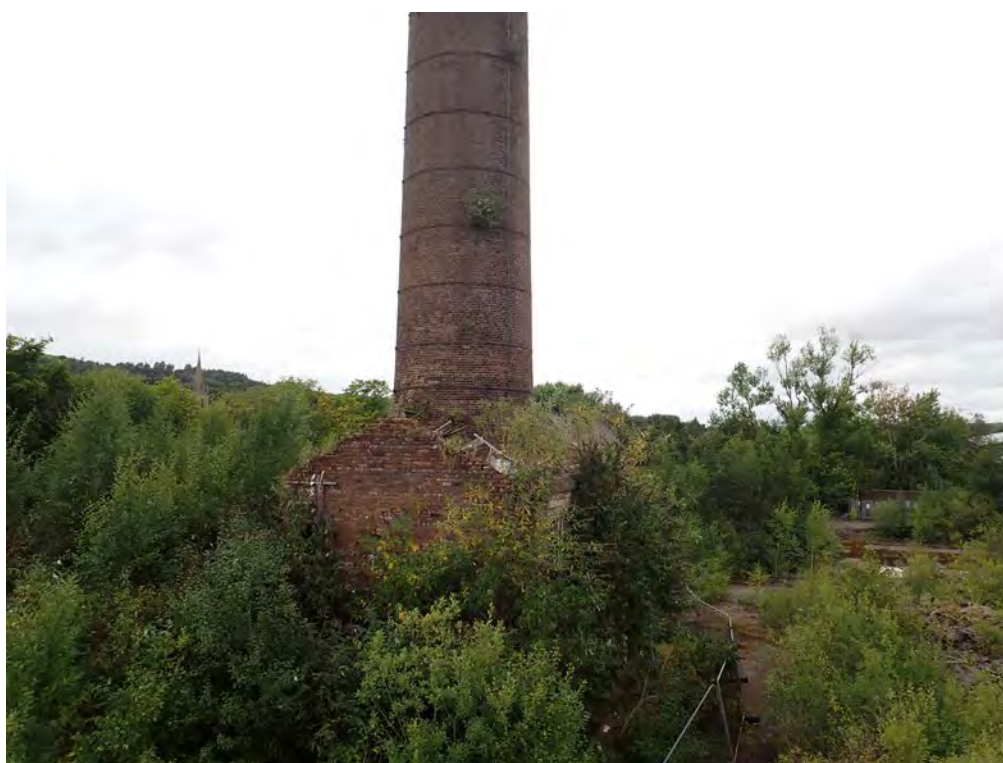
Photograph No : 64 Digital Ref: HOMI\_HBR\_0097 Direction: N  
Description: South gable of Building C with chimney in background

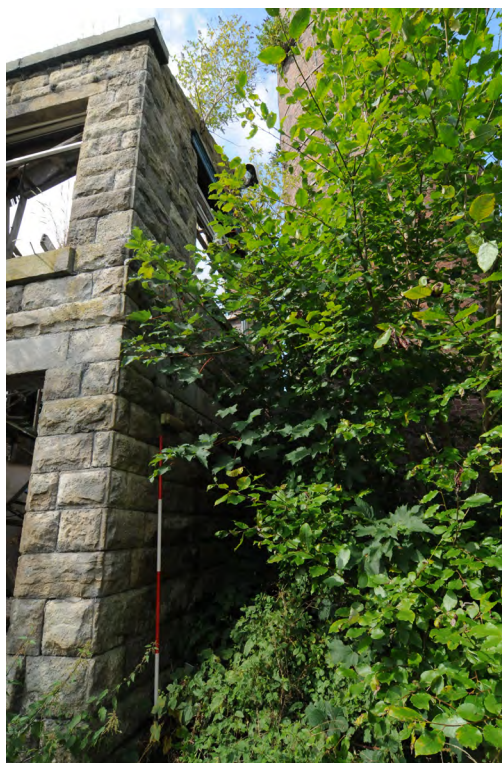
Photograph No : 65 Digital Ref: HOMI\_HBR\_0019 Direction: SW  
 Description: Oblique view of east elevation (left) and north elevation of Building C with Chimney in background

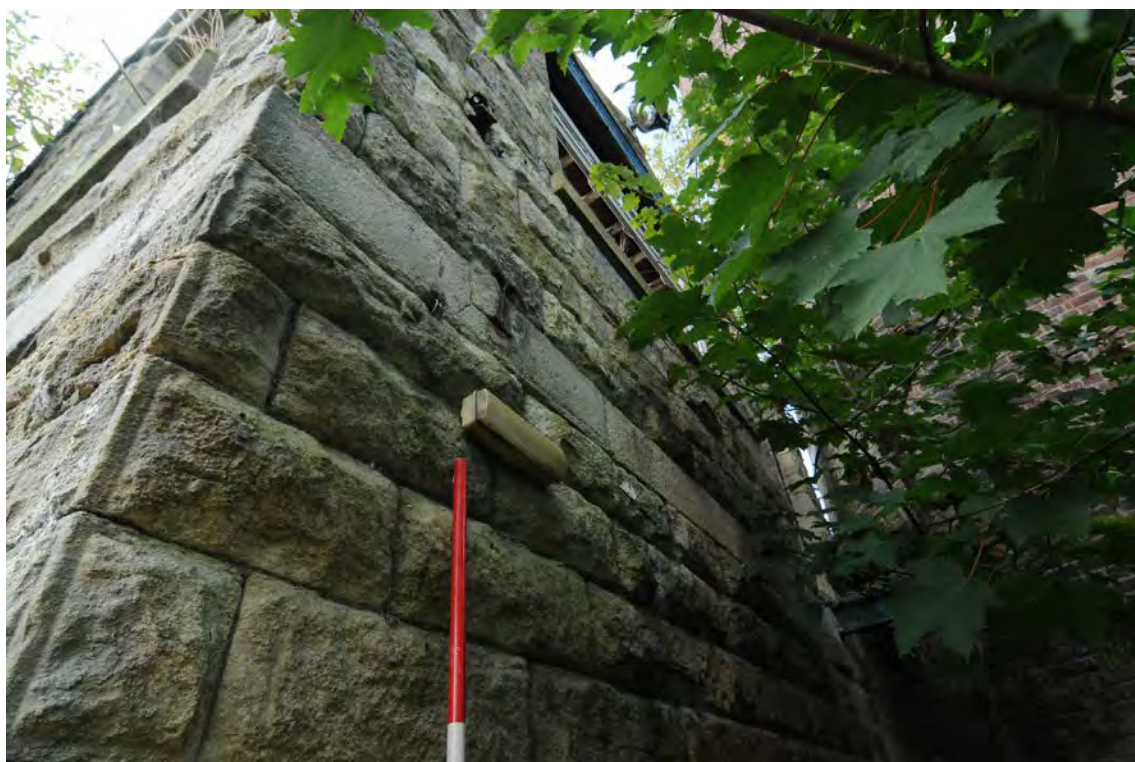
Photograph No : 66 Digital Ref: HOMI\_HBR\_0020 Direction: SW  
 Description: Detail of ashlar band in north elevation of Building C with large window on first floor

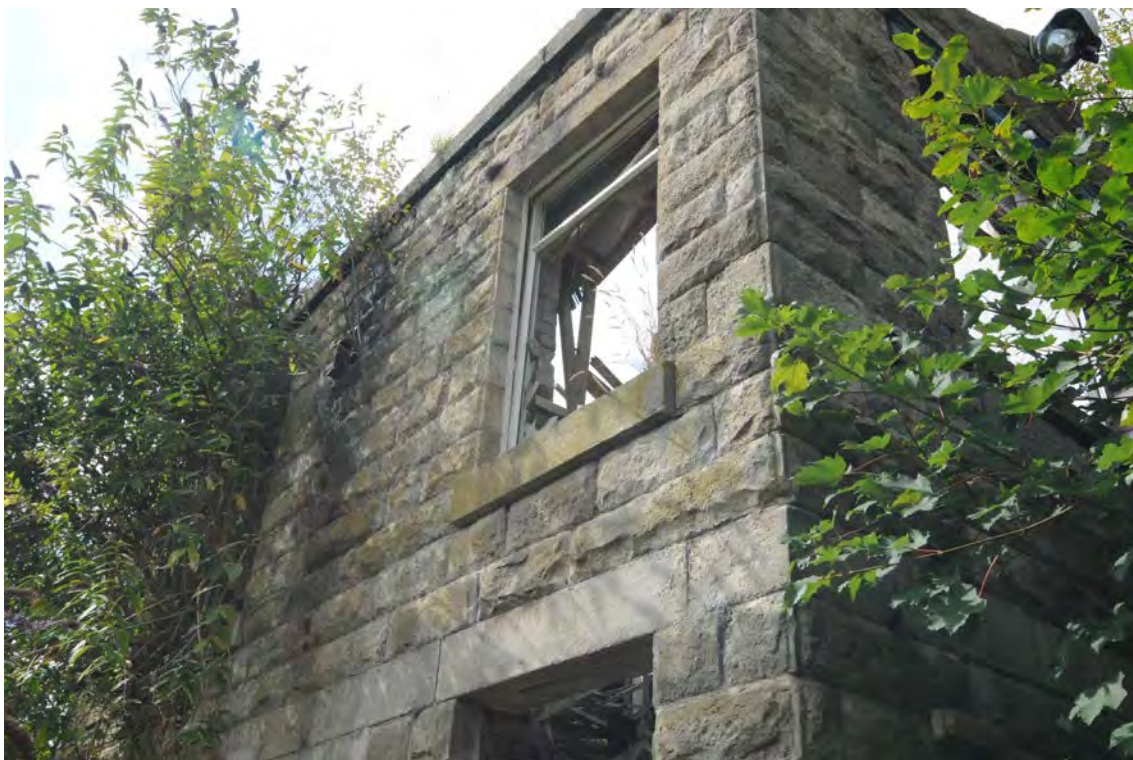
Photograph No : 67 Digital Ref: HOMI\_HBR\_0026 Direction: SW  
Description: First floor east elevation of Building C with window exposing internal brick

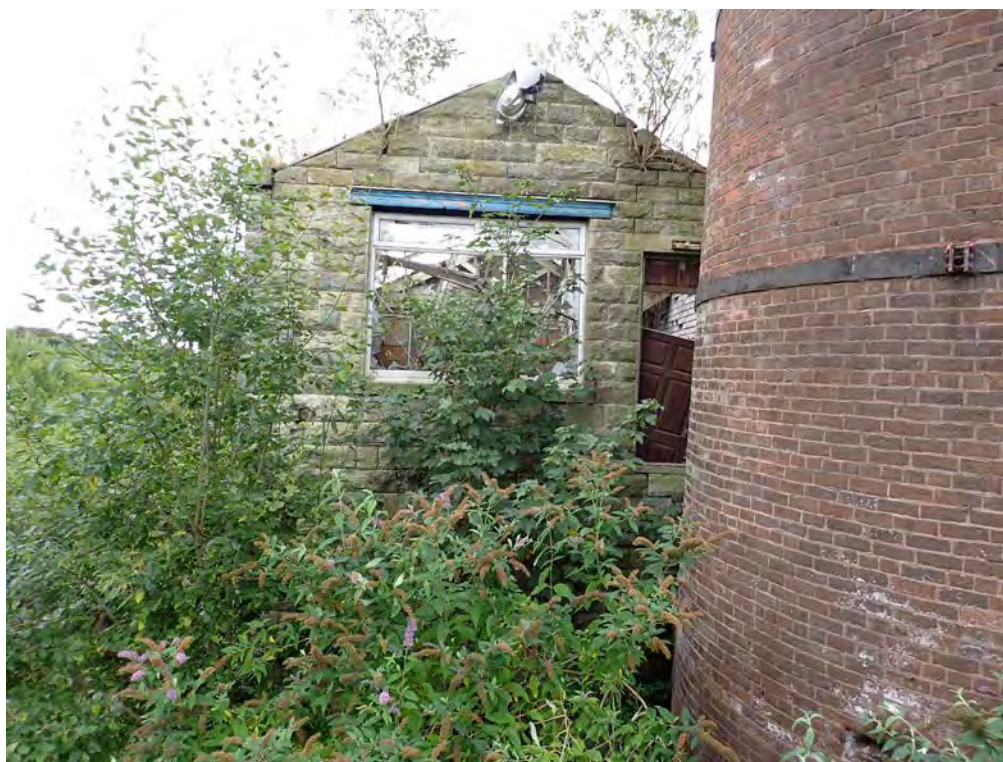
Photograph No : 68 Digital Ref: HOMI\_HBR\_0096 Direction: S  
Description: North gable of Building C with Chimney at NW (right)

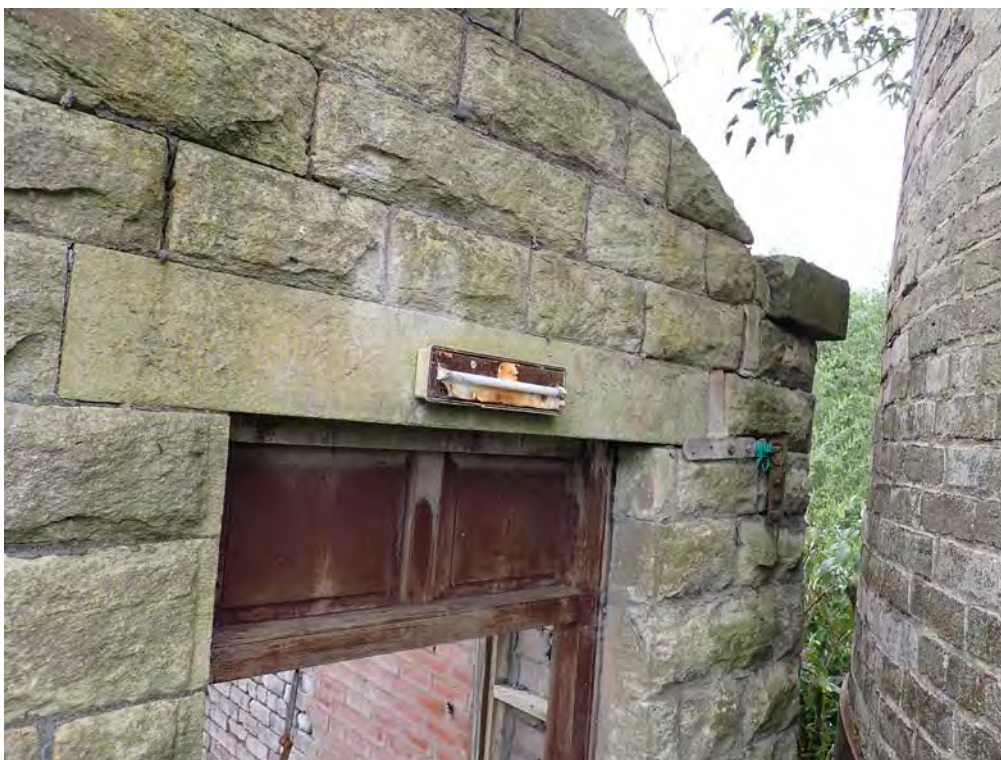
Photograph No : 69 Digital Ref: HOMI\_HBR\_0095 Direction: SW  
Description: Detail of lintel above first floor doorway in north gable of Building C with chimney at west (right)

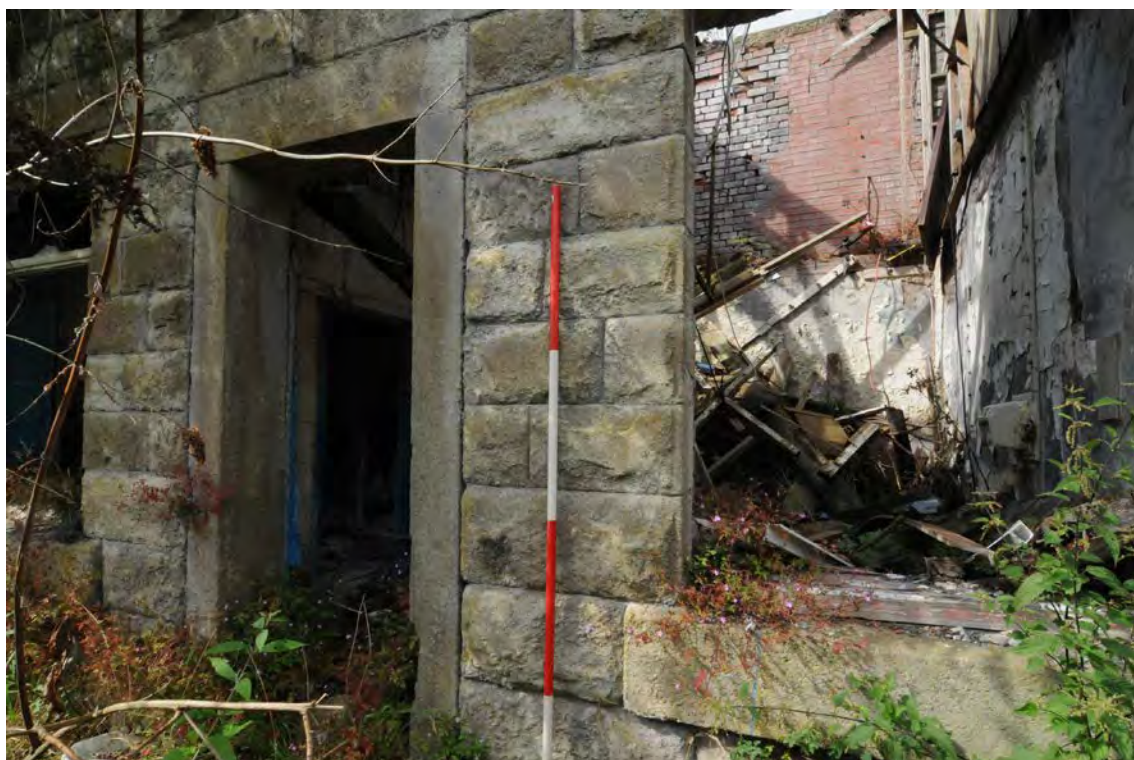
Photograph No : 70 Digital Ref: HOMI\_HBR\_0014 Direction: SW  
Description: SW view of east elevation of Building C and view into building

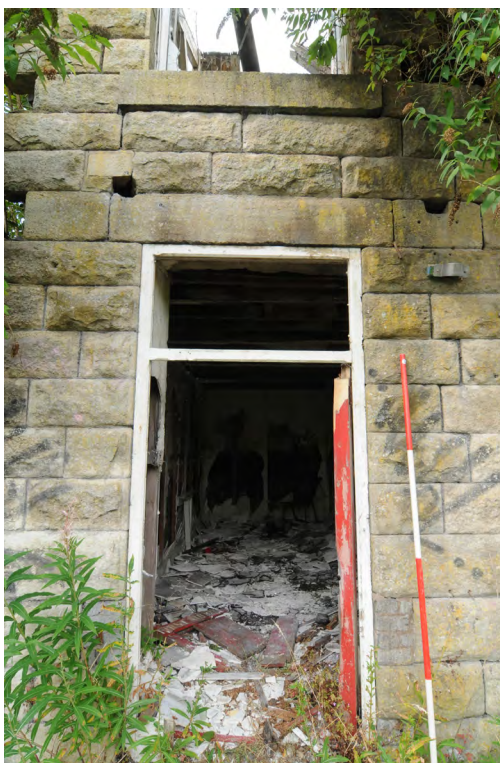
Photograph No : 71 Digital Ref: HOMI\_HBR\_0009 Direction: W  
Description: East elevation of Building C, westward view into ground floor

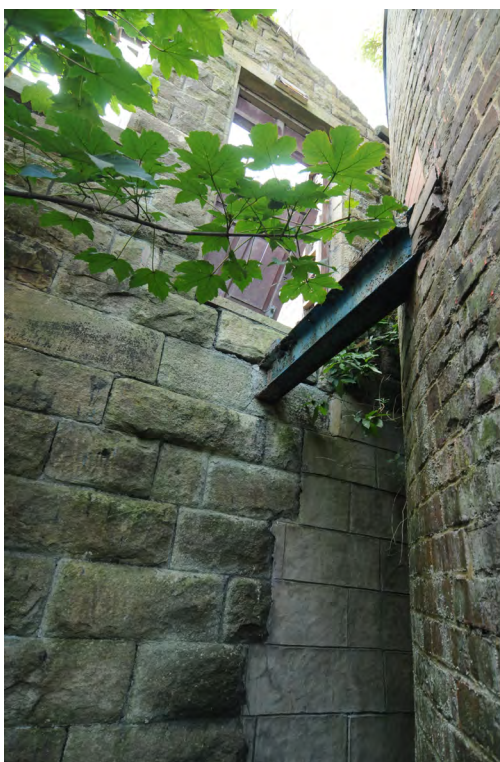
Photograph No : 72 Digital Ref: HOMI\_HBR\_0021 Direction: SW  
Description: Door at first floor and blocked opening at ground floor in north elevation of Building C with Chimney to north (right)

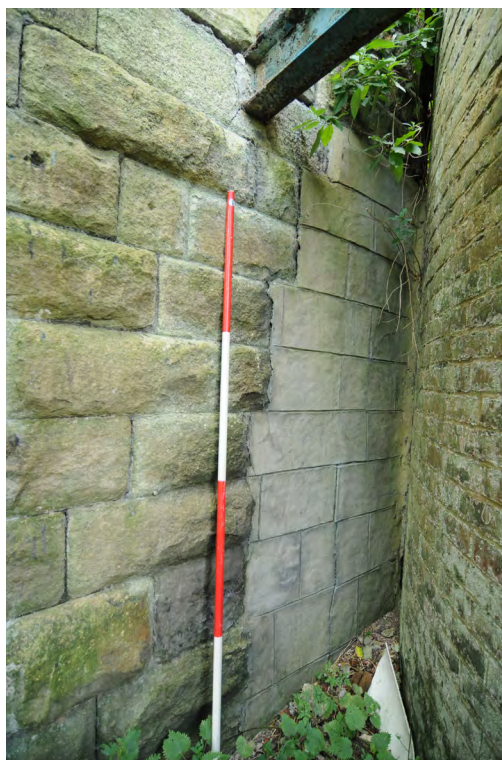
Photograph No : 73 Digital Ref: HOMI\_HBR\_0023 Direction: SW  
Description: Blocked opening at west extent of north elevation of Building C with chimney to north (right)

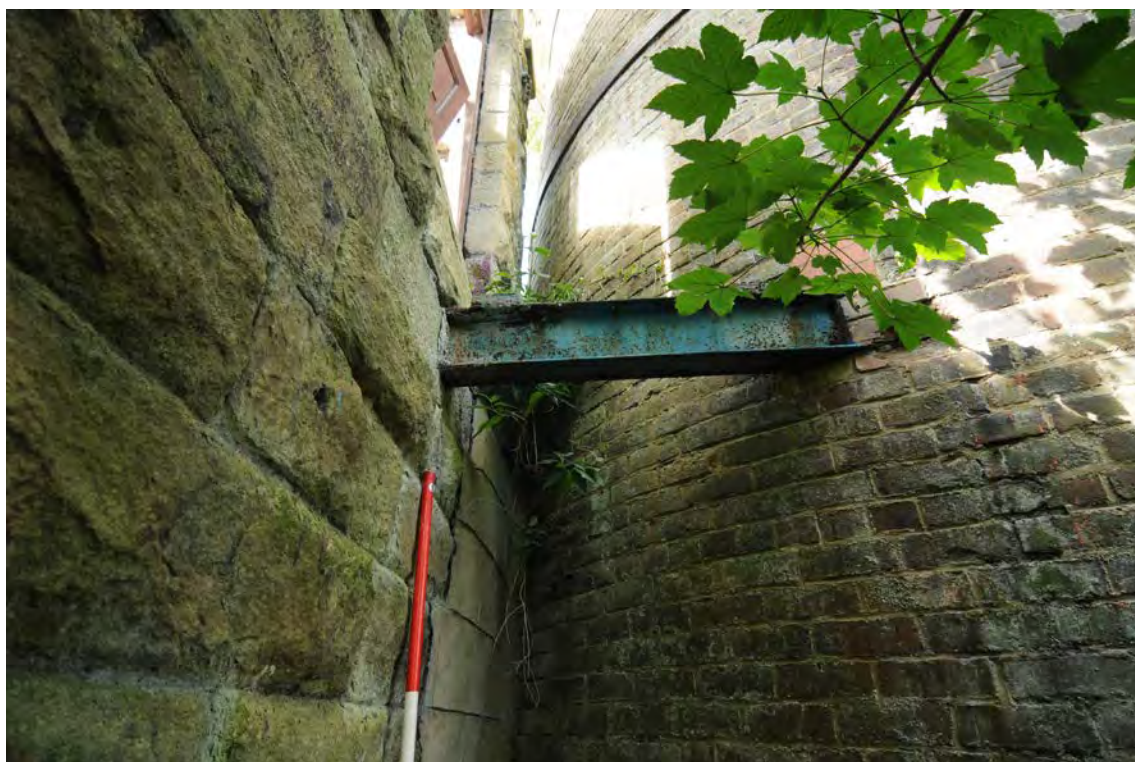
Photograph No : 74 Digital Ref: HOMI\_HBR\_0024 Direction: SW  
Description: Detail of steel I-beam between north elevation and chimney

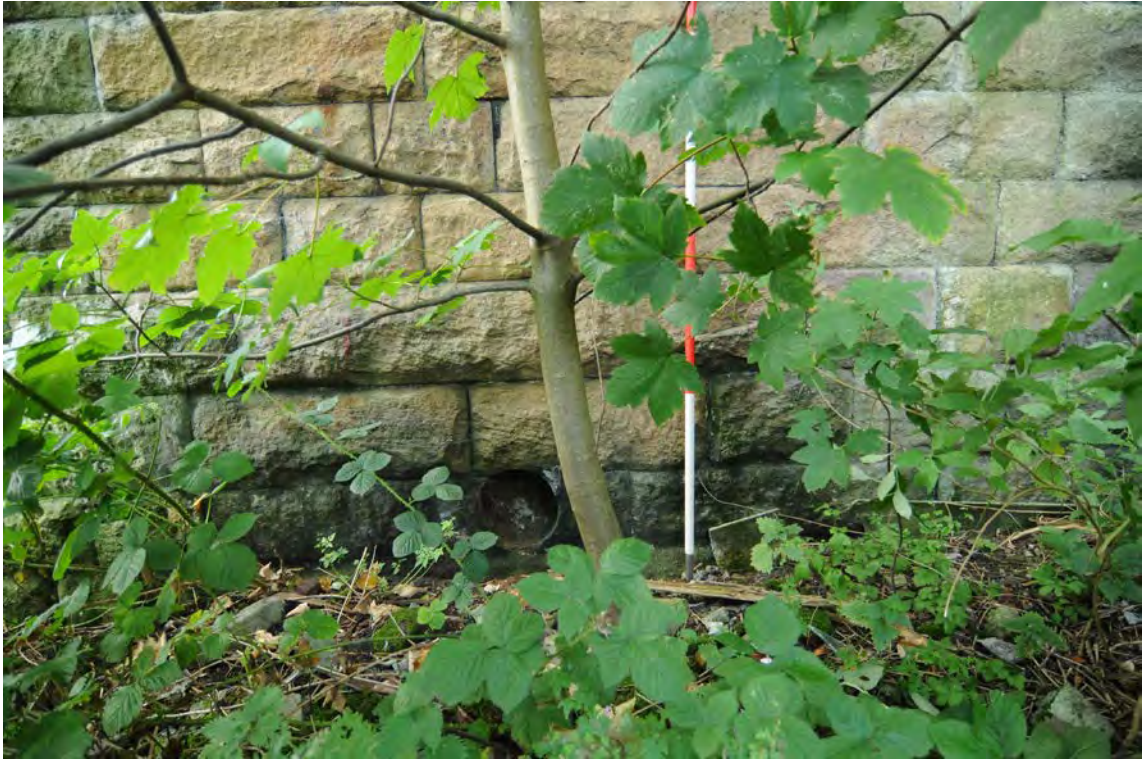
Photograph No : 75 Digital Ref: HOMI\_HBR\_0022 Direction: SW  
Description: Opening in lower stone course in north elevation of Building C

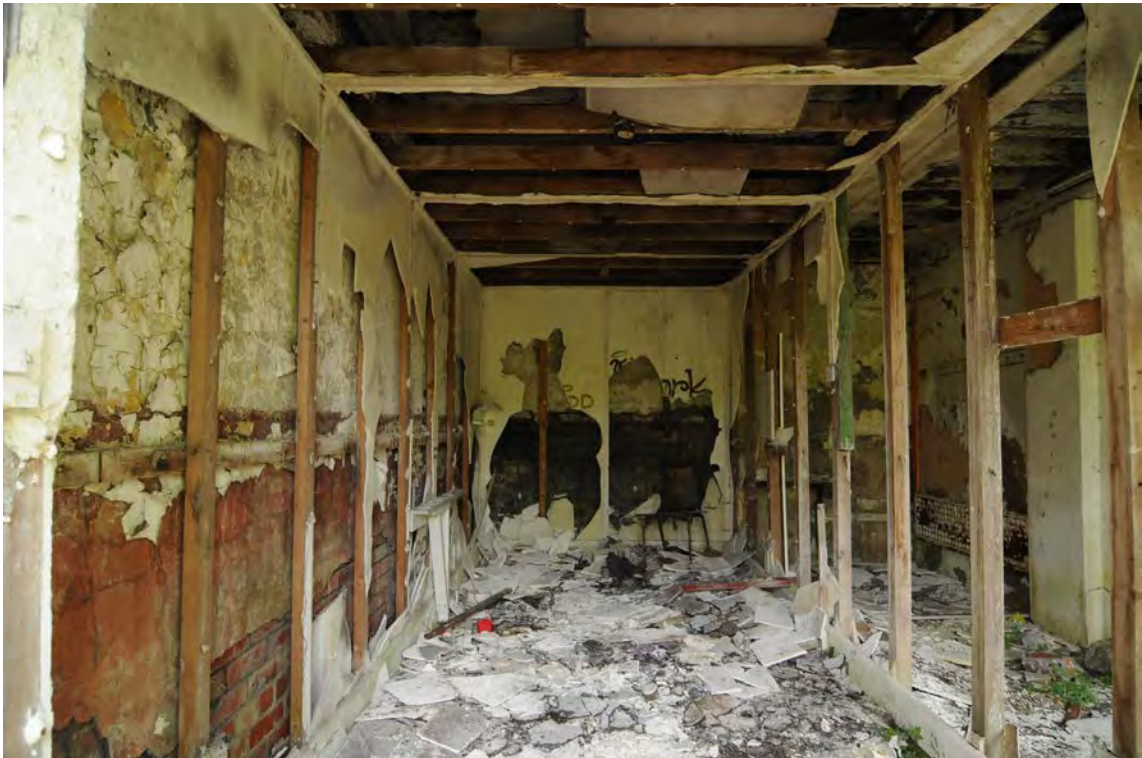
Photograph No : 76 Digital Ref: HOMI\_HBR\_0010 Direction: W  
Description: Westward view into ground floor of Building C

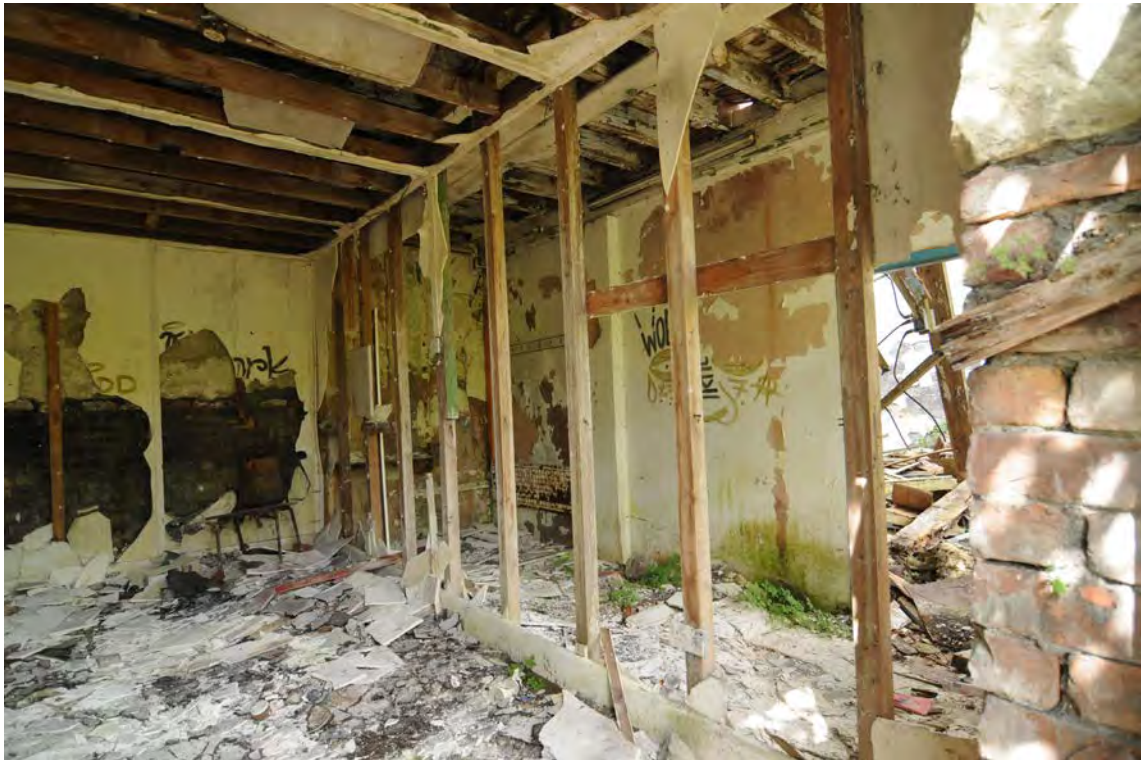
Photograph No : 77 Digital Ref: HOMI\_HBR\_0011 Direction: NW  
Description: NW view into ground floor of Building C

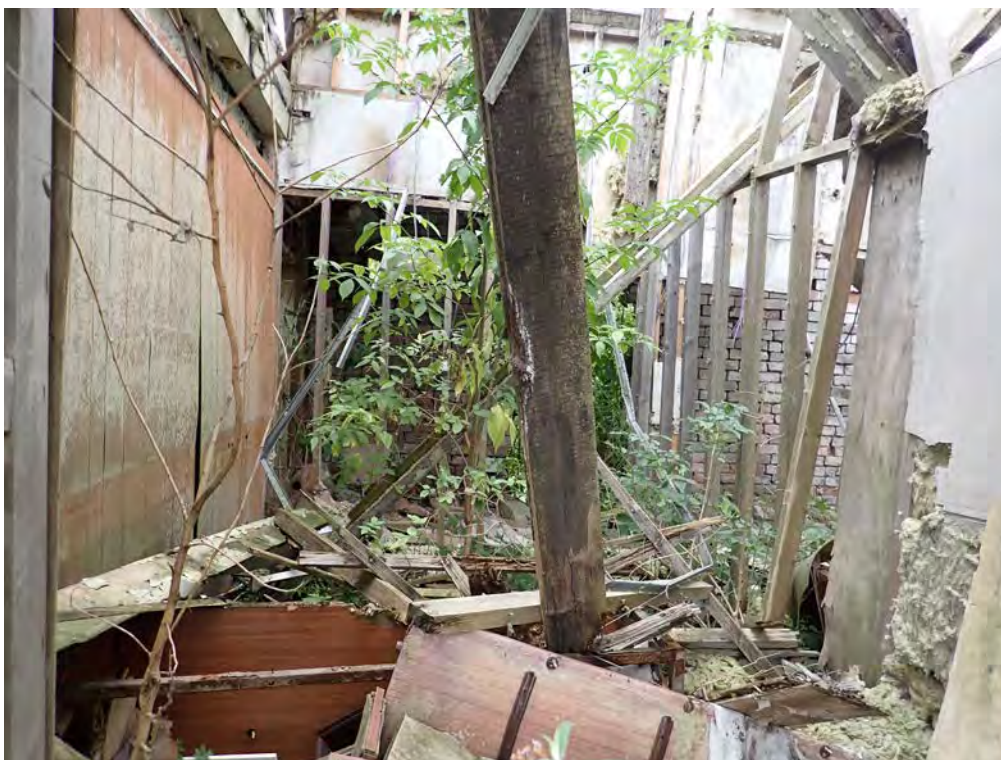
Photograph No : 78 Digital Ref: HOMI\_HBR\_0012 Direction: W  
Description: Westward view into ground floor of Building C

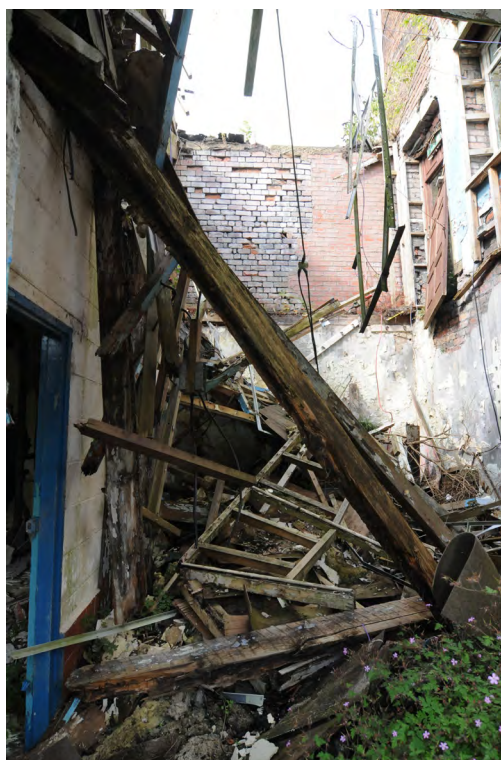
Photograph No : 79 Digital Ref: HOMI\_HBR\_0090 Direction: W  
Description: General view of first floor of Building C

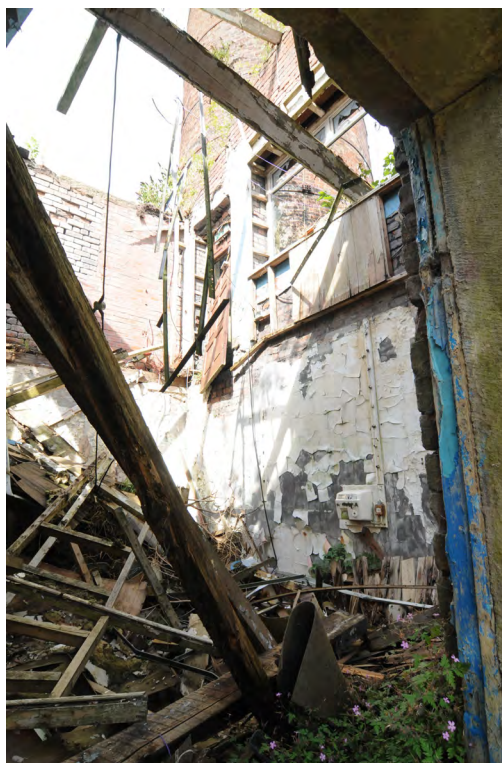
Photograph No : 80 Digital Ref: HOMI\_HBR\_0015 Direction: W  
Description: Westward view into ground and first floor of Building C

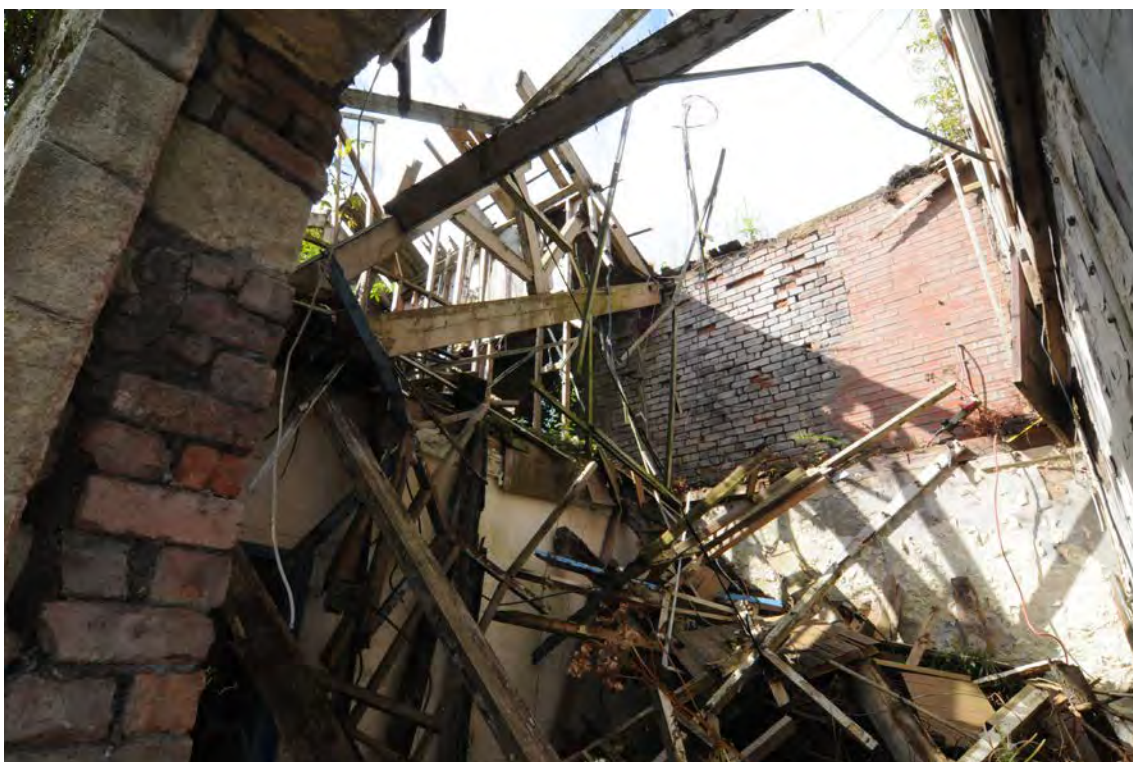
Photograph No : 81 Digital Ref: HOMI\_HBR\_0016 Direction: NW  
Description: NW view into ground and first floor of Building C

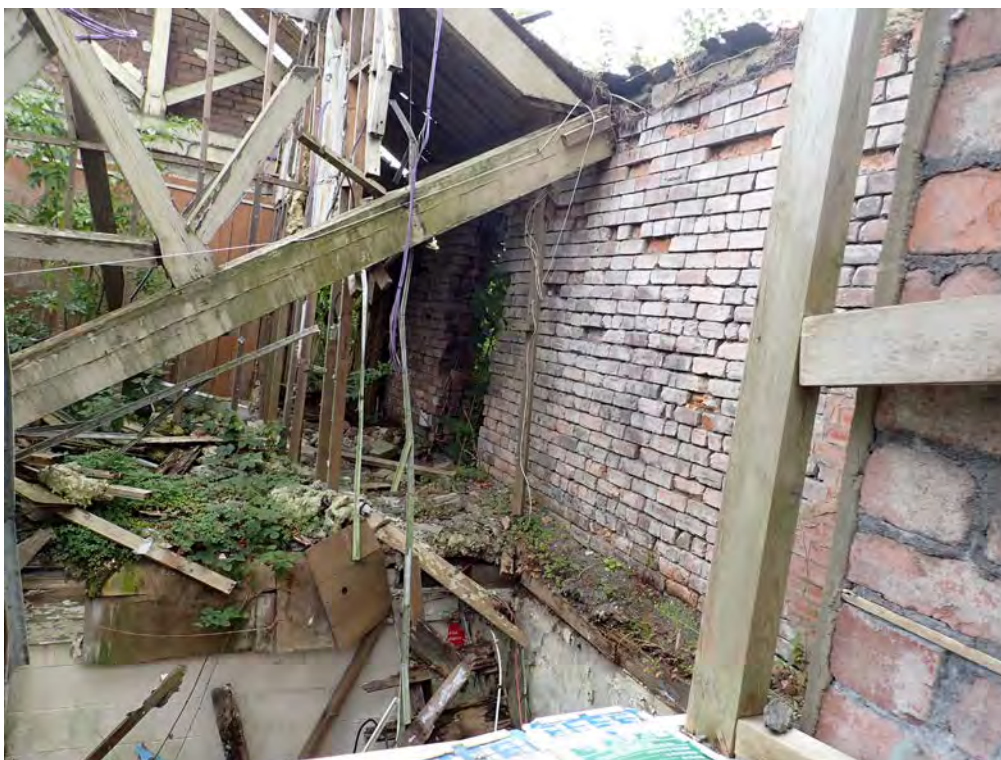
Photograph No : 82 Digital Ref: HOMI\_HBR\_0017 Direction: SW  
Description: SW view into ground and first floor of Building C

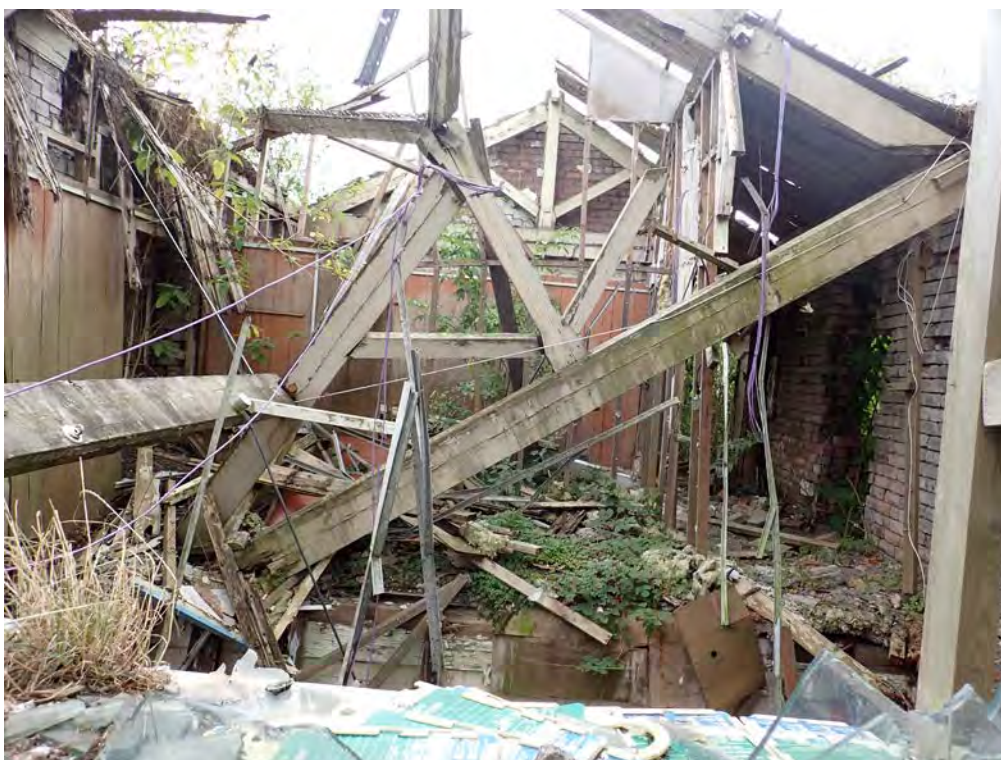
Photograph No : 83 Digital Ref: HOMI\_HBR\_0094 Direction: SW  
Description: King post trusses and general view of first floor of Building C

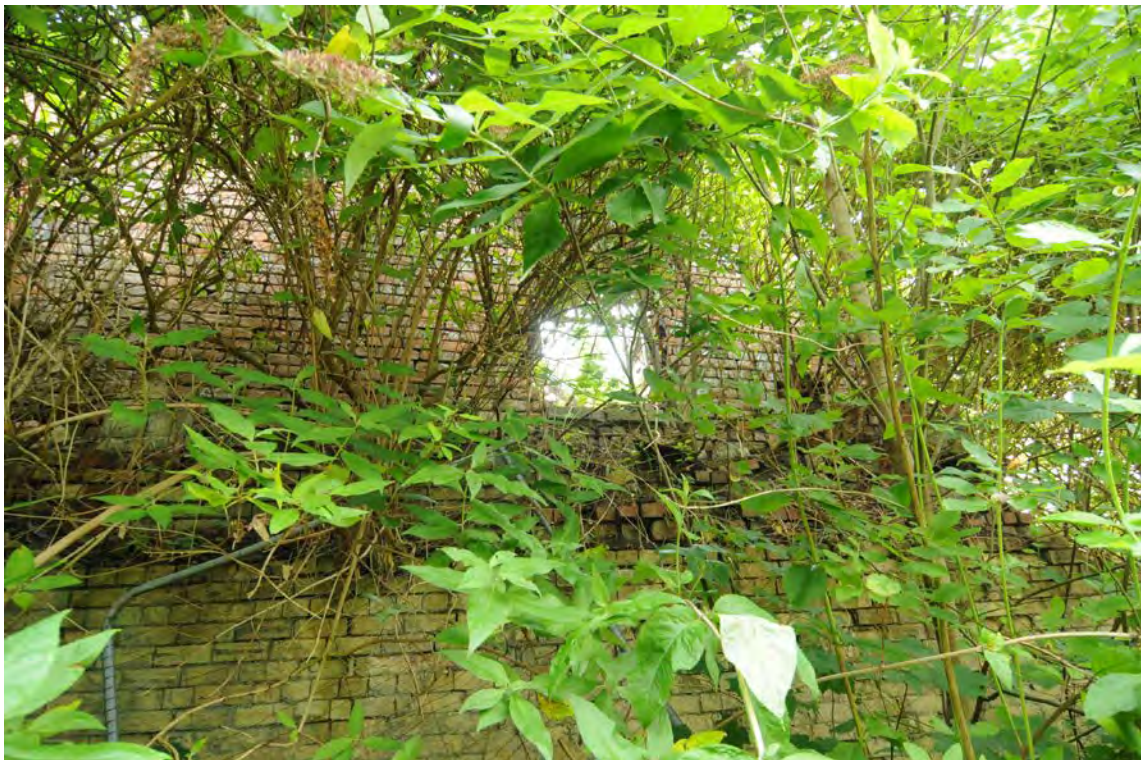
Photograph No : 86 Digital Ref: HOMI\_HBR\_0037 Direction: E  
Description: Window in first floor of west elevation of Building C, brick wall on ground floor

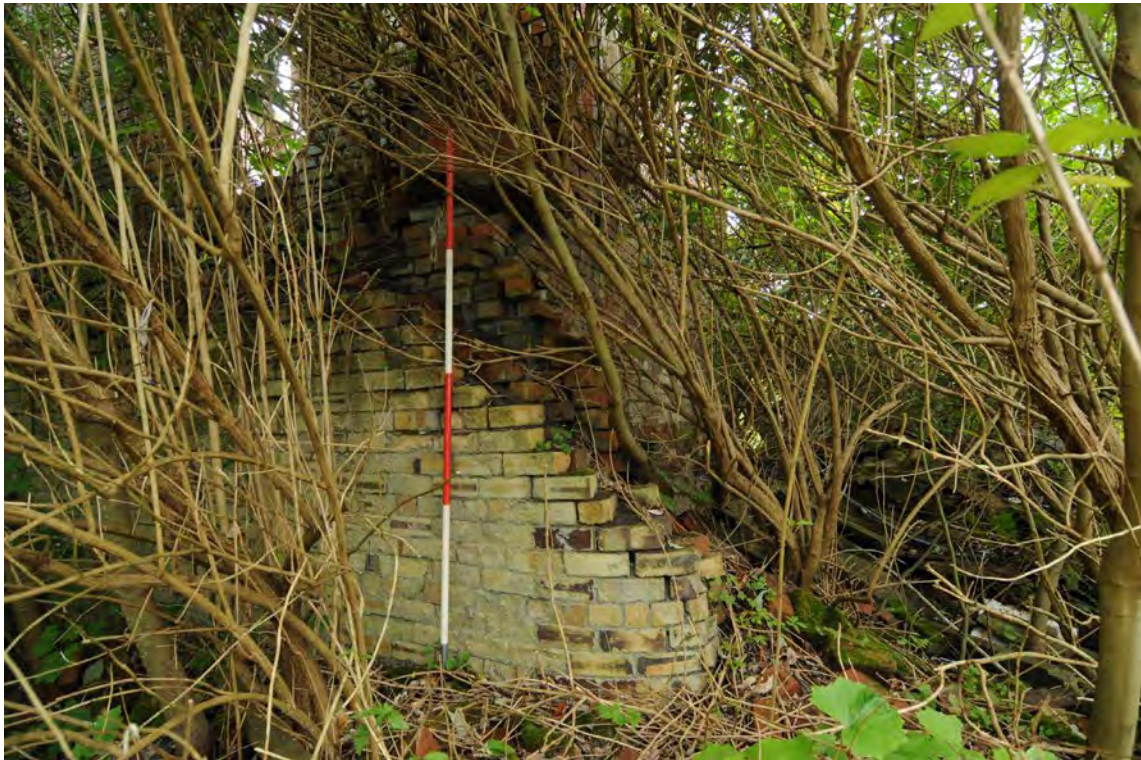
Photograph No : 87 Digital Ref: HOMI\_HBR\_0038 Direction: NE  
Description: Curve in brick at ground floor southern extent of west elevation of Building C

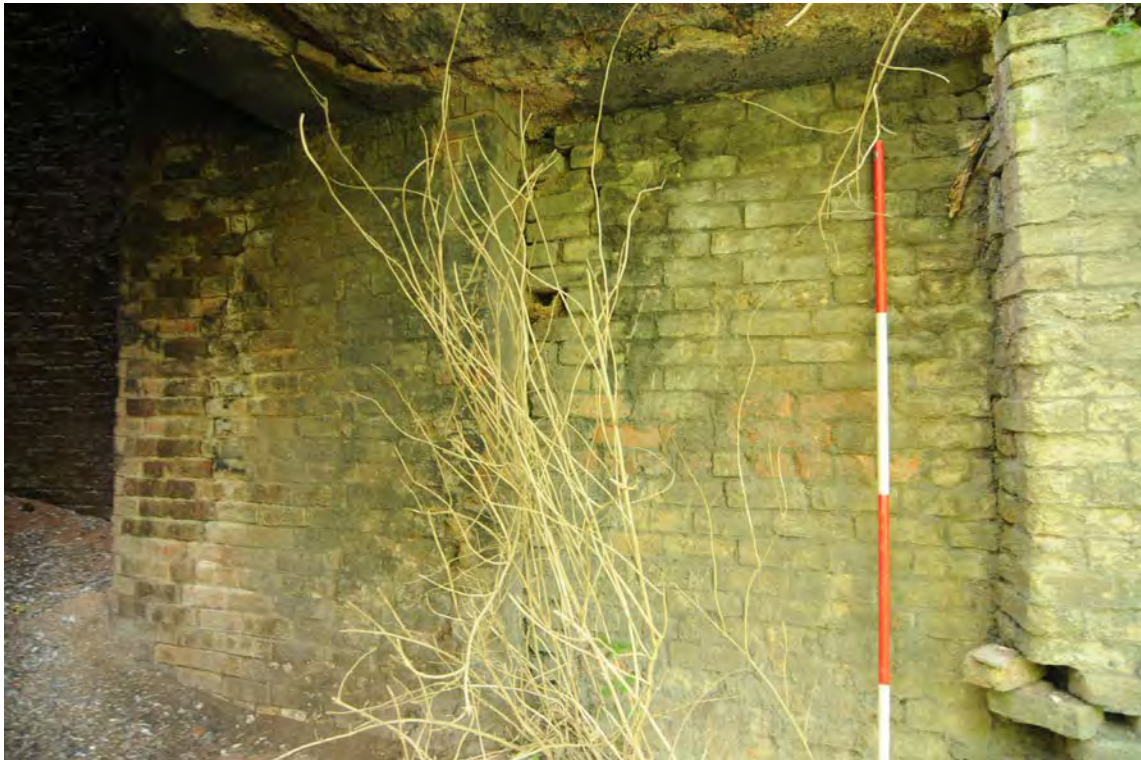
Photograph No : 89 Digital Ref: HOMI\_HBR\_0029 Direction: NE  
Description: Opening in south side of chimney and west elevation of Building C (right)

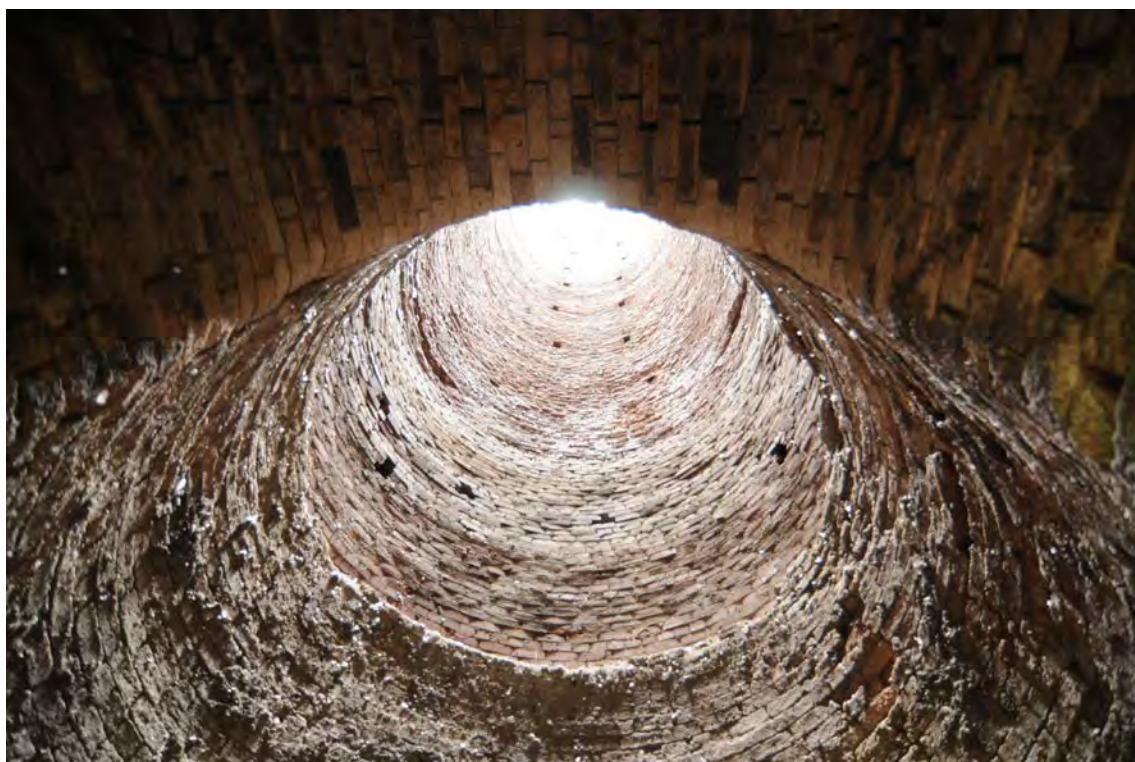
Photograph No : 92 Digital Ref: HOMI\_HBR\_0032 Direction: N  
Description: Internal view of chimney

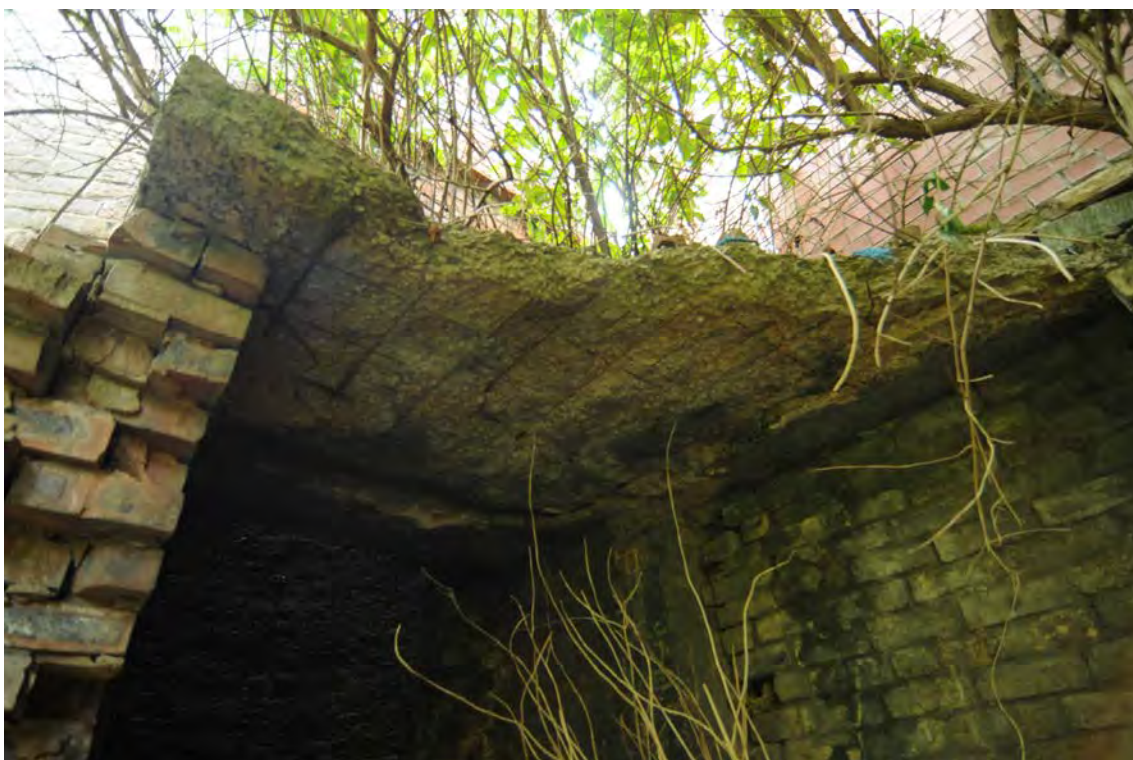
Photograph No : 93 Digital Ref: HOMI\_HBR\_0033 Direction: N  
Description: Ledge in internal chimney

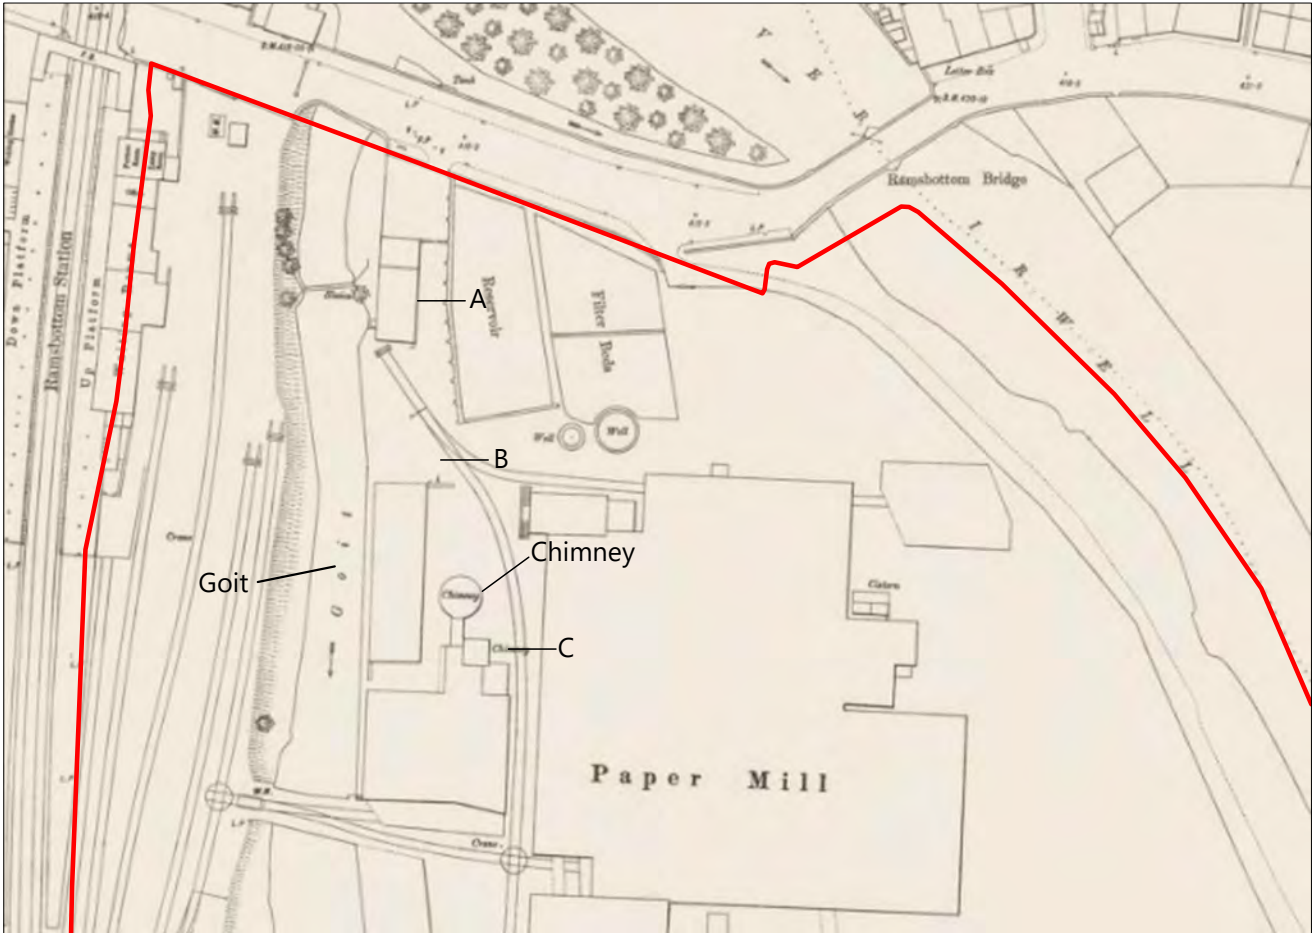
Fig. 2.2: Extract from the OS Map of Ramsbottom - Lancashire LXXIX.12.15, Published 1892

The 42-inch Town Plan OS map of Ramsbottom – Lancashire LXXIX.12.15 published in 1892 (fig. 2.2) shows the site labelled as a 'Paper Mill' with the presence of multiple buildings, including within the footprints of Building A and the Chimney. A building is present to the south of Building B. Building C is not present, although several buildings are present just south of the Chimney.

The east and north elevations of Building C had a similar but plainer decorative scheme as Building A, indicating a nod to the local vernacular style and signalling a congruent relationship between the buildings on site as well as a potential indicator of hierarchy. Building C was constructed between 1892 and 1908. From its initial construction, each successive map shows the building changing slightly, with the southern wall changing to a straight line sometime between 1964 and 1983 (Section 4.2). Although it was constructed in the location of an earlier square chimney shown in the 1892 map (Section 4.2.2, fig. 2.2), the building did not appear to retain elements of the earlier chimney.
