## Three Buildings & Chimney Former Mondi Site, Holcombe Mill Bridge Street Ramsbottom

Level 1-2 Historic Building Recording  
[Report No. 4556](#)

**Level 1-2 Historic Building Recording**

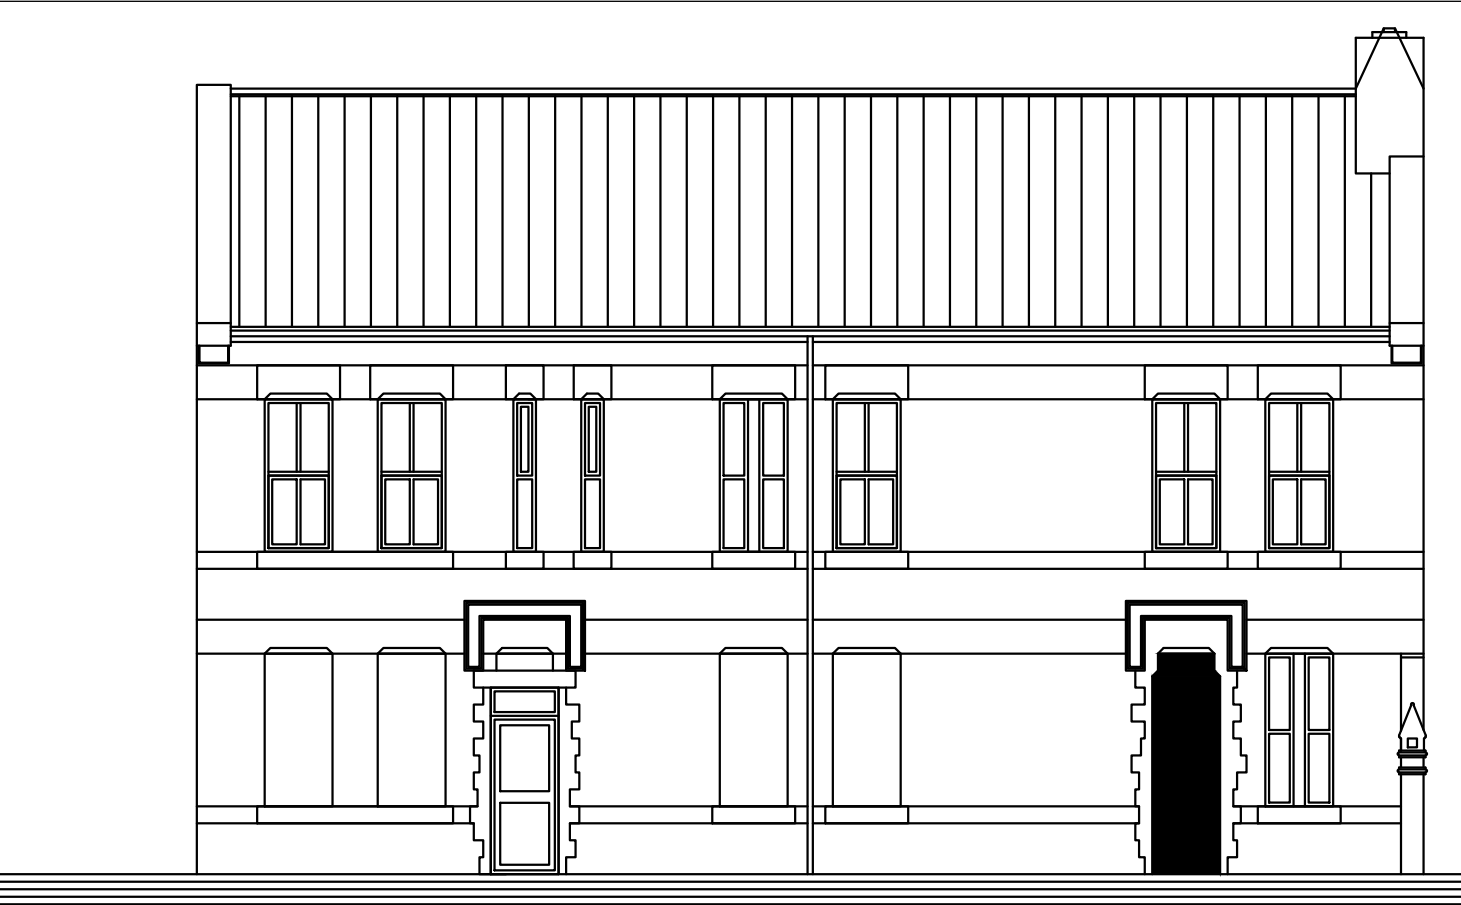
Fig. 3.3: Building A - East Elevation

Building A was comprised of a coursed roughhewn grey sandstone façade with four ashlar string courses aligned with fenestration lintels and cills. It had a slate gable roof with stone ridge tiles, raking gable copings, interrupted by a partially projecting chimney breast at the north gable ridge, moulded stone eaves brackets and moulded stone cornices (**Photographs 7 & 10**). The east elevation had an ornately decorative sandstone gatepost at the northern extent (fig. 3.3; **Photograph 11**).

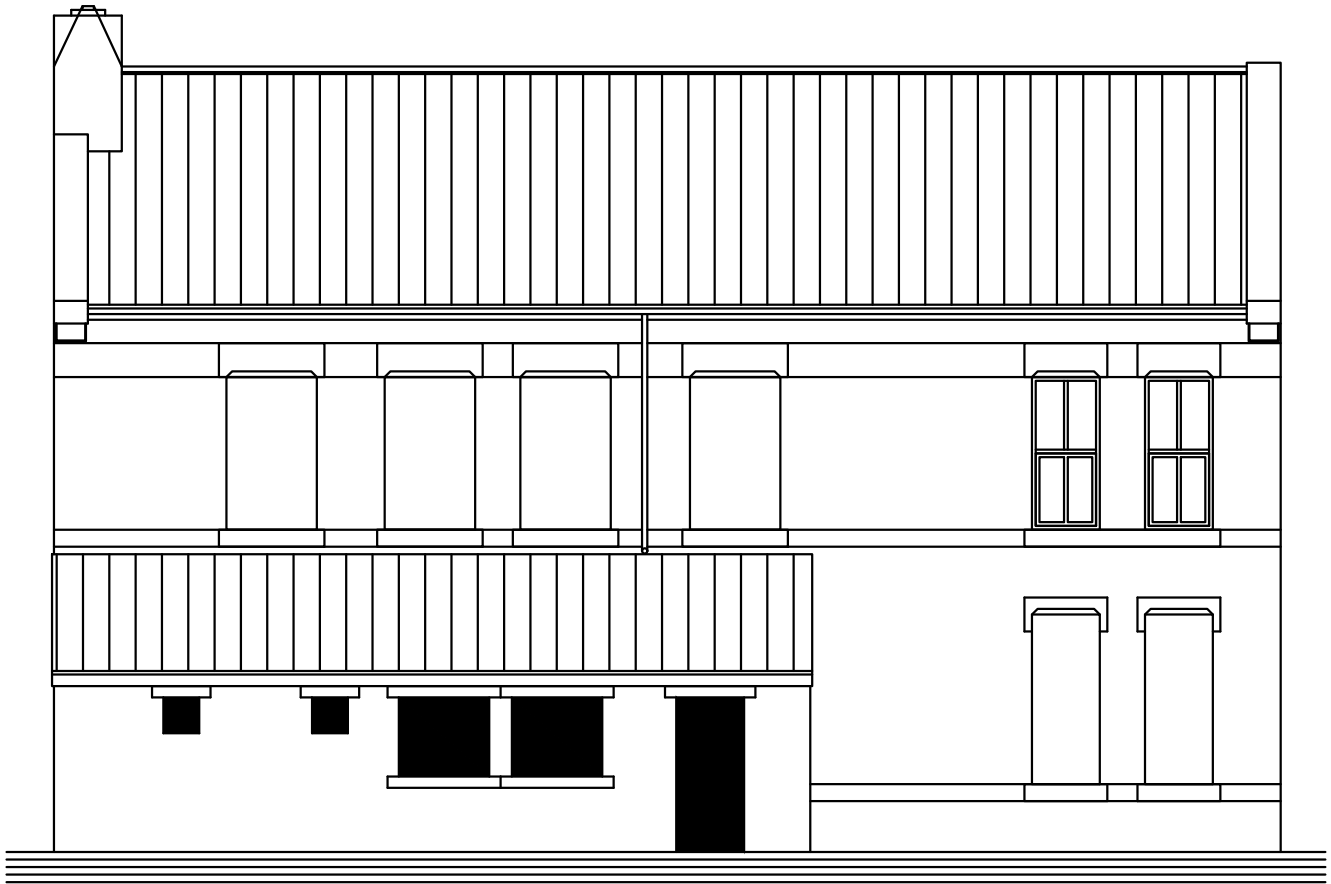
Fig. 3.5: Building A - West Elevation

The single storey addition at the west elevation had a single-pitched lean-to roof, was comprised of evenly coursed sandstone, and the fenestration had ashlar flush lintels and projecting ashlar cills (fig. 3.5; **Photograph 9 & 17**). All fenestration was blocked in uneven courses of sandstone. The addition at the south gable was comprised internally of stretcher bonded brick and externally of courses of uneven sandstone (**Photograph 18**). The gable at the south elevation previously had enclosed the gas mains.

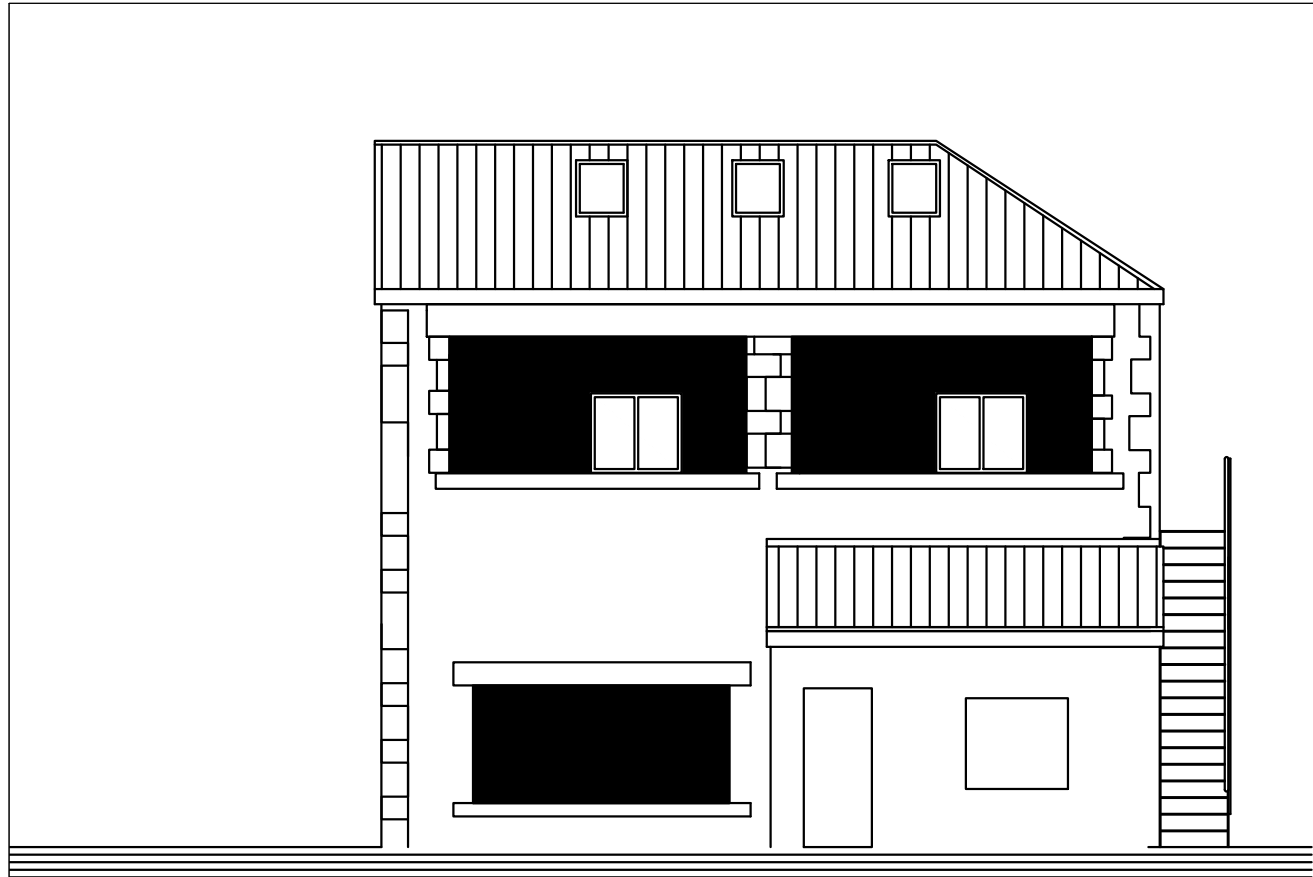
Fig. 4.3: Building A - East Elevation

The building was comprised of roughhewn uneven sandstone brought to course with alternating raked sandstone quoins at each corner (**Photographs 27 - 30**). The quoins at the SE corner differ as they were smaller in size and roughhewn with a margin, with brick fitted at the south (fig. 4.3; **Photograph 31**). The south gable was constructed over and west of an earlier stone gable which led to a south projecting wall at the east (fig. 4.4; **Photographs 32 - 35**). The earlier elevation was comprised of uneven sizes of sandstone rubble. Brick was revealed below surviving render at the west (**Photograph 36**).
