Star Academy, Radcliffe – Temps 2

Addendum Geo-Environmental Report and Outline Remedial Strategy

PH/C5394/13776

December 2024

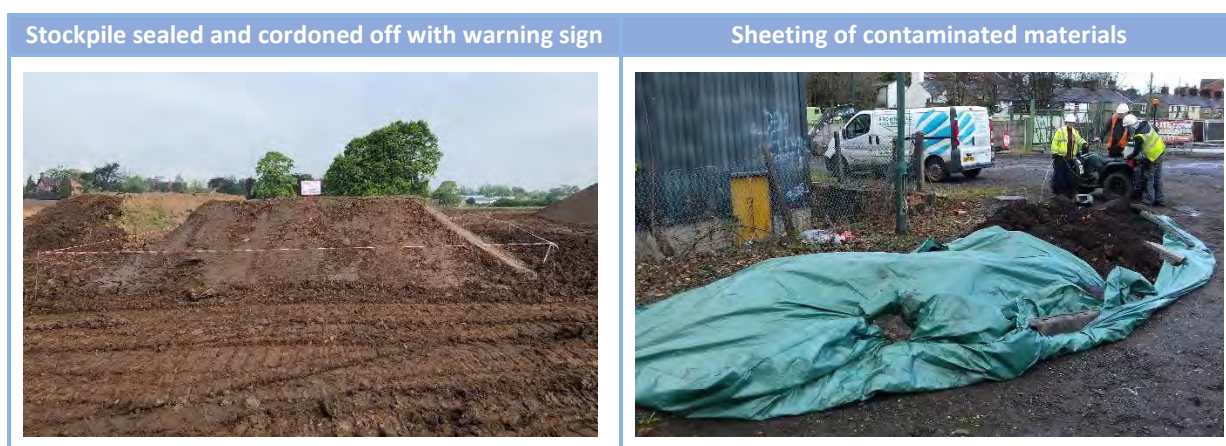
Examples of good site practice for stockpile management are presented below:

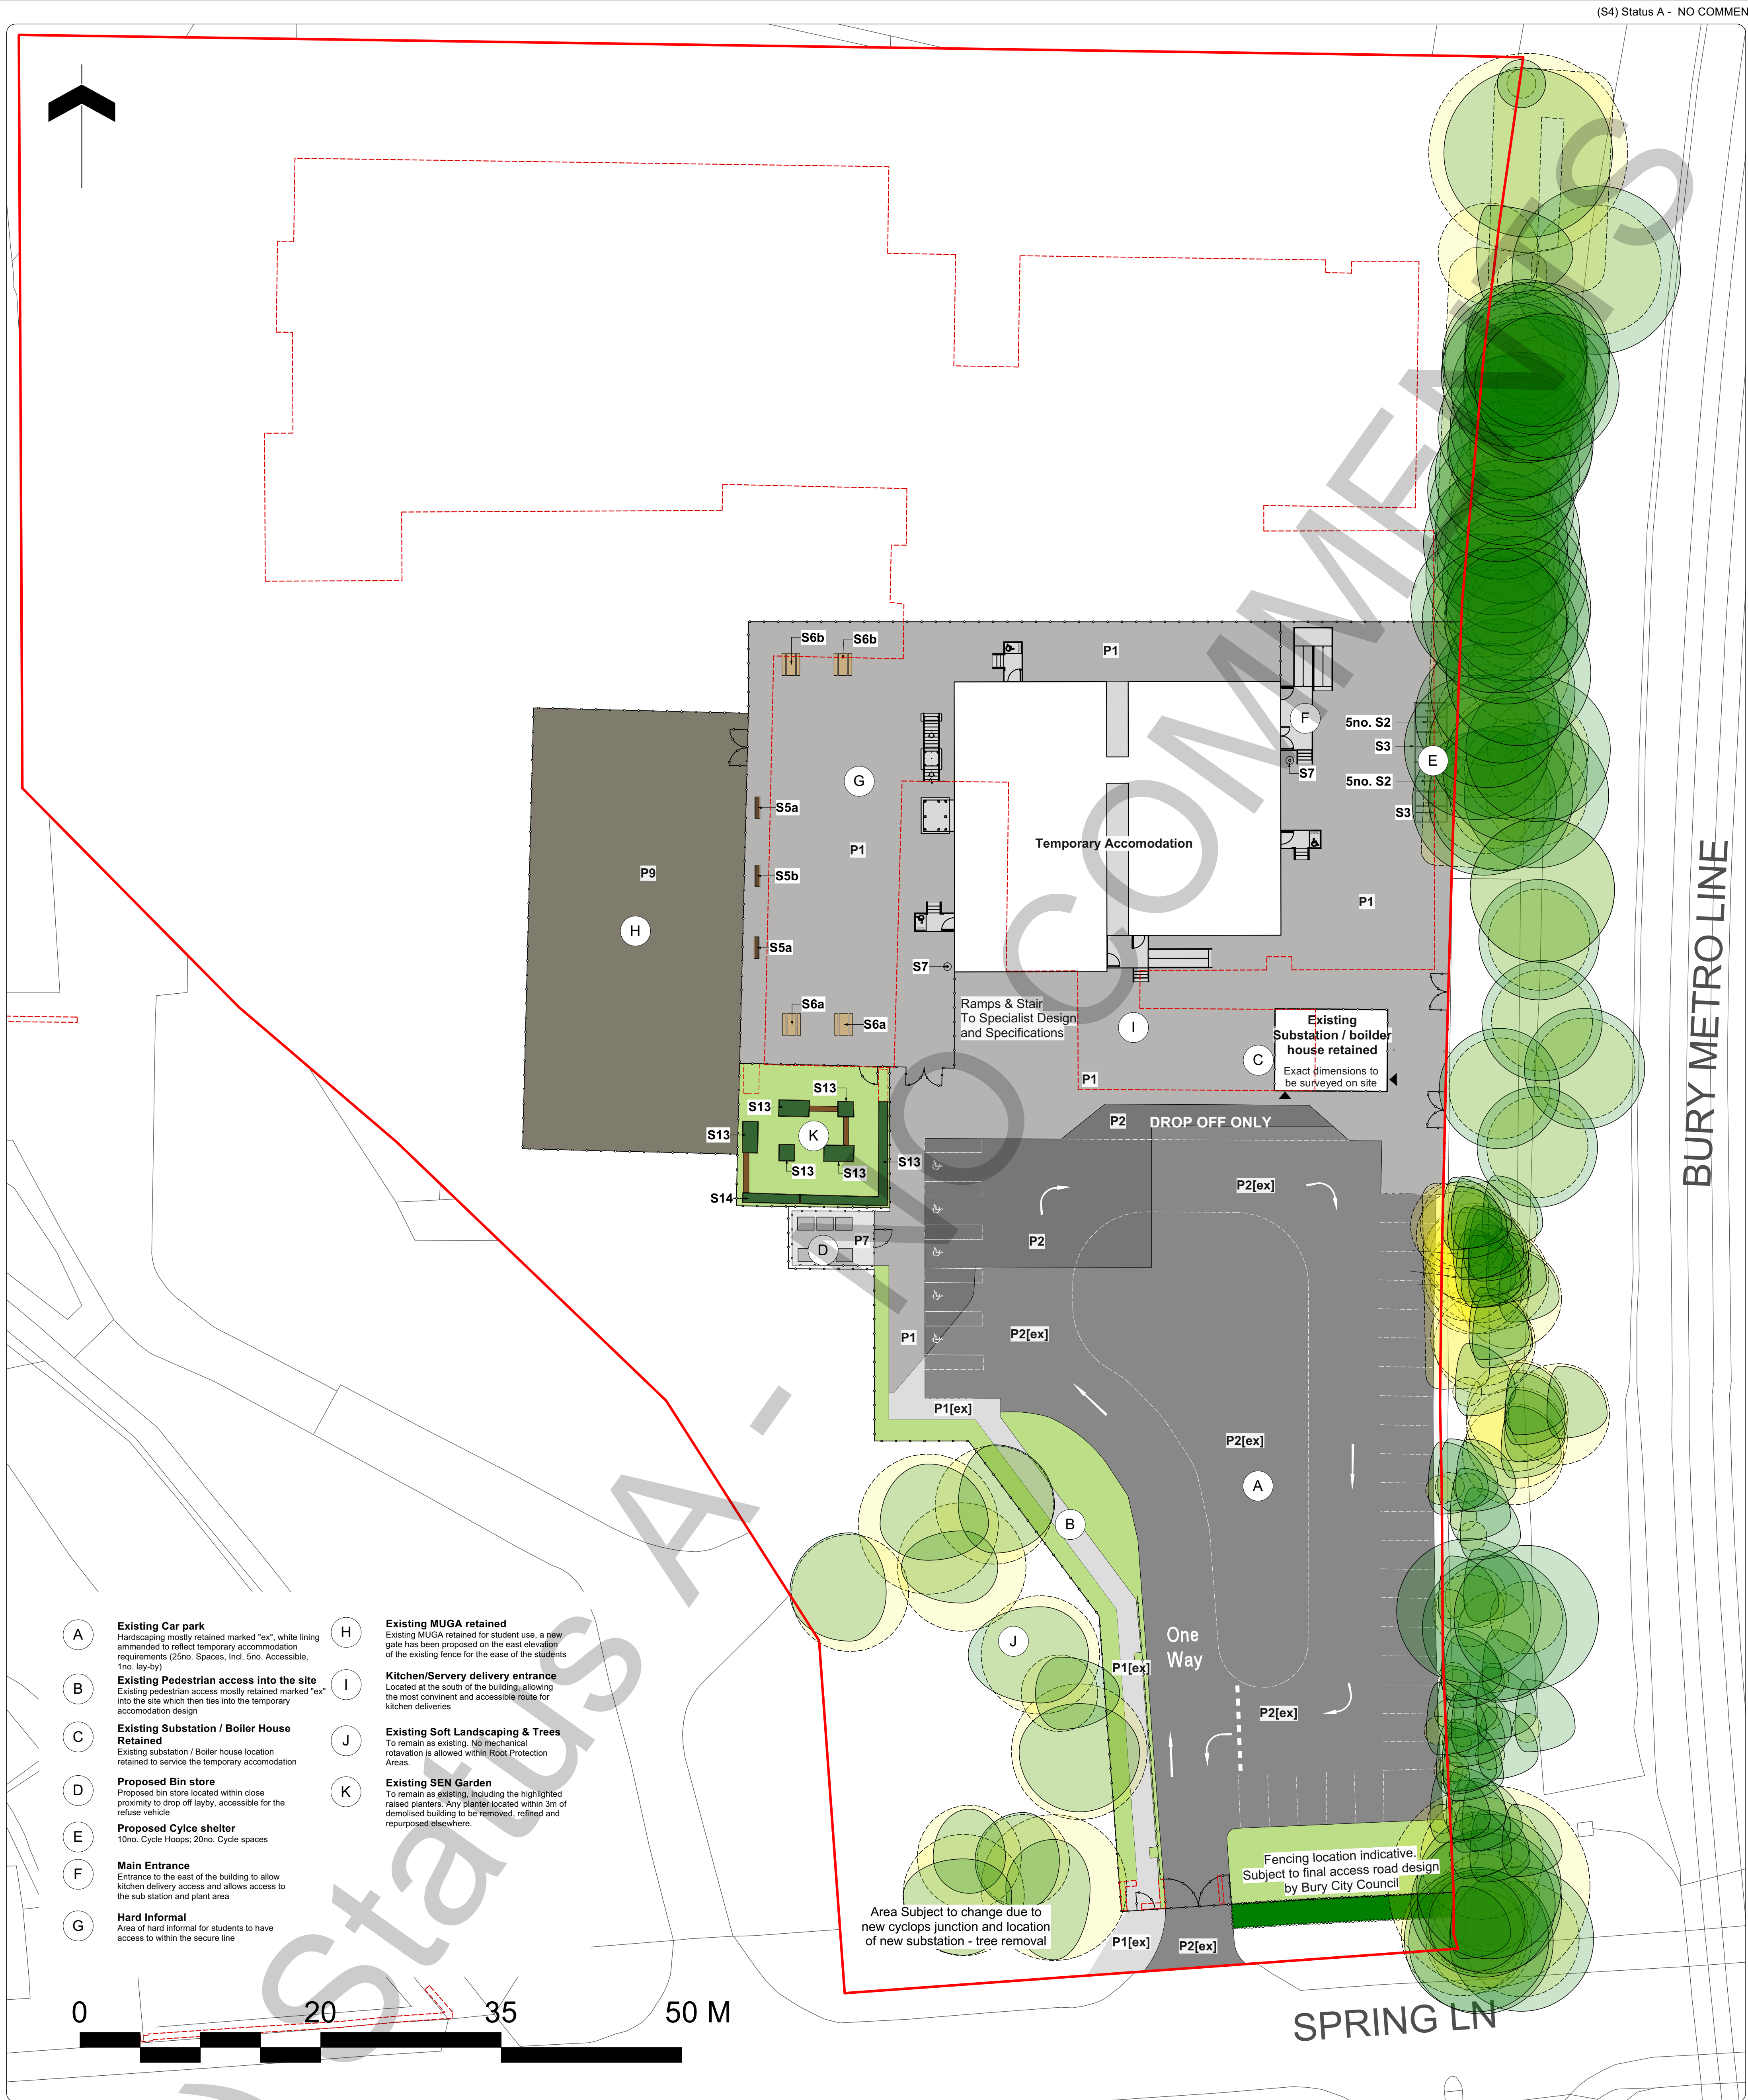
| DRAWING NUMBER : | FS1013-ALA-EX-ZZ-D-0101 | STATUS : | S2 |

- A** Existing Car park  
Handscaping mostly retained marked "ex", while lining amended to reflect temporary accommodation requirements (25no. Spaces, Ind. 5no. Accessible, 1no. lay-by)

- B** Existing Pedestrian access into the site  
Existing pedestrian access mostly retained marked "ex" into the site which then ties into the temporary accommodation design

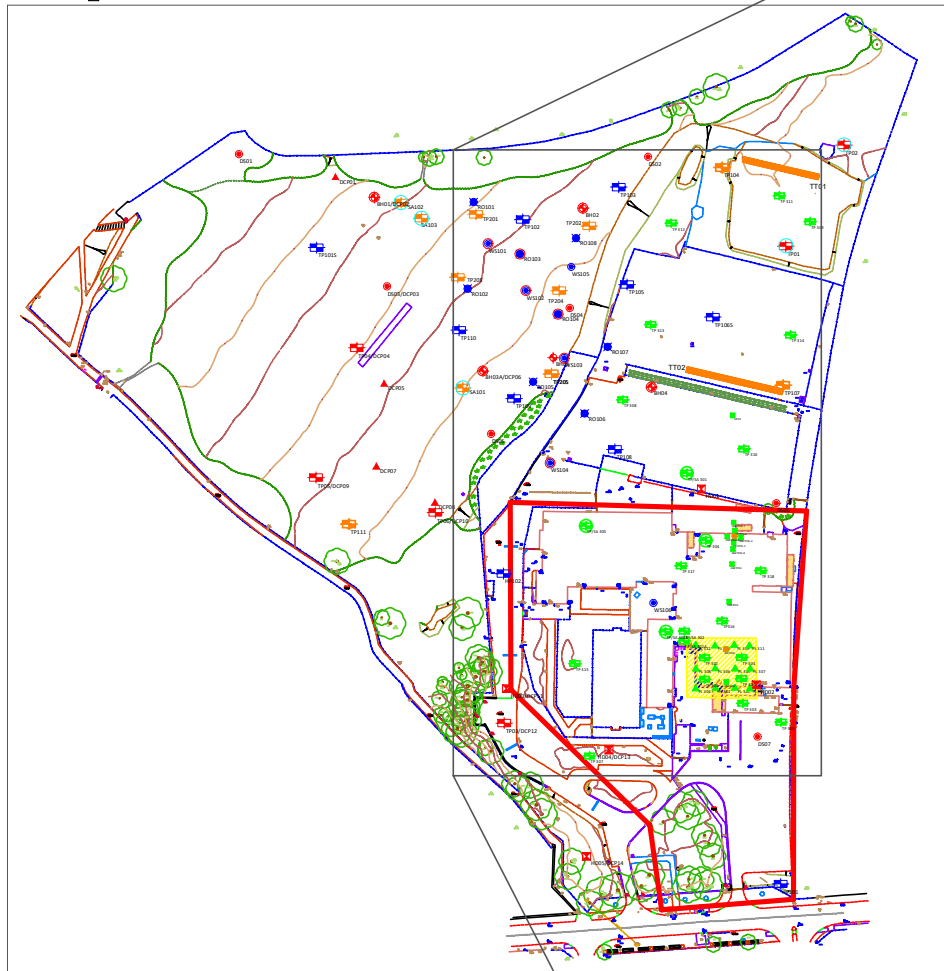
TARGETING SCHOOL PLANT ROOM

TARGETING BOILER HOUSE

TARGETING HISTORIC GOODS SHED
