**ARBORICULTURAL REPORT  
to BS 5837:2012  
at  
St. Stephens Church of England  
Primary School  
Colville Drive  
Bury  
Lancashire  
BL8 2DX**

## Appendix 5: Tree Constraints Plan

### Appendix 6: Arboricultural Implications Plan

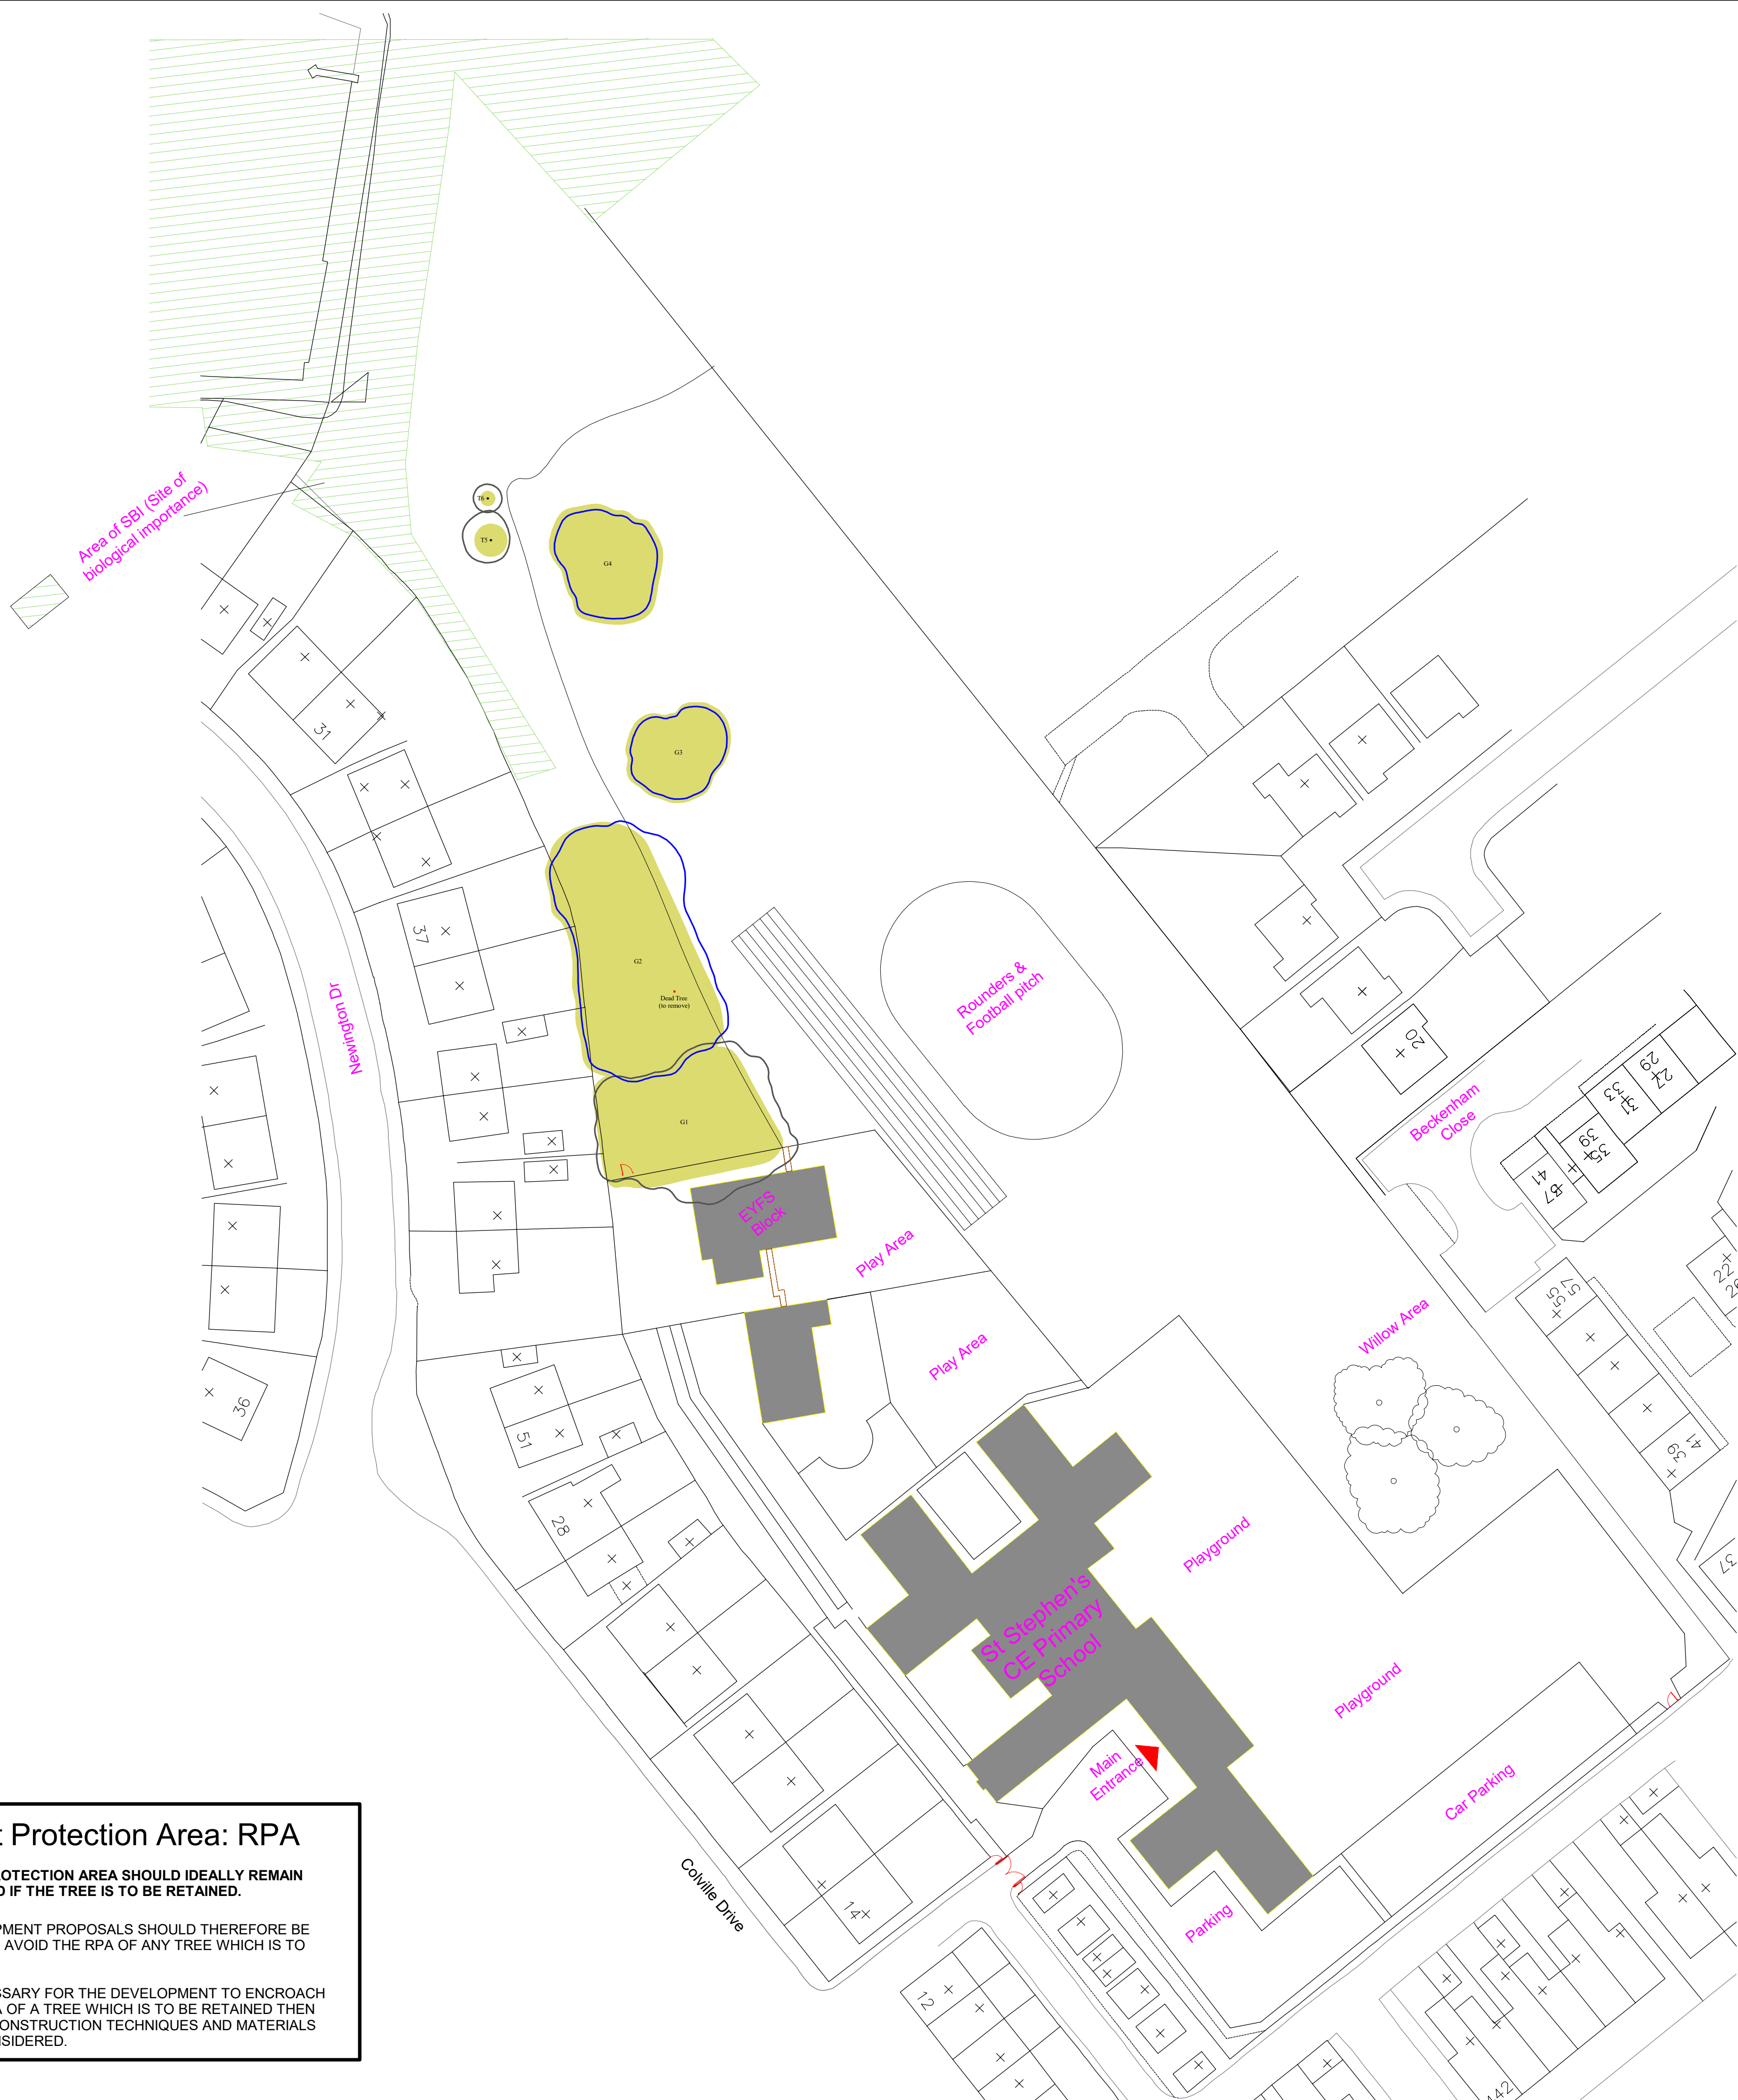
**Root Protection Area: RPA**

THE ROOT PROTECTION AREA SHOULD IDEALLY REMAIN UNDISTURBED IF THE TREE IS TO BE RETAINED.

THE DEVELOPMENT PROPOSALS SHOULD THEREFORE BE DESIGNED TO AVOID THE RPA OF A TREE WHICH IS TO BE RETAINED.

IF IT IS NECESSARY FOR THE DEVELOPMENT TO ENCROACH INTO THE RPA OF A TREE WHICH IS TO BE RETAINED THEN SPECIALIST CONSTRUCTION TECHNIQUES AND MATERIALS MUST BE CONSIDERED.

- 5.1 A dead tree within **G2** has been recommended for removal for reasons of public safety. The removal of this tree is required for Arboricultural reasons and should be undertaken irrespective of development. The approximate location of this tree is highlighted in **red** on the Tree Constraints Plan at **Appendix 5**.

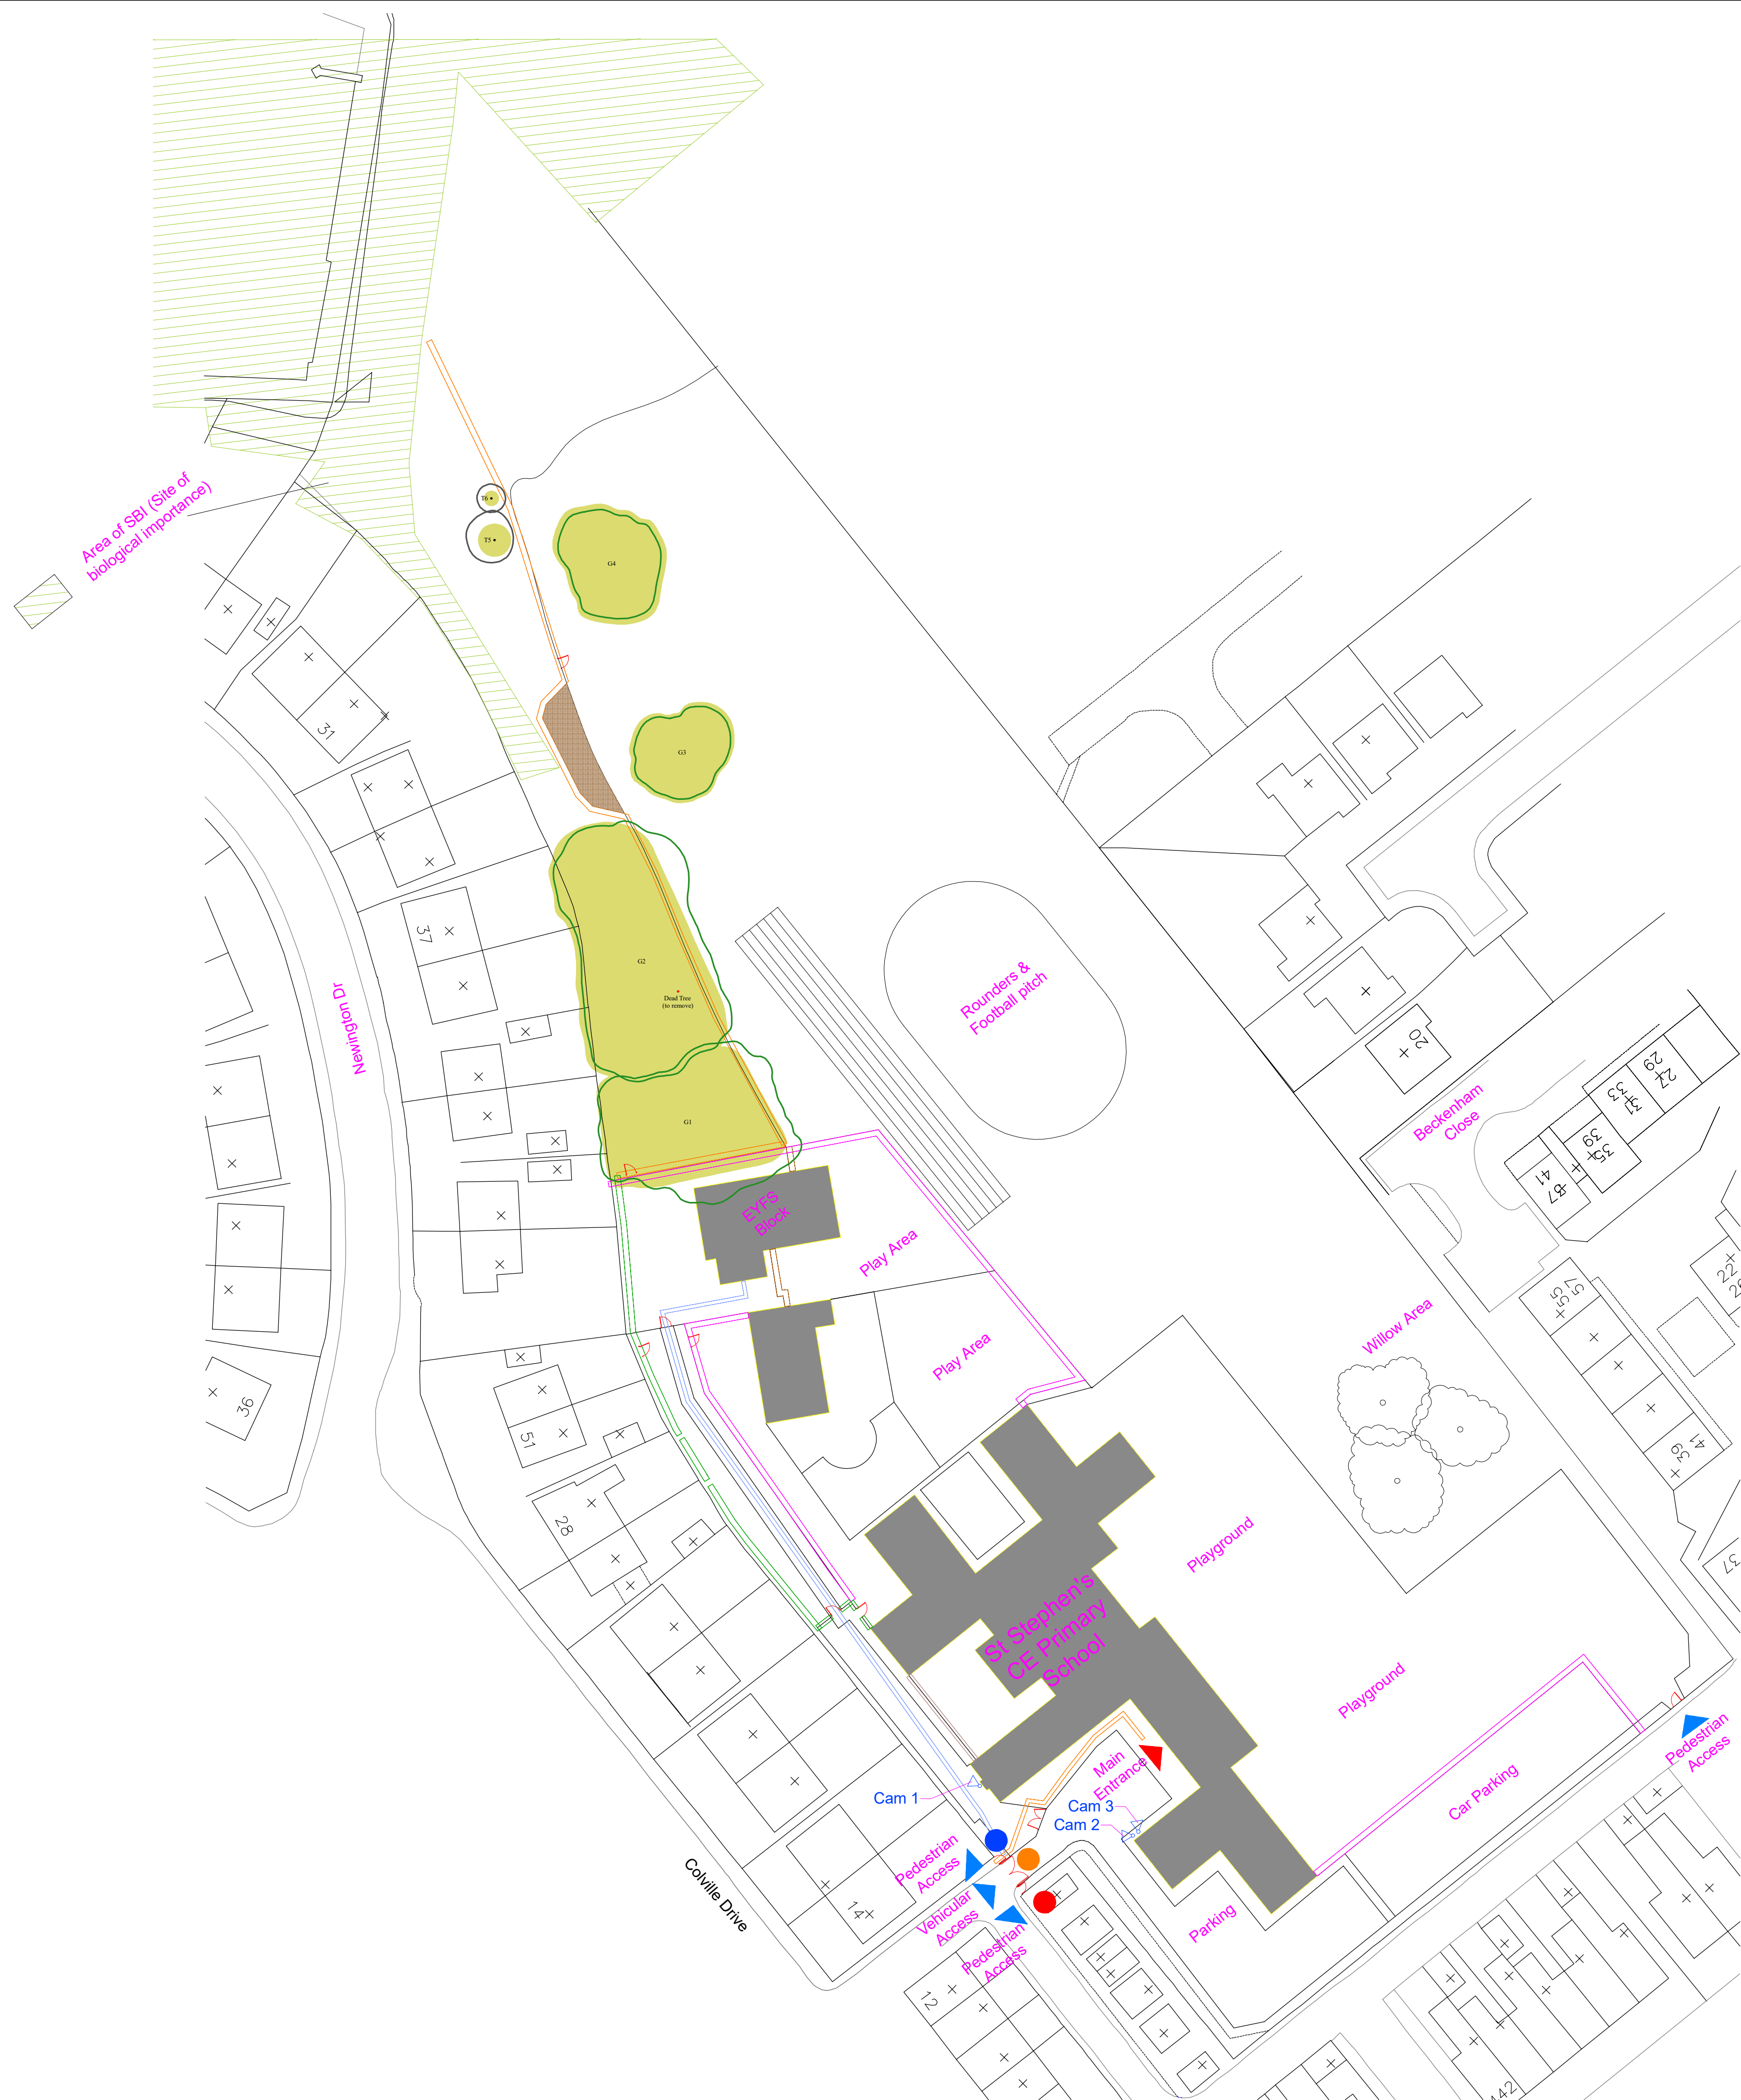
- 4.4.1.1 The security fence will marginally encroach the outer RPAs of the edge trees forming **G1** and **G2**.
- 4.4.1.2 To install the support posts of the fencing, excavations need to be undertaken within the RPAs of **G1** and **G2**. The required footings of each support post are 650mm deep by 300mm wide.

- 4.4.1.3 To minimise root loss/damage, where situated within RPA's, each support post hole is to be excavated using hand tools under the supervision of an appointed arboriculturist. Where necessary, root pruning will be undertaken.

- 4.4.1.4 It is important that no fence posts are positioned immediately adjacent to a tree stem, to avoid damaging the buttress roots/structural roots and to prevent future problems as the trees mature in size. Ideally, no fence posts should be positioned within 1m of a tree stem, which based on the proposals is achievable.

- 4.4.1.5 Each post hole will need to be lined with a non-permeable material prior to any concrete being poured, to prevent leaching (which can be damaging for trees).

- 5.3 No trees require removal to accommodate the security fence. However, due to the low hanging tree canopies, **G1**, **G2** and possibly **T6** will require pruning to accommodate the fence (as discussed in **Section 4.3**).

- 5.4 As the security fence will be positioned close to trees, it must be installed in a manner sympathetic to their needs. To achieve this; each support post hole will be excavated using hand tools under the supervision of an appointed arboriculturist, who will undertake root pruning where necessary. In addition, each post hole will be lined with a non-permeable material prior to any cement being poured, to prevent leaching (as discussed in **Section 4.4**).

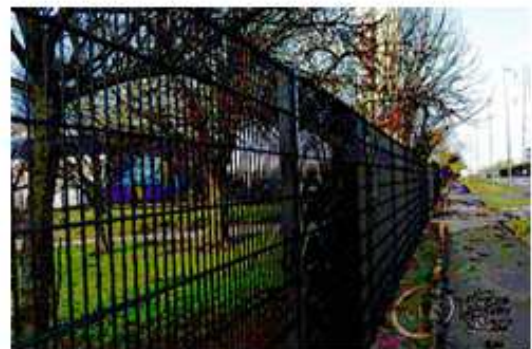
## Appendix 7: Fence Details

- 4.1.1 It is proposed to install a security fence adjacent to the maintained playing fields in the northern part of the school. A 2.4m high Dulok SR1 fence is proposed, which will run along the western edge of the playing fields. Please refer to **Appendix 7** for the fencing details.
- 4.1.2 We have been supplied with **Drawing No. TA 02 - Rev E (Job No. 2501-80)**, which details the location of the proposed security fence. The location of this fence has been overlaid onto the Tree Constraints Plan in order to create the Arboricultural Implications Plan, which can be found at **Appendix 6**. This provides the basis for which this Arboricultural Impact Assessment has been prepared.
- 4.1.3 All tree works required to accommodate the proposals are detailed in the "Works Required to Accommodate the Proposals" column at **Appendix 1**.
