## Bat Emergence and Re-Entry Surveys (BERS)

Former Whitefield Library & Adult Learning Centre, Pinfold Lane, Whitefield, Manchester, M45 7NY

This report is prepared to inform a planning application for the proposal described as: The redevelopment of the site into a GP centre  
[Unsubmitted]

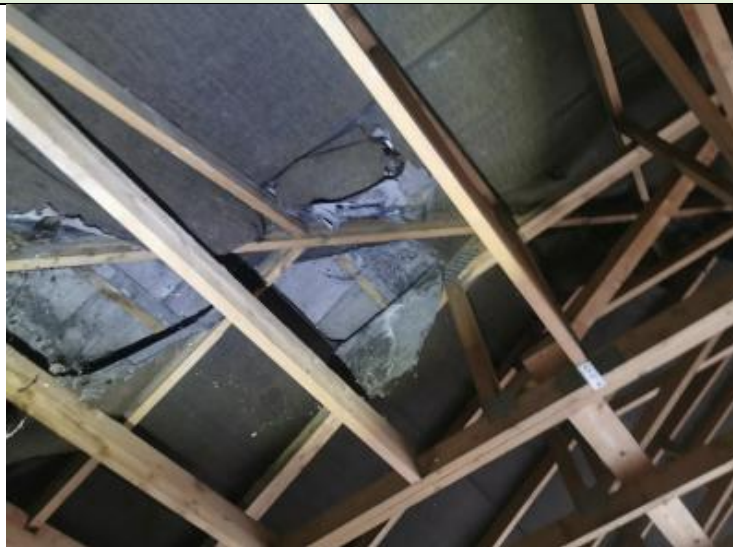
In B1, internal walls, ceilings, and windows showed no indications of bat use, and no features suitable for roosting were identified internally. In B2, the interior was in poor condition with some ripped and degraded roofing felt, though this did not appear to lead into potential roosting features, and cobwebbing suggested a lack of bat use.

**B2:** Interior of B2, roofing felt gaps with cobwebbing

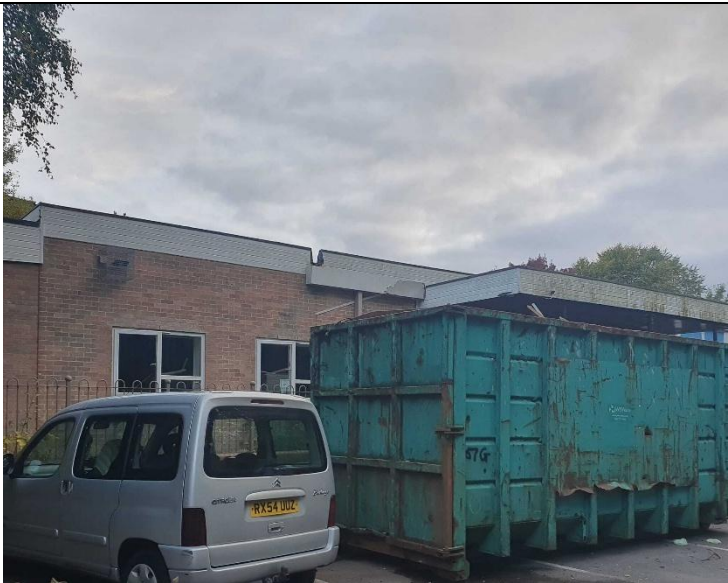
| <b>Surveyor 1</b> | <b>No</b> emergencies or re-entries were observed.<br><br><b>Species observed:</b> Common pipistrelle<br><br><b>Summary of general activity:</b><br>The first activity was recorded at 18:50 when a common pipistrelle was seen passing from the trees to the east of the building, heading west in front of the property to | | Full elevation photo showing surveyor's view. | | | | |

| | <p>forage over the trees to the northwest. At 19:12, a common pipistrelle passed from the southwest over the building heading east, although this was not captured on IR footage. At the same time, another individual was seen passing northeast to west over the building, also not confirmed on IR. At 19:58, a common pipistrelle was again observed following the same east-west route across the site. This route was used regularly for the remainder of the survey, with common pipistrelles foraging and commuting both east to west and west to east. The last activity was at 19:56 with a common pipistrelle heard but not seen.</p> <p><b>Key foraging areas:</b></p> <ul style="list-style-type: none"> <li>— Trees to the northwest of the property.</li> </ul> <p><b>Key flight areas:</b></p> <ul style="list-style-type: none"> <li>— Regular commuting route between trees to the east and west of the property.</li> </ul> | |

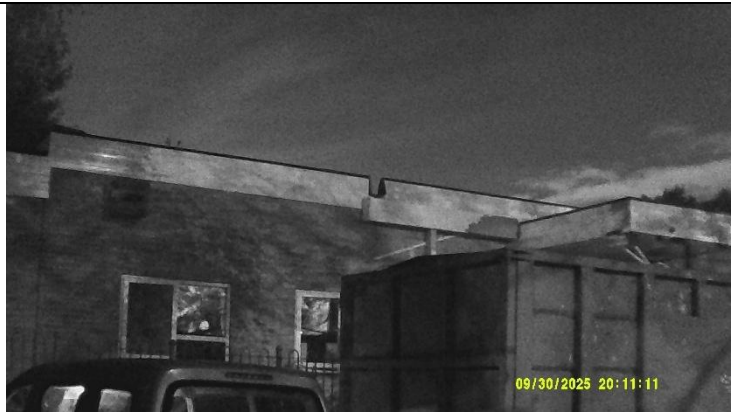
| <p><i>IR position 1</i><br/><i>Nightfox Whisker IR</i><br/><i>Camera + X50 Torch</i></p> | <p><b>Camera position:</b> Observing the northern elevation of B1.</p> <p><b>Emergences observed:</b> No.<br/>No emergences were observed, and the footage confirmed the observations of Surveyor 1, with no additional activity recorded.</p> | <p>Screenshot of darkest part of survey.</p> |

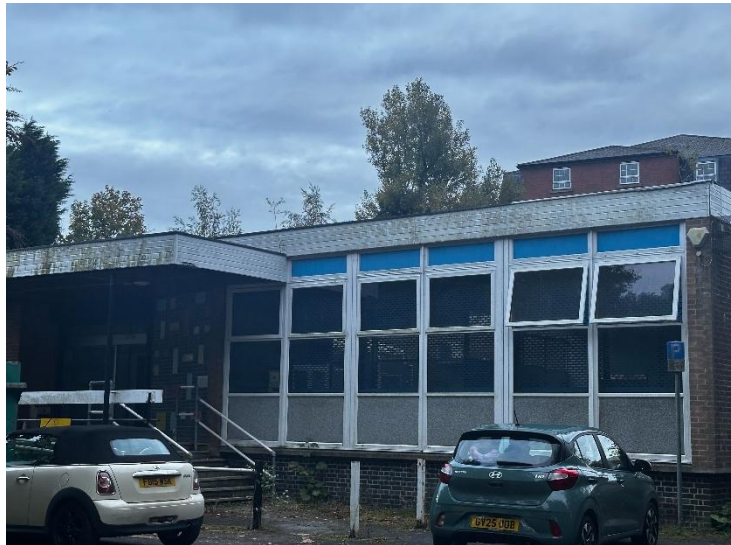
| <p><b>Surveyor 2</b></p> | <p><b>No</b> emergencies or re-entries were observed.</p> <p><b>Species observed:</b> Common pipistrelle</p> <p><b>Summary of general activity:</b><br/>The first activity was noted at 18:57 when two common pipistrelles flew from the tree line behind Position 2 on a southeast flight. At 18:59, another individual flew from the same tree line east towards Position 1, followed by further activity at 19:03 with a southeast flight. At 19:05, a common pipistrelle flew from a tree between Positions 1 and 2 towards the tree line behind Position 2 to the northwest. This was followed at 19:06 by a southeast flight towards Position 4 and, at 19:09, a northwest return flight towards the tree line. At 19:12, IR confirmed a common pipistrelle flying over the roof elevation from the east. Additional flights were noted at</p> | <p>Full elevation photo showing surveyor's view.</p> |

| | <p>19:19 (west) and 19:34 (east from the tree line), with foraging also recorded. Common pipistrelles were heard but not seen at 19:38 and 19:56. The final activity was at 20:03 with a common pipistrelle foraging in the tree next to Position 2.</p> <p><b>Key foraging areas:</b></p> <ul style="list-style-type: none"> <li>Tree adjacent to Position 2.</li> </ul> <p><b>Key flight areas:</b></p> <ul style="list-style-type: none"> <li>Regular commuting between the tree line behind Position 2 and areas east and west across the site.</li> </ul> | |

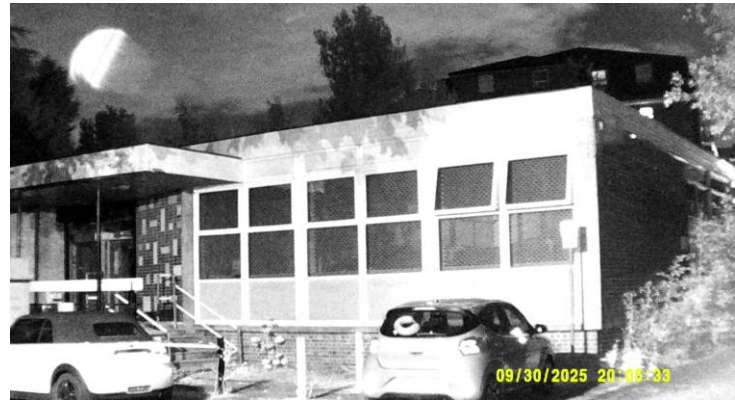
| <p><i>IR position 2</i><br/><i>Nightfox Whisker IR Camera + X50 Torch</i></p> | <p><b>Camera position:</b> Observing the northern and western elevation of B1.</p> <p><b>Emergences observed:</b> No.<br/>No emergences were observed, and the footage confirmed the observations of Surveyor 2, with no additional activity recorded.</p> | <p>Screenshot of darkest part of survey.</p> |

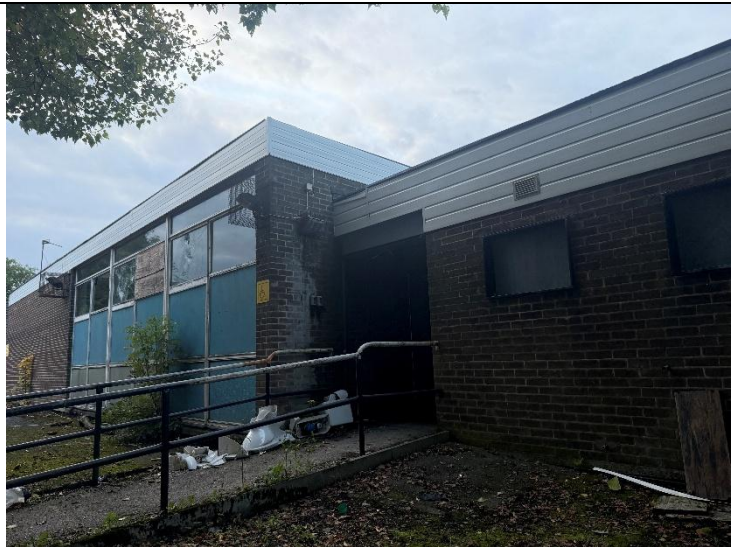
| <b>Surveyor 3</b> | <b>No</b> emergences or re-entries were observed. | Full elevation photo showing surveyor's view. |

| | <p><b>Species observed:</b> Common pipistrelle</p> <p><b>Summary of general activity:</b><br/>The first activity was recorded at 19:05 with a common pipistrelle observed foraging to the west of B1. At 19:09, a common pipistrelle was observed passing west from an easterly direction over B1. Faint social calls from common pipistrelles, heard but not seen, were recorded at 19:12, 19:39 and 19:51. At 19:27, a common pipistrelle was observed foraging above B1. The last activity recorded was at 19:57 with a faint common pipistrelle heard but not seen.</p> <p><b>Key foraging areas:</b></p> <ul style="list-style-type: none"> <li>• Area above and to the west of B1.</li> </ul> <p><b>Key flight areas:</b></p> <ul style="list-style-type: none"> <li>• Flight path west from an easterly direction over B1.</li> </ul> | |

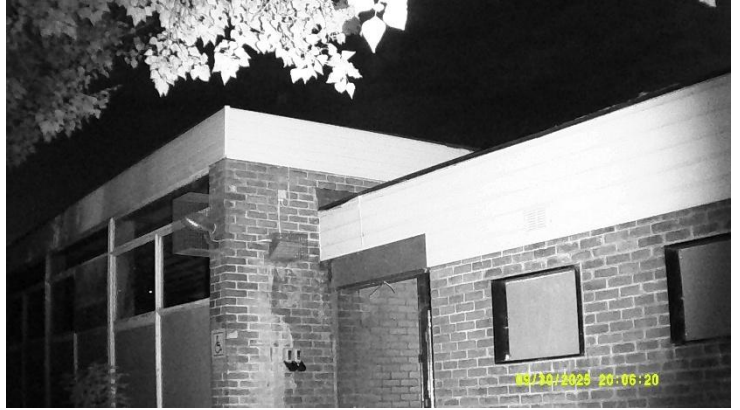
| <p><i>IR position 3</i><br/><i>Nightfox Whisker IR</i><br/><i>Camera + X50 Torch</i></p> | <p><b>Camera position:</b> Observing the southern elevation of B1.</p> <p><b>Emergences observed:</b> No.</p> | <p>Screenshot of darkest part of survey.</p> |

| | <p>No emergencies were observed, and the footage confirmed the observations of Surveyor 3, with no additional activity recorded.</p> | |

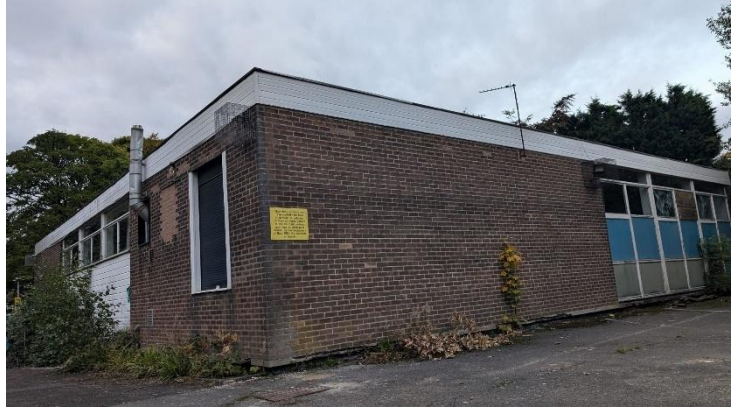
| <b>Surveyor 5</b> | <p><b>No</b> emergencies or re-entries were observed.</p> <p><b>Species observed:</b> Common pipistrelle</p> <p><b>Summary of general activity:</b><br/>The first activity was recorded at 18:51 with two common pipistrelles foraging in the trees to the northwest of B1. This activity continued until 18:58. From 19:01, common pipistrelle activity became more infrequent, with occasional passes observed travelling east to west over B1 and south to north between B1 and B2. From 19:20 onwards, foraging and commuting calls were heard but not seen, continuing intermittently until the end of the survey. The last activity was recorded at 20:03, when a common pipistrelle was heard but not seen foraging.</p> | <p>Full elevation photo showing surveyor's view.</p> |

| | <p><b>Key foraging areas:</b></p> <ul style="list-style-type: none"> <li>• Trees to the northwest of B1.</li> </ul> <p><b>Key flight areas:</b></p> <ul style="list-style-type: none"> <li>• East to west over B1.</li> <li>• South to north between B1 and B2.</li> </ul> | |

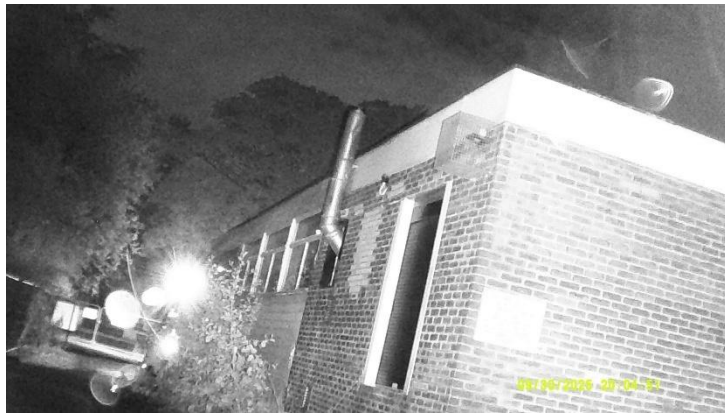
| <p><i>IR position 5</i><br/><i>Nightfox Whisker IR</i><br/><i>Camera + X50 Torch</i></p> | <p><b>Camera position:</b> Observing the western elevation of B1.</p> <p><b>Emergences observed:</b> No.</p> <p>No emergences were observed, and the footage confirmed the observations of Surveyor 5, with no additional activity recorded.</p> | <p>Screenshot of darkest part of survey.</p> |

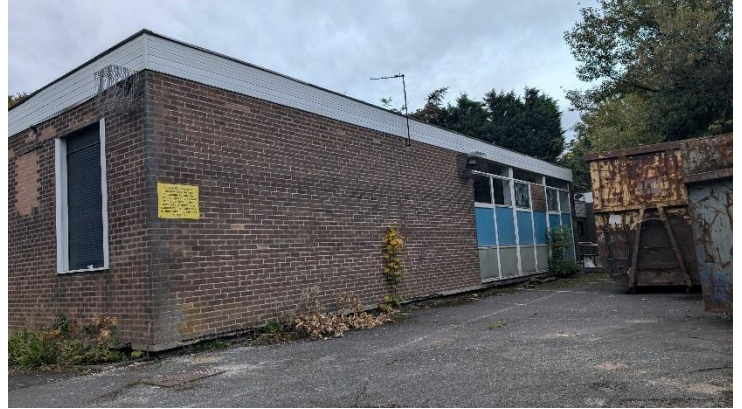
| <p><b>Surveyor 6</b></p> | <p><b>No</b> emergences or re-entries were observed.</p> <p><b>Species observed:</b> Common pipistrelle</p> <p><b>Summary of general activity:</b><br/>The first activity was recorded at 18:51 when two common pipistrelles were observed foraging in the</p> | <p>Full elevation photo showing surveyor's view.</p> |

| | <p>trees to the northwest of B1, continuing until 18:58. From 19:01, activity became infrequent, with passes seen from east to west over B1 and south to north between B1 and B2. From 19:20, common pipistrelle foraging and commuting calls were heard but not seen, continuing intermittently until the end of the survey. The last activity was at 20:03, when a common pipistrelle was heard but not seen foraging.</p> <p><b>Key foraging areas:</b></p> <ul style="list-style-type: none"> <li>• Trees to the northwest of B1.</li> </ul> <p><b>Key flight areas:</b></p> <ul style="list-style-type: none"> <li>• East to west over B1.</li> <li>• South to north between B1 and B2.</li> </ul> | |

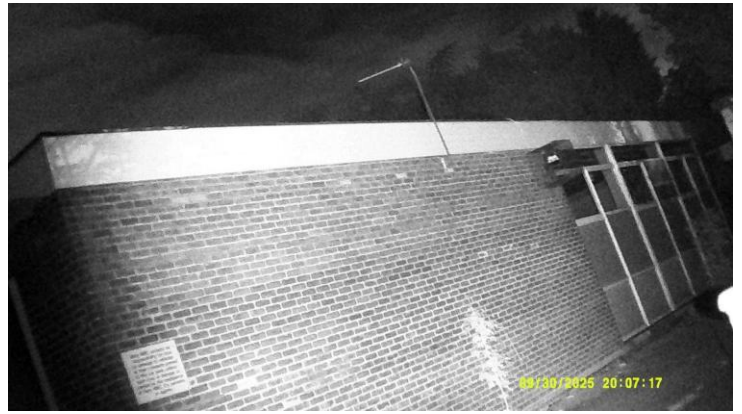
| <p><i>IR position 6</i><br/><i>Nightfox Whisker IR</i><br/><i>Camera + X50 Torch</i></p> | <p><b>Camera position:</b> Observing the southern elevation of B1.</p> <p><b>Emergences observed:</b> No.</p> <p>No emergences were observed, and the footage confirmed the observations of Surveyor 6, with no additional activity recorded.</p> | <p>Screenshot of darkest part of survey.</p> |

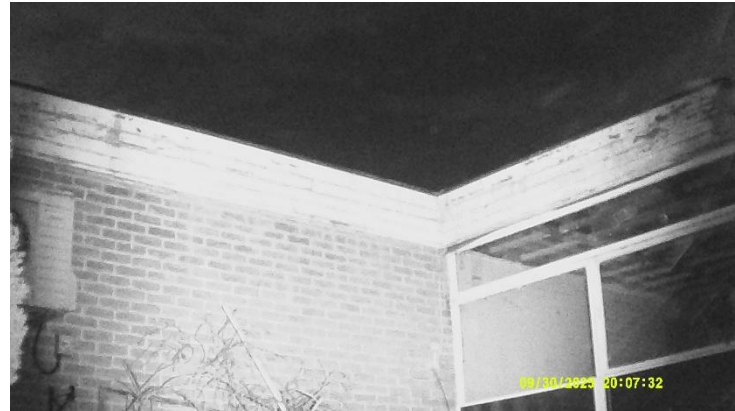
| <b>IR position 7</b><br>Nightfox Whisker IR<br>Camera + X50 Torch | <p><b>Camera position:</b> Observing the southwestern elevation of the courtyard within B1.</p> <p><b>Emergences observed:</b> No.</p> <p>No emergences were observed. The only activity recorded was a bat passing northeast to west over the roof at 19:21, followed by a bat circling over the roof from southwest to east at 19:25.</p> | <p>Screenshot of darkest part of survey.</p> |

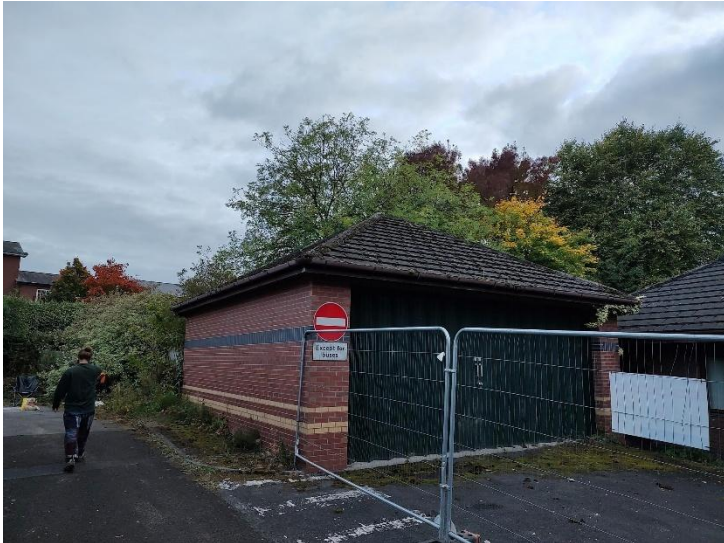
| <b>Surveyor 4</b> | <p><b>No</b> emergences or re-entries were observed.</p> <p><b>Species observed:</b> Common pipistrelle</p> <p><b>Summary of general activity:</b><br/>The first activity was recorded at 18:46 with two bats foraging around the trees north of the building adjacent to B2, observed again at 18:50 and 18:58 without calls detected. At 18:56, a common pipistrelle was seen behind the surveyor position flying east towards the main road. At 19:02, another individual was observed flying south towards B2 before heading east over the surveyor position to the trees by the main road. Further activity was recorded at 19:06 and 19:08 with common pipistrelles flying west over the surveyor position, turning north, and flying to the trees north of the building adjacent to B2. Additional common pipistrelle passes were heard but not seen at 19:12, 19:19, 19:25 and 19:34, followed by fairly consistent activity between 19:41 and 19:47. The final record was at 20:03.</p> <p><b>Key foraging areas:</b></p> <ul style="list-style-type: none"><li>• Trees north of the building adjacent to B2.</li><li>• Trees by the main road.</li></ul> <p><b>Key flight areas:</b></p> | <p>Full elevation photo showing surveyor's view.</p> |

| | <ul style="list-style-type: none"> <li>• East towards the main road from behind the surveyor position.</li> <li>• South towards B2, then east over the surveyor position.</li> <li>• West over the surveyor position, then turning north towards trees north of B2.</li> </ul> | |

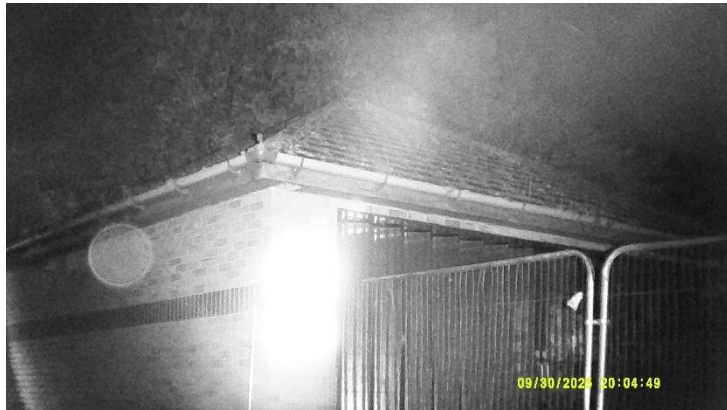
| <i>IR position 4</i><br><i>Nightfox Whisker IR</i><br><i>Camera + X50 Torch</i> | <p><b>Camera position:</b> Observing the eastern and southern elevations of B2.</p> <p><b>Emergences observed:</b> No.</p> <p>No emergences were observed, and the footage confirmed the observations of Surveyor 4, with no additional activity recorded.</p> | <p>Screenshot of darkest part of survey.</p> |

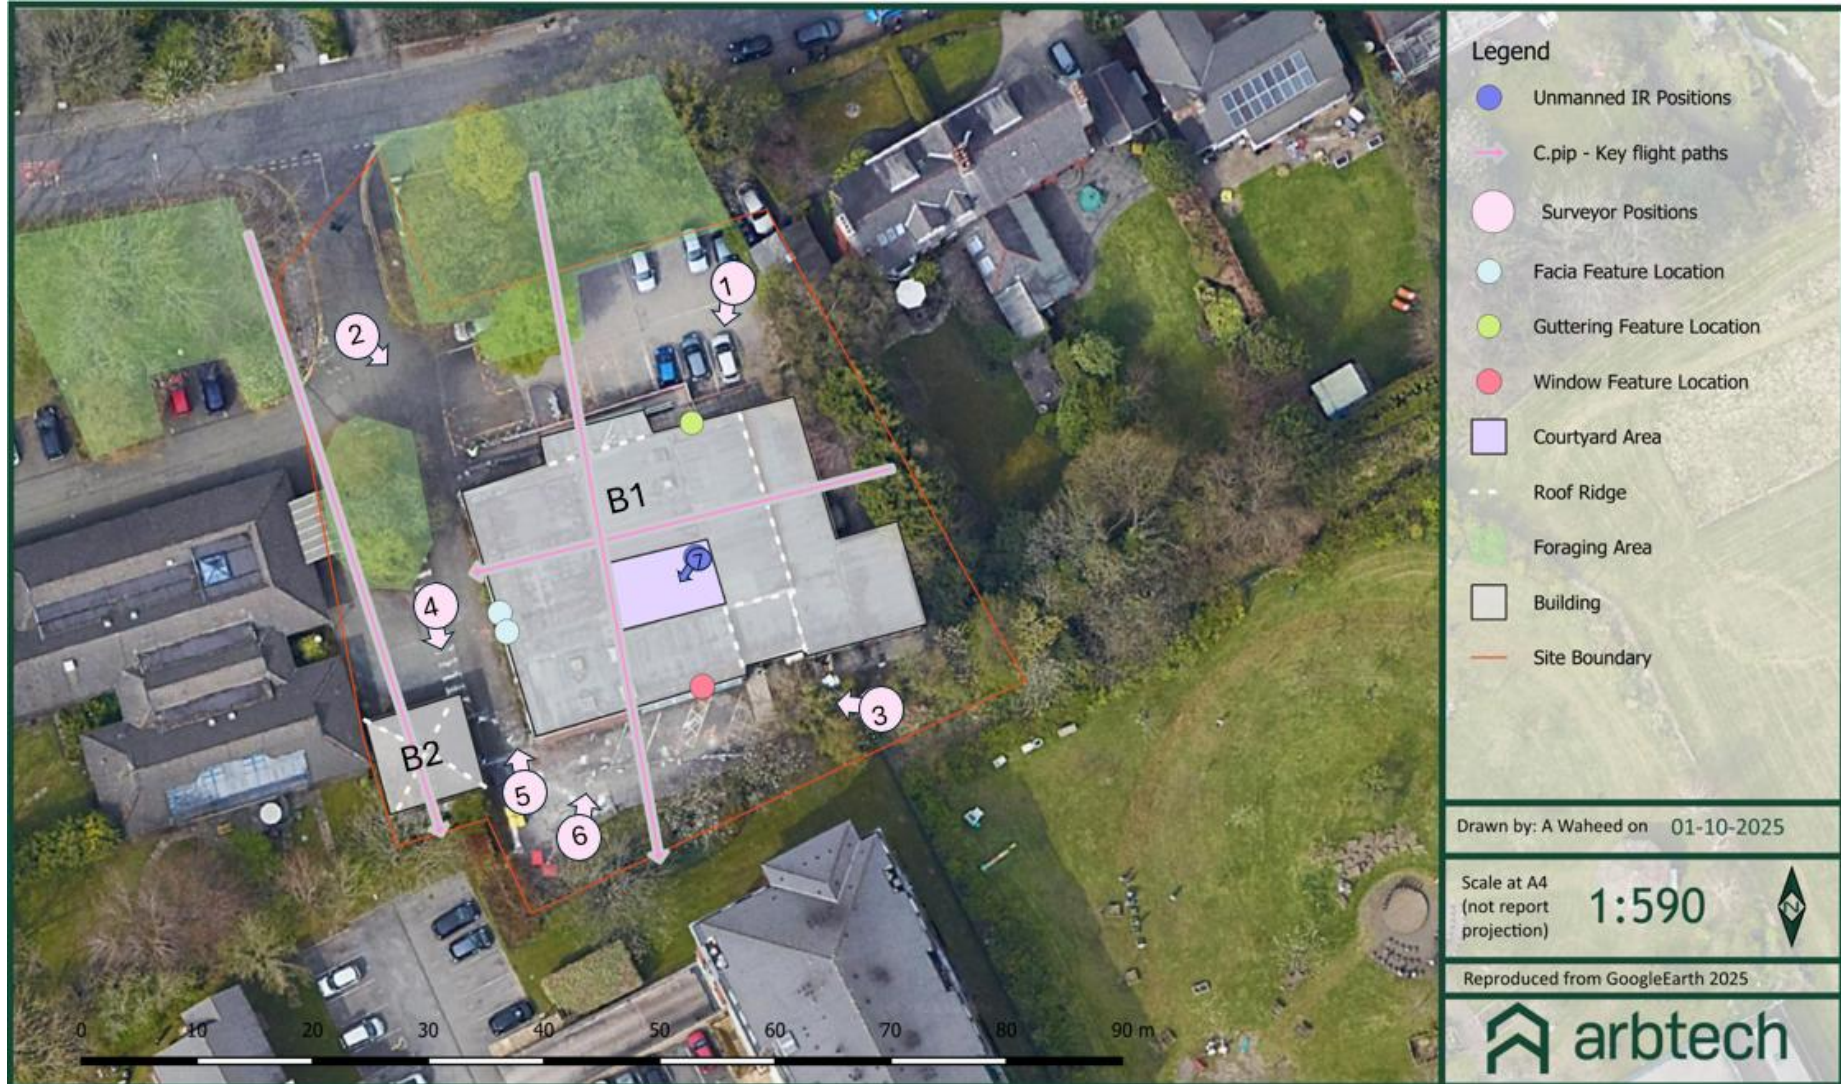
## Appendix 1: BERS plan

| See surveyor locations in the BERS plan in Appendix 1, proposed plans in Appendix 2. | |

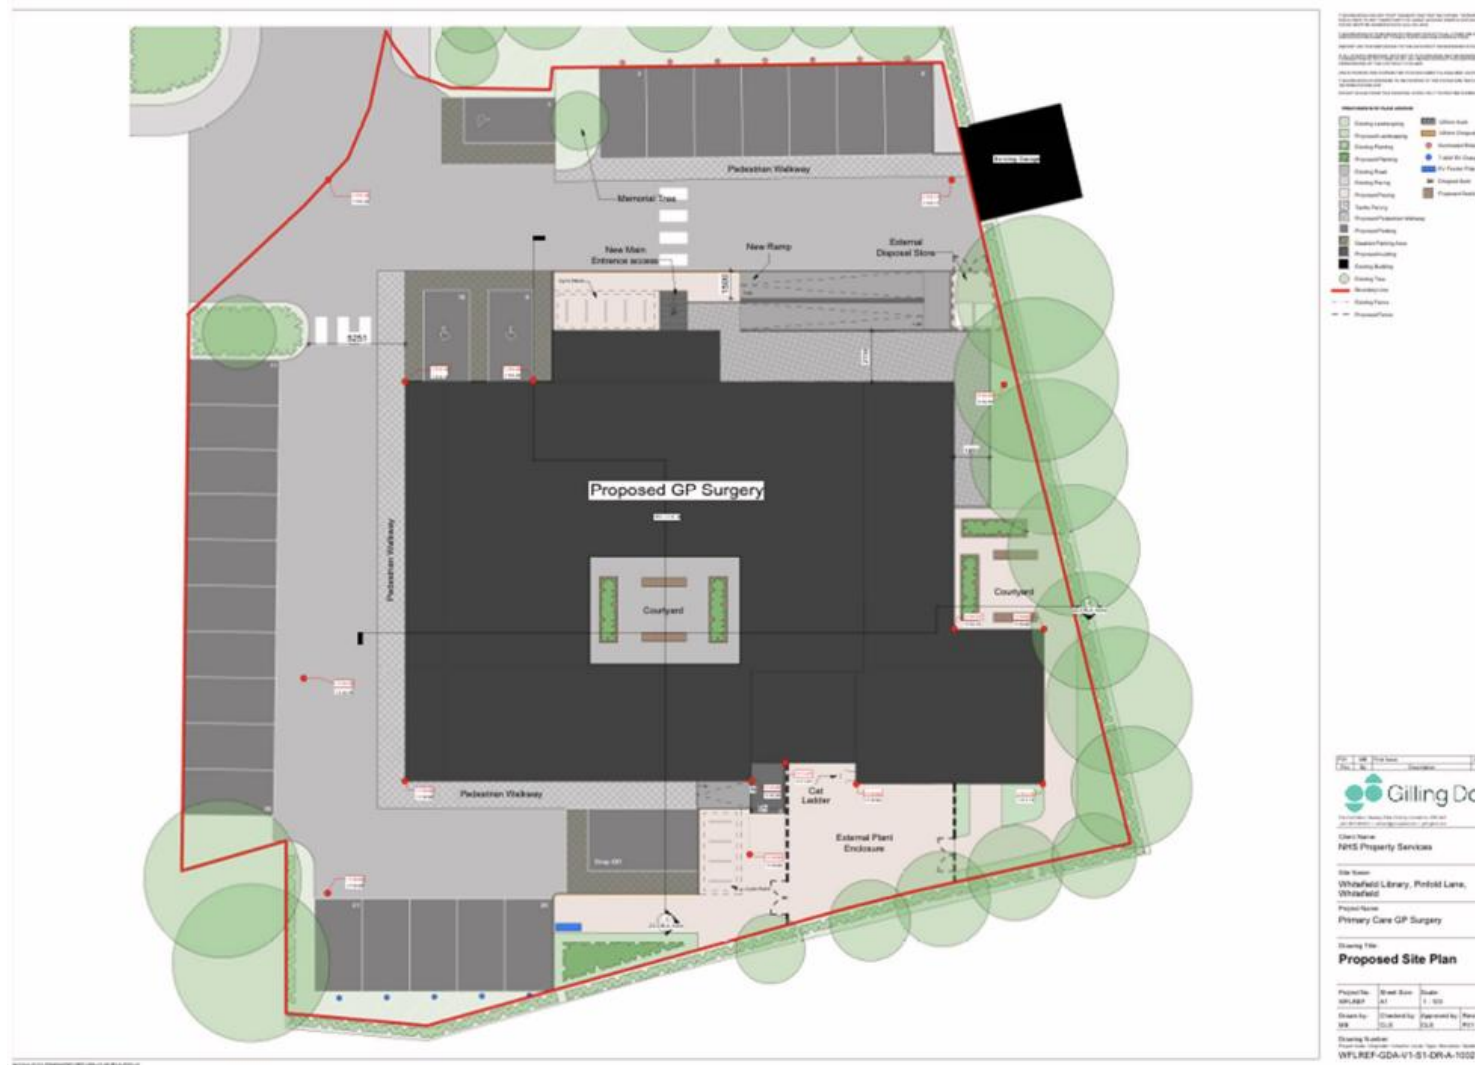
## Appendix 2: Proposed Plans

Structural changes to building – Internal reconfiguration and some external alterations to accommodate the surgery layout, accessibility ramps, plant enclosures, and associated infrastructure as indicated on the proposed plans.
