## Bury Market & Flexi Hall

# Outline Demolition Method Statement & Assessment of Risks

BURMAR/DEM/PA/RS/01

## Revision D

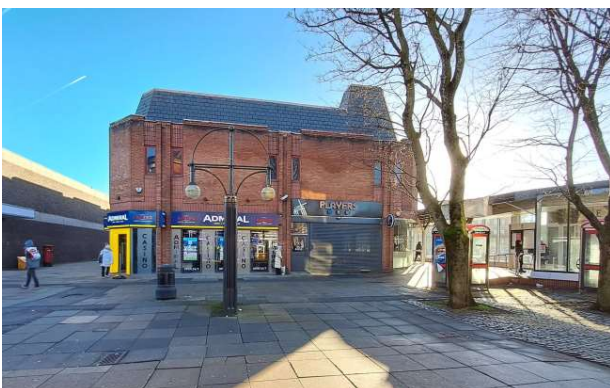
North Elevation

*Existing Building 1* is a 2-storey building with structural steel frame, concrete floors and brick facades incorporating timber framed windows to first floor and glazed aluminium shopfronts at ground floor. There are metal security shutters to glazed areas at ground floor level.

The building has a flat roof with brick parapets and a partial slate pitched roof at the north end. Surveying has confirmed that ACM is present in this building. All ACM will be removed prior to demolition by licenced contractors.

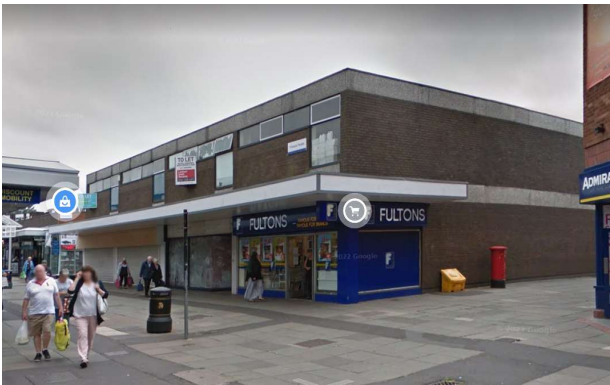
North & West Elevations

*Existing Building 2* is an existing 2 storey building with structural steel frame, concrete floors and masonry facades. There is a pebble dash render mid band and parapet band.

Aluminium framed glazed shop fronts are at ground level to the north elevation – these include metal security shutters. There are smaller metal framed windows to the first floor level.

This building features a projecting canopy panel over the shopfronts and features a flat roof with parapet upstands. There is a parking area to the rear.

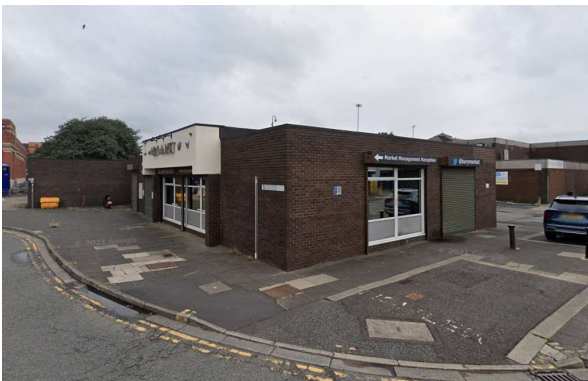
South & East Elevations

*Existing Building 3* is an existing single storey building with brick facades and part rendered facades, with a signage band to the south elevation.

UPVC framed full height windows are evident to 3 elevations with metal security shutters. The building has a flat roof with parapet edges.

An ENWL sub station is also contained within this building. This building is to be only partially demolished until a new substation has been completed. This existing substation is to be protected during demolition activities.

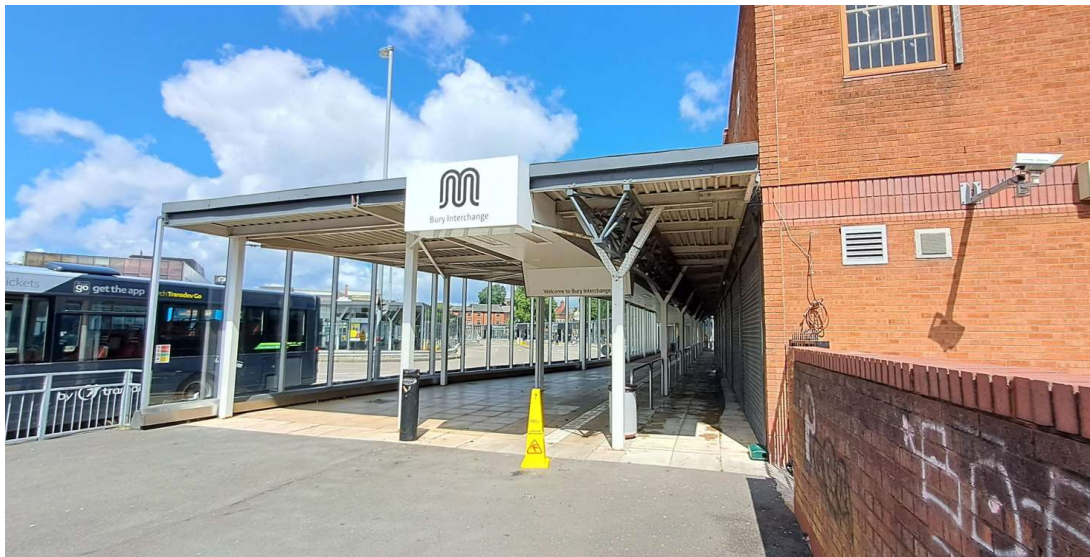
*Stand E – TfGM Transport Interchange*

Existing Structure 4 is a steel framed canopy structure, with a glazed screen to one elevation. This is located within Bury Transport Interchange. Demolition of this structure will be undertaken immediately ahead of the demolition of Building 1.

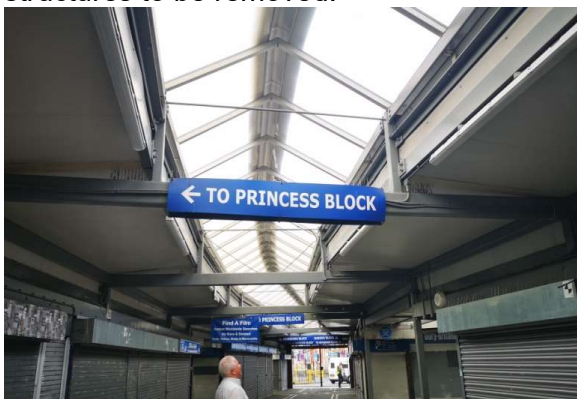
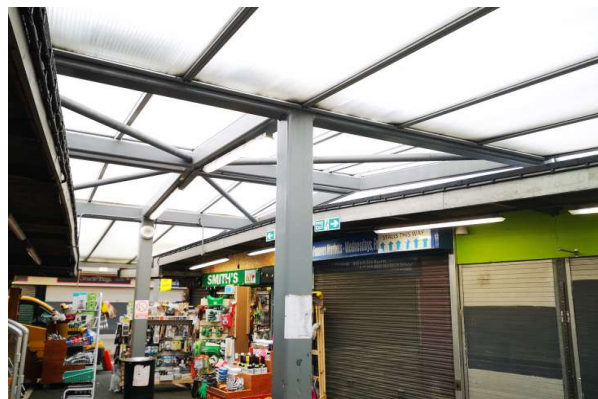
*Typical Existing Canopy*

Also, there are existing canopies of various construction are located above the Bury Market open stalls. Generally, the canopy sections to be removed are lightweight polycarbonate sheet panels supported by metal frames, metal ridge beams and steel tie rods.

The canopies appear to be independent of the market stalls as they were added at various points in time. These will all require careful removal down to ground level.

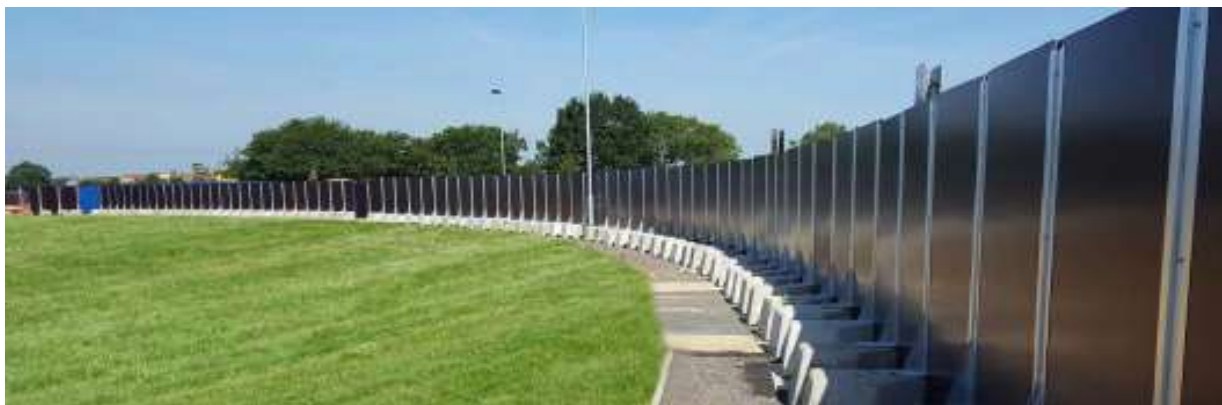
Concrete ballast blocks provide the support and stability, which removes the risks associated with digging into the ground to set posts. The concrete ballast will also be designed to provide vehicle restraint/protection where the hoardings are adjacent the highway (such as Dale Street).

This hoarding system complies with BS5975 Temporary Works, and the panels are re-useable. As a further safeguard, the temporary works design calculations provided by the supplier are checked by our own Temporary Works Engineers.

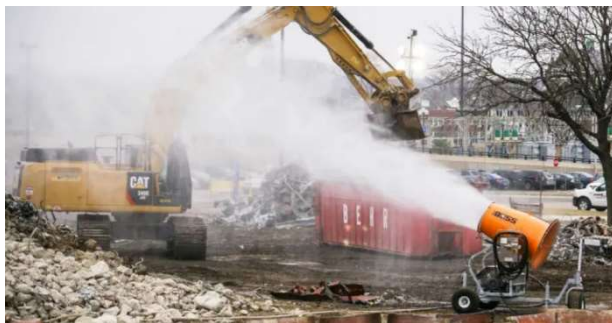
*Atomiser in action*

The building will be brought in on itself. As this activity has potential to create fugitive airborne dust, water suppression will be available throughout this activity to control release of dust at source. Water mist atomiser will likely be deployed to achieve this.
