**Job title:** 137 The Rock, Bury

**Report type:** Preliminary Risk Assessment

**Prepared for:** 21 Living Limited

**Date:** March 2023

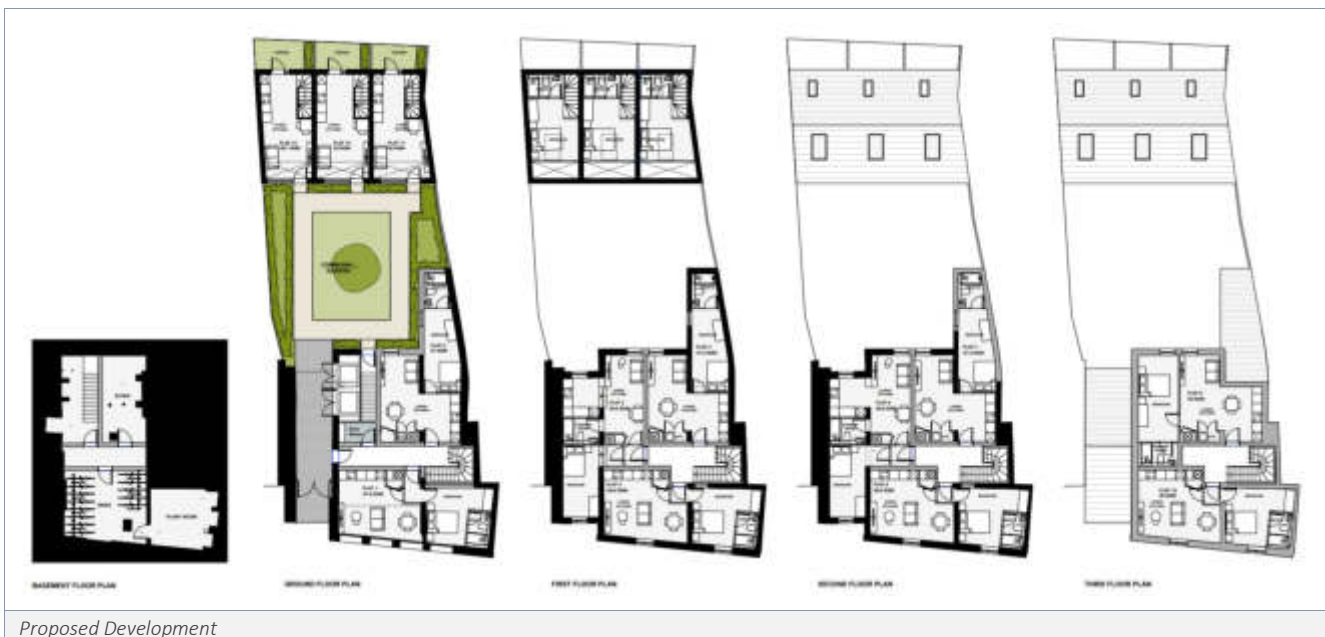
The proposed development is residential end use comprising the conversion and extension of the existing property in the south and a new two-storey residential building to the rear in the north. The conversion of the existing southern building will include adding an additional storey onto the already three-storey development.

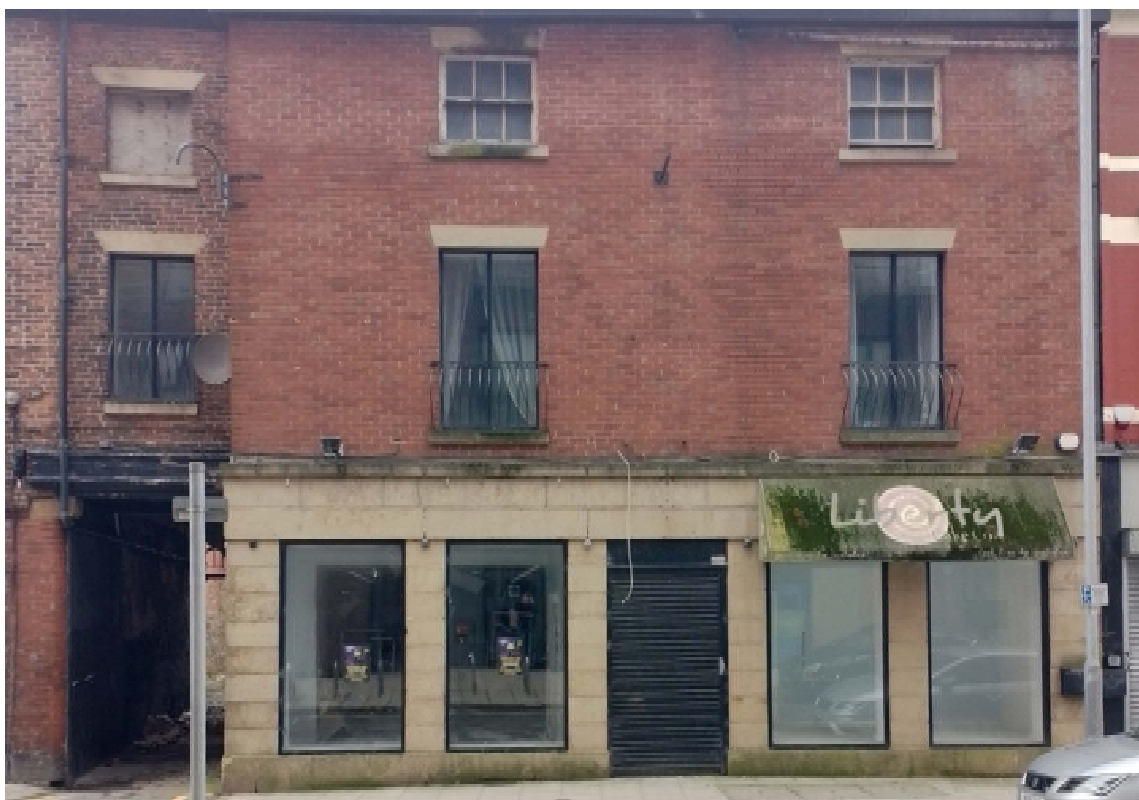
The site is fronted by a disused three-storey building of brick and stone block construction, the windows at the rear are boarded up. It appears that the ground floor was used commercially and the upper two floors residentially. Evidence of subsidence was observed at the rear of the property where a significant crack was present beneath an existing window and the building was generally in poor condition.

Photograph 1 - Front elevation of the property from The Rock.

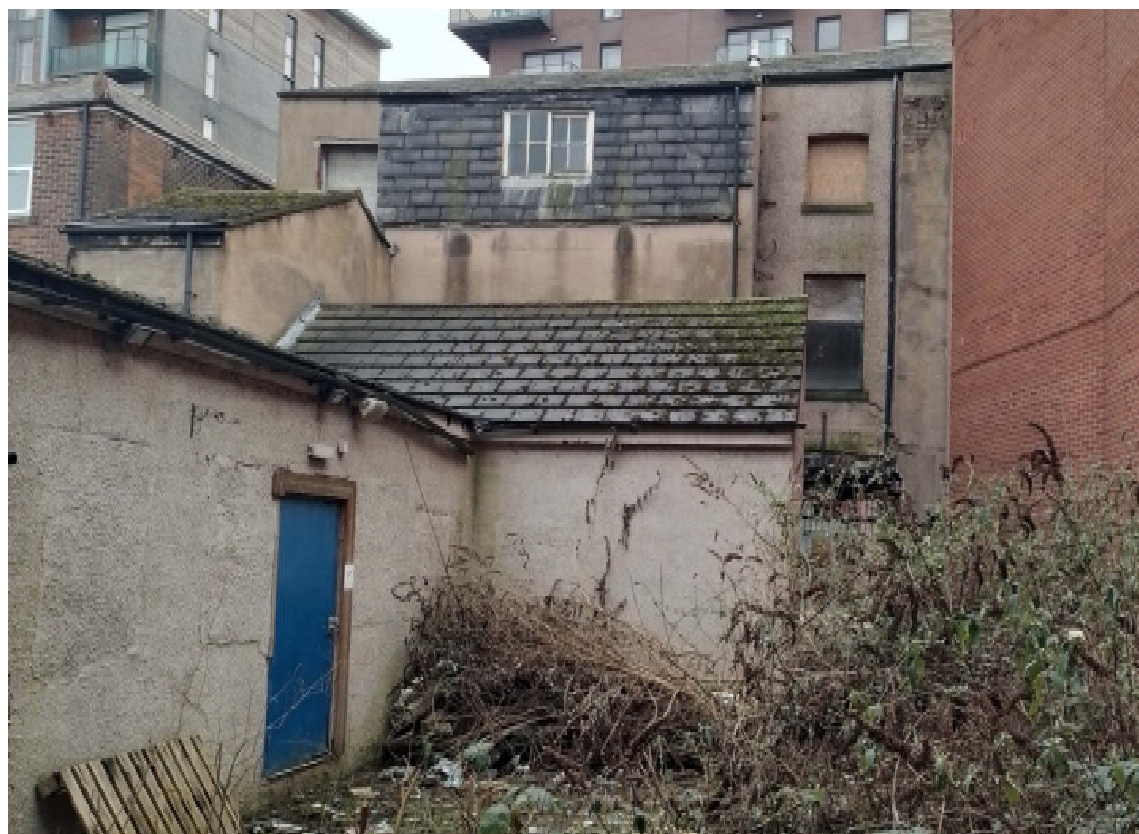
Photograph 2 - Rear elevation of the property.

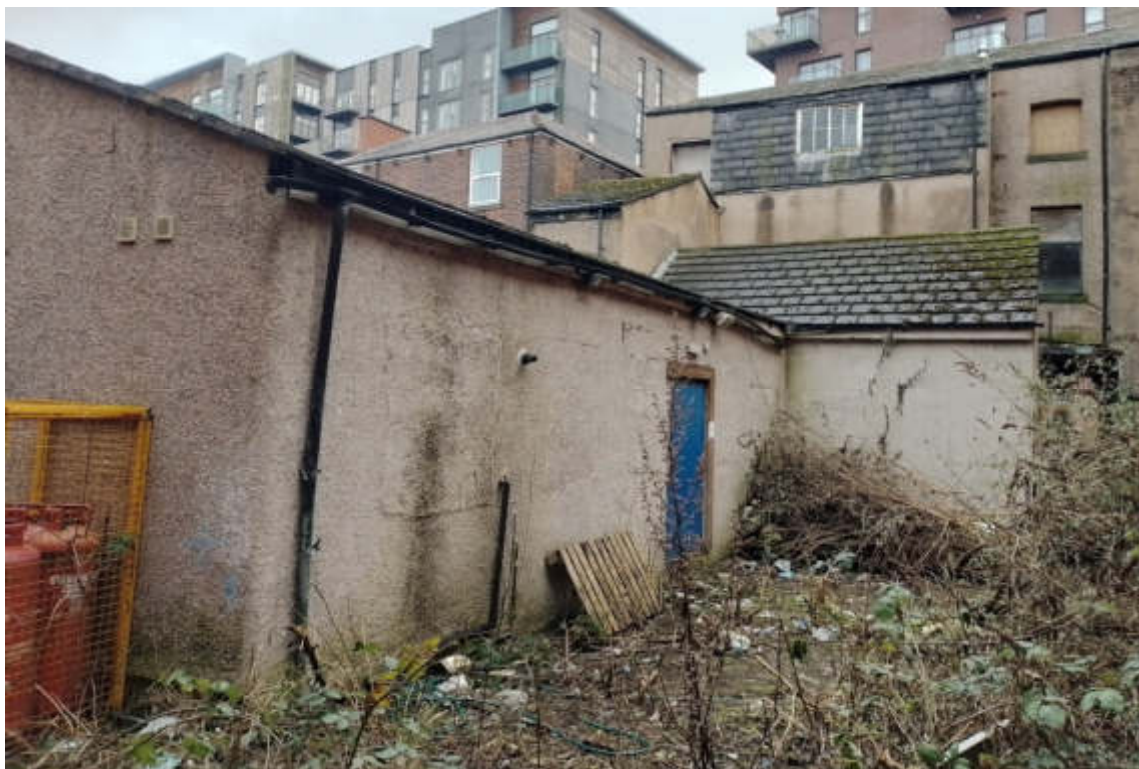
Single storey extensions exist at the rear of the three-storey property which extend towards the northern site boundary.

Photograph 3 - Rear buildings and central western courtyard.

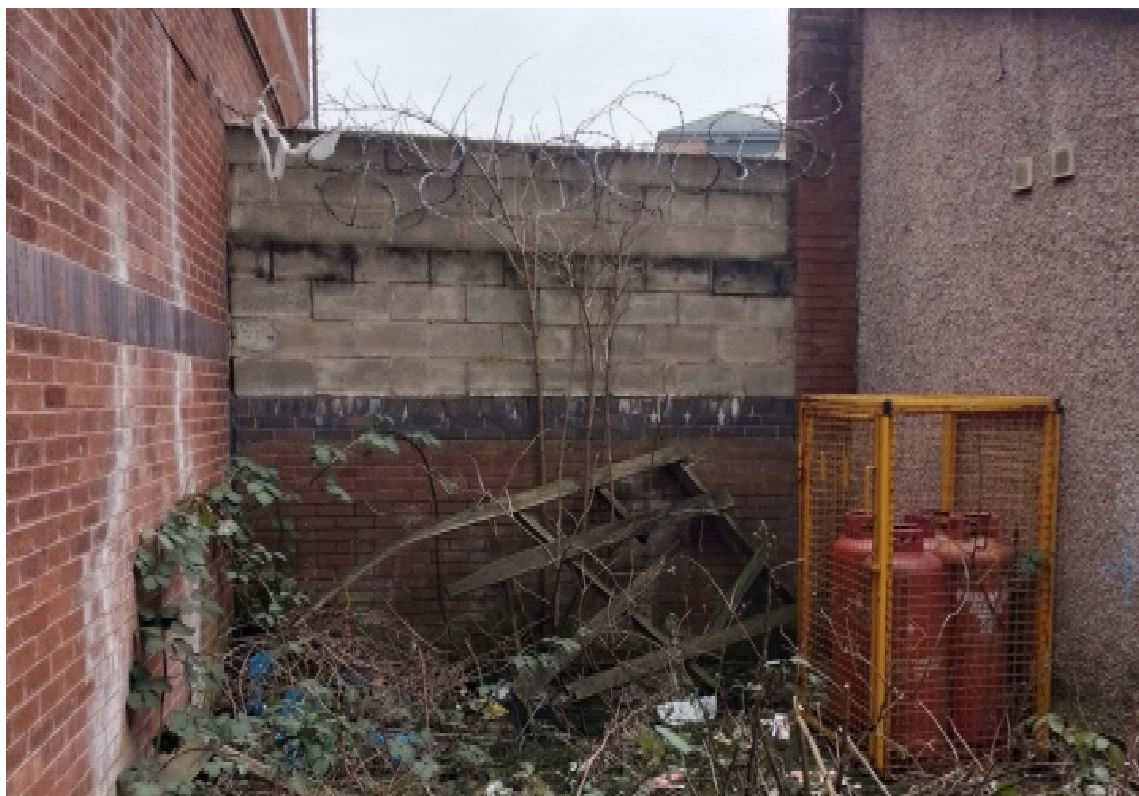
A disused concrete surfaced yard lies adjacent to the single storey buildings at the rear. The yard is overgrown and contains much rubbish, wooden pallets and a cage containing gas canisters.

Photograph 4 – North east boundary wall and container storage.

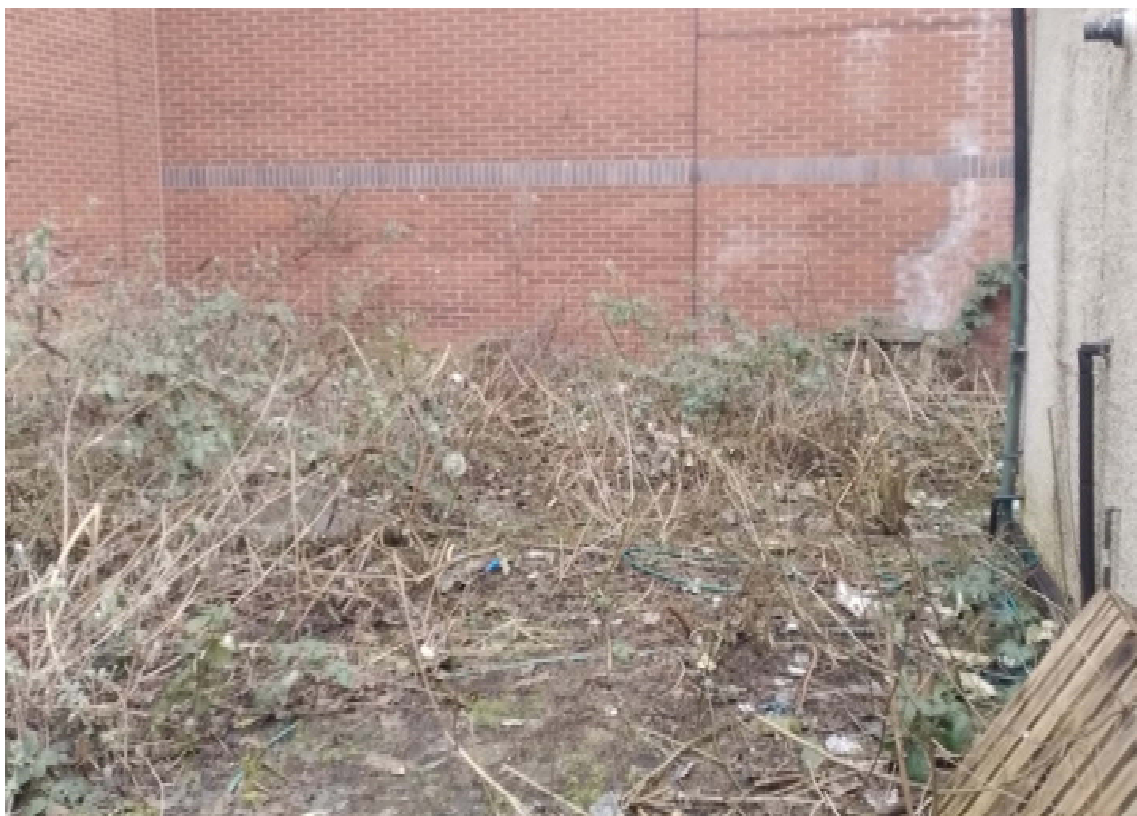
*Photograph 5 - North boundary wall and central western courtyard.*

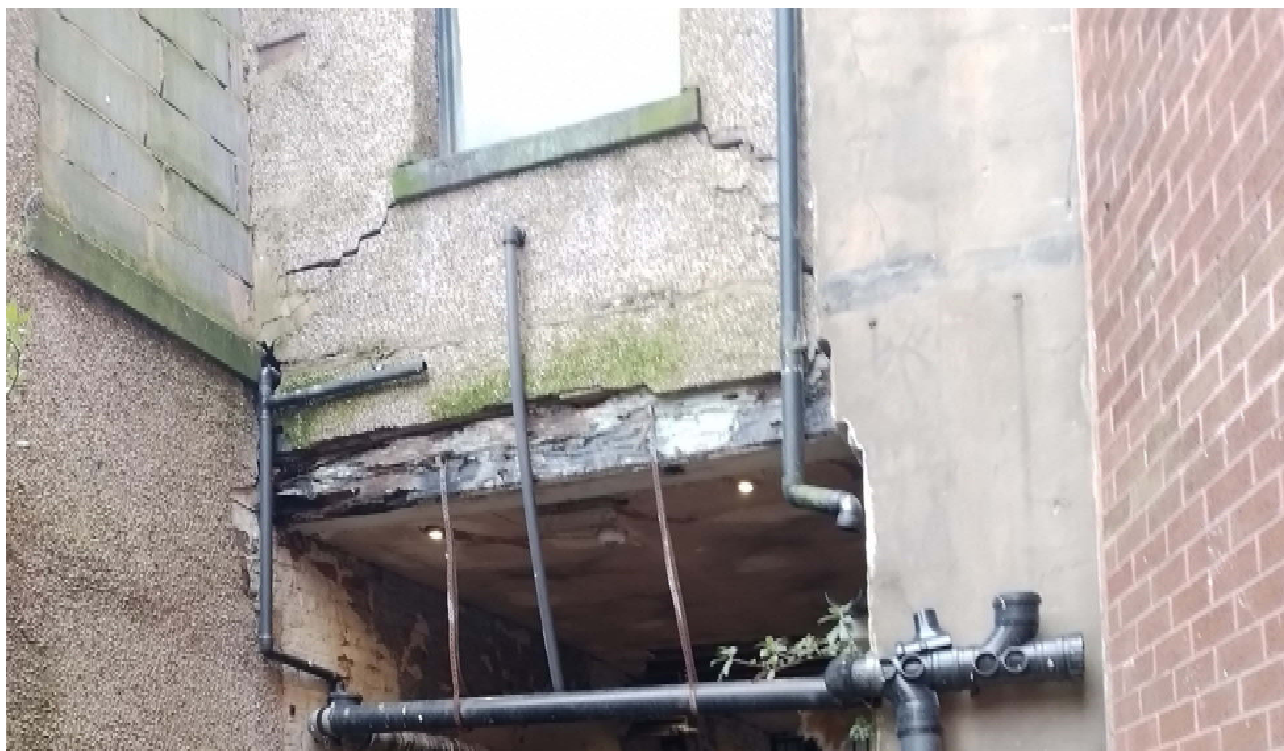
Three two-storey residential flats are proposed within the existing courtyard area of the site in the north. The existing building in the south has been on site since at least 1849 and it is proposed to construct an additional storey on this building as part of the conversion. Evidence of possible subsidence was observed during the site walkover where a significant crack had formed beneath an existing window. This may be due to ground subsidence associated with mine workings or due to the poor general condition of the building which requires some maintenance. Photos are provided in Appendix 2.

*Photograph 6 - Subsidence damage on existing building in the south.*

New buildings are to be constructed in the north and an additional load is to be placed on the existing building in the south. Shallow mine workings may be present based on the desk-based information and intrusive investigation is recommended, including drilling rotary boreholes to identify the presence of shallow coal mine workings.

Any new foundations should be designed such that they do not undermine existing foundations or nearby buildings and a movement joint should be incorporated between the existing building and proposed extensions.

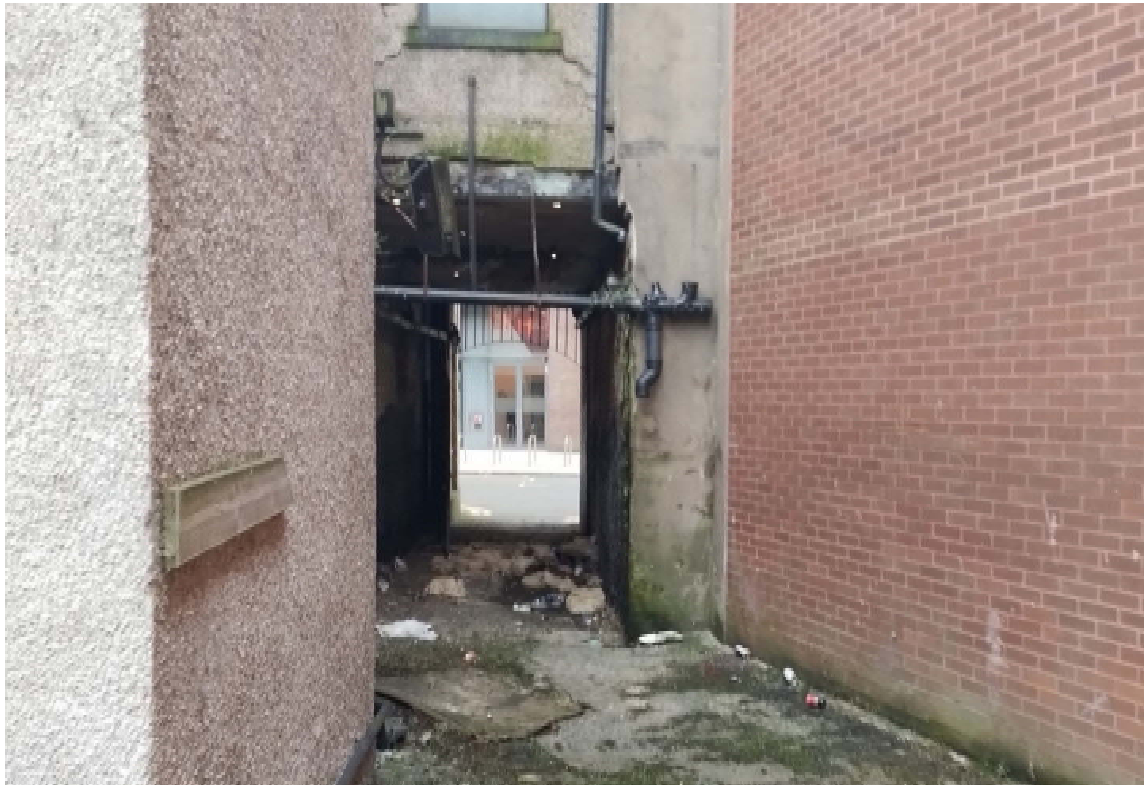
Access to the rear of the property is gained via an alleyway which passes beneath the existing structure. The ceiling of the underpass is in a state of disrepair.

*Photograph 7 - West boundary wall, central western courtyard and alley on the west side of the property.*
