## Desk Study

Star Radcliffe

for  
Department for Education

| <b>Document Title</b> | PC228400 Geotechnical and Geo-environmental Desk Study Report at Star Radcliffe |

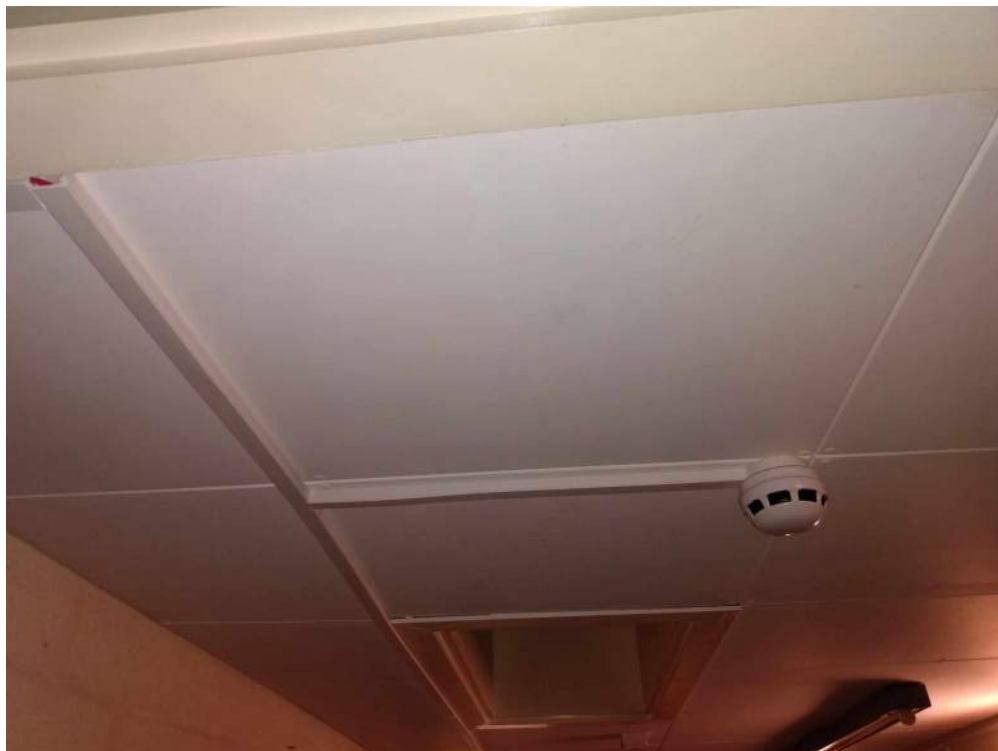
| Asbestos | <p>It is understood from the Radcliffe Leisure Centre maintenance staff that all potential Asbestos Containing Materials (ACMs) have been removed from Spring Lane School. However, the maintenance staff pointed out that some ACMs still exist within the Radcliffe Leisure Centre, both in the ceiling tiles (Photos 7 &amp; 8) and also in the adhesive compound used below the floor tiles (No ACM's were observed exposed on the ground surface).</p> <p>The inside of buildings have not been formally assessed by Geotechnics Ltd for the possible presence of ACMs.</p> |

8) Asbestos cement ceiling tiles of Leisure Centre building with overhead hatch in background

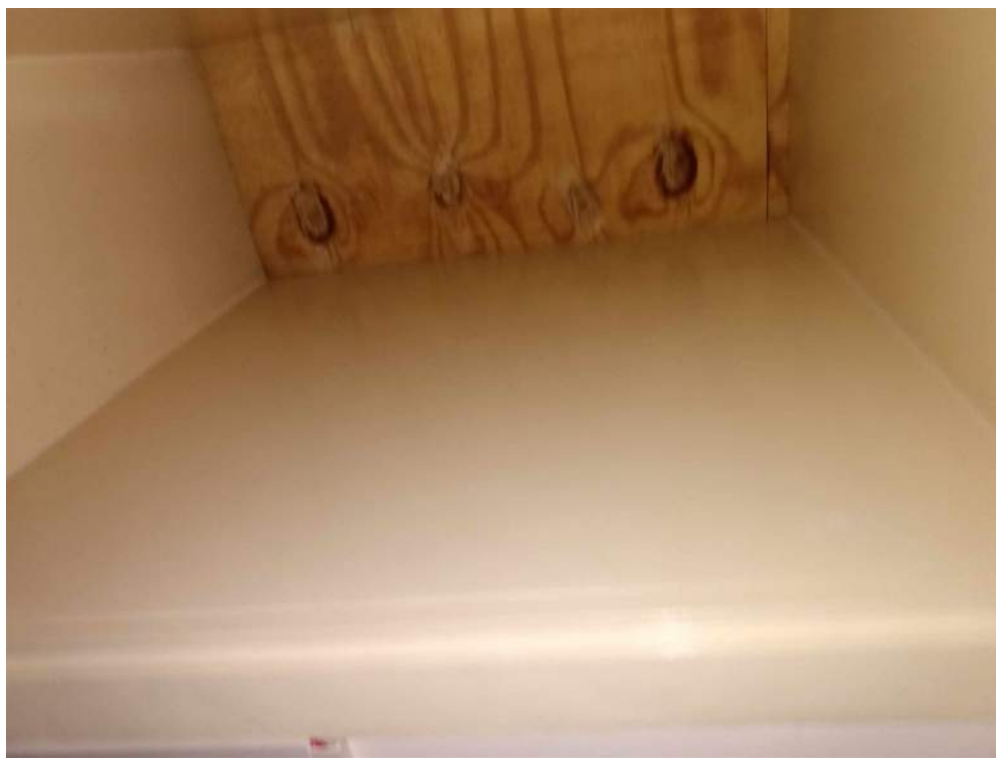
9) Plywood boards blocking overhead hatch in Leisure Centre building

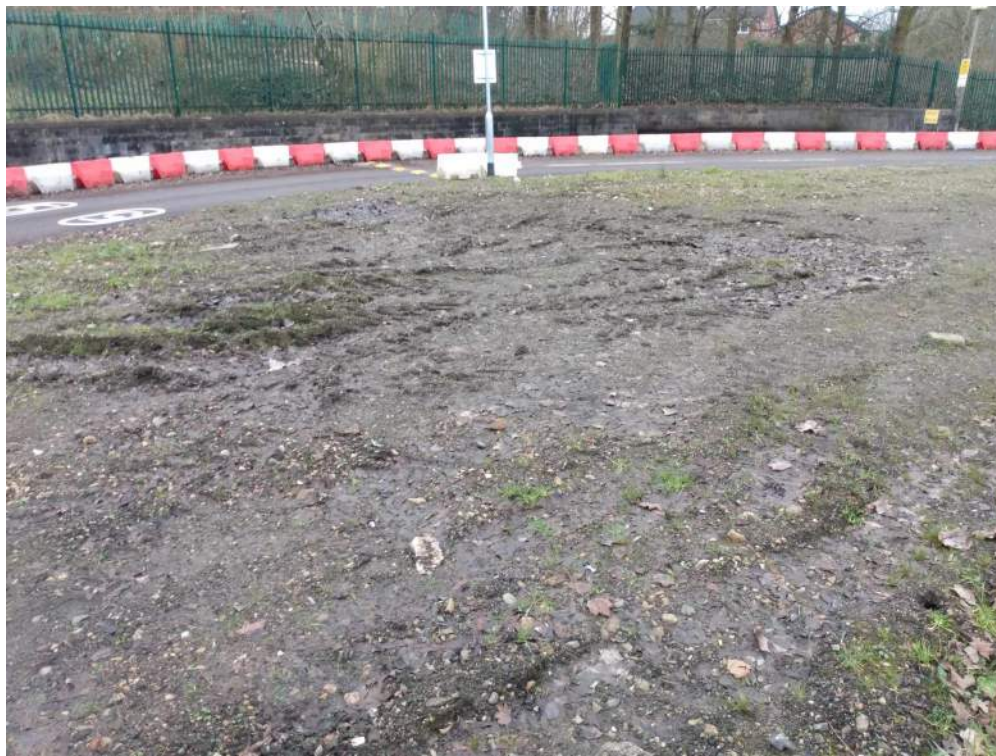
| Geohazards | |
|---|---|
| Landslip | Very low hazard potential.<br>(Gradual slope of the ground means that only minor, low retaining walls are currently present. Localised steeper slopes are present in places on the western perimeter and along the scarp of the former Clifton, Accrington & Colne Line that run southwest to northeast across the centre of the site). |

17) Rough ground, access road and stone retaining wall with Banana Path beyond

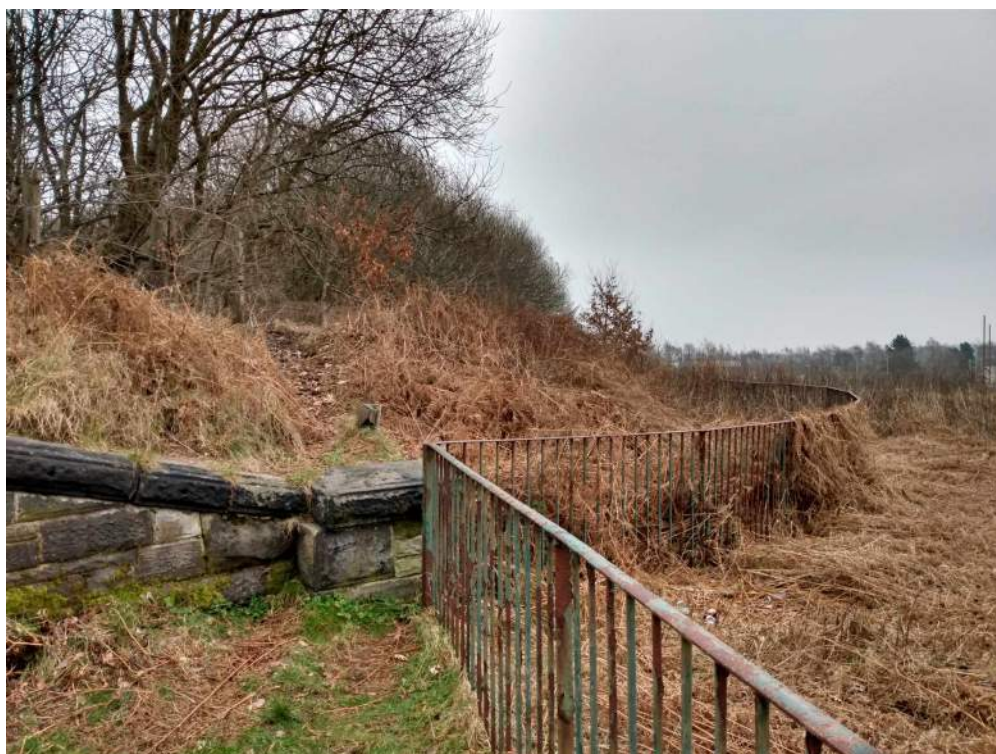
22) Wing wall of former bridge carrying L. & Y. R. Radcliffe West Fork over canal

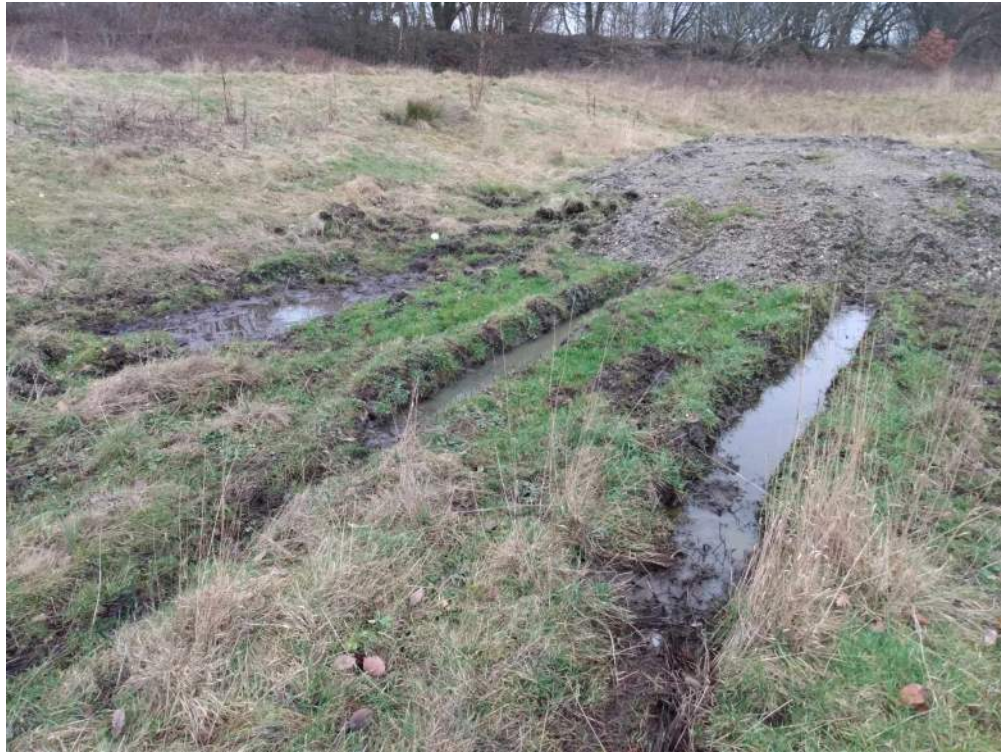
| Geohazards | |
|---|---|
| Compressible Ground | Negligible. No hazard recorded.<br>(Some soft, wet, rutted ground noted in north-eastern corner of the site). |

29) Soft rutted ground west of former running track

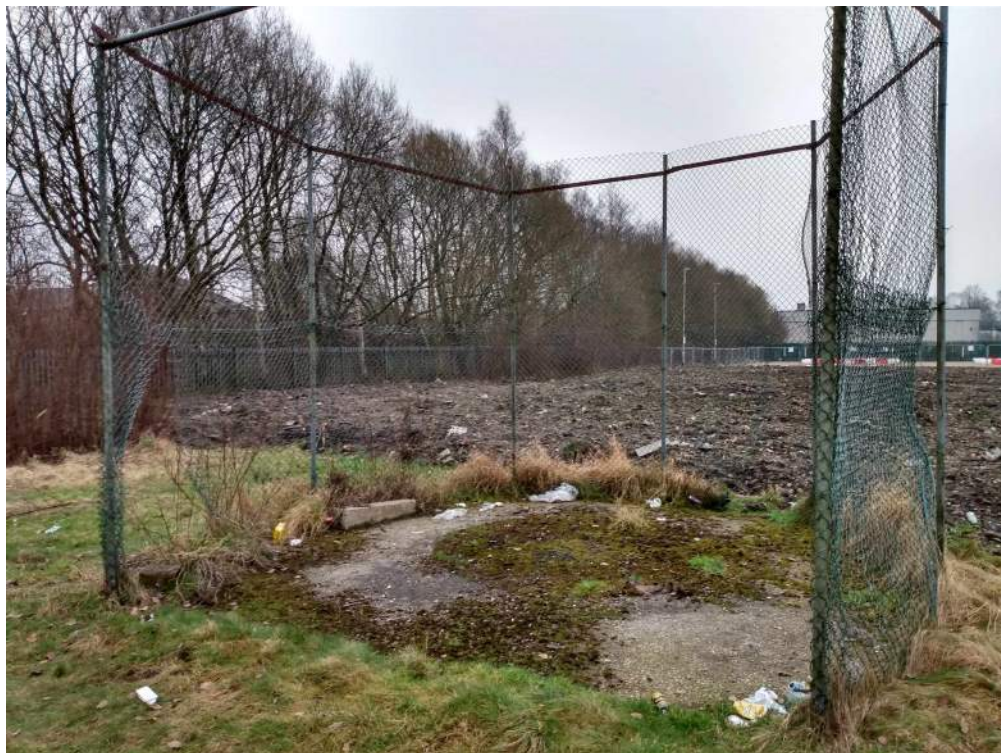
30) 5m diameter concrete base to former hammer and discus throwing area

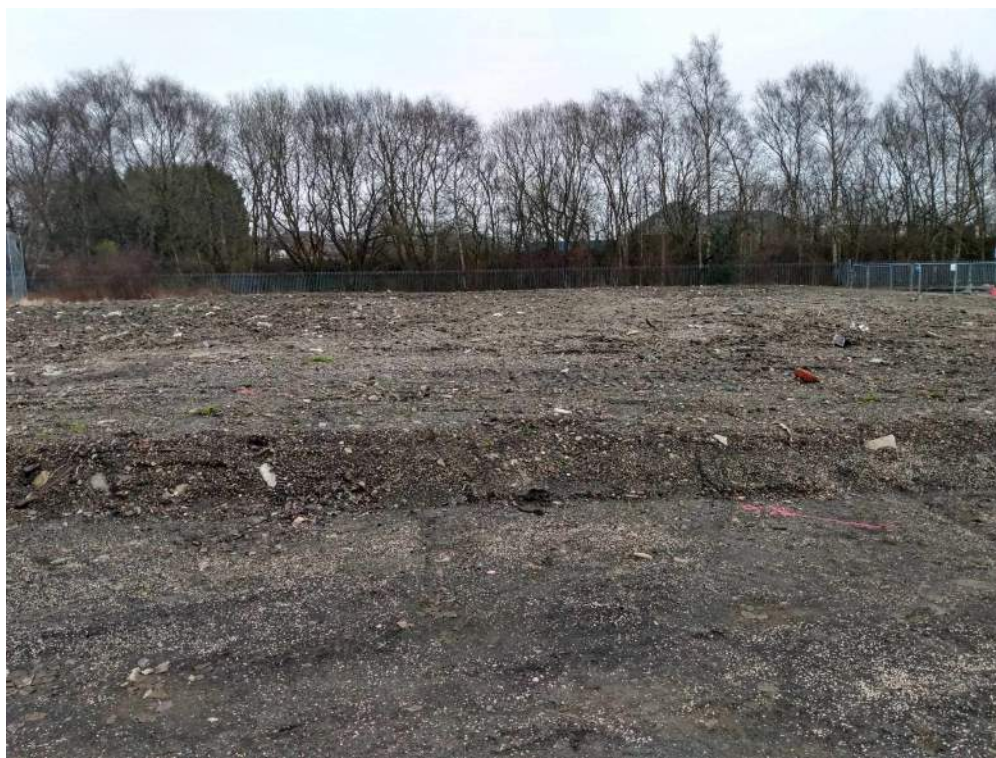
31) Construction rubble placed over former running track and athletics ground

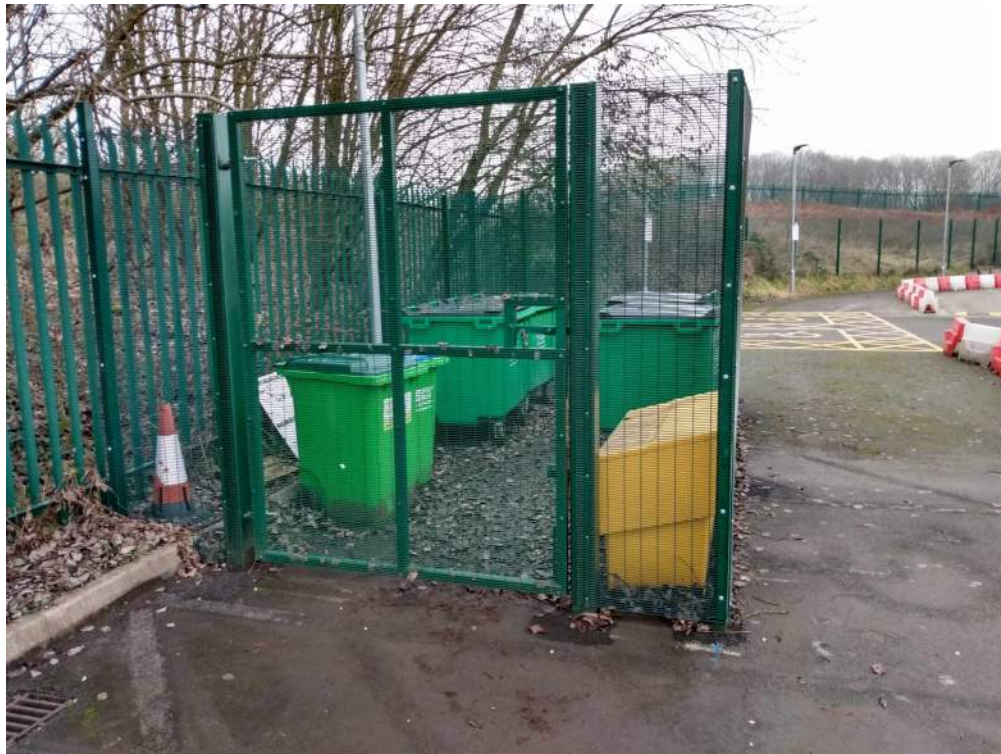
| Waste Disposal/<br>Materials Storage | <p>A bin store is located on the access road near to the entrance to the existing Spring Lane School (Photos 39 &amp; 40). Further recycling bins were noted near to the entrance to Radcliffe Leisure Centre (Photos 12 &amp; 13).</p> <p>The school/leisure centre site was observed to be clean and tidy, with only limited outdoor storage of materials seen. There is a single blue shipping container on the north side of Spring Lane School near to the Plant Room (boiler house).</p> <p>No evidence of burning was observed on-site. However, some small fires were noted in wooded areas immediately off-site.</p> |

39) Recycling bin store near entrance to Spring Lane School (looking north)

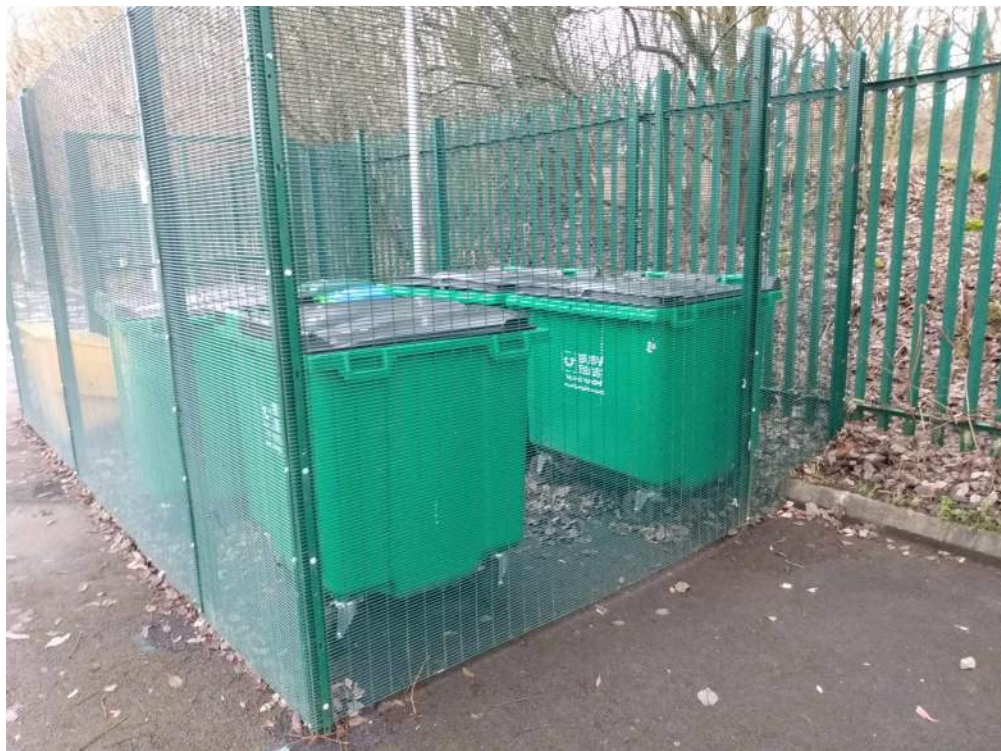
40)) Recycling bin store off car park access road near entrance to Spring Lane School (looking south)

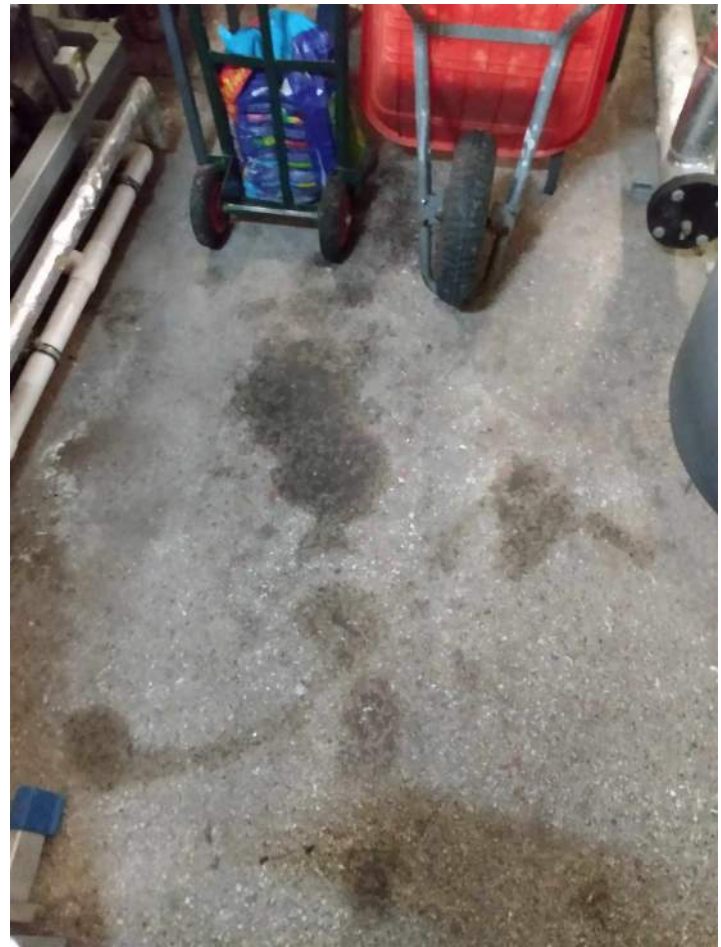
| Evidence of surface staining | Possible oil stains were noted on the Plant Room (boiler house) floor at Spring Lane School (Photo 50). |

50) Possible oil stains on Plant Room floor

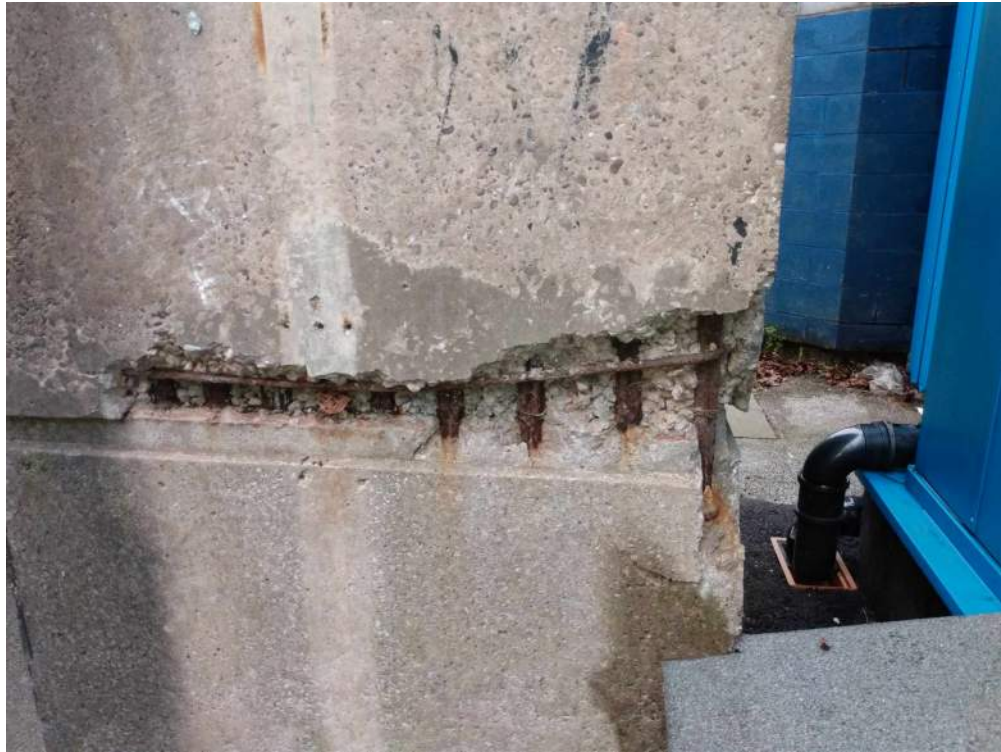
61) Corrosion to steel reinforcing bars and concrete of boiler house chimney

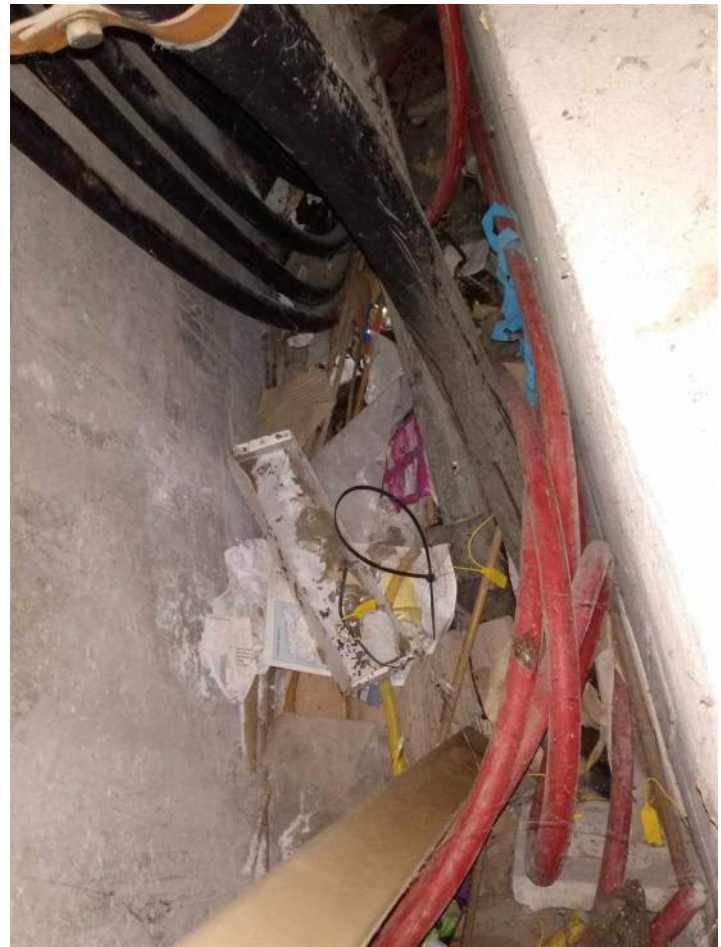
68) Electrical cables in pit in boiler house

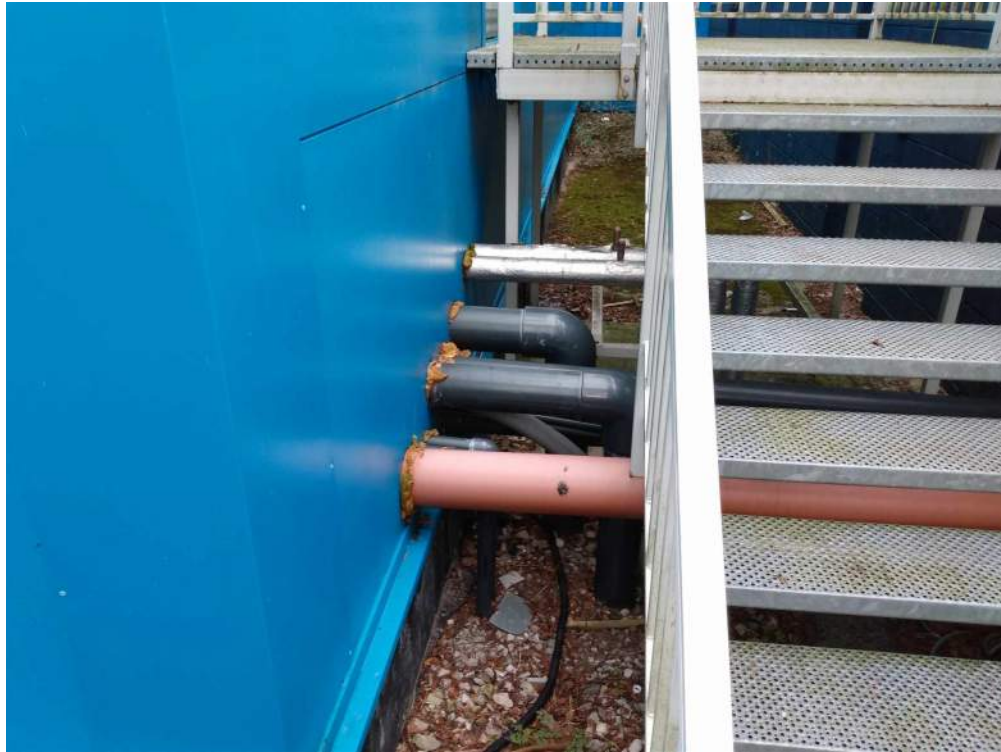
- Potential spillages /leaks of chemicals and chemically treated water associated with both the previous and current swimming pools, plant and filtration systems.

71) Pipework from blue swimming pool building passing under stairs to the filtration unit

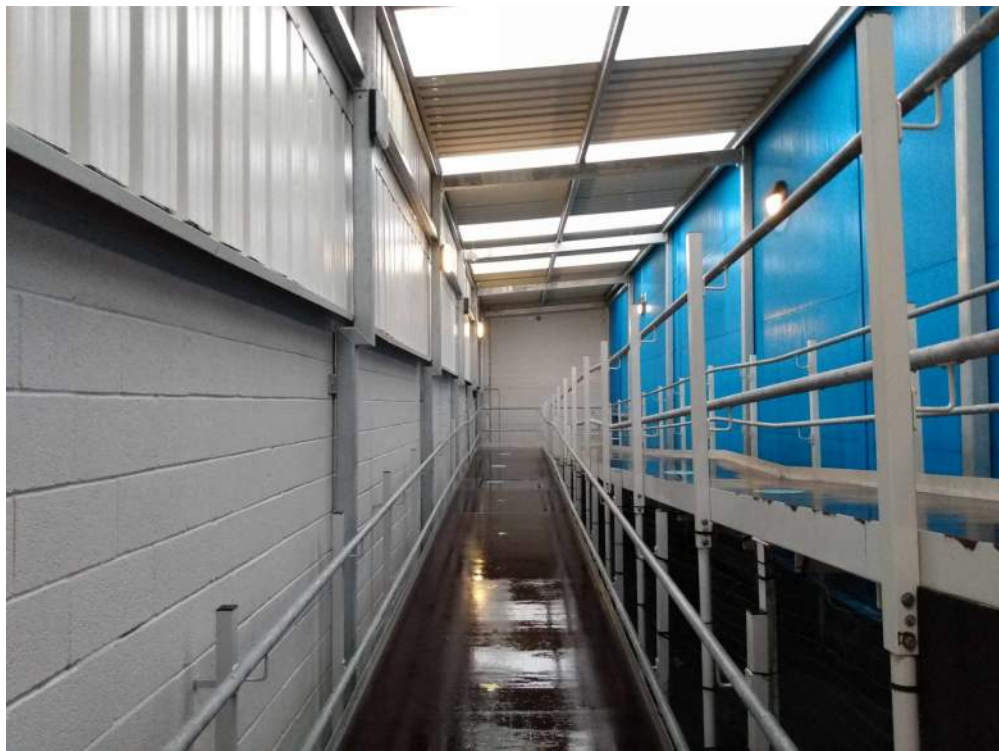
74) Looking north up access ramp to walkway around swimming pool building (Old tarmacadam surface visible on right below pool)
