## **4. UK Regulatory Environment and Guidelines**

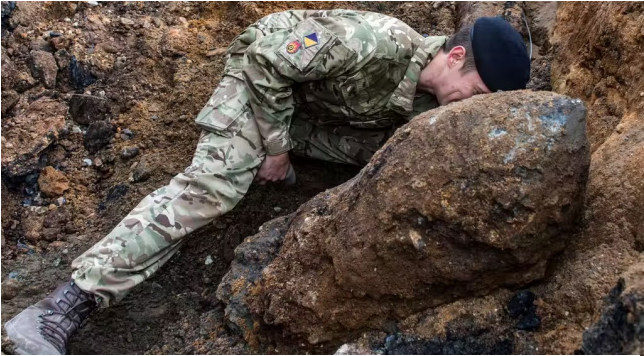
### Bermondsey bomb: World War Two device safely removed

**An unexploded World War Two bomb found in south London has been driven away safely under police and Army escort.**

The 500lb (250kg) device was found on a building site in Grange Walk, Bermondsey on Monday.

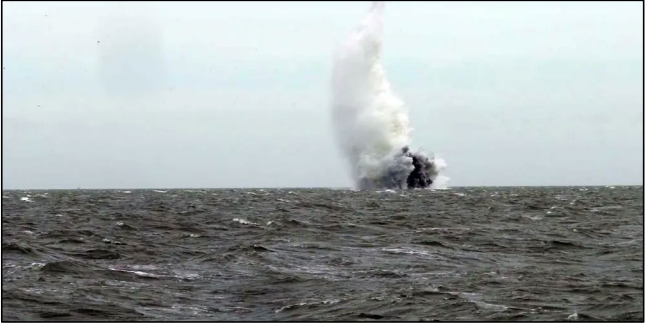
### WW2 bomb found near London City Airport blown up

**An unexploded World War Two bomb found near London City Airport has been detonated.**

The 500kg device was discovered at the King George V Dock on Sunday during planned work at the airport.

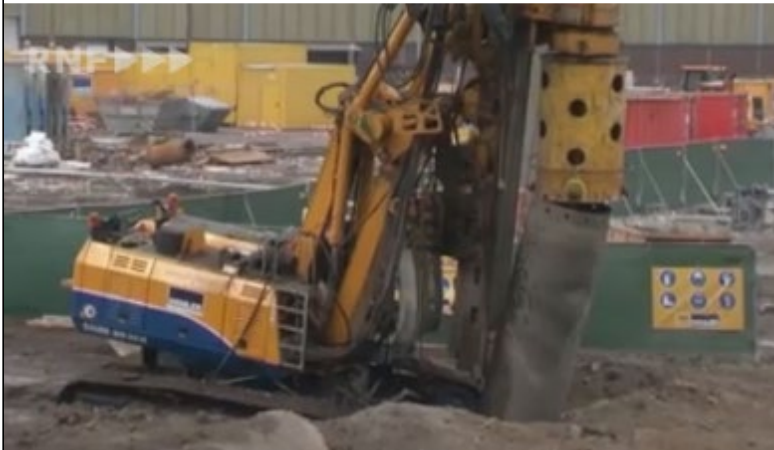
BASF has confirmed that an explosive device, most likely a World War II-era bomb, caused the blast that left one person injured Tuesday at a plant construction site in Germany.

The explosion was reported at BASF's Ludwigshafen toluene diisocyanate (TDI) plant, which recently broke ground for a 300,000 metric tons per year TDI production plant and other construction to expand its facilities.

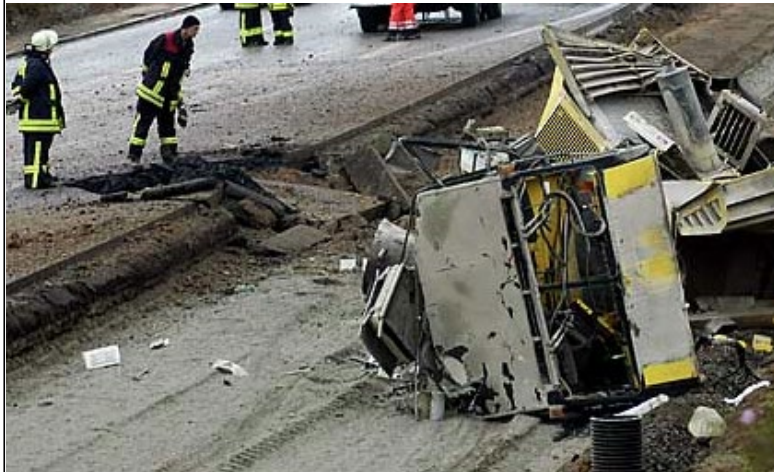
**World War II Bomb Explodes on German Motorway**

A highway construction worker in Germany accidentally struck an unexploded World War II bomb, causing an explosion which killed him and wrecked several passing cars.

A World War II bomb has exploded during construction work on a German highway, killing one worker and injuring several motorists who were driving past, police said.

The worker had been cutting through the road surface near the south-western town of Aschaffenburg when his machine struck the bomb and triggered it. Police said they weren't sure yet what type of bomb it was. "The explosion seems to have been too small for it to have been an aircraft bomb," a police spokesman said.

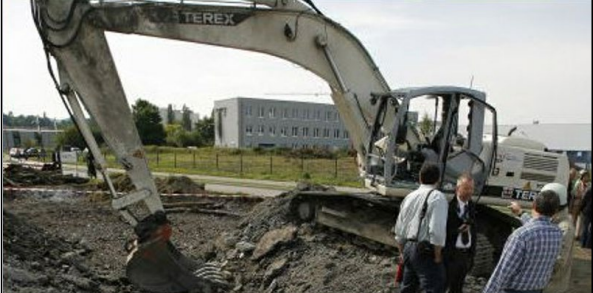
**WWII bomb injures 17 at Hattingen construction site**

**Seventeen people were injured on Friday when a construction crew unwittingly detonated a buried World War II-era bomb in Hattingen.**

An excavator apparently drove over a 250-kilogramme (550 pound) American bomb, damaging surrounding buildings. Most of the injured suffered auditory trauma from the blast, and the excavator operator suffered injuries to his hands, police in the German state of North Rhine-Westphalia said.

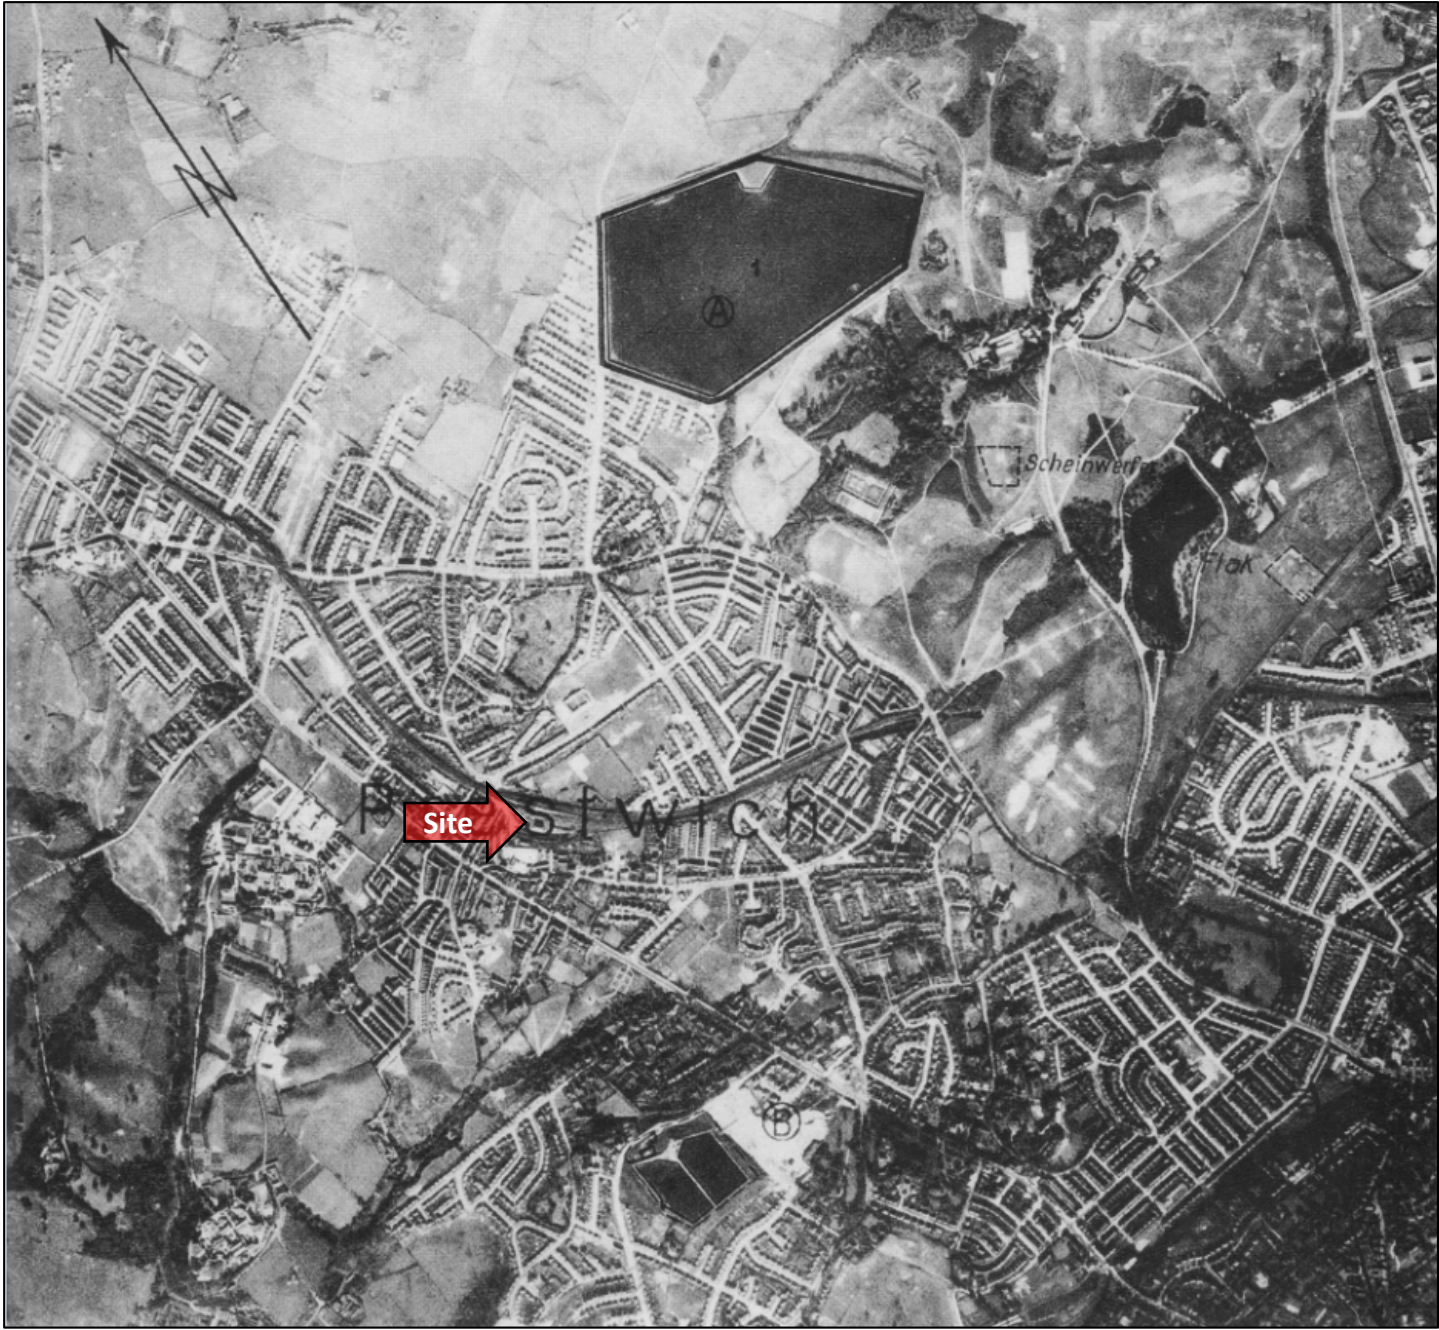
Heaton Park reservoir, Manchester 1940

Above: Heaton Park reservoir, Manchester 1940. The reservoir is marked by 'A' and to the south west in Prestwich is another target marked 'B', just to the left of Bury New Road. It is now covered by houses, but in 1940 appears to be a water treatment plant.
