22 COCKEY MOOR ROAD,  
BURY

PHASE 2 GEO-ENVIRONMENTAL  
INVESTIGATION, RISK ASSESSMENT  
AND REMEDIATION STRATEGY

**Job Number:** LKC 20 1870

**Date:** March 2021

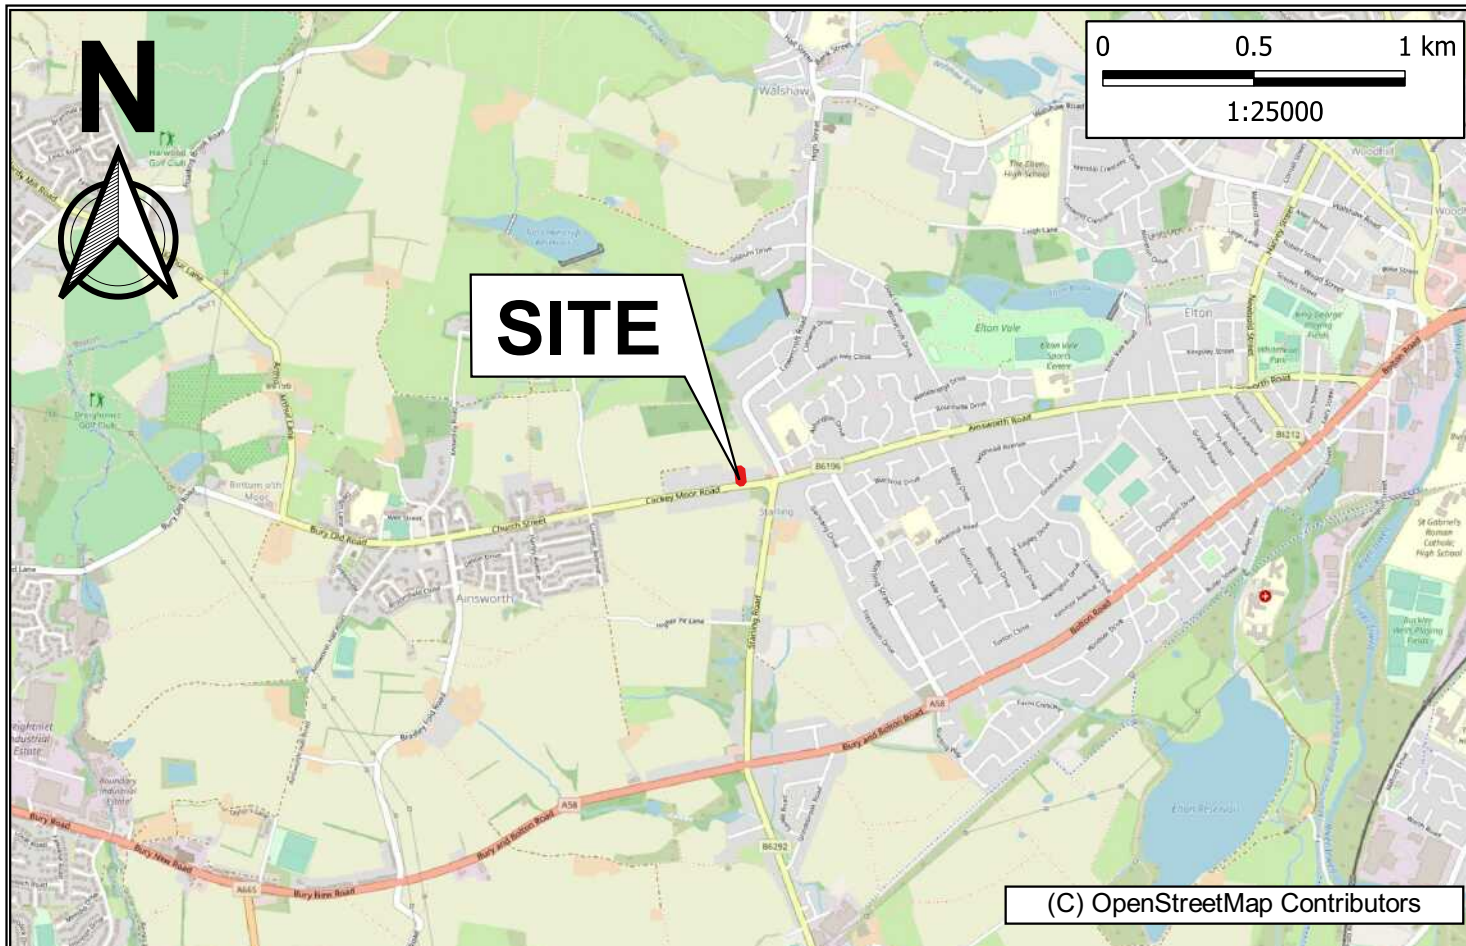
| Client:<br><br>Mr S Postchi | | | | Title:<br><br>Site Location &<br>Boundary Plan | | | |
