## **BAT SURVEY AT**

Further Davises Farm, Mather Road, Bury

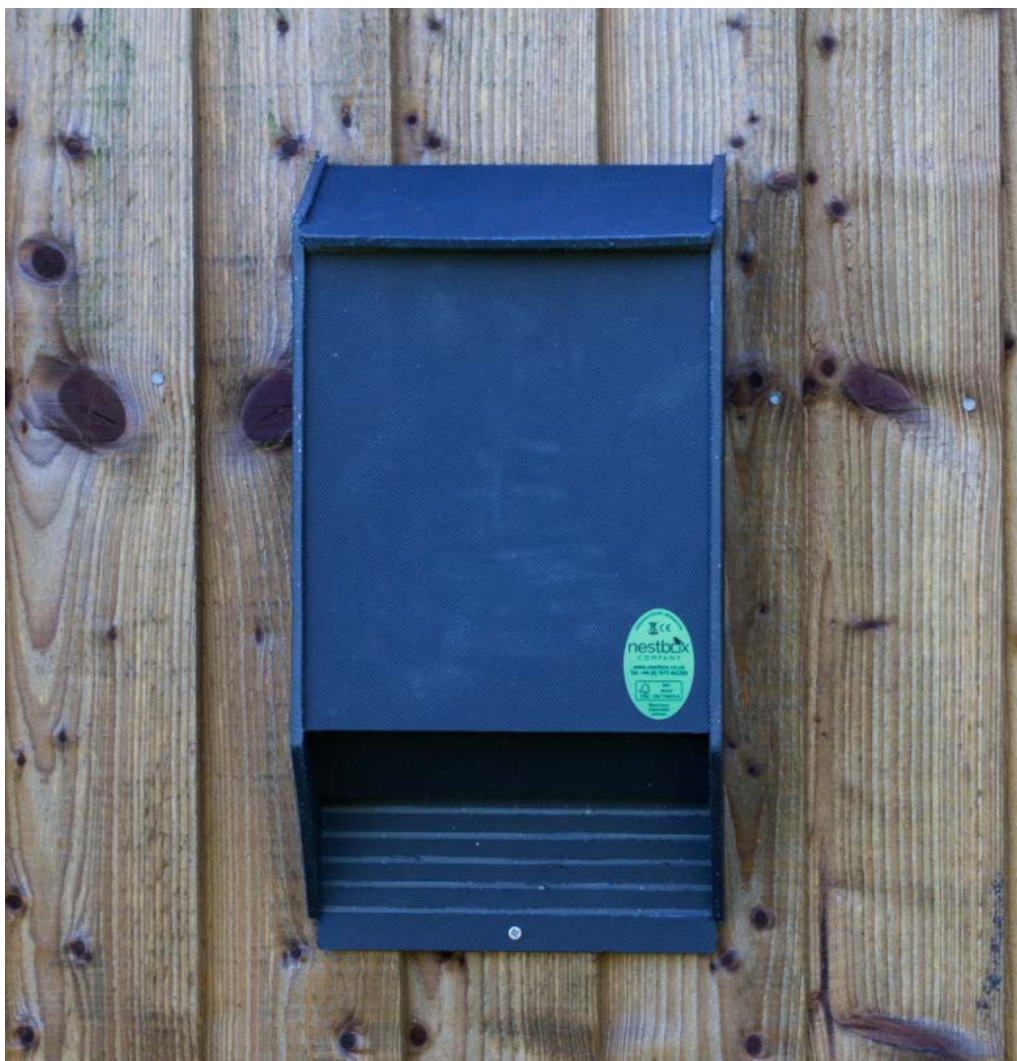
**Figure 5** Eco Bat Box by The Nest Box Company.

6. Remove all roof coverings by hand only.
7. Install at least one bat box on the southern elevation of the building or another retained building on site. An example of a suitable wall mounted bat box is provided within Figure 5. This potential roost site will be a significant improvement on existing site conditions.

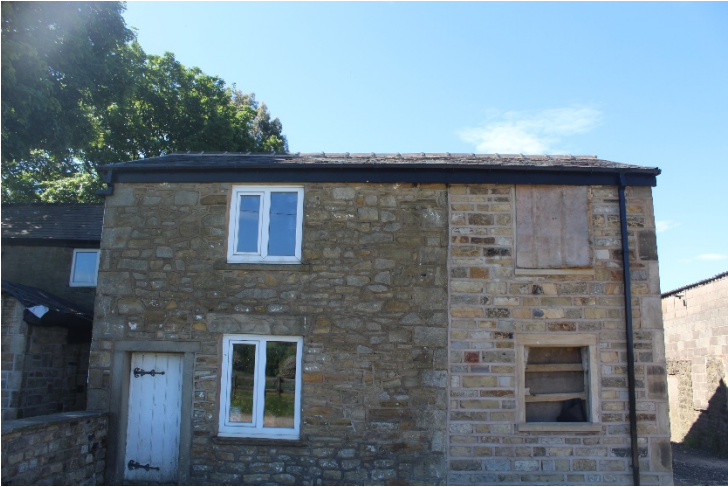
| Photograph | Notes |
|---|---|
| A photograph showing the northern elevation of a two-story stone building. The walls are made of light-colored, roughly-hewn stone blocks. On the left, there is a white door and a white-framed window. On the right, there is a larger white-framed window and a smaller, partially boarded-up window above it. The roof is dark and appears to be tiled. A black downspout is visible on the right side of the building. | Northern elevation<br>Walls well pointed<br>Roof tiled and ridgeline well sealed<br>Windows tightly fitted |

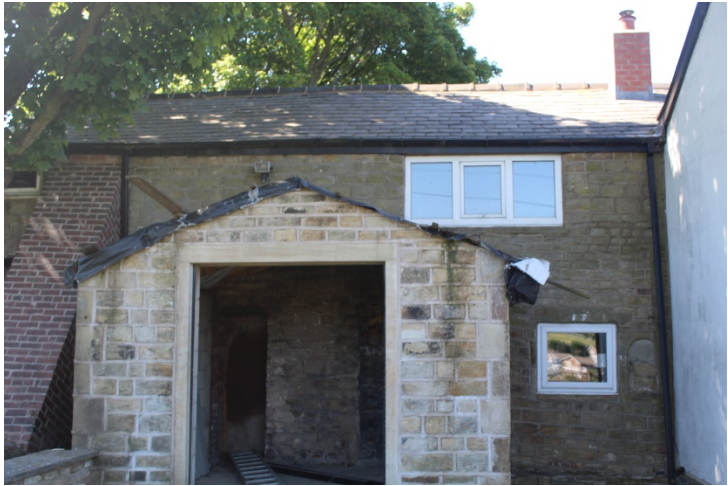
| Photograph | Notes |
|---|---|
| A photograph showing the eastern gable end of the same stone building. The gable is made of the same light-colored stone blocks. There is a small, white-framed window in the gable. To the left of the gable, there is a small, arched stone structure, possibly a well or a small entrance. The roof is dark and appears to be tiled. A brick chimney is visible on the right side of the roof. | Eastern gable end<br>Walls well pointed |

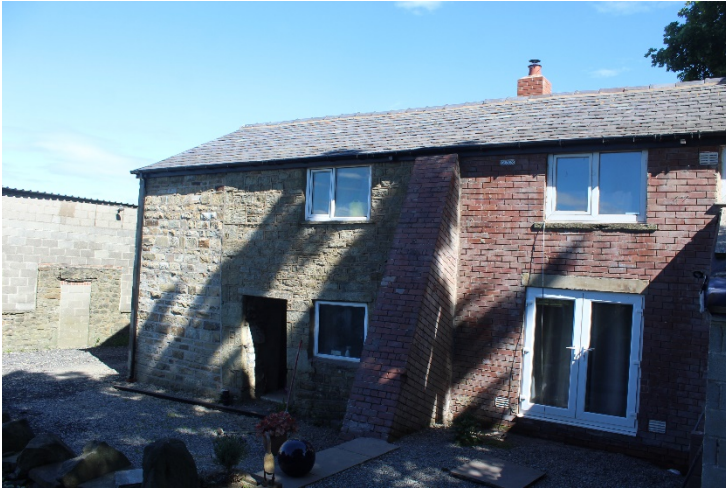
Southern elevation

Windows tightly fitted

Porch still under construction

Roof tiles and ridgeline well sealed

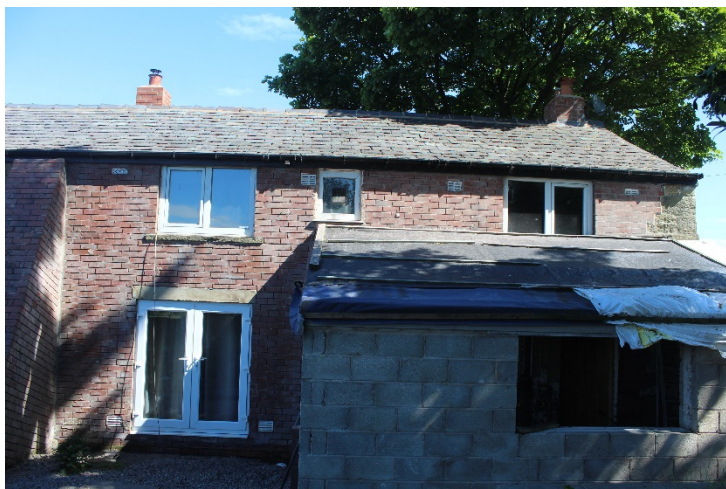
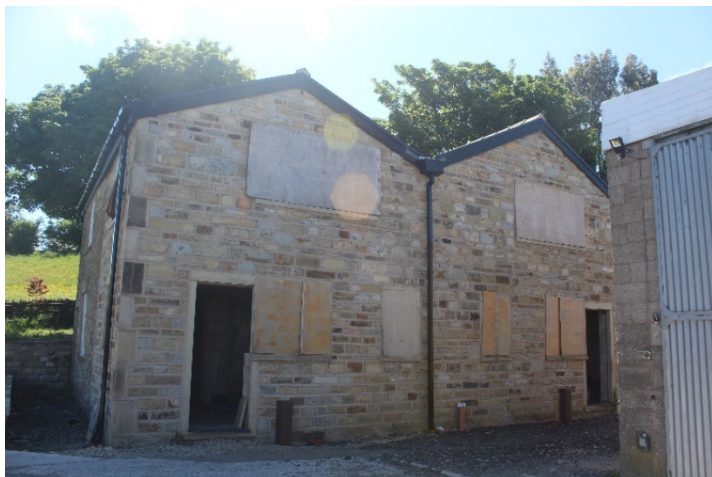
Western gable end

Walls well pointed and in excellent condition

Verge well sealed

Open doorways

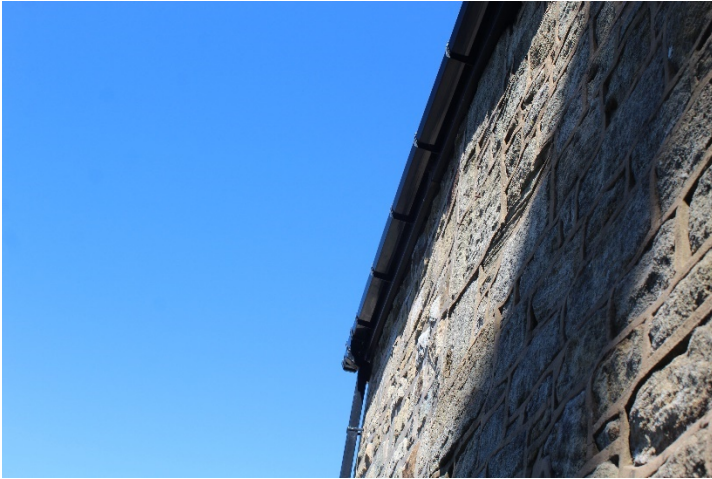
Gaps between the eaves boards and the walls to be retained

There are no soffit boxes but eaves boards are present. Gaps were identified between the eaves boards and the walls, however, these gaps did not appear to extend over the wall top and into the roof area. Some of these gaps were considered to be too shallow and exposed for use by roosting bats. A single shallow gap was also identified along the verge on the eastern gable end. No indication of use by bats was identified in these areas such as droppings, scratch marks, grease marks or urine staining. It is understood that all of these gaps can be retained within the final development.

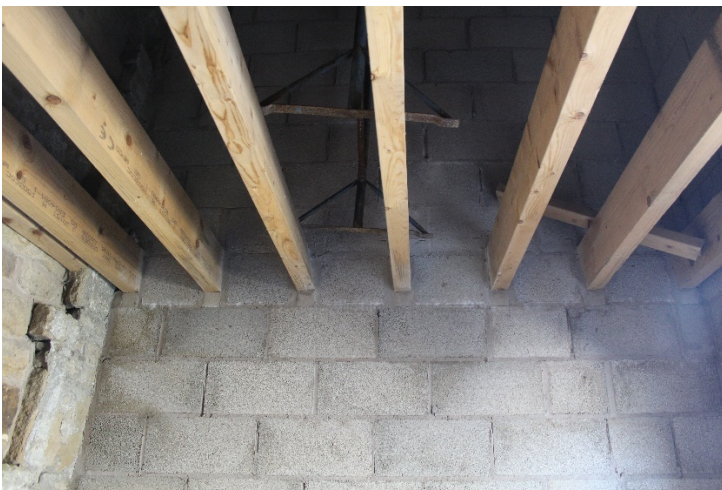
Internal walls generally well sealed

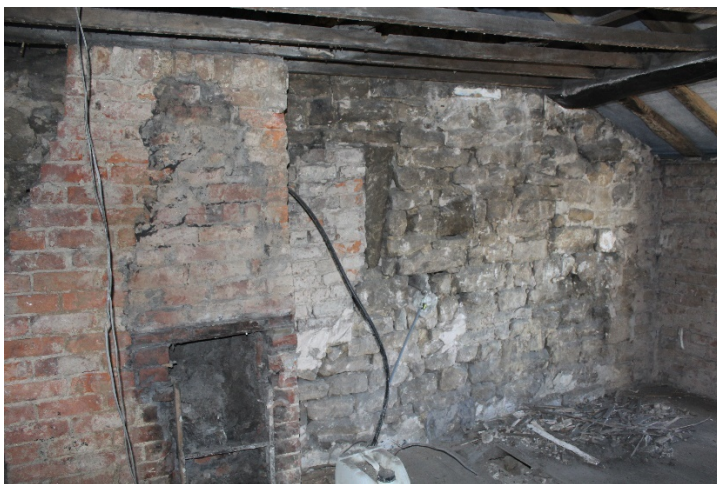
Low number of gap between stones in areas - covered in cobwebs and debris and no indication of use

The majority of the internal walls are well sealed with no gaps present suitable for use by roosting bats, however a low number of gaps between the stones were identified within the porch and on the second storey of the area of building in the south east of the site. These gaps were found to be covered in cobwebs and filled with debris indicating no recent use by bats. No indication of use by bats were identified within these areas. The internal areas of the building are illuminated from the presence of windows in some areas and are illuminated and draughty from the absence of windows and doors in other areas of the building, both of which would reduce suitability for use by roosting bats.

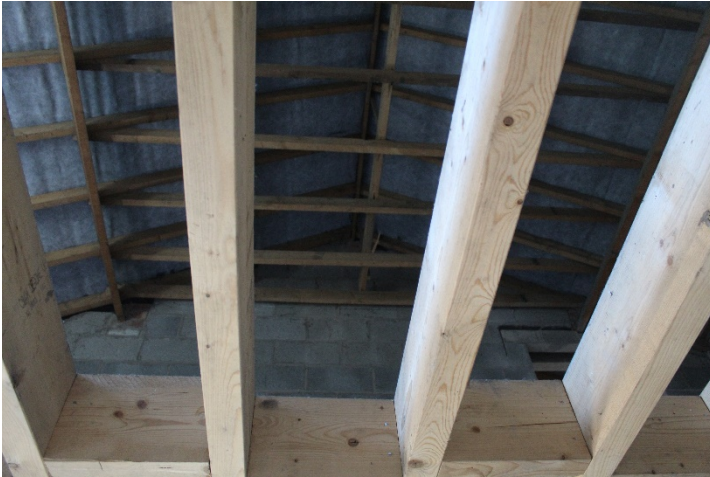
No roof void

Internal areas illuminated and draughty

Roofs lined with breathable roofing membrane

There are no roof voids within the building, the timber beams in the roof area of the building in the south east of the site are showing signs of degradation, however, no splits or gaps were identified suitable for use by roosting bats. The timber beams in the rest of the roof areas were found to be in excellent condition. The roofs are lined with a modern breathable roofing membrane. No indication of use by bats could be found. As the internal areas are illuminated and draughty this would reduce suitability for use by roosting bats.
