# Preliminary Bat Roost Assessment

Land Adjacent to 88 Watling Street, Affetside

Bury, BL8 3QW

29<sup>th</sup> December 2021

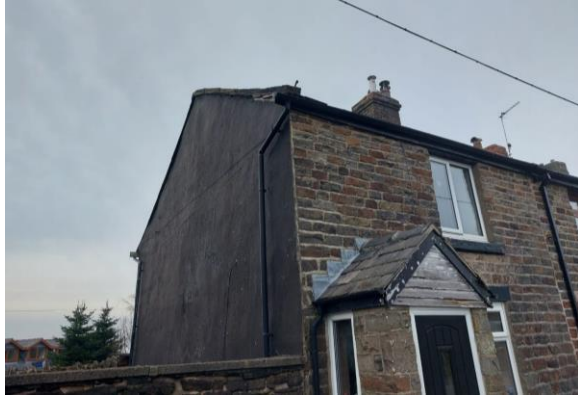
The property of 88 Watling Street is an end terrace with an apex roof. The north facing gable end is painted black, with the roof tiles sitting flush to the walls and held down by capping stones. All potential gaps beneath the tiles are otherwise neatly cemented, with no PRF (no access points) on the north facing aspect of the property.

**Plate 1:** Front view of property & gable end

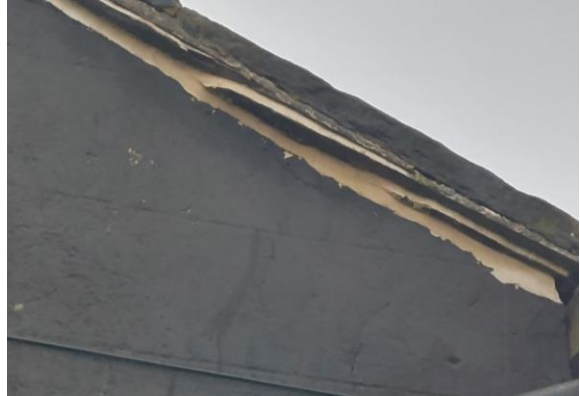
**Plate 2:** Sealed tiles on gable end.

The PRA has confirmed 88 Watling Street to be of Negligible value for bats. There were a small number of PRF that could be inspected with use of a ladder and torch light. These features were superficial and in the case of wooden cladding, any gaps were otherwise clogged with cobwebs. The gable end did not have any PRF.

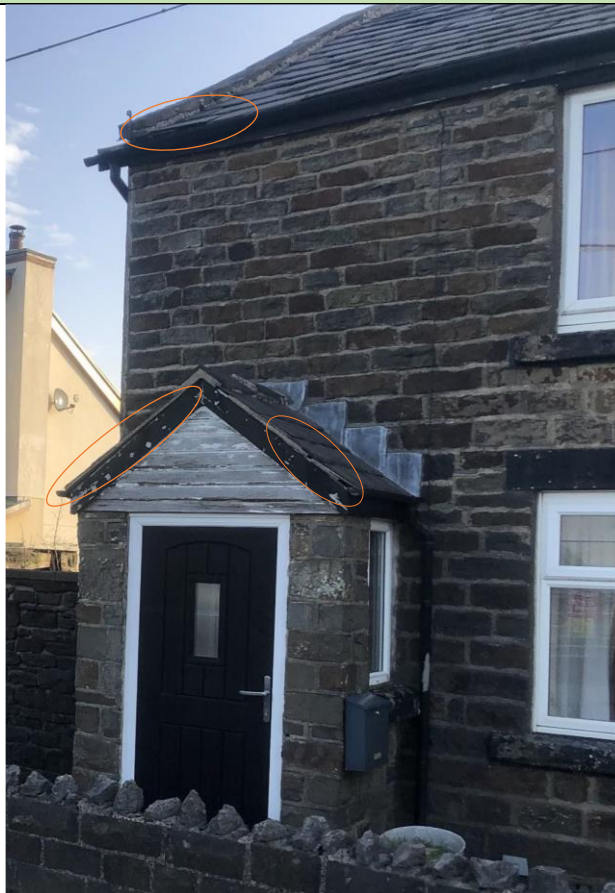
The property has slate tiles which are mostly flush, with a single gap beneath a tile at the front of the property, close to the overhang. This tile was inspected using ladders and torchlight, where it was visible that the gap did not extend inwards. Wooden cladding at the rear and front of the property is mostly well-sealed with some gaps between the cladding and wall, which were consistently clogged with accumulations of cobwebs and not suitable as a PRF.

A small porch at the front of the property had a gap between the wooden cladding and at the edge of the roof tiles. Close inspection revealed the gaps to extended inwards by 1-2 inches and met with further wooded cladding attached to the brick work.

**Plate 3:** Gaps inspected at front of property

Based on the concluding assessment of Negligible roost potential for bats, the proposal does not present any ecological constraints and no further surveys for bats are required.
