**Bat Survey Report (preliminary day-time survey):**

**39 Bradshaw Road,  
Tottington,  
BL8 3PW**

**Survey Date: 14/4/22**

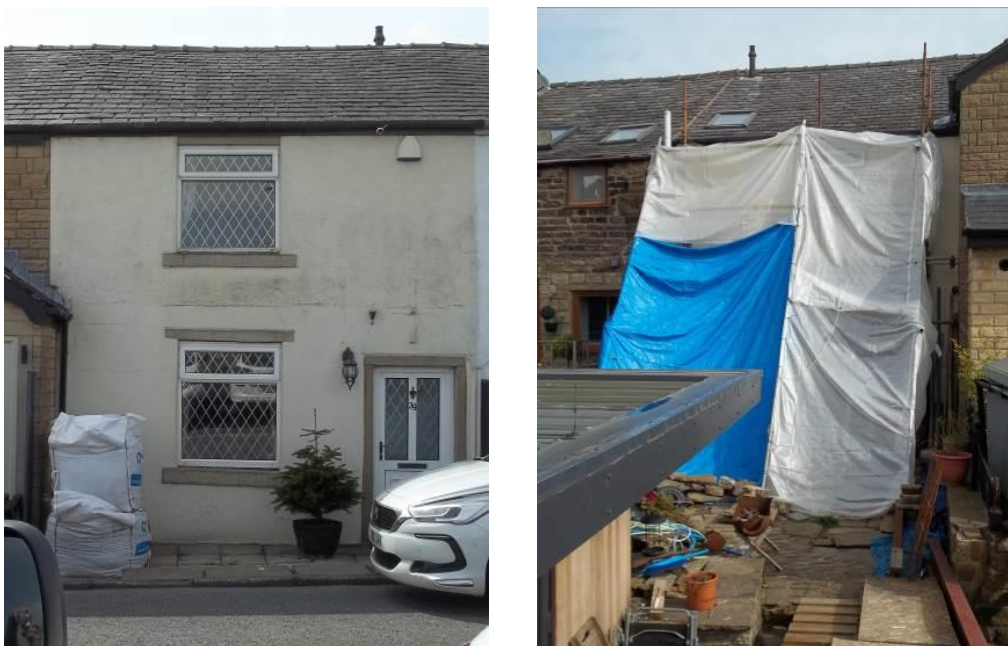
This is a small, stone, terraced cottage:

Front (east) and rear elevations

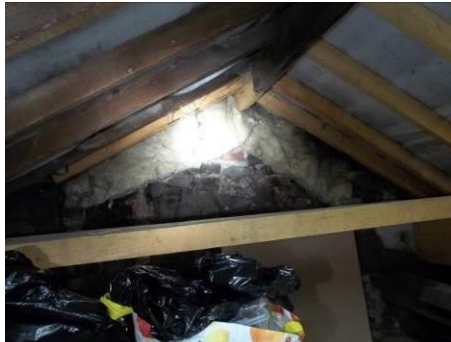
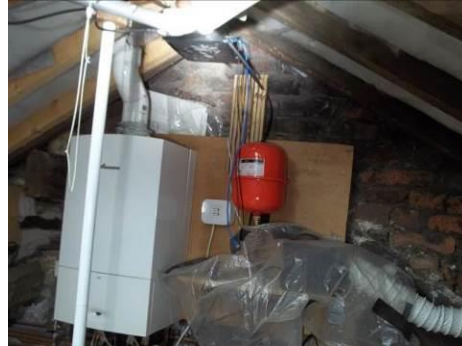
The property has a small, cluttered loft:

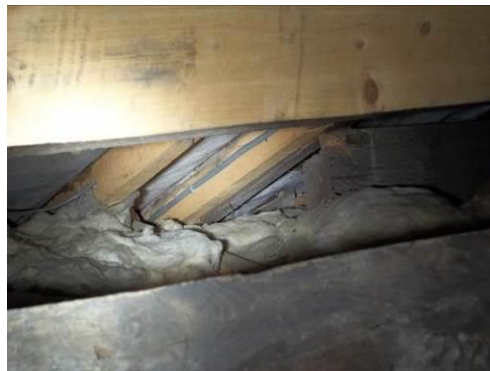
The roof is lined with breathable membrane. The loft is partially boarded and the insulating material extends to the eaves:

There was no evidence to suggest bats had been present.

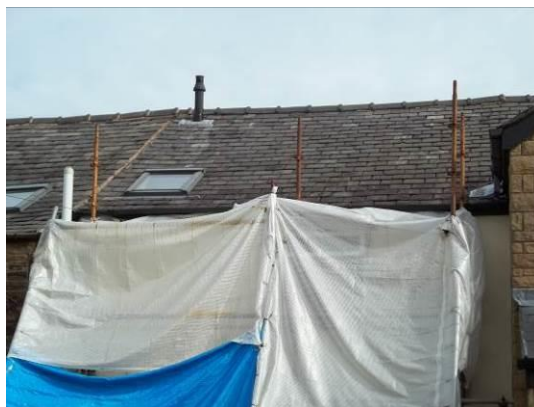
The back wall is absent at ground-floor level so the rear of the property is protected by sheeting attached at eaves level:

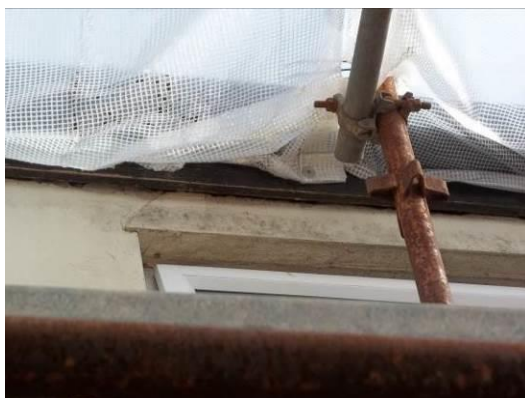
There is bat access available behind the rear fascia and bats can fly in behind the sheeting, though they may well choose not to:

Any lost bat roosting potential at the front eaves should be reinstated as outlined above. Roosting potential at the rear eaves should be maintained. This is likely to also benefit house sparrows, which could also be provided-for via sparrow terracing.

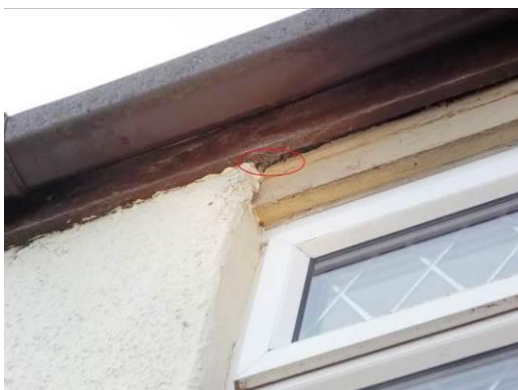
There is access available behind the front fascia too, over the window:

I understand the property will not be re-roofed, but the roosting opportunity to the front fascia will be impacted directly by works to the front wall. The likelihood of this being used by bats is probably sufficiently low that further investigative survey work is unnecessary. Appendix 3 gives the basic criteria for additional survey work being needed. As the available roosting opportunity will be lost to the development, either the fascia should be reinstated with a gap of 15 to 20mms between it and the wall, with access maintained for bats from it to the wall-head, or an integrated bat box should be installed towards the eaves. This would accord with the biodiversity objectives of the National Planning Policy Framework. The existing gap at the rear fascia should similarly be retained.

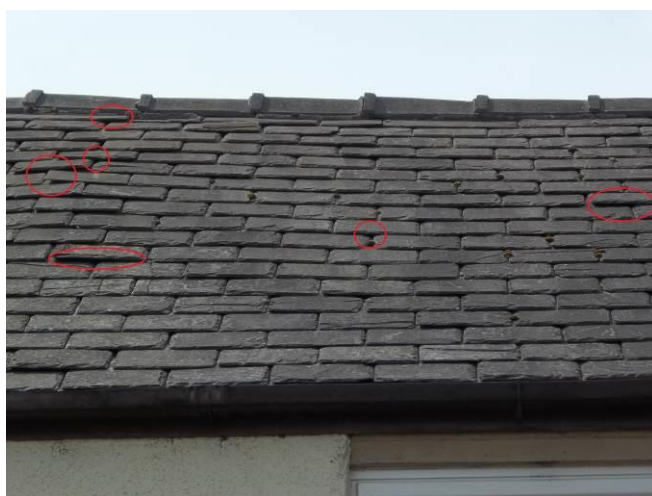
The rear roof is in good condition but there are gaps under slates to the front roof-pitch that would allow bat access:

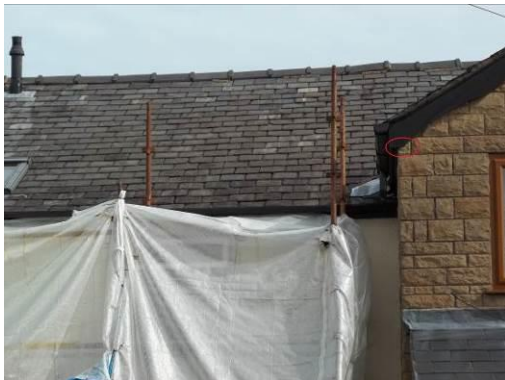
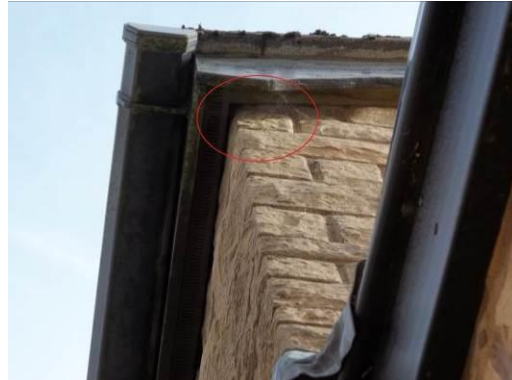
There is bat access available at the soffits of the adjoining property to the south:

It seems neither the rear fascia nor the soffits of the adjoining property to the south will be impacted directly by the development. However it's not impossible that those soffits, and possibly even the adjoining fascia to the north, may be used by a maternity colony of pipistrelles with dependent young in the summer.

The issue would be one of disturbance rather than roost destruction, so if the development will be progressed between the months of May and August inclusive, there should be a precautionary bat activity survey immediately before any work that will generate noise and/or vibration (within around 48 hours, but preferably the night before) to double check there are no bats roosting that might be disturbed by this type of work. Bats are protected from disturbance as well as direct interference.

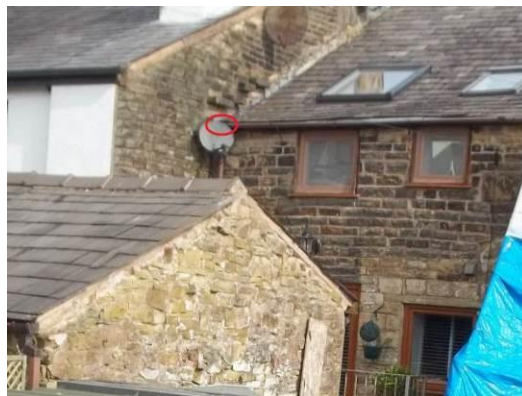
It's likely there's bat access available behind the rear fascia of the property to the north also. Incidentally house sparrows were seen entering at the corner eaves of that property:

Incidentally the house sparrow was noted to be nesting at the eaves of the adjoining house to the north, though at the far end of the property. The client reported some nesting having taken place in association with his own property. This was likely to have been by the house sparrow too. As this species is on the red list of conservation concern, unless it is certain access to nest at the rear wall-head will still be available after the work, it would be a commendable pro-active measure, to provide sparrow terracing at

the eaves. See Appendix 5. Integrated boxes are preferable but wall-mountable boxes are also available. This again would accord with the biodiversity objectives of the National Planning Policy Framework.

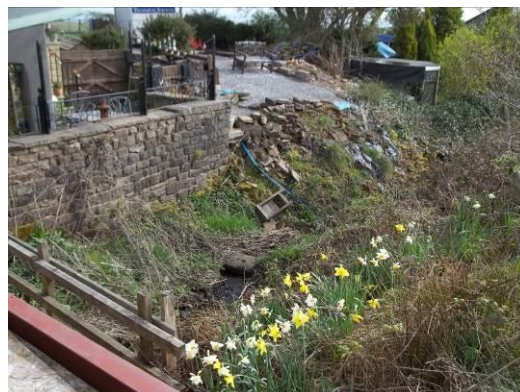
To the rear the property is sheltered at the foot of a slope, with a stream in the bottom:
