## **Westchurch Homes Limited**

### **A Feasibility Study for Development of Soccer Pitches on Land Adjacent to Radcliffe Moor Road, Bradley Fold, Bury.**

**O/002/RMR/1721/R-PL/210917**

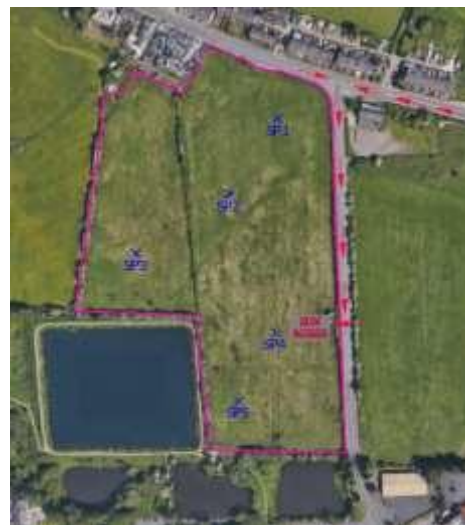
Plate 1: Extent of proposed development area within red line, trial pit locations and site access.

To evaluate soil type and structural condition, 5 soil profiles were excavated at targeted locations (Plate 1) using a spade and hand auger to gain an overall view of the site.

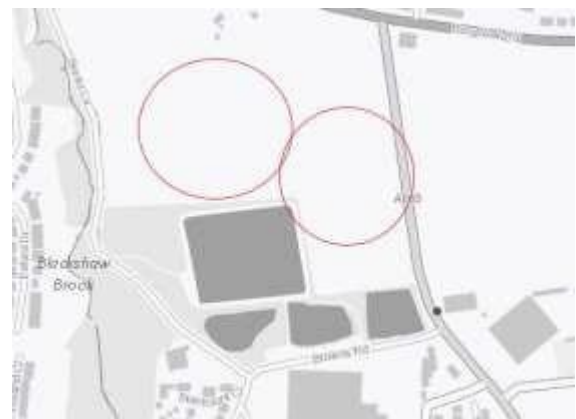
Figure 5: Historical Landfill

The site is not shown to be located in an area formerly used for landfill (Fig. 5) although the GIR records an area on the site was used for a period of time for a refuse tip. This area will need to be inspected during the bulk earthworks operations and potentially some material may require disposing off-site.

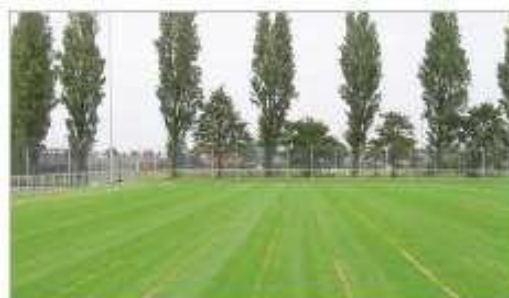
Combined pipe and slit drainage will significantly improve the drainage of most pitches

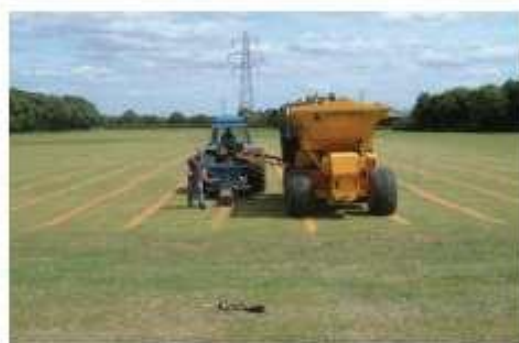
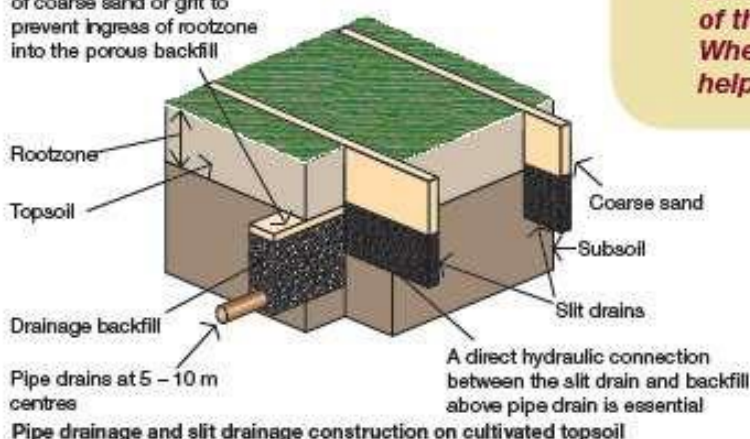
Where coarse porous backfill material is used, it may be necessary to include a 50 mm deep blinding layer of coarse sand or grit to prevent ingress of rootzone into the porous backfill
