Former Mondi Site  
Holcombe Mill  
Bridge Street  
Ramsbottom

Report type: Archaeological Evaluation  
Report No. 4546

**Archaeological Evaluation**

**Report No. 4546**

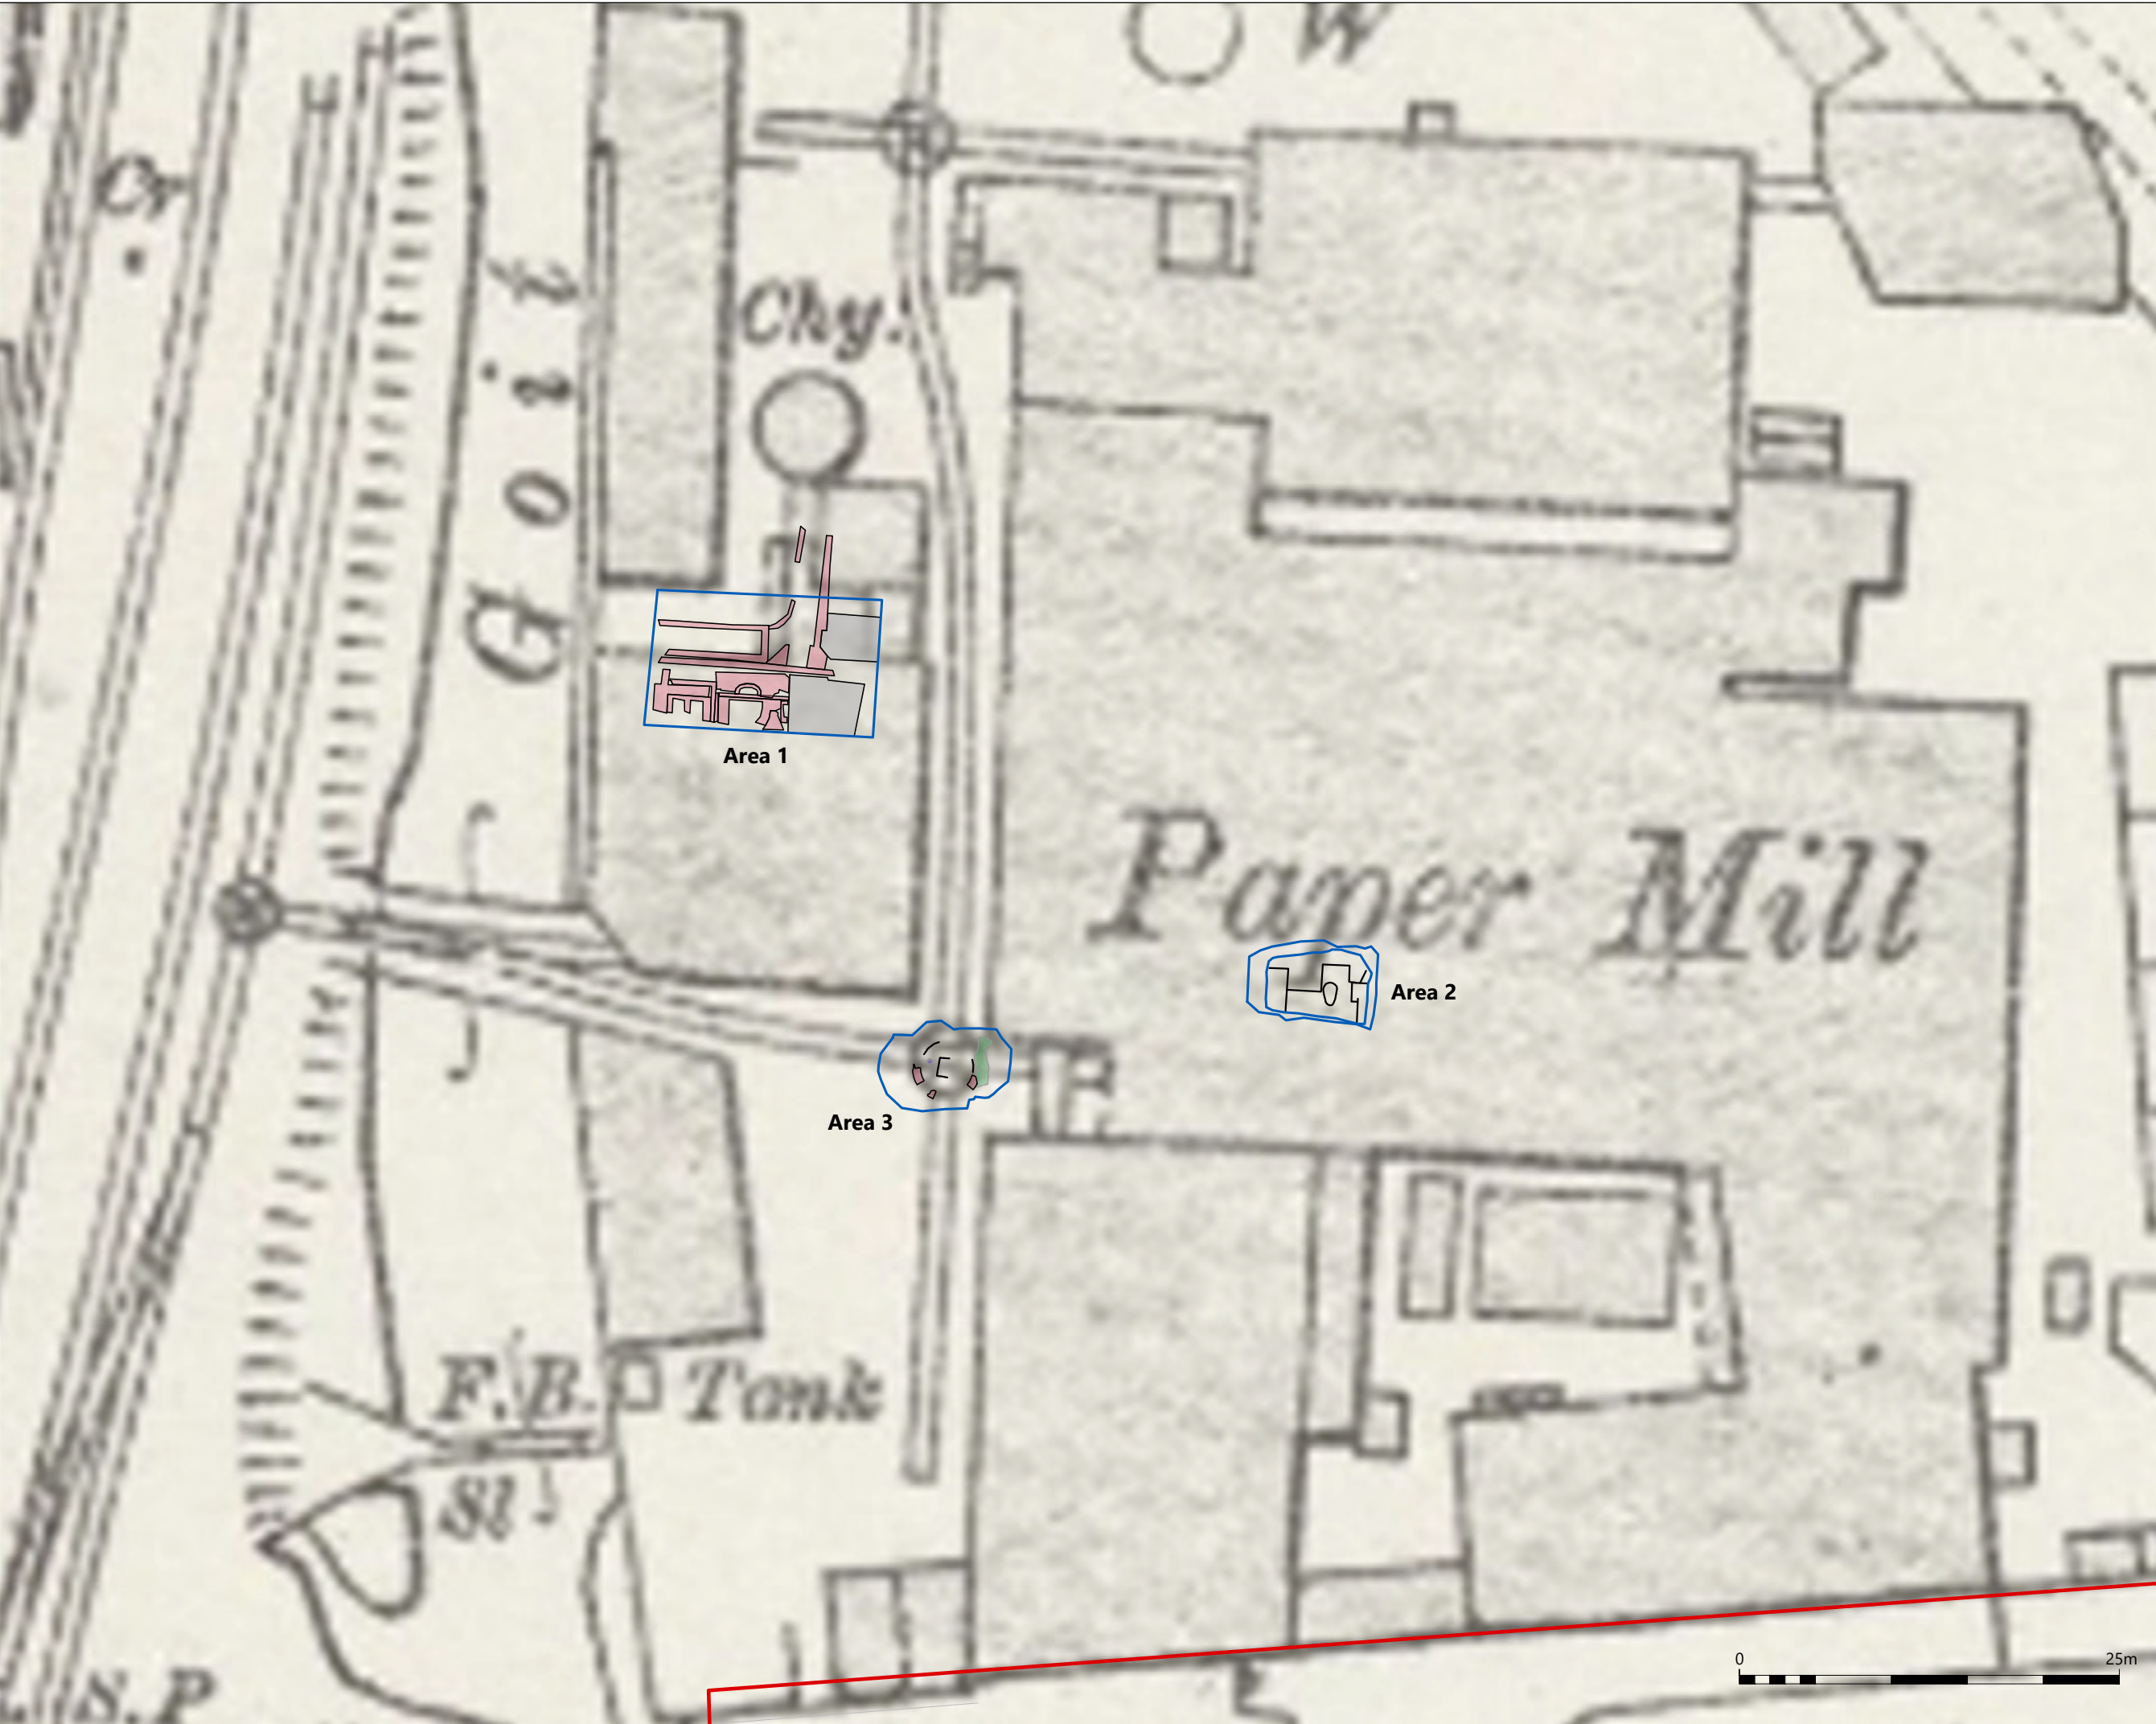
| Report No:<br>4546 | Fig. No:<br>2.1 - 2.3 | |

- Site Boundary
- Trench
- Feature
- Structure
- Concrete Floor Surface
- Modern
- Drain

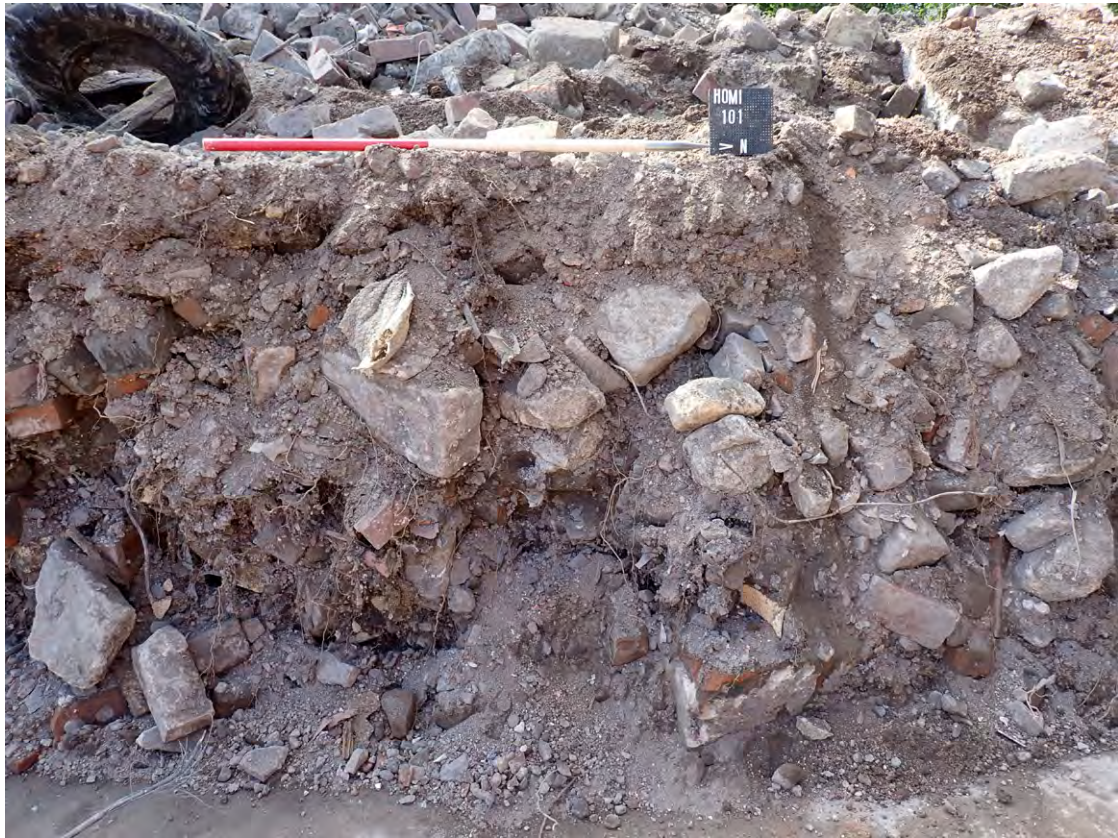
Fig. 4.1: Demolition rubble 101 in section

| Context no. | Type | Length (m) | Width (m) | Height/Depth (m) | Description |
|---|---|---|---|---|---|
| 101 | Deposit | +10 | +5 | 1.2-1.6 | Demolition backfill deposit covering the whole area. Formed through the demolition of the mill site. Mid brownish grey in colour that was very firmly compact. 80% of this deposit was rubble and broken building material. |

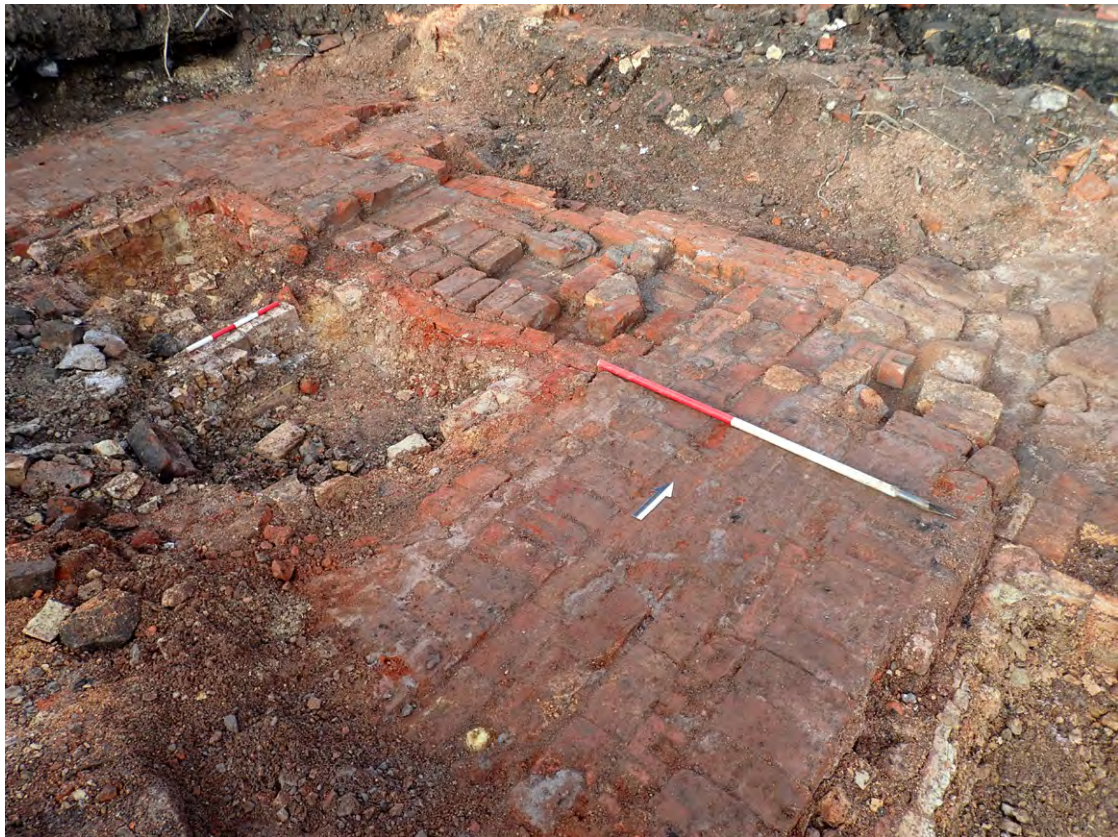
Fig. 4.4: Chamber 123 and foundation 115/118 at rear of setting A

| Context no. | Type | Length (m) | Width (m) | Height/Depth (m) | Description |
|---|---|---|---|---|---|
| 123 | Structure | >1.28 | 2.65 | >0.24 | Brickwork forming the north end of the bottom flue of a setting for a boiler. Constructed from red bricks to the rear, with a lining of yellow firebricks to the exposed faces. The firebricks are in very poor condition, having been degraded by heat and chemical attack. Retains a north/south orientated central partition of firebricks which separated the two halves of the end of the bottom flue. |

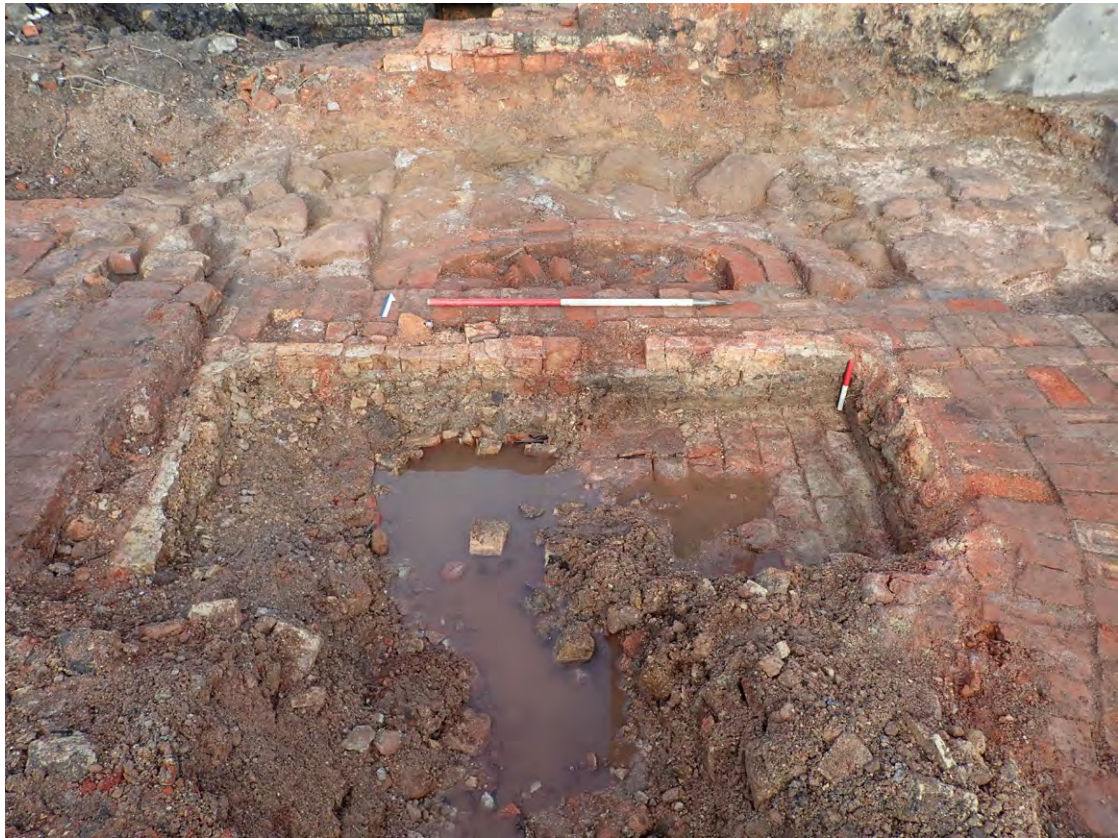
Fig. 4.5: Firebrick lined chamber at rear of setting B

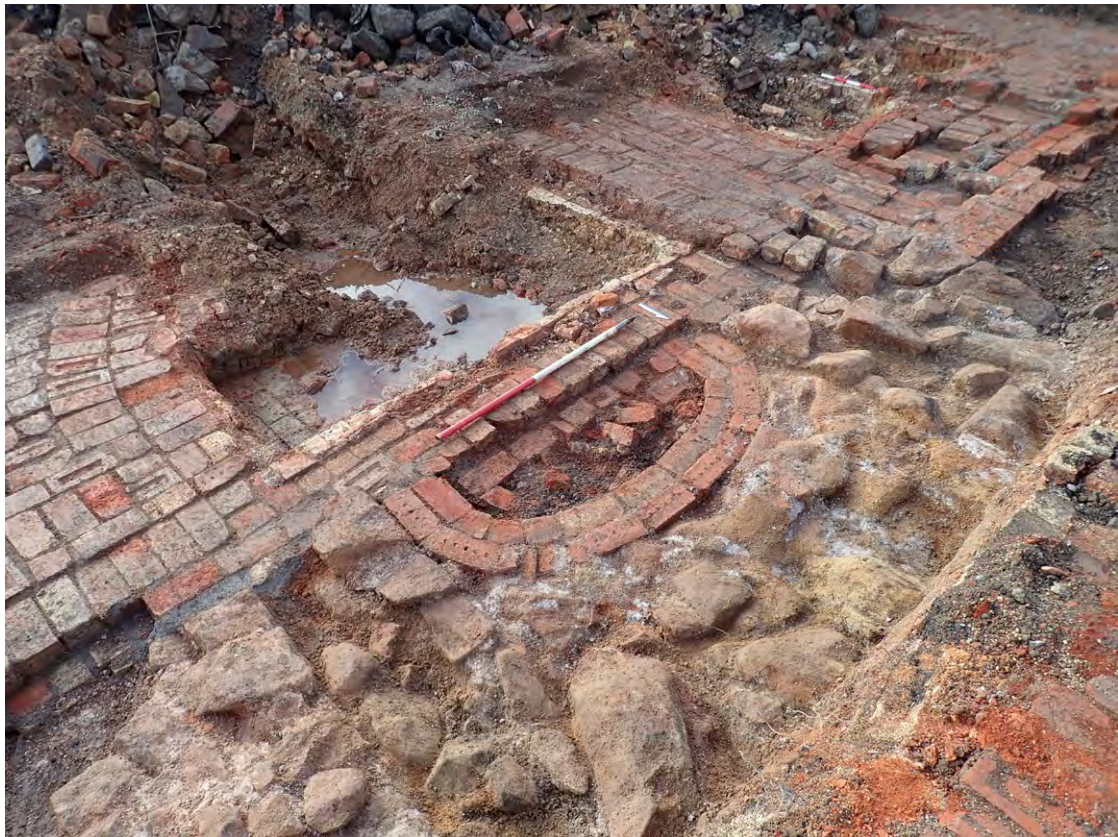
Fig. 4.8: Stonework 110 and brickwork 114 at north end of setting C

| Context no. | Type | Length (m) | Width (m) | Height/Depth (m) | Description |
|---|---|---|---|---|---|
| 110 | Structure | 4.92 | 1.60 | | Structure constructed from sandstone rubble bedded in light pink lime mortar. Appears to underlie the east/west foundation of the final phase boiler house, so possibly forms part of an earlier foundation. |

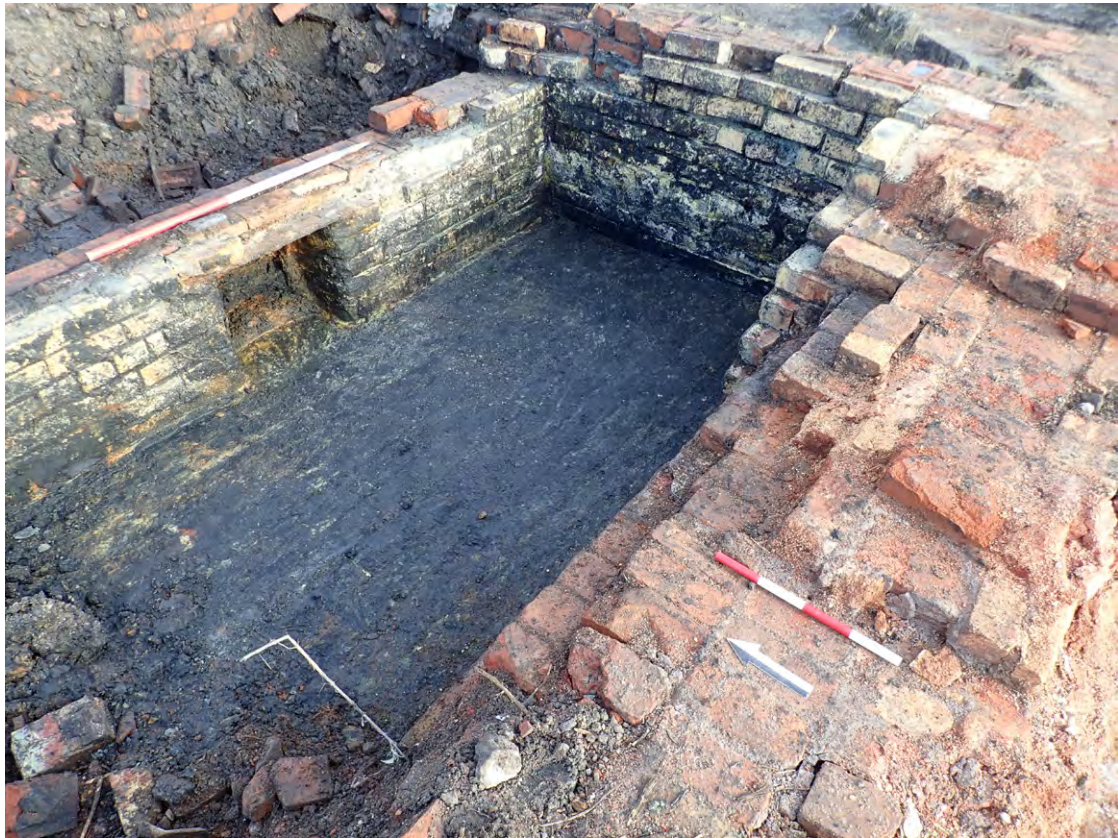
Fig. 4.9: View looking NE across the east end of economiser chamber 117

west end of the structure lay beyond the edge of the trench) with a floor surface at 124.64m aOD. The internal elevations and floor of **117** were lined with light yellow firebricks which retained a surface coating of ash, and a single fragment of a part of a water tube scraper mechanism was recovered from the rubble backfill within the economiser house. This indicated that **117** represented the soot chamber, comprising the bottom part of the economiser house. External access to carry out inspections, cleaning, maintenance and repairs to the economiser unit was via a 0.50m wide hatch in the north wall of **117** (Fig. 4.10). The opening through **117** was supported by a metal lintel and was sealed by a metal framed door mounted in the north side of the wall. The area on the north side of the economiser house featured an external concrete floor surface at 124.61m aOD.

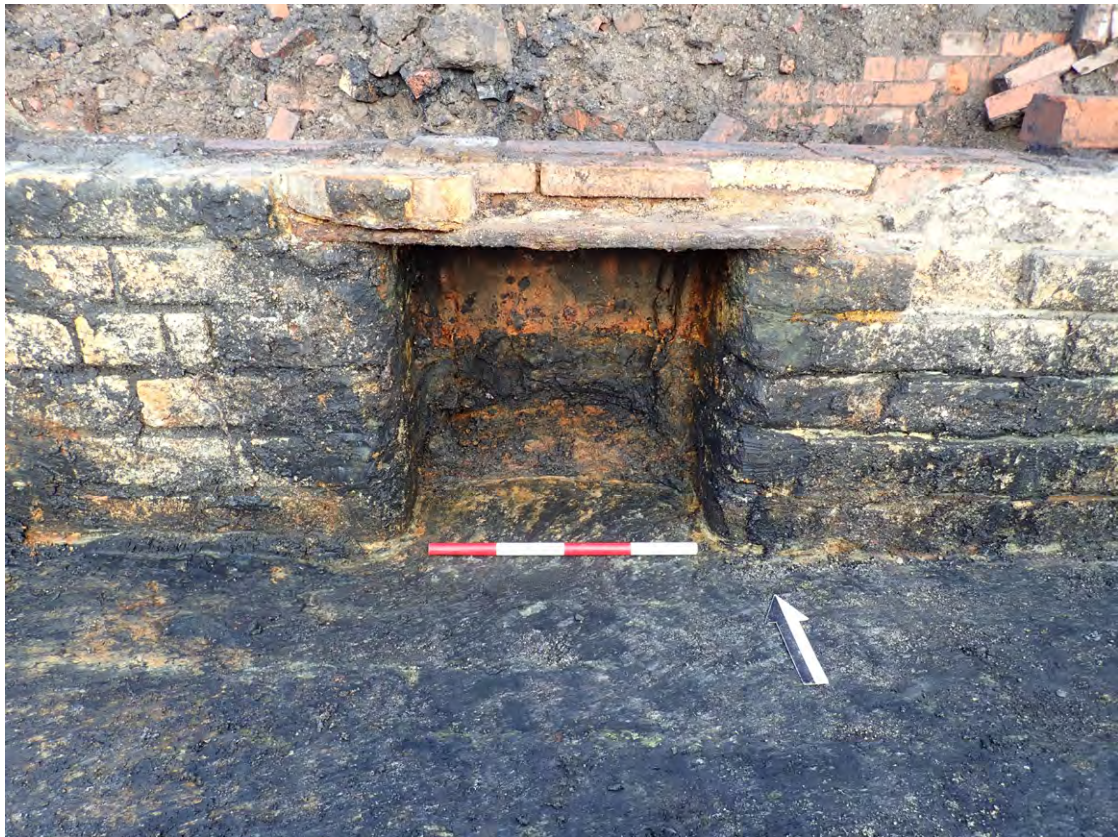
Fig. 4.10: Access hatch in south facing internal elevation of economiser chamber

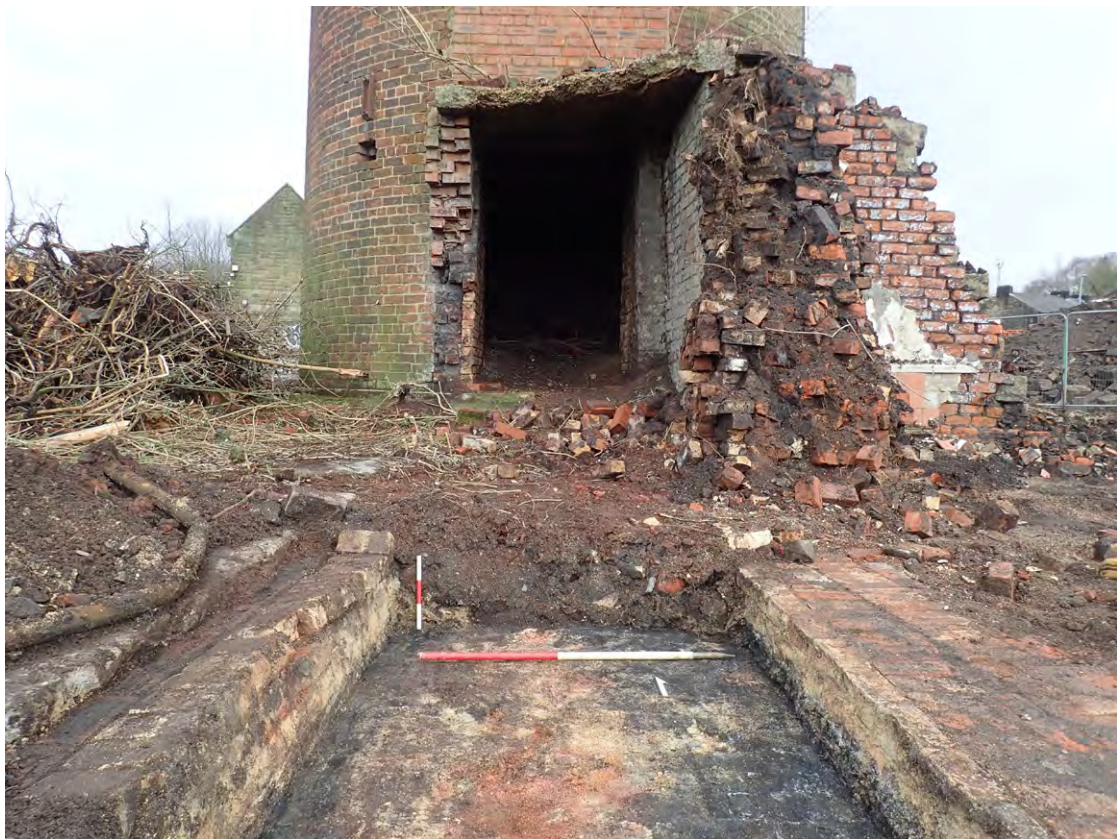
Fig. 4.13: View looking north along main flue towards the chimney stack

Evidence suggestive of a modification to the main flue which connected the boiler house to the chimney was observed at the base of the stack. The opening in the base of the chimney from the main north/south orientated flue was capped by a flat, reinforced concrete roof at approximately 2.50m above ground level. Brickwork had been inserted into the south elevation of the chimney above the concrete roof which indicated that the opening at the north end of the flue system had at one time been almost double the height it was during its final phase of operation. The chimney is known to have been lowered in height on two occasions, which may tie in with the modifications seen at the base of the stack; a lessening in boiler requirements, and the shortening of the stack would be a suitable explanations for the reduction in size of the internal cross section of the main flue.

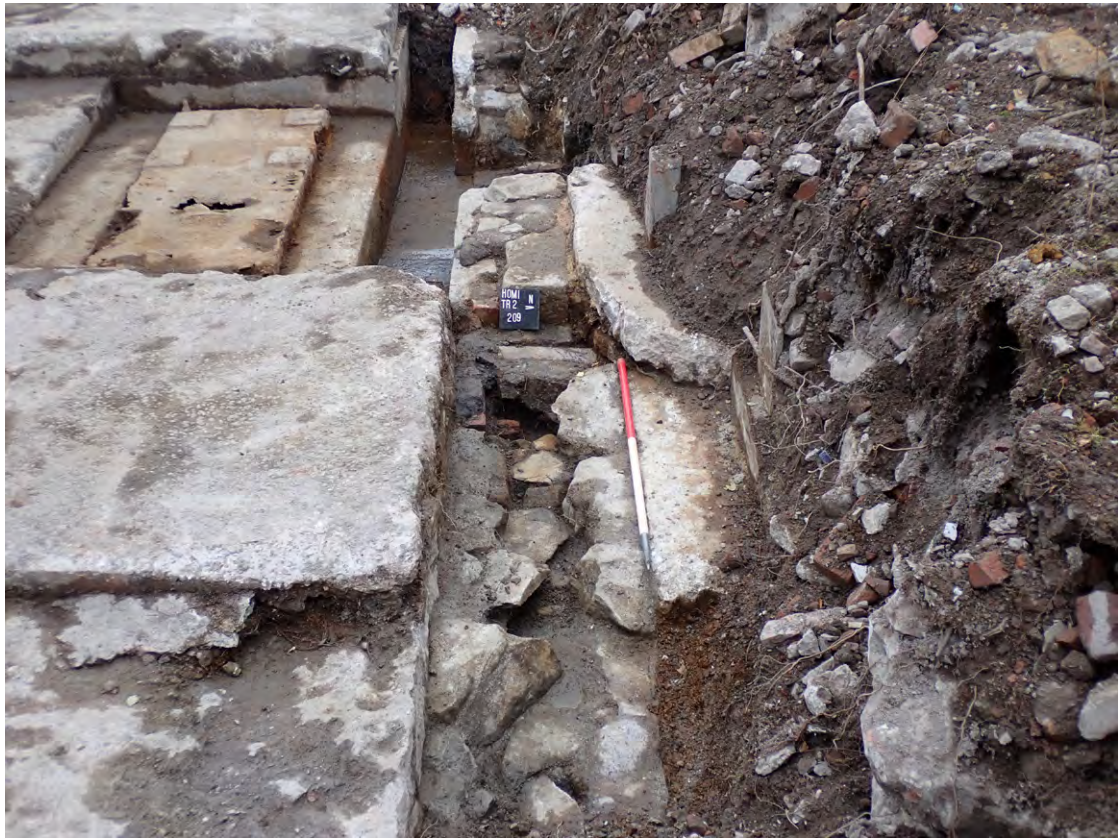
Fig. 4.15: View looking west along foundation 209

| Context no. | Type | Length (m) | Width (m) | Height/Depth (m) | Description |
|---|---|---|---|---|---|
| 209 | Structure | 7.3 | 0.6 | 0.4 | East/west orientated linear foundation running across the northern end of Area 2. Partially truncated by culvert (210). Appear to relate to an earlier phase of the building and was demolished to floor level with the addition of the later concrete floors. Constructed from sandstone blocks, those on the faces of the wall were dressed and bonded with lime mortar. Probably supported an interior wall. The fact that it was replaced by concrete blocks housing iron stanchions suggests this wall wasn't simply a partition but probably added to the structural integrity of the building. |

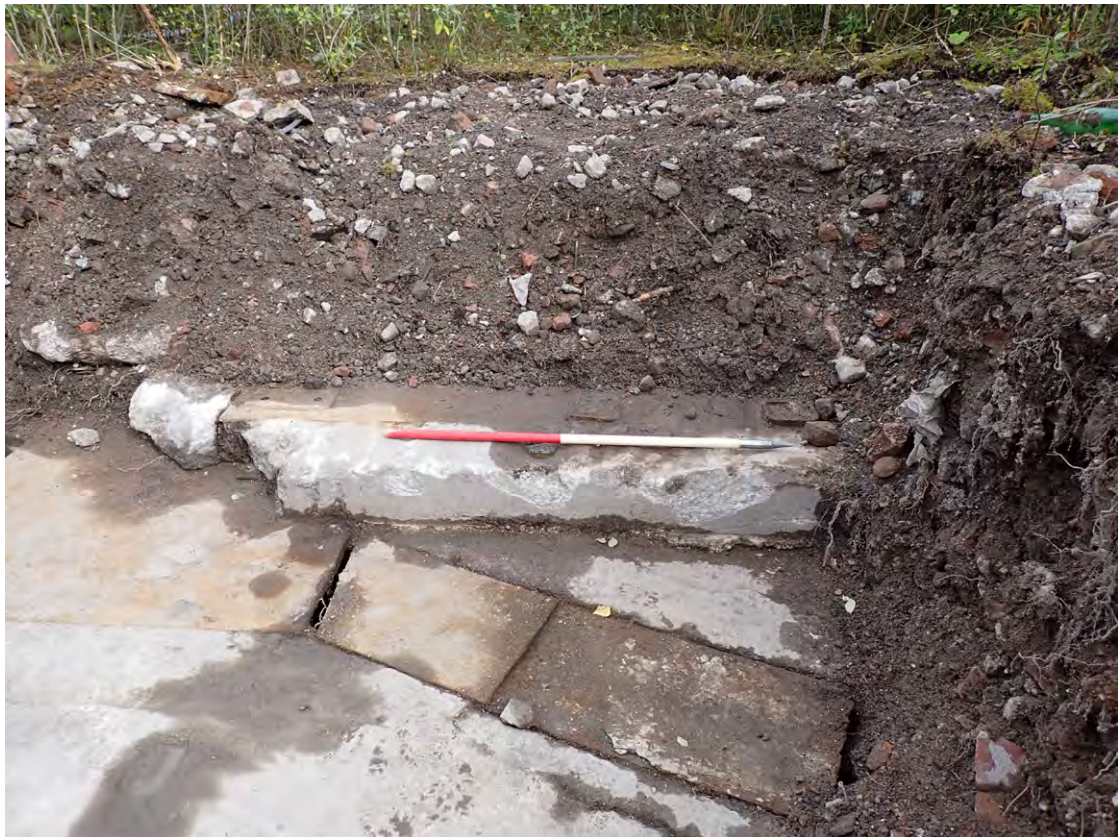
Fig. 4.16: View looking east at concrete floor 202 and culvert 203

| Context no. | Type | Length (m) | Width (m) | Height/Depth (m) | Description |
|---|---|---|---|---|---|
| 203 | Structure | 3.36 | 0.38 | 0.43 | This culvert was linked to the sites industrial process. The feature was moulded between the concrete slabs (202) and (204) with vertical sides and a very flat base. It ran on a northeast-southwest alignment diagonally through the eastern side of the area, it was covered by iron plates roughly 0.8m long and the same width as the culvert. the base of the feature was also lined with an iron plate. a strong smell of oil was noted during its excavation. |

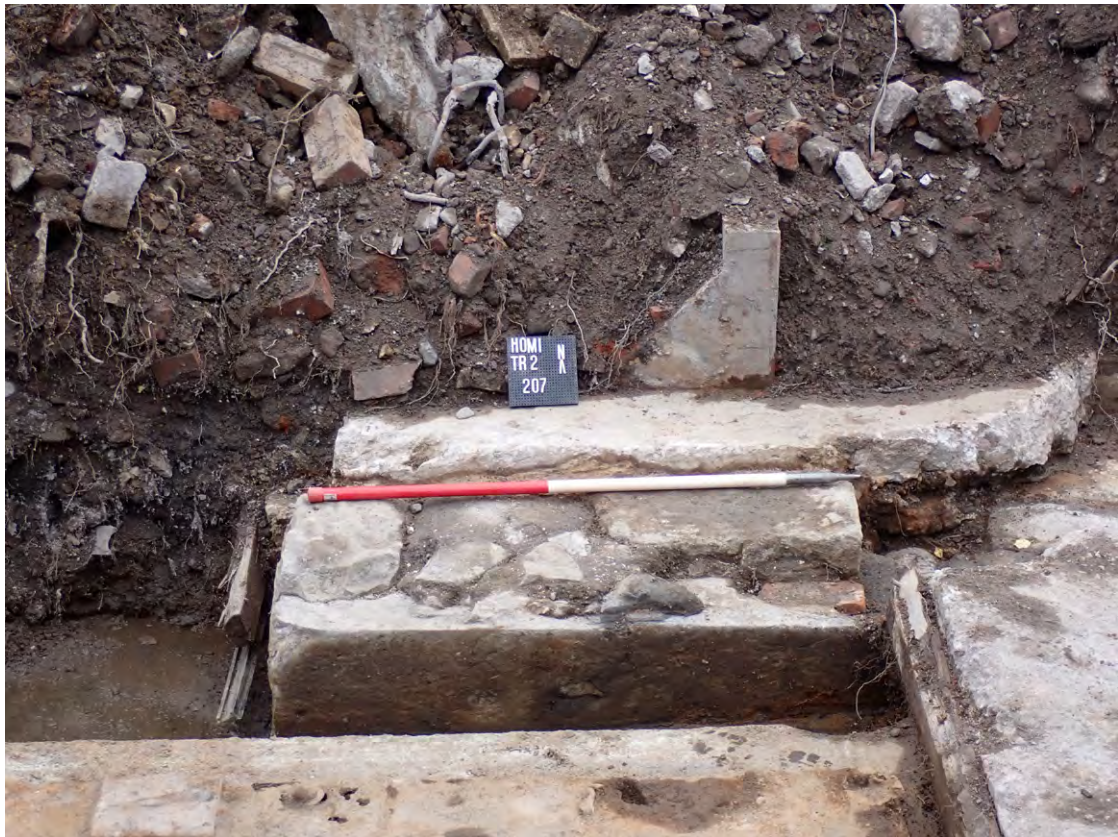
Fig. 4.18: Stanchion base 207 at the north edge of Area 2

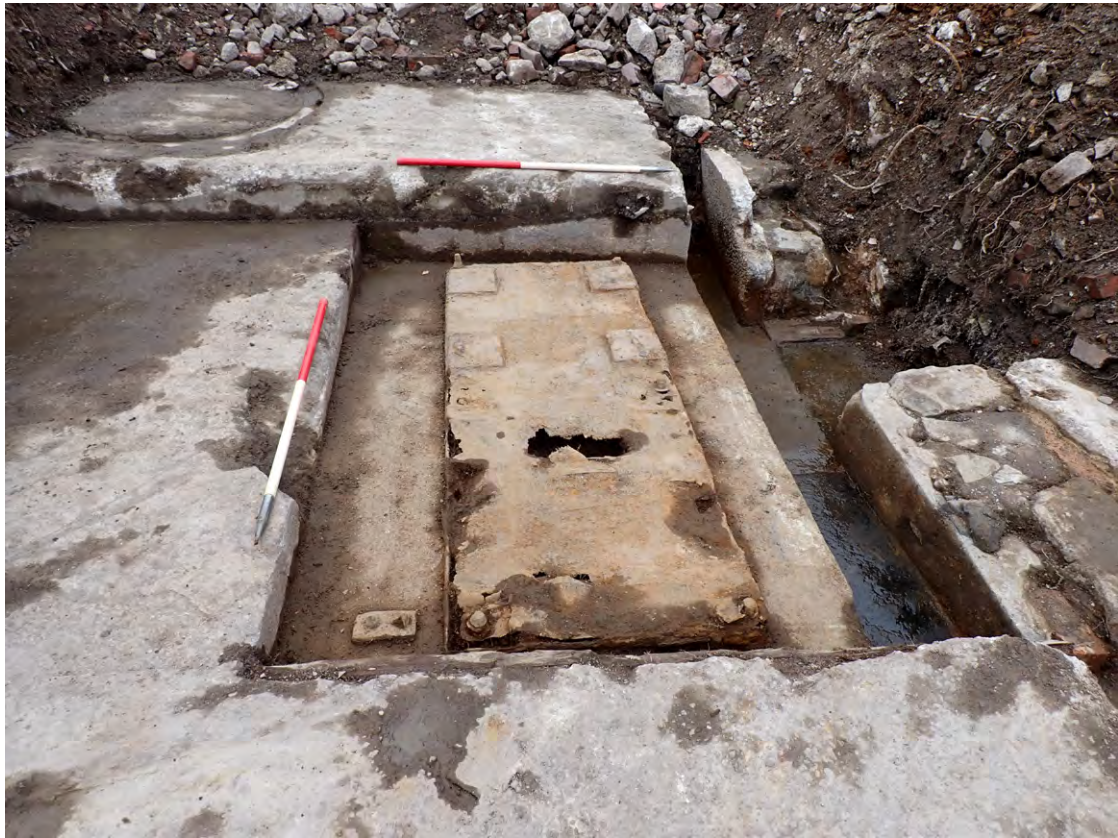
Fig. 4.19: Concrete and iron structure 205

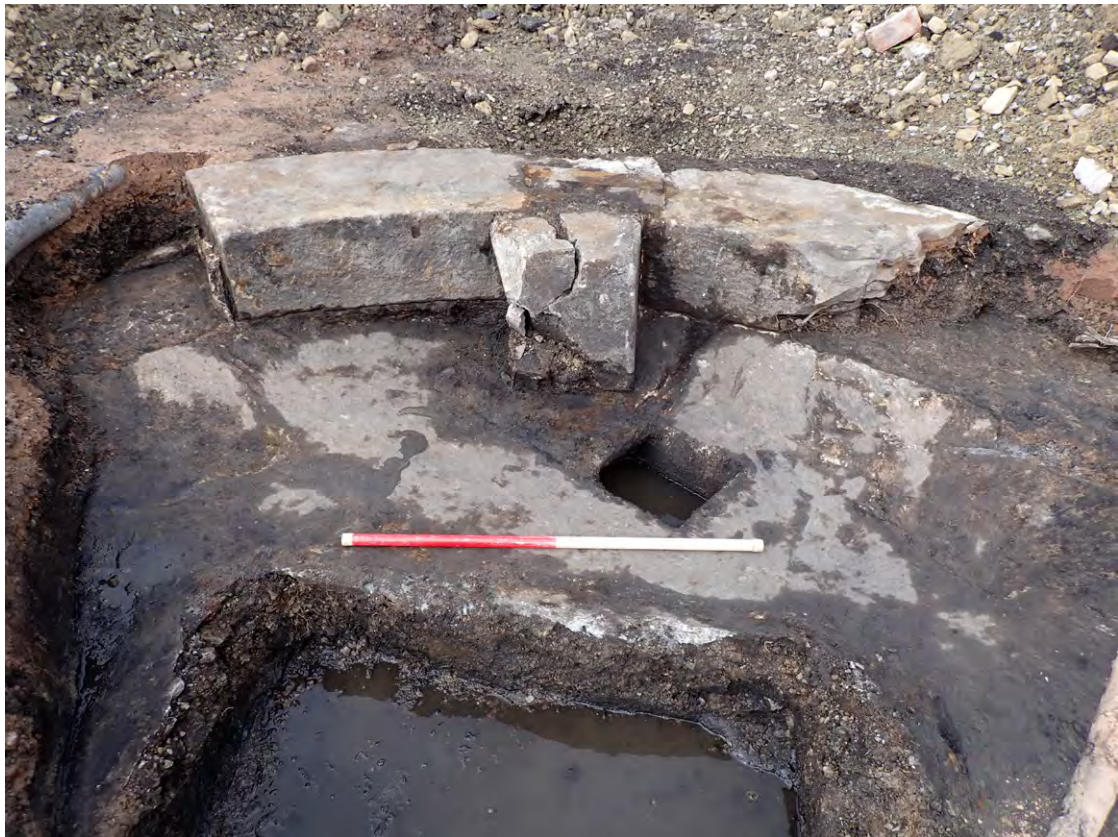
Fig. 4.22: Rim of turntable 304 with base 305, incorporating square drain

The most complete section of the upper ring of the turntable was on its western side (Fig. 4.22) as the central part of the structure was heavily truncated by services and the eastern side had been damaged by later concrete structures associated with the expansion of the paper mill. The stone ring (**304**) was sat on top of a broad, shallow concrete bowl (**305**) which formed the majority of the surviving structure. The bowl had a very gradual gradient sloping from the edge down to the central flat plain. The sides and base of the bowl incorporated two features. The first being a 0.50m deep vertical shaft measuring 0.32m by 0.30m in cross section, located over a linear drain. The second feature was a recess in the centre of the bowl that was 0.19m deep, 1.34m wide north/south by at least 0.71m wide east/west (Fig. 4.23). This recess had contained the mechanism featuring the central pivot that allowed the turntable to rotate.

| Context no. | Type | Length (m) | Width (m) | Height/Depth (m) | Description |
|---|---|---|---|---|---|
| 304 | Structure | - | - | 0.37 | Stone ring that made up the top part of the turntable structure. Well faced and well cut sandstone that was a mid to dark grey in colour, possibly stained through industrial use. Heavily damaged due to being truncated to the west by later concrete buildings and through the centre by modern services. |

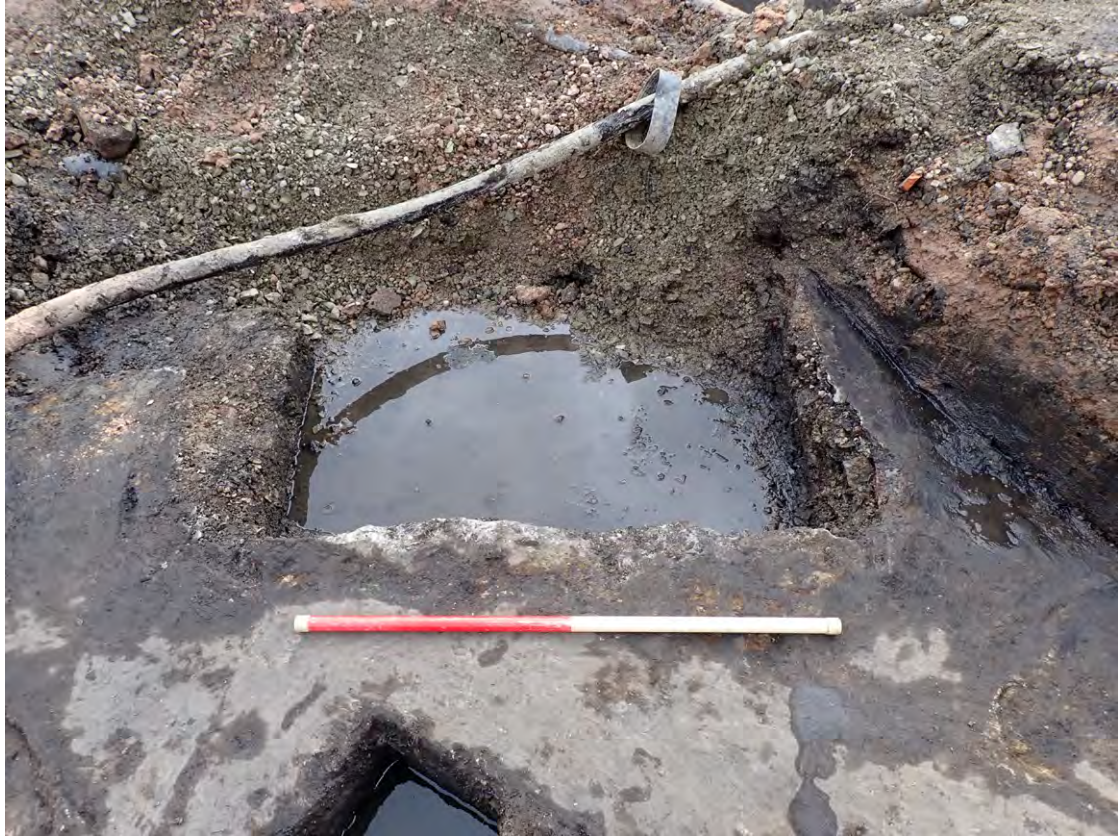
Fig. 4.23: View looking east at the recess in the centre of concrete bowl 305
