**Westchurch Homes**

**REMEDIATION STRATEGY**

**Land at Radcliffe Moor Road, Bolton**

**REPORT No: 20WCH011/RS**

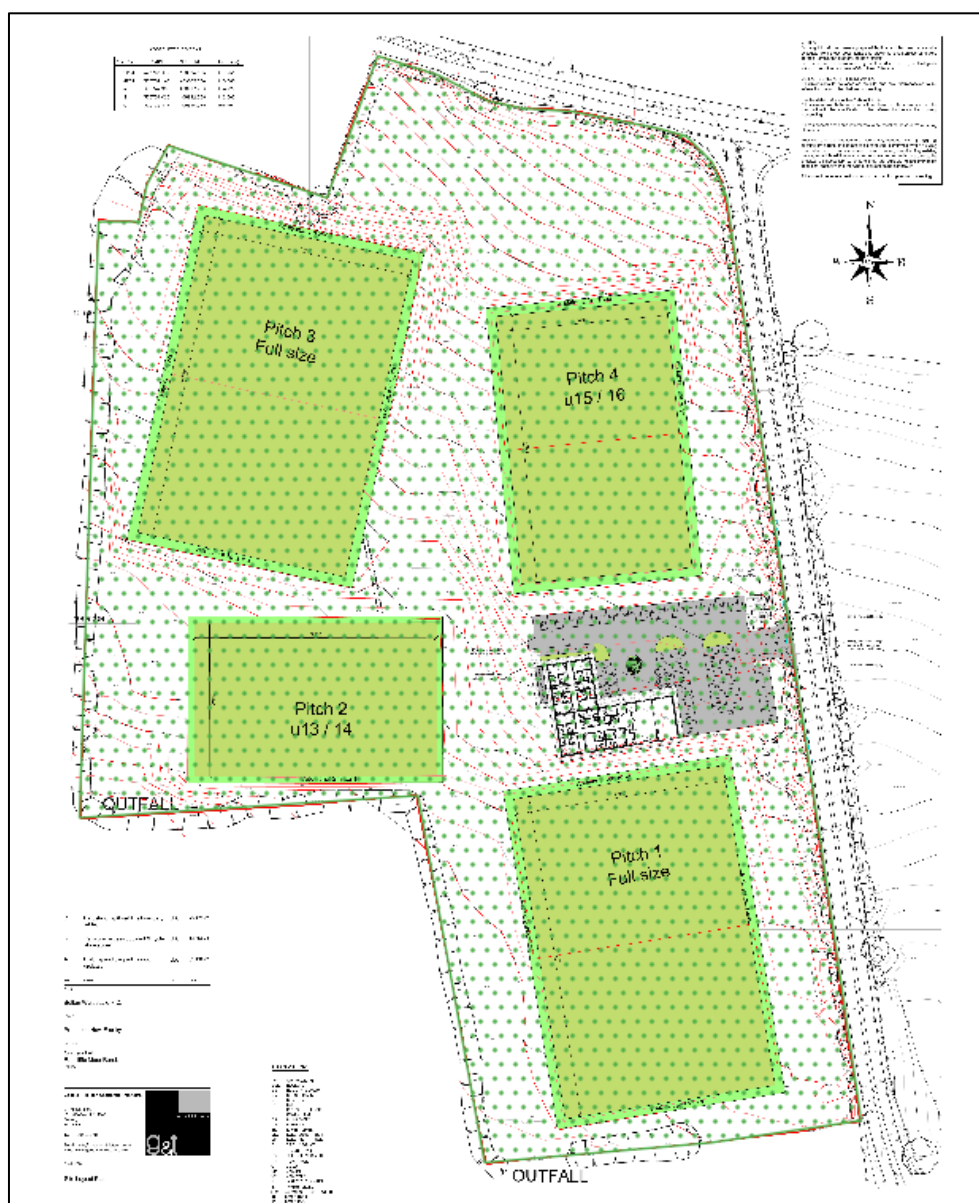
The below plan shows where the 300mm growing medium is required in green polkadot hatch, it is anticipated that the construction layers of the playing pitches will likely be deeper;

Due to the lack of contamination encountered from the site investigation works and sampling only a 300mm clean and inert growing medium has been recommended for installation with soft landscaped areas, depth validation of the cover system will be required.
