## Phase I & II Geo-Environmental Assessment

ASDA Pilsworth  
Pilsworth Road  
Bury  
BL9 8RS

EPS Reference Number: UK23.6302b

Date Issued: 2<sup>nd</sup> June 2023

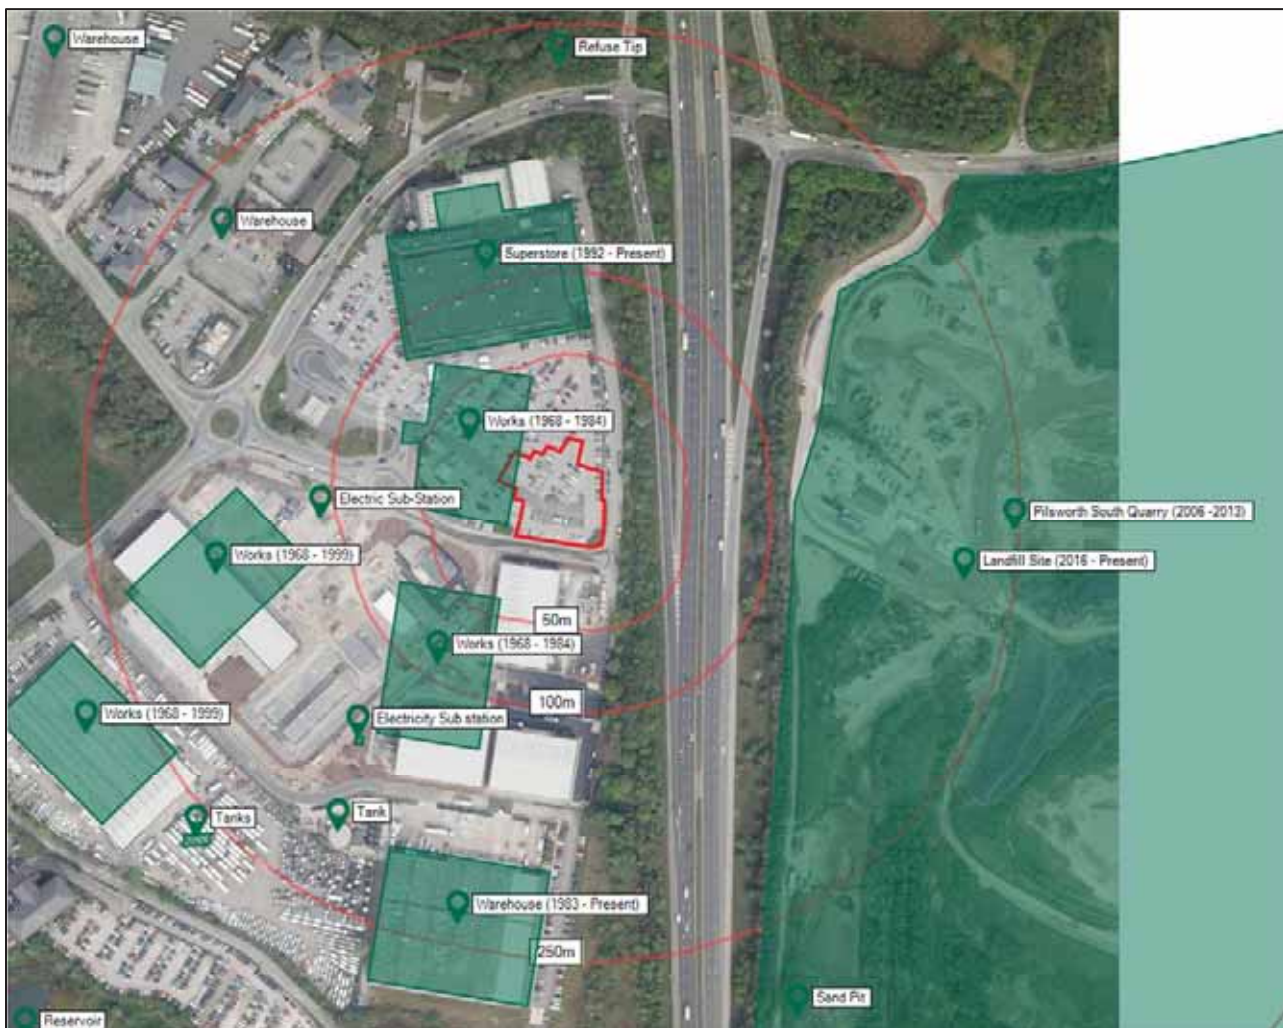
A summary of historical map data from 1854 to 2023 is provided below and copies of relevant historic maps and any others examined during the investigation are included in this report as Appendix F. A map detailing historic features in the area surrounding the site is displayed below.

- Earliest mapping from the 1850s shows the site to be undeveloped, while the surrounding land has multiple sand pits and a few 'Works' and 'Mills' and associated reservoirs. By 1968, a building named 'Works' is seen to be encroached onto the site boundary. At the same time as this, three additional 'Works' buildings are also seen to have been developed within 250m of the site.
- The current ASDA Superstore was erected in 1992. In the surrounding area to the east of the site is Pilsworth South quarry that was developed into a landfill around 2016. A further quarry that has presumably been infilled is also located north east of the site, mapped as 'Sand Quarry'.
- The site is currently part of the active car park associated with the ASDA Superstore.

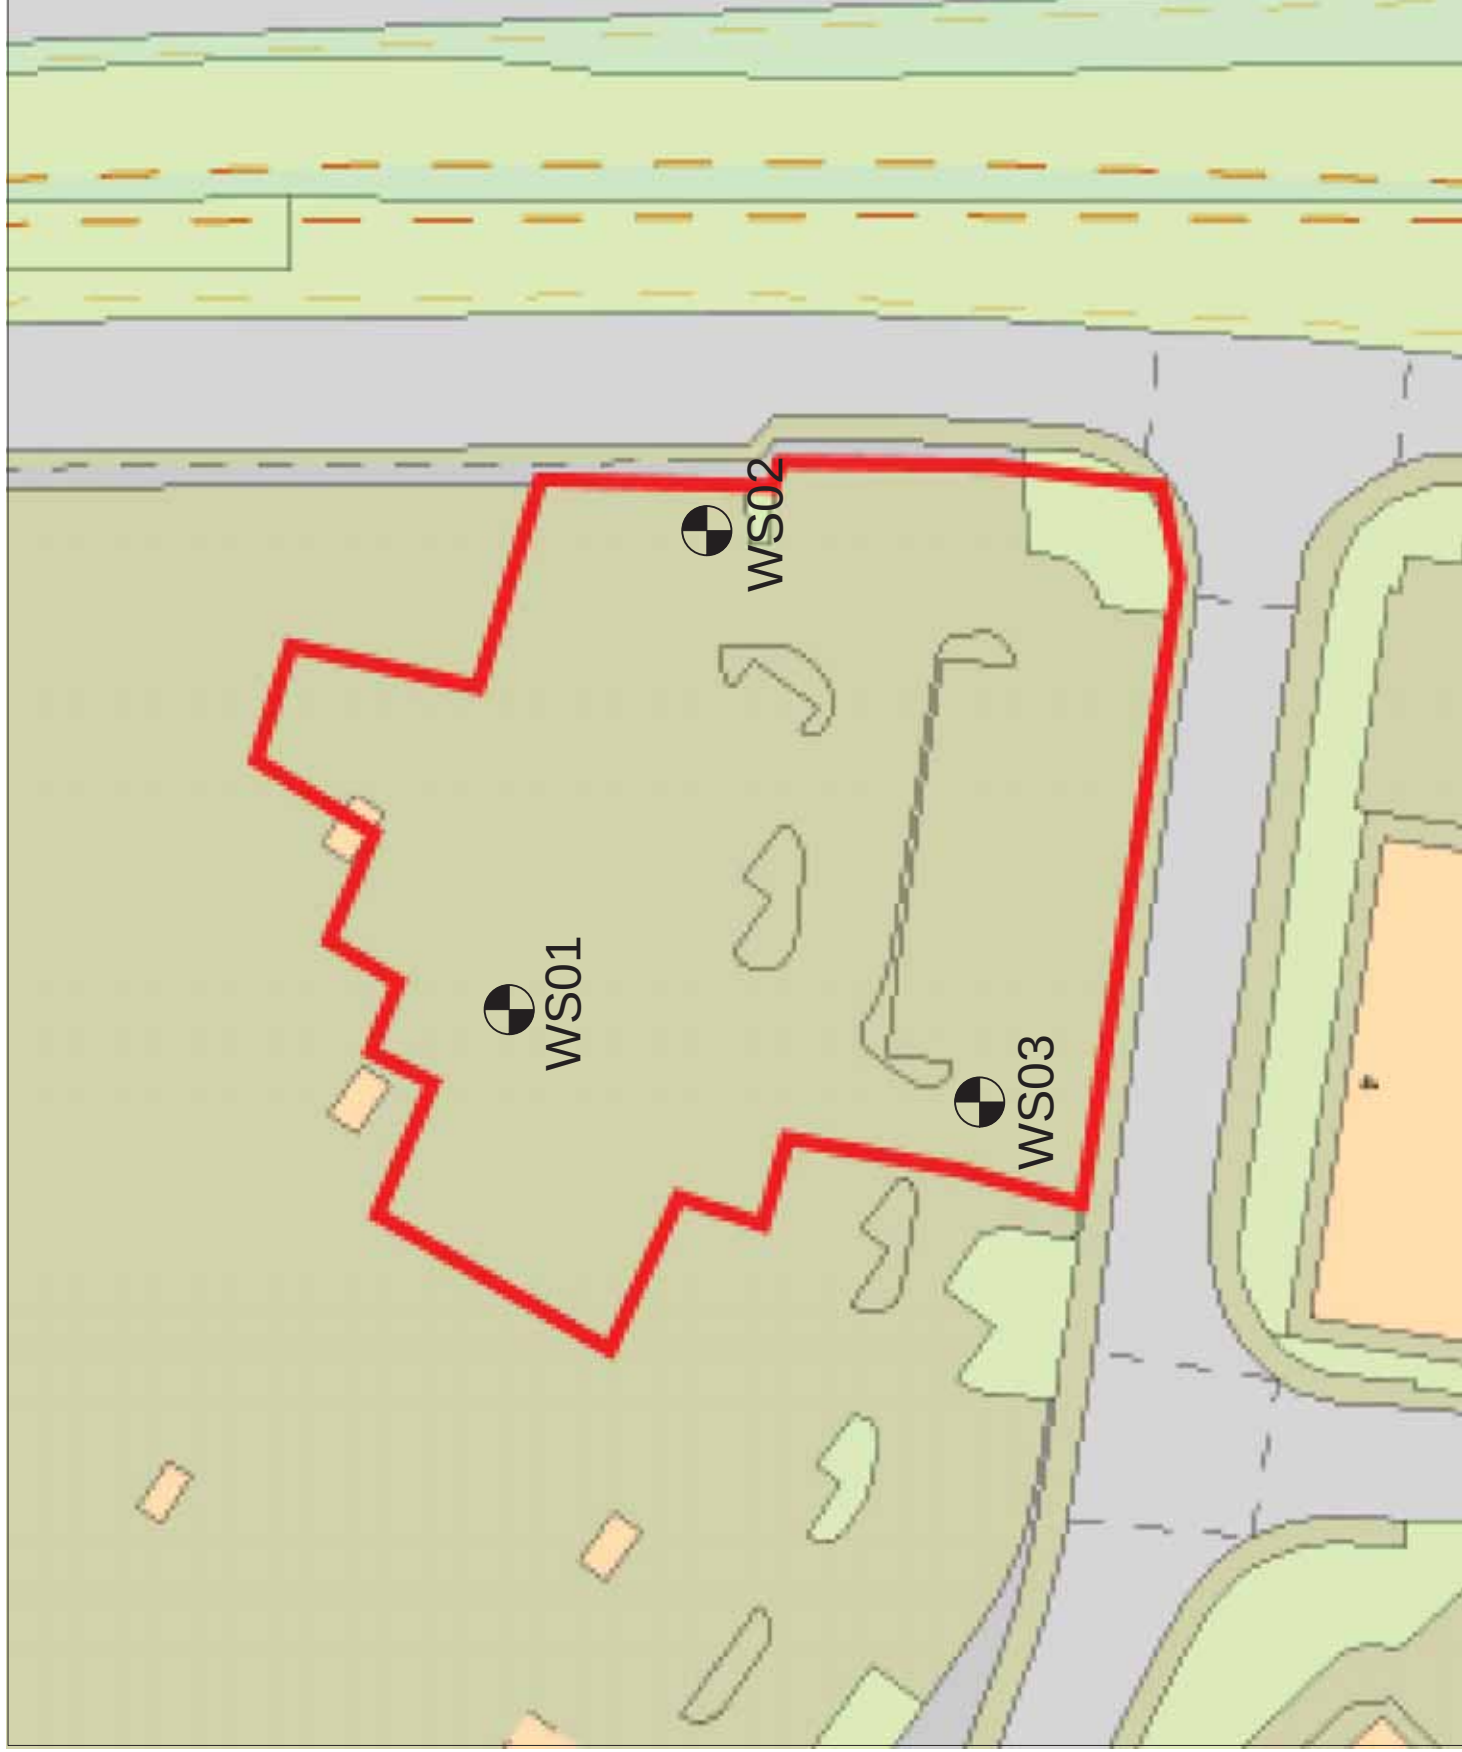
SITE BOUNDARY

EPS WINDOW SAMPLE BOREHOLE

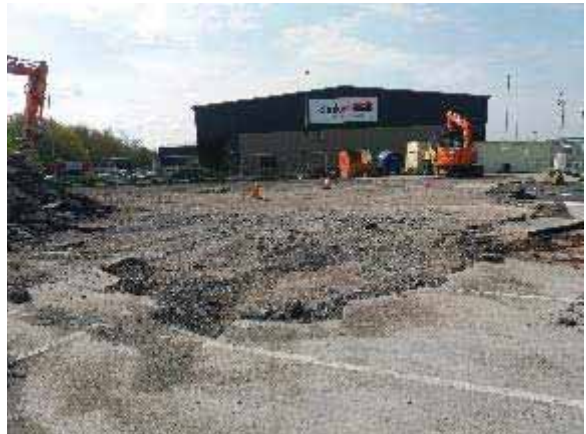
| <p>Photo 1: View facing west across site</p> | <p>Photo 2: Location of WS02</p> |

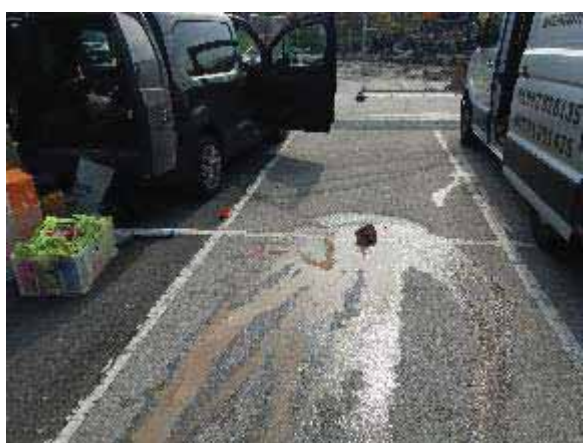
| <p>Photo 3: Location of WS03</p> | <p>Photo 4: Soils recovered from WS02</p> |

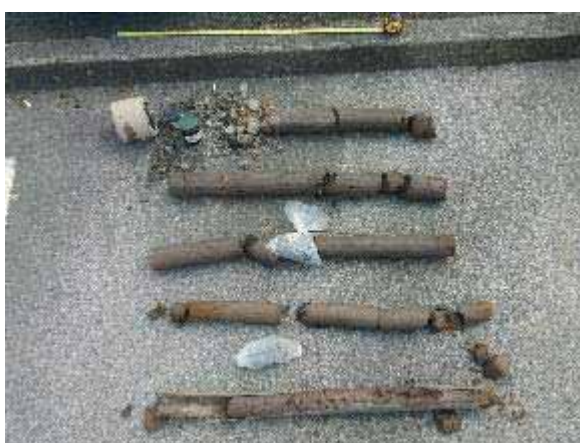
An initial 10-15cm asphalt hardstanding was cored through at each of the three locations. Beneath this at all locations a grey/brown slightly sandy slightly clayey gravel subbase material was observed with tarmac and concrete fragments included. Some variation was observed noted beneath this subbase material. WS02 progressed directly into the natural superficial Glacial Deposits whilst both WS01 and WS03 had an additional thickness of made ground, observed to be black/brown sandy clayey gravel with significant red brick fragments included.

In all locations beneath the made ground, soils interpreted as the mapped superficial Glacial Deposits were encountered. These were found to be soft to firm/firm, slightly sandy slightly gravelly clays. The gravels ranged from fine to coarse in size.

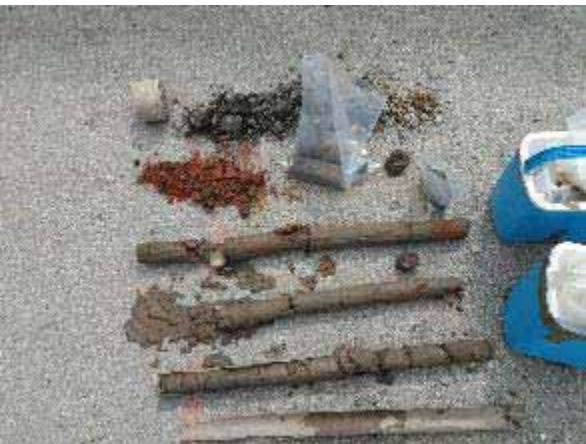
| <p>Photo 5: Soils recovered from WS03</p> | <p>Photo 6: View of Heras Fencing and stockpile of hardstanding</p> |
