## BURY FUSILIERS MUSEUM, CHIMNEY/TOWER REPAIRS

Design, Access & Heritage Impact Statement.  
Chambers Conservation Ltd, December 2025.

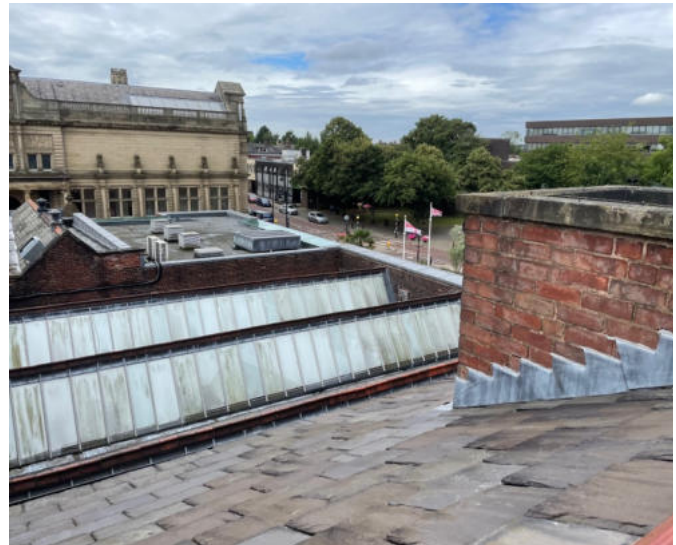
02 General view across the roofs, towards the new entrance. Note the weaving shed north-light roof and the art gallery in the background.

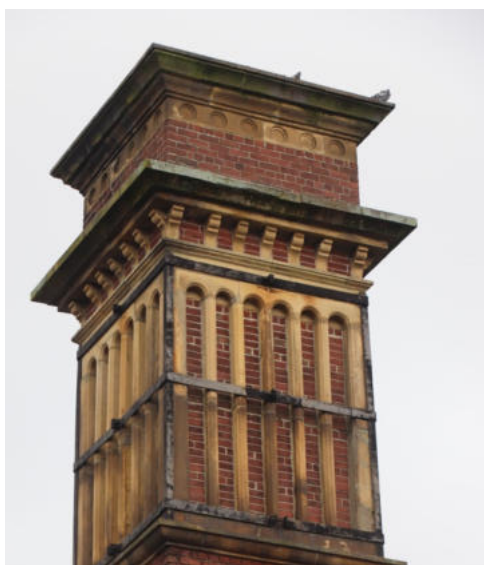
**03** View of the cornice and decorative stonework at high level. Note unsightly staining and corrosion of metal strapping.

1. Removal of corroding metal (external strapping)
2. Removal of corroded metal bed-joint reinforcement.
3. Stonework repairs (indents) to spalled areas and sections with cementitious mortar repairs.
4. Repointing in lime mortar.
5. Small areas of lime mortar repairs to sound stonework to enable water to shed effectively.
6. Internal pointing and localised brickwork repairs.

The works will allow the removal of the unsightly metal strapping, bed joint reinforcement and replace cementitious mortars with lime. Overall the works will achieve a **Highly Beneficial** impact, through enhancing both the aesthetic value and historic value through removal of the unsightly later strapping and through the protection of the internal plasterwork and detail.

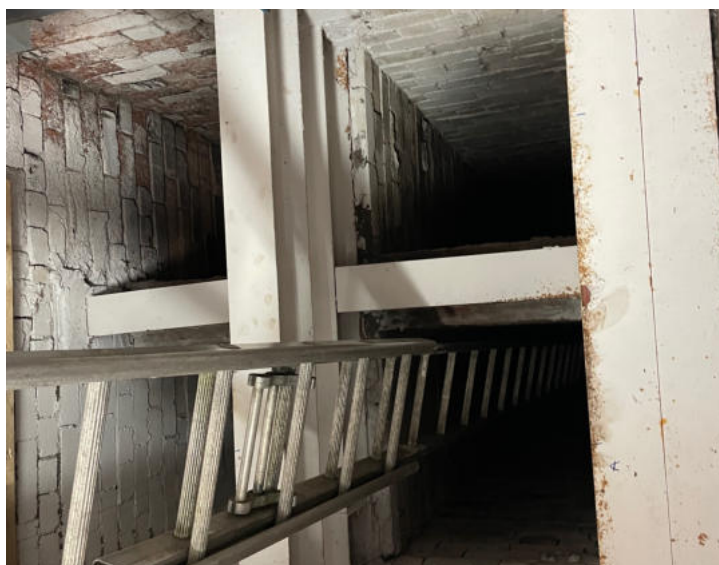
**04** Internal view of the chimney/tower, showing the steelwork installed to support the brickwork separating the different flues (installed when a lift was installed)
