## **Fletcher Fold Bury Ground Investigation Report**

On behalf of Bolton at Home

Report 23-12-115972/GIR1 Rev B

April 2024

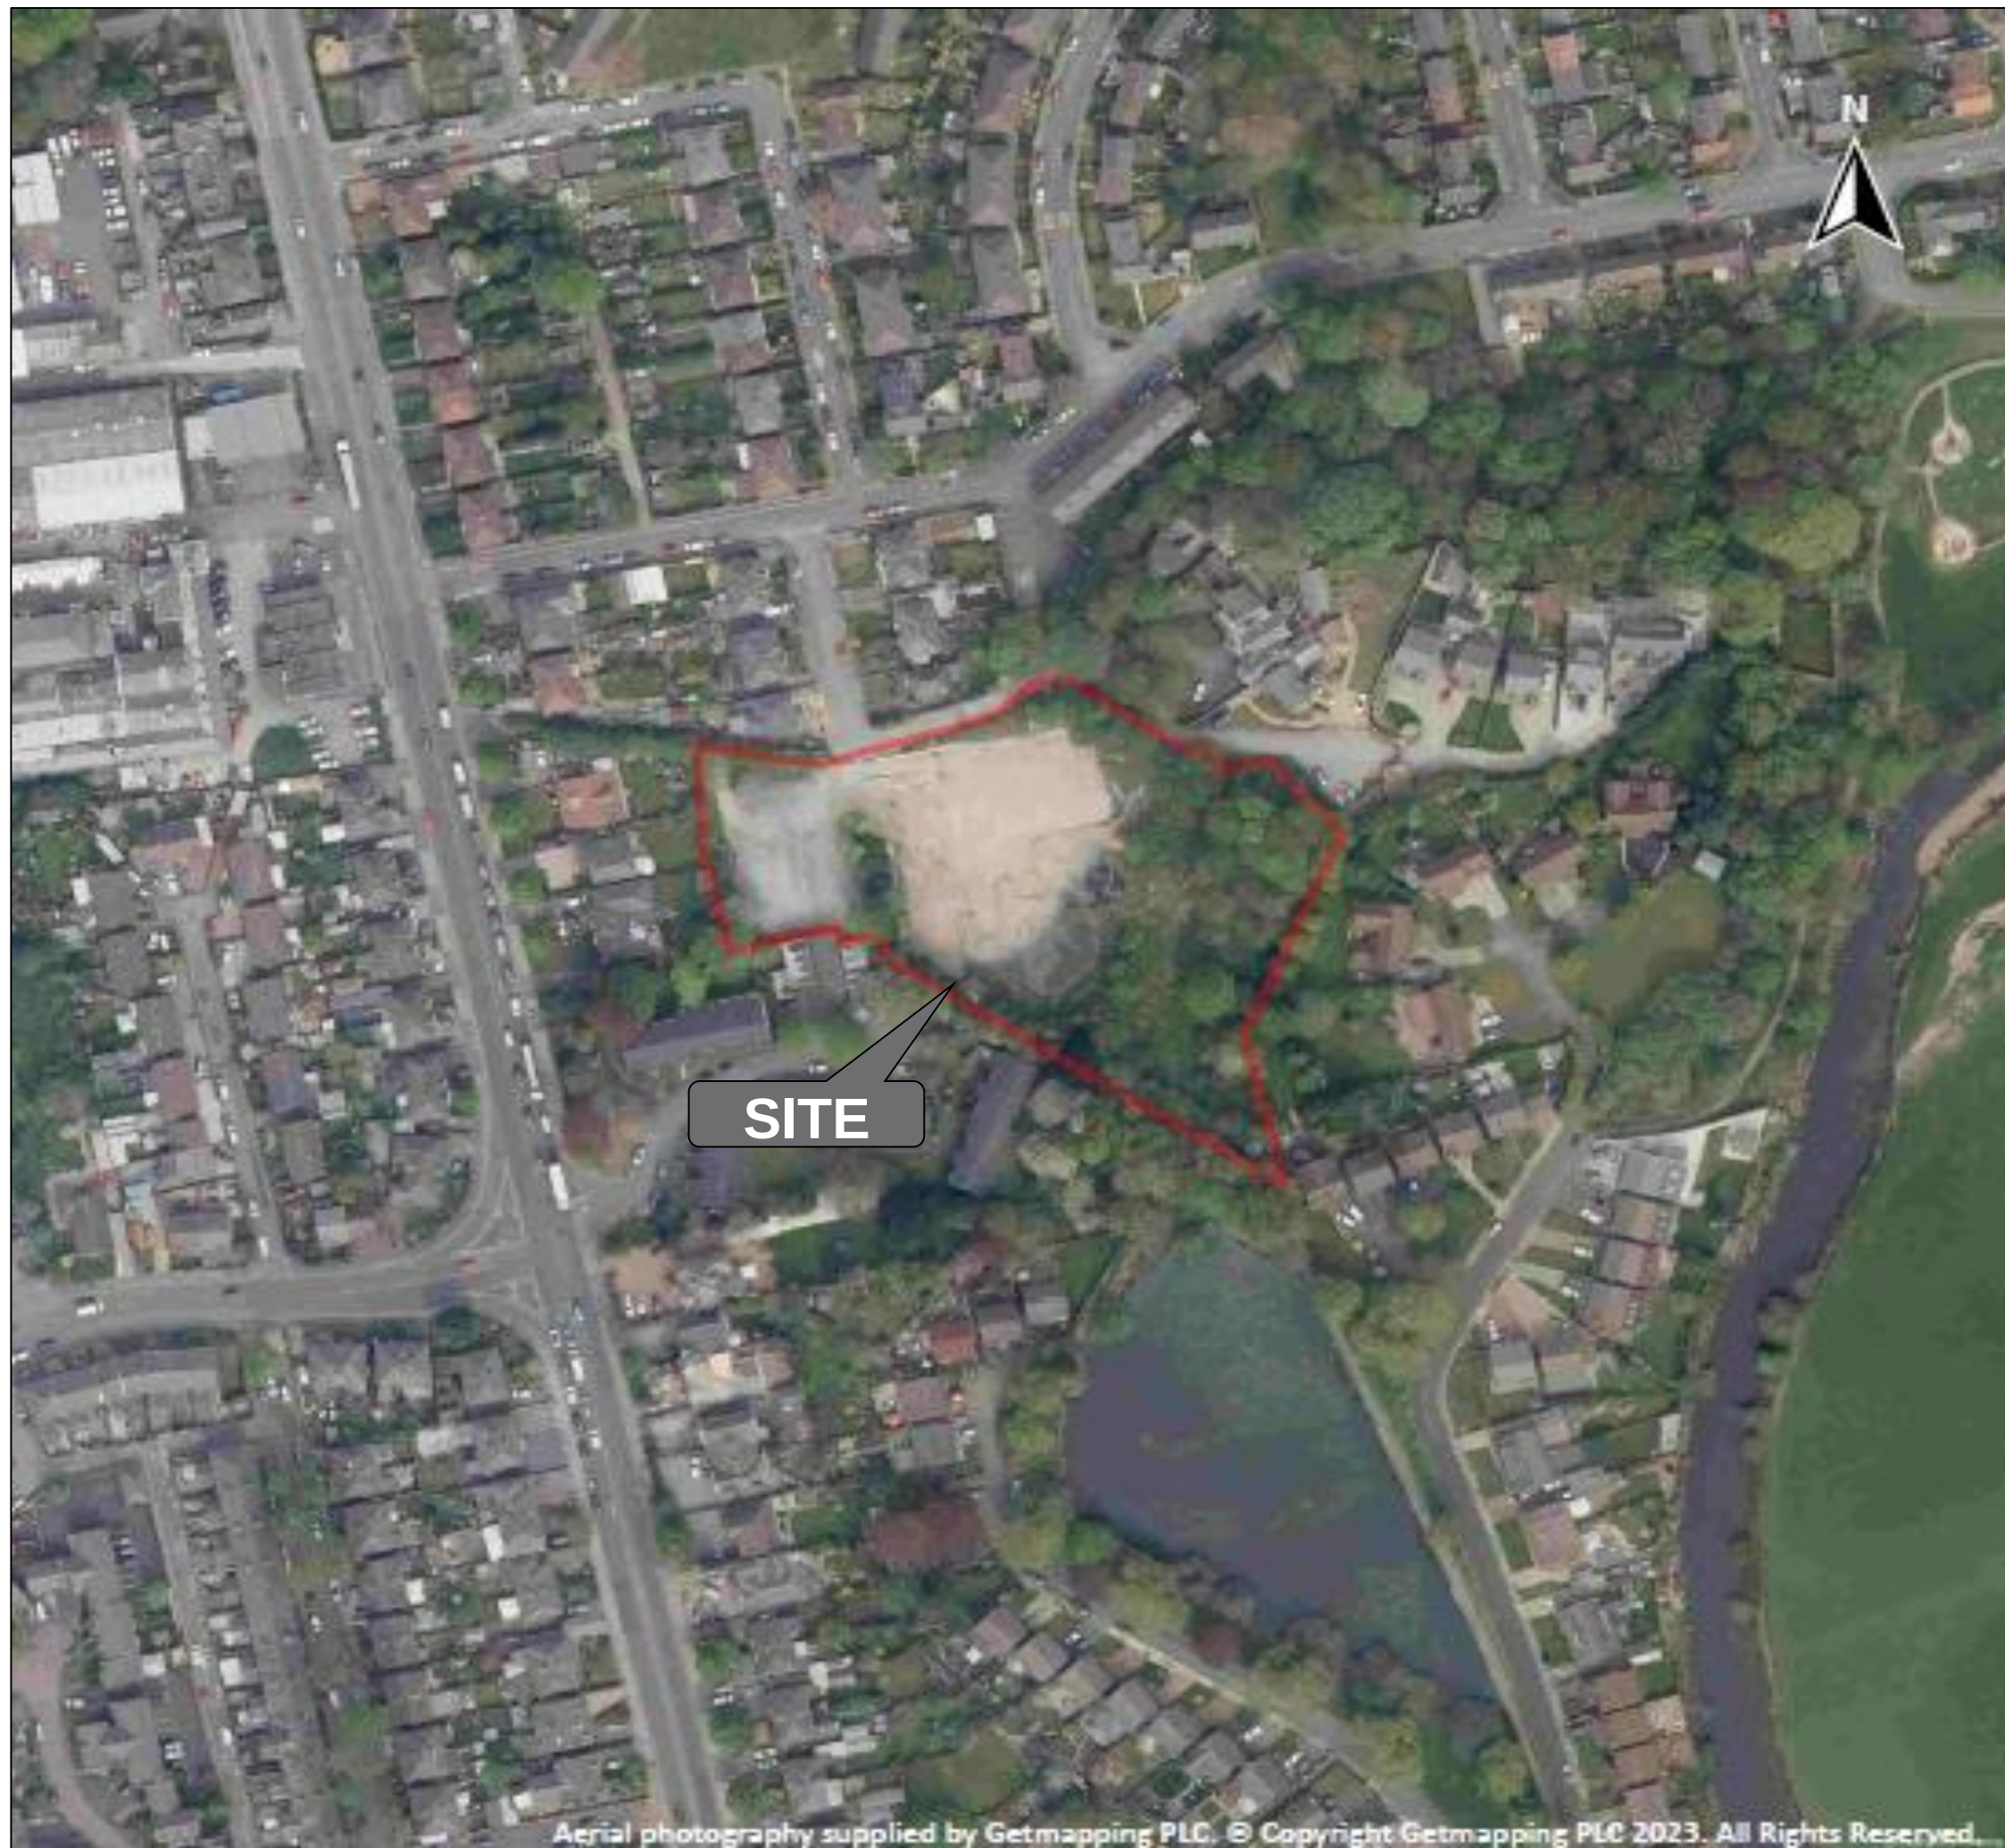
## Site plan

Project: Fletcher Fold

The site comprises a parcel of brownfield land. The site historically contained a school however the former school buildings have been demolished. The location of the site is shown on Figure 1 and a site plan is included in Appendix A.
