Phase II Geoenvironmental Site Assessment  
Fairways Lodge, Prestwich

Reference: 17-206-R2-1  
Date: December 2023

## PHASE II GEOENVIRONMENTAL SITE ASSESSMENT

Fairways Lodge  
George Street  
Prestwich  
Greater Manchester  
M25 9WS

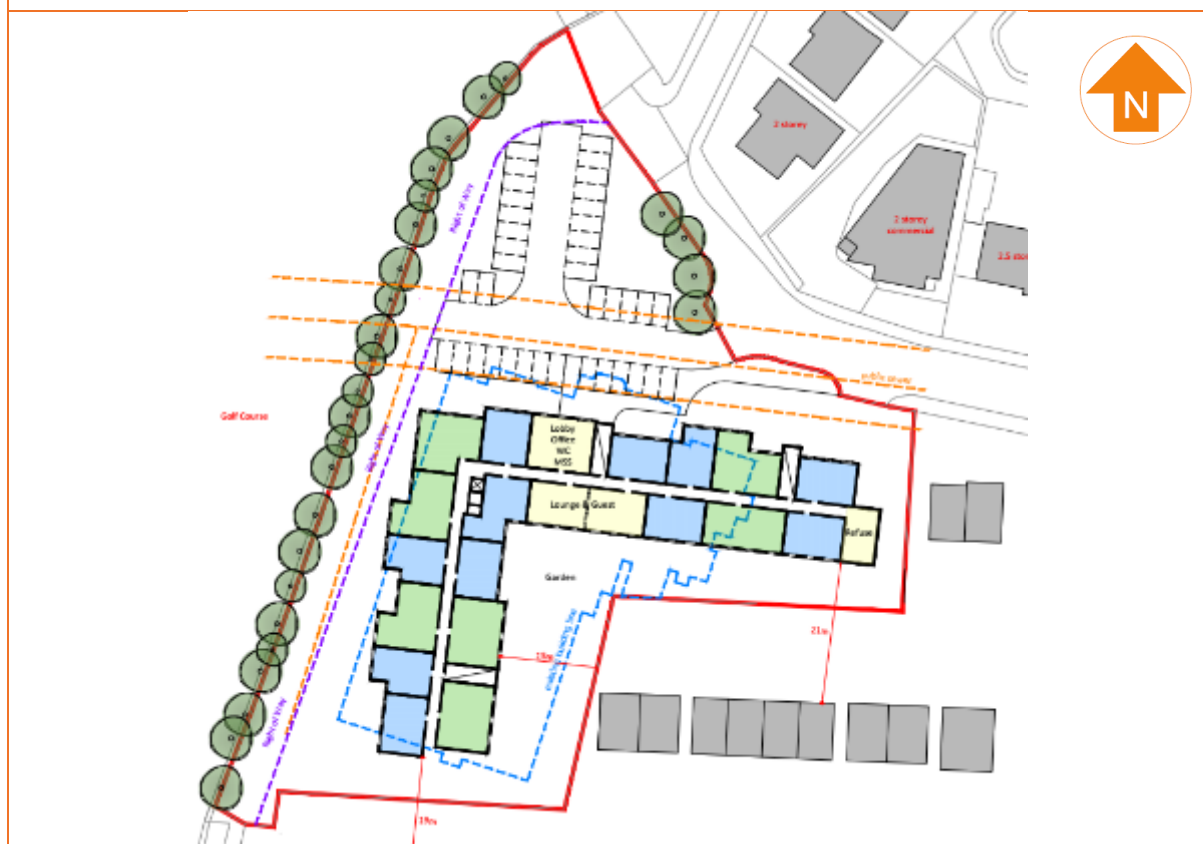
FIGURE 1.1 SNAPSHOT OF PROPOSED DEVELOPMENT

A snapshot of the proposed development layout is indicated in Figure 1.1.

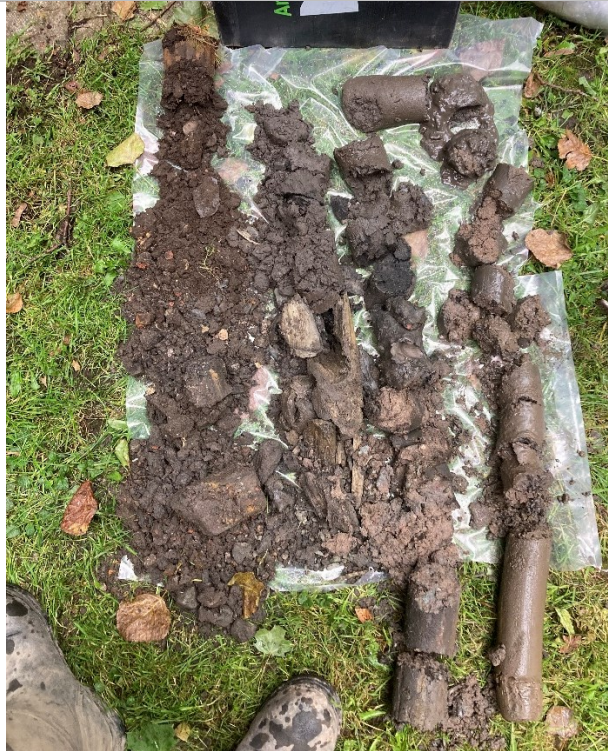
PLATE 3      WS105 ARISINGS

In WS105 in the location of the former reservoir, Made Ground was identified to 3.80 m bgl comprising reworked topsoil overlying dark brown to grey gravelly sand with mudstone, sandstone, ash and brick. Plant debris was noted in the very silty sand between 1.00 m – 2.60 m bgl.
