# Jackson Fold Farm Bury

## Bat Scoping Assessment

7<sup>th</sup> February 2023

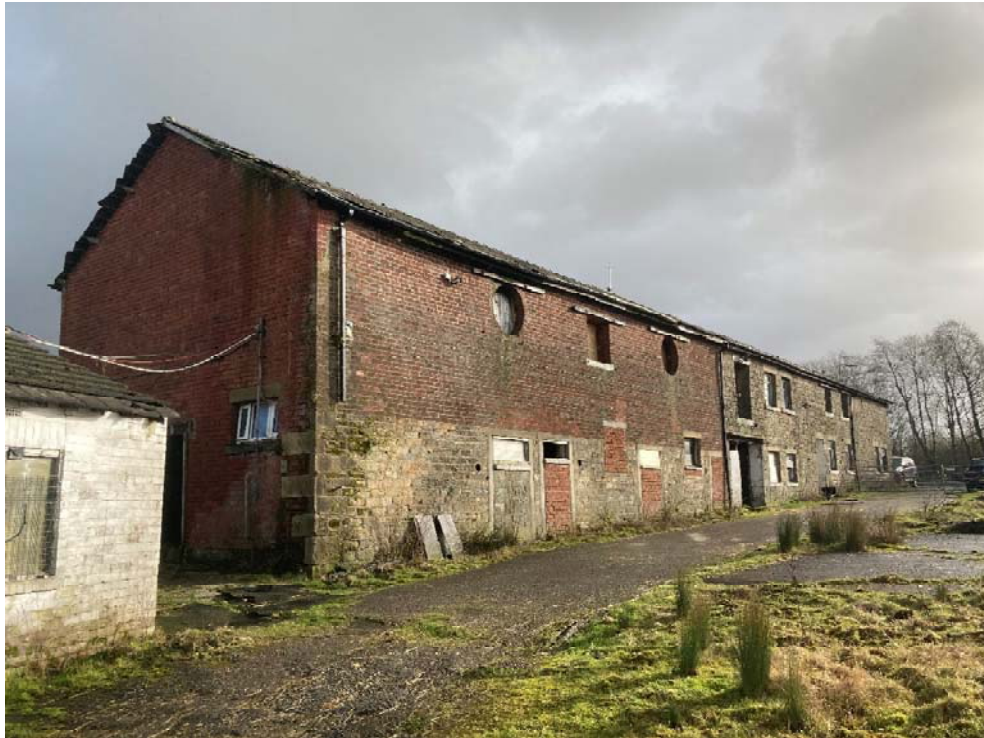
*Photograph 1- Building 3*

This section of the main outbuilding comprises of a two-storey building constructed partly of stone and of brick. The building has a pitched roof clad in slate with ceramic ridge tiles. The building has sealed hayloft windows.

Externally, the building offers some limited areas of potential bat roosting habitat including occasional gaps beneath roof slates at the north gable, areas of missing slate, gaps under the ridge tiles and some occasional wall crevices.

The building was assessed as offering a 'moderate' bat roosting potential.

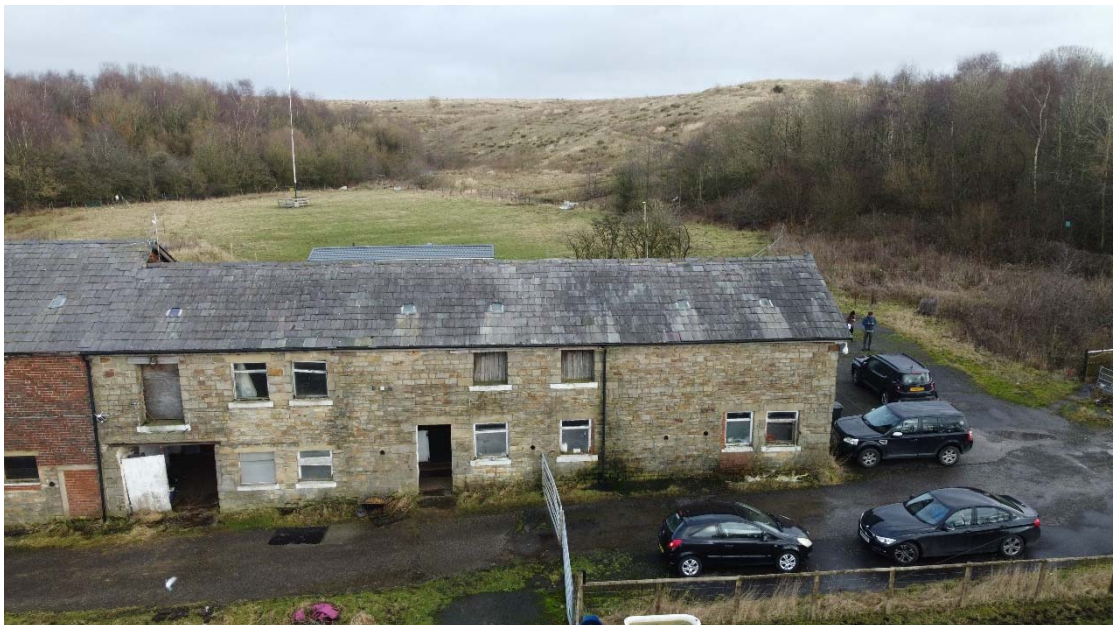
*Photograph 2- Building 1 and 2*

This section of the main outbuilding is a large, two-storey, stone-built structure with glazed windows and a pitched roof clad in slate. The building is currently in active use as a horse stable.

Externally, the building offers some areas of potential bat roosting habitat where there are occasional gaps under roof slates at the south facing gable and some occasional gaps between the stone block work where mortar has decayed.

The building section was assessed as offering a 'moderate' bat roosting potential.

The building was assessed as offering a 'moderate' bat roosting potential.

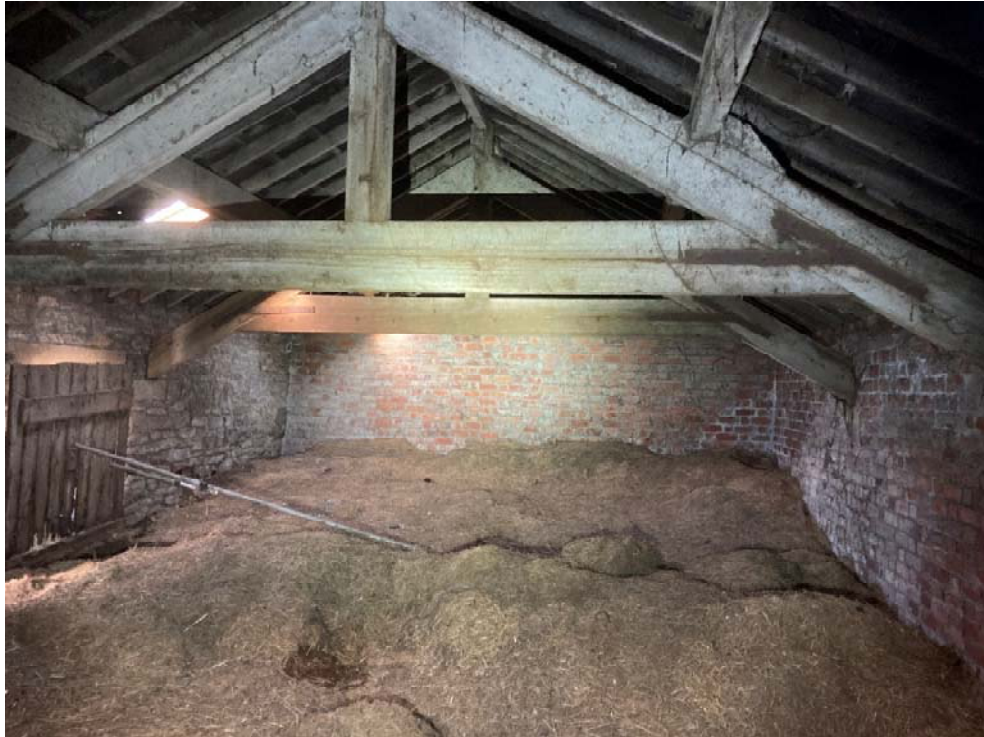
*Photograph 3- Interior of Building 1*

Internally, the upper floor measures approximately 14m in length and 3.5m in height. The upper floor haylofts are largely disused with some old hay bales present. The hayloft entrances are closed with wooden boarding propped on scaffold poles.

The internal face of the slate roof is not lined. The roof is supported on the original stout wooden trusses. There are small, glazed skylights on both roof pitches so the interior of the hayloft is relatively bright.

Potential bat access to the loft is offered via gaps around the hayloft windows at the building's South and West faces. There are also occasional gaps leading into the hayloft where there are intermittent missing roof slates. The roof of the building is cobwebbed including cobwebbing running along the ridge beam. The interior of the hayloft has been used by nesting feral pigeon in the past.

Internal masonry and stonework is generally well pointed throughout with only occasional crevices in walls. Potential bats roosting habitat is offered behind roof trusses and at the ridge.

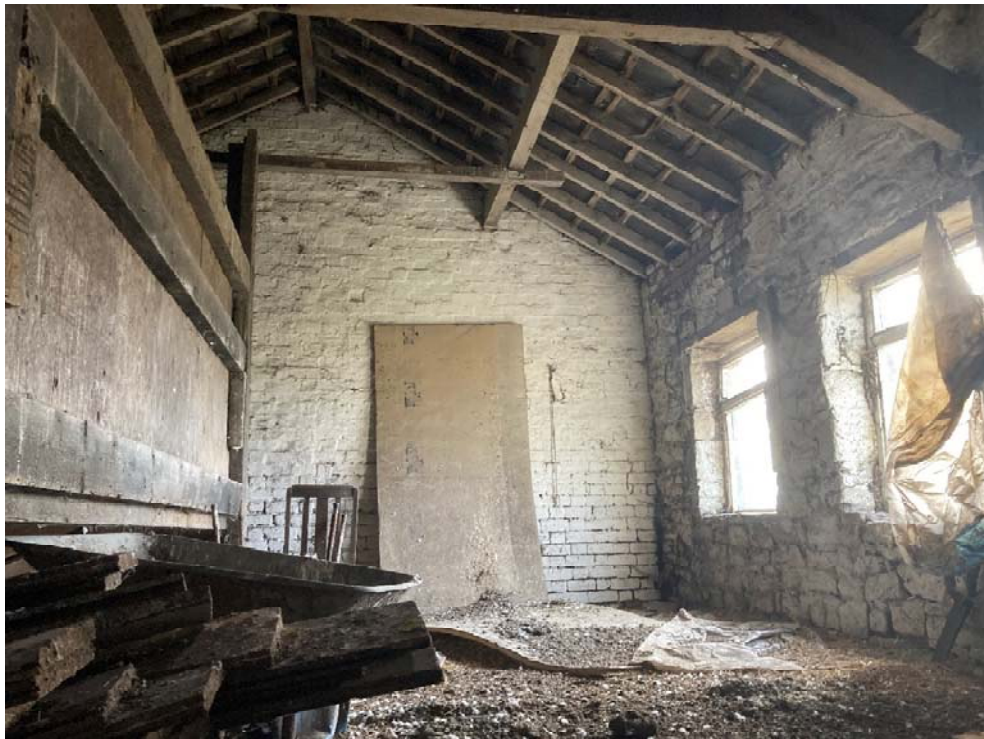
*Photograph 4- Interior of Building 2*

The upper floor room measures approximately 7m in length and 4.3m in height. The room has glazed windows at its west face so the interior of the outbuilding is bright. The upper floor has been used by nesting feral pigeons with droppings and old nests present throughout .

The internal face of the roof is unlined. The roof is clad in slate with skylights. Potential bat roosting habitat is offered behind the roof trusses and ridge. There is potential access to the interior of the building via occasional missing slates near the ridge.

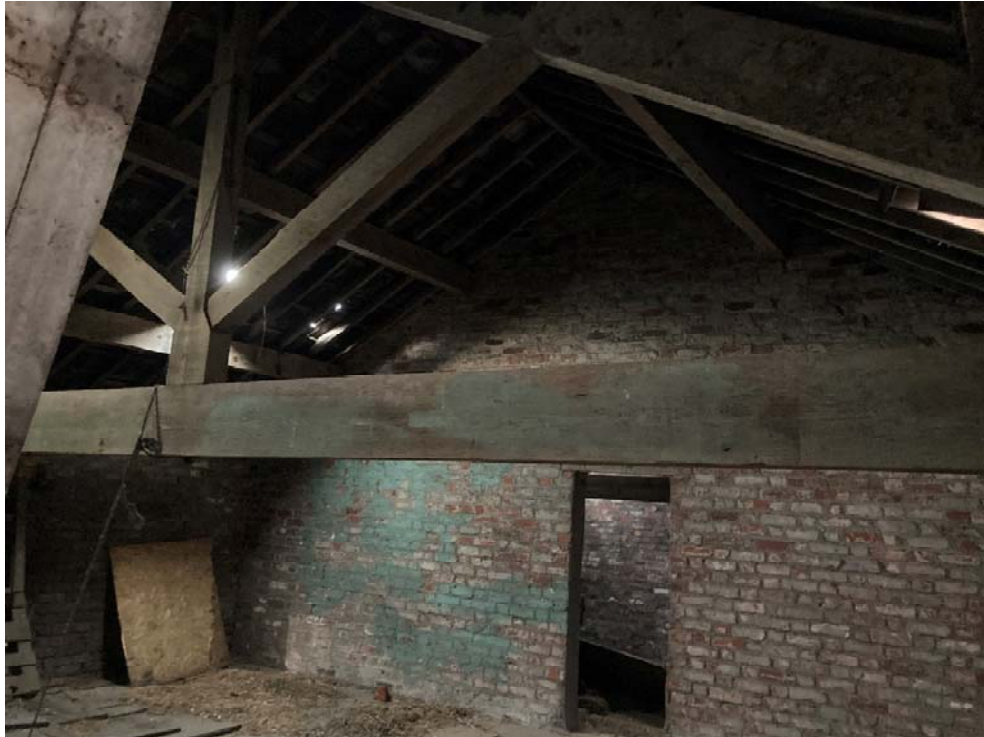
*Photograph 5- Interior of Building 3*

Internally, the upper floor of Building 3 is divided into two sections. The first section at the east end of the building is approximately 10m in length and 4.5m in height. The roof is supported on stout wooden beams and the internal face of the roof is unlined with small skylights. Consequently, the interior of this section of Building 3 is relatively bright. The hayloft windows have been boarded over and sealed shut with boards and wooden pallets. There is an old grain chute at the centre of the loft however the interior of the hayloft is relatively open.

The western section of the upper floor is approximately 5m in length and 6m in height. Old hay has been stored in this section. There are several holes in the roof so the interior of the building is relatively bright and draughty. The north facing pitches of both sections of Building 3 are lined internally with bitumen felt. The interior of the hayloft has been used by nesting feral pigeon in the past. The full extent of the loft space could not be investigated in detail as the floor had rotted away parts and was unsafe, however the majority of the loft space was accessible. The internal walls are generally well pointed with only occasional intermittent crevices. Further potential roosting habitat is offered behind the bitumen roofing felt and behind the roofing trusses and ridge.

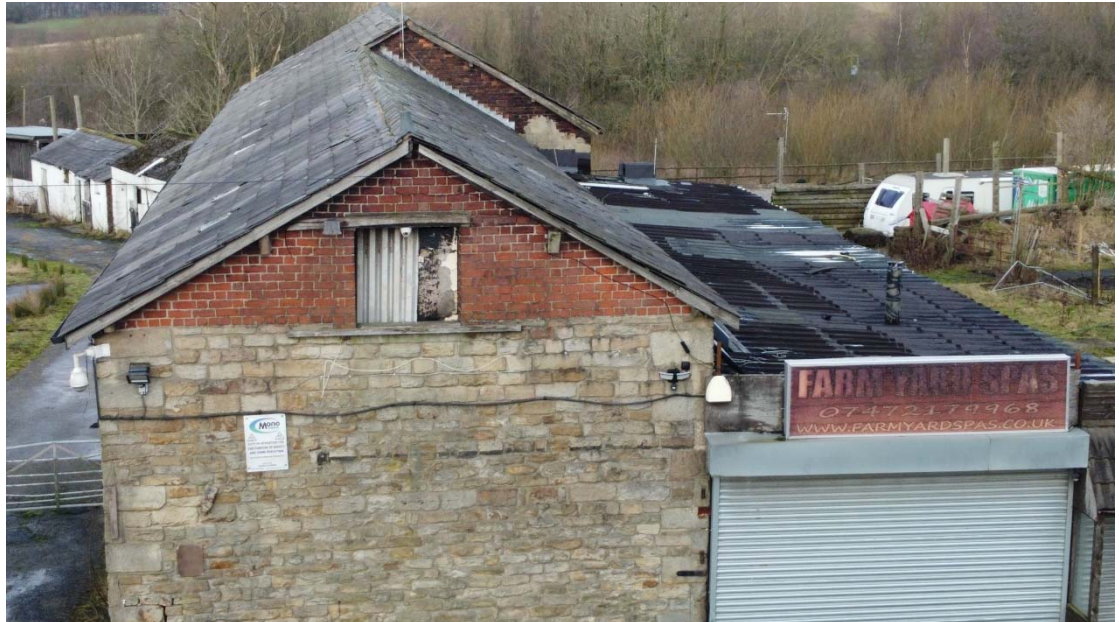
*Photograph 7- South facing gable of Building 1*

| <b><i>PBRF Reference</i></b> | <b><i>Description</i></b> |
|---|---|
| 5 | Gaps under slates at south facing gable providing potential bat roosting habitat between the slates and the mortar. |

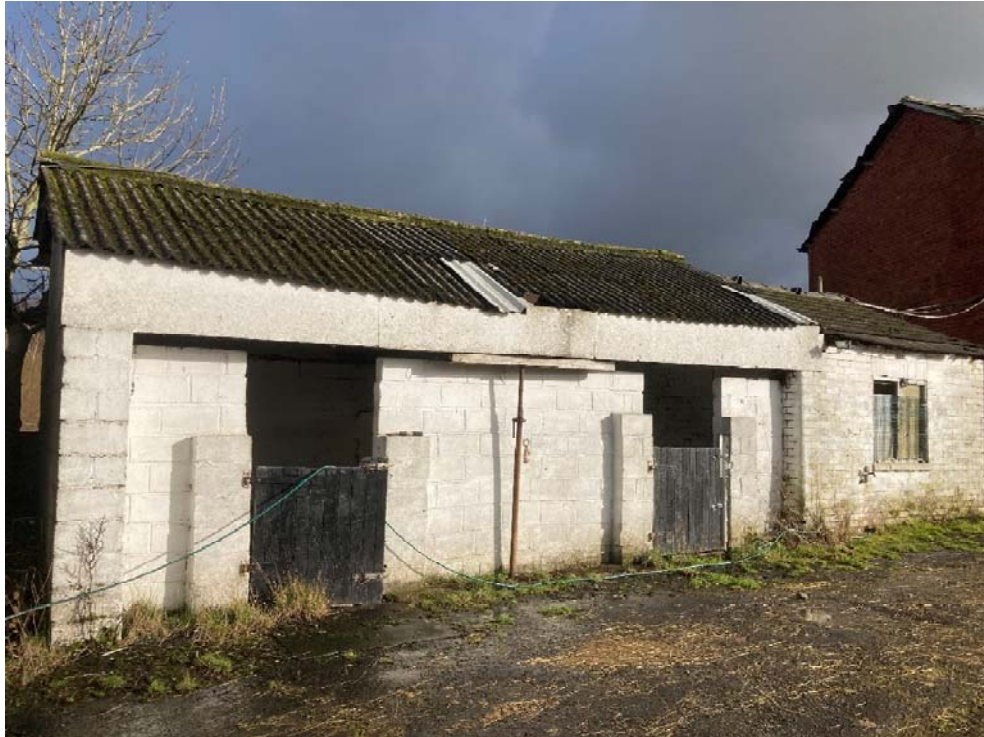
*Photograph 9- Building 4 and 5*

Externally, the building offers some limited areas of potential bat roosting habitat including gaps under the gable end slates.

Externally, the building offers some limited areas of potential bat roosting habitat where there are gaps under a length of chipboard fascia at the building's west face.

| <b><i>PBRF Reference</i></b> | <b><i>Description</i></b> |
|---|---|
| 6 | Gaps under chipboard fascia provide potential bat roosting habitat between the fascia and the wall. |

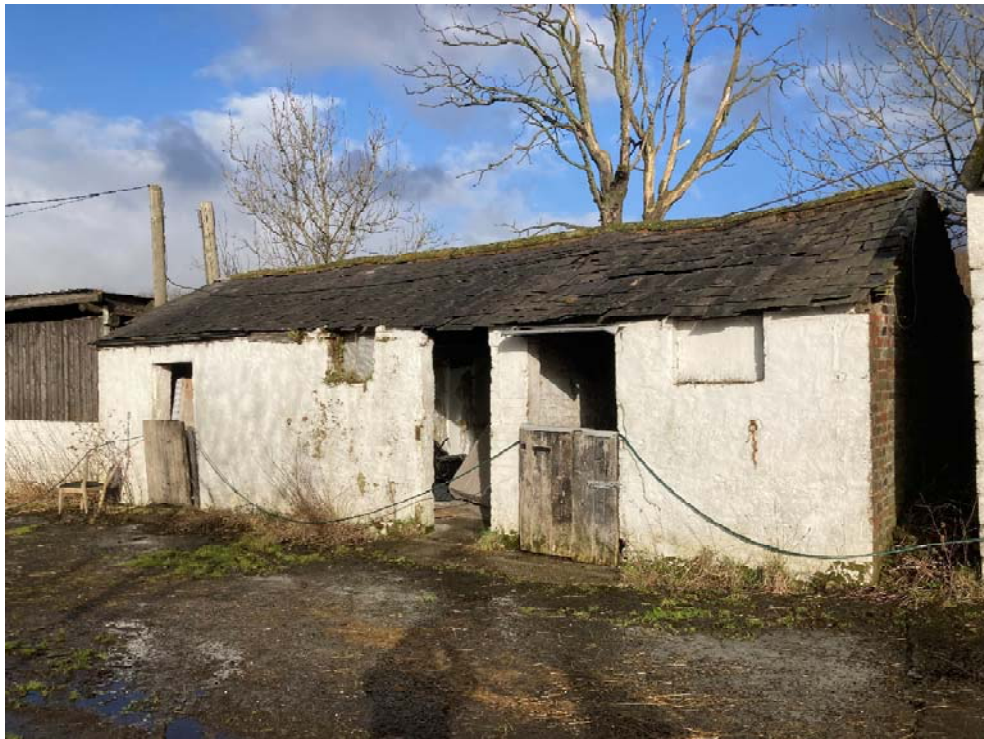
*Photograph 10- Building 6*

This building is a single storey former cottage. The building is constructed of brick with a pitched roof clad in slate with stone ridge tiles. There is a dead tree to the rear of the building offers low value potential roosting for bats under areas of lifting bark.

Externally, the building offers some limited areas of potential bat roosting habitat where there are occasional missing slates and gaps under the ridge tiles.

| <b><i>PBRF Reference</i></b> | <b><i>Description</i></b> |
|---|---|
| 9 | Dead tree to the rear of the building which could offer potential roosting for bats under areas of lifting bark |

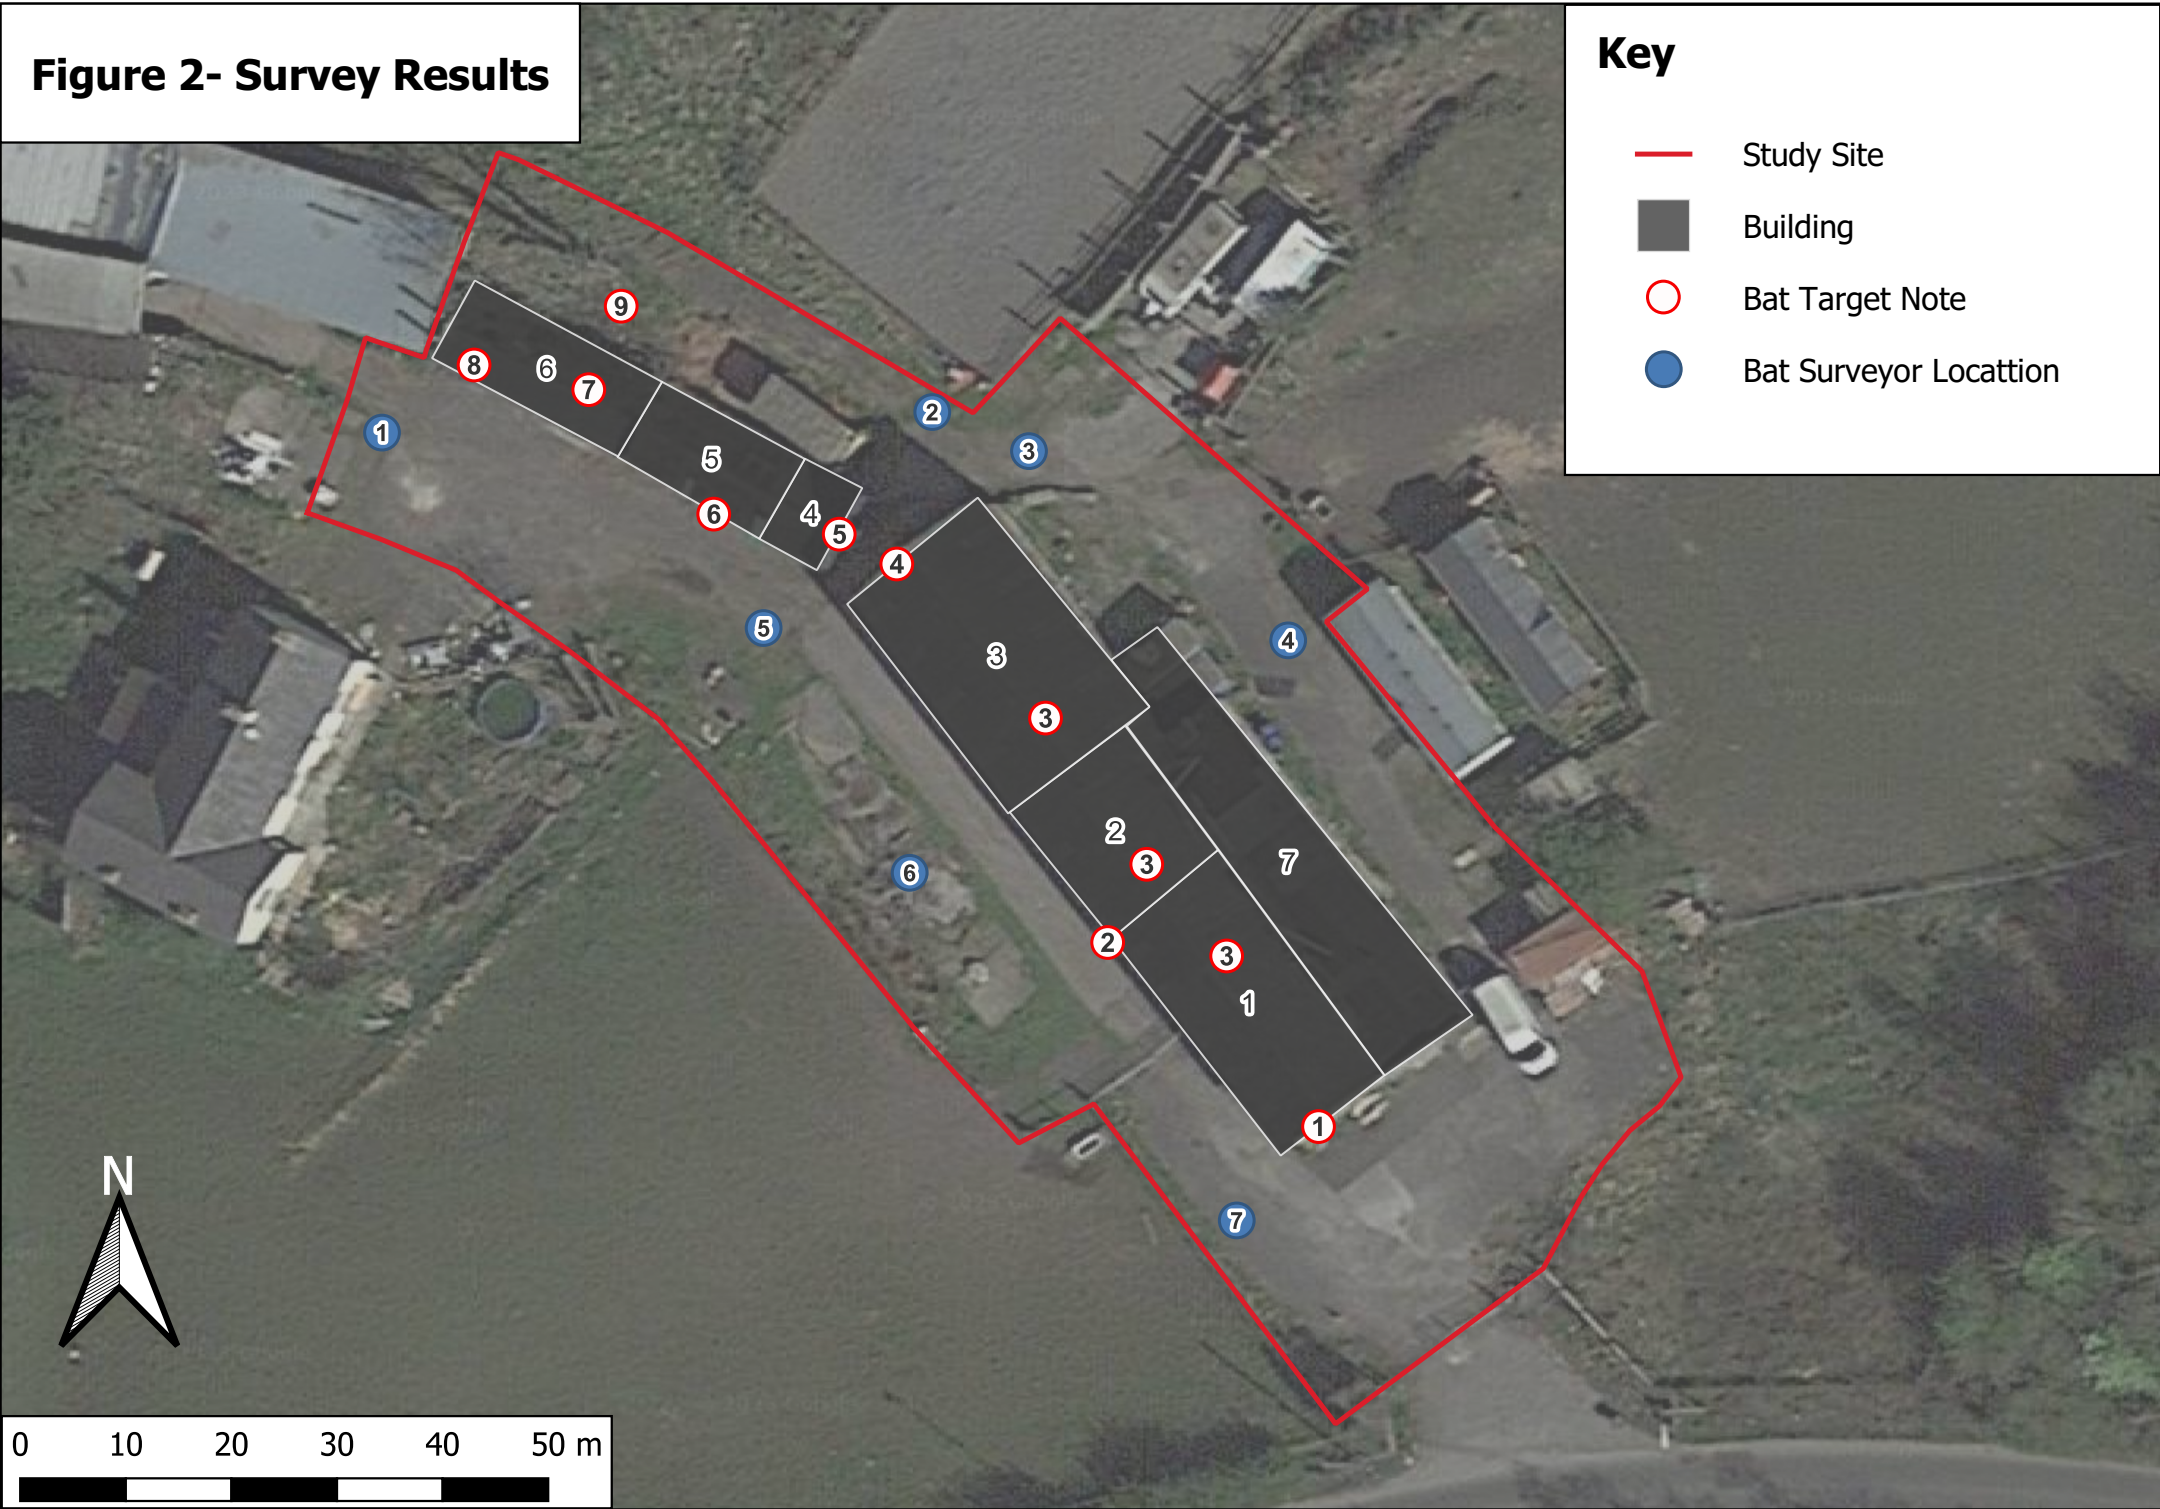
Figure 2- Survey Results

Building sections are numbered and shown on Figure 2 in the Appendix. Descriptions of each building section are provided below. Identified potential bat roosting features are Target Noted and described in Table 2 and shown on Figure 2 in the Appendix.

The bat scoping survey found the two-storey row of outbuildings (Building 1, 2 and 3 on Figure 2) to be of '**moderate**' suitability for roosting bats and found the row of single storey row of outbuildings (Buildings 4, 5 and 6) to be of '**low**' suitability for bats.

In order to further assess the identified potential bat roosting features associated with Buildings 1-3, it is recommended that at least two dusk/dawn bat activity surveys are carried out during the active bat survey season (May-September inclusive with at least one survey completed between early June and the end of August).

The surveys would aim to confirm the presence or otherwise of any bat roosts associated with the building. Recommended surveyor locations are shown on Figure 2.
