## **Ground Investigation Report**

### **Woodbank Primary School**

**EPS Reference Number:** UK23.6632

## WOODBANK PRIMARY SCHOOL, BURY

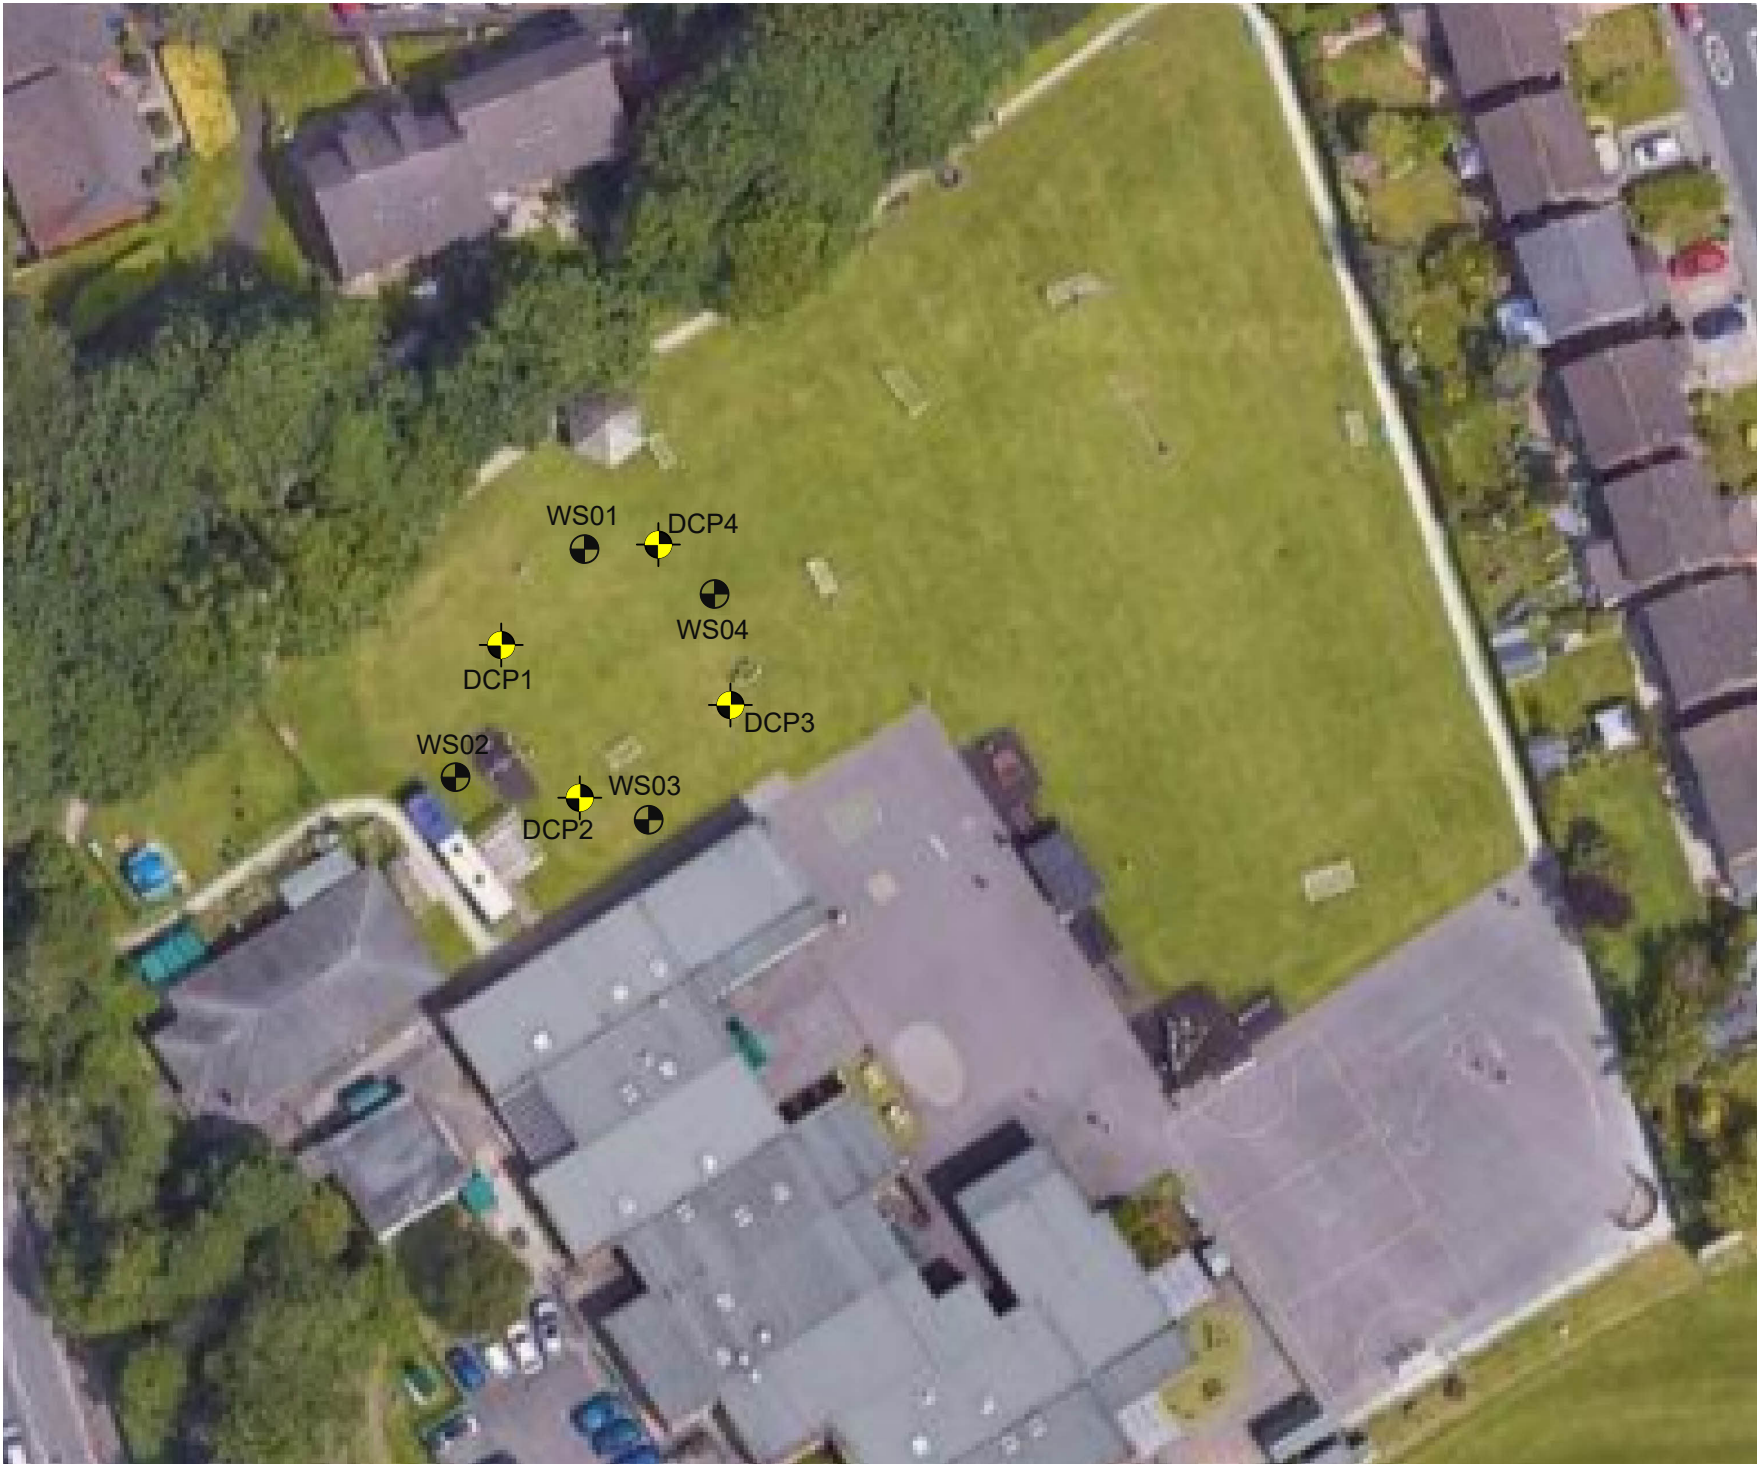
A total of 4 windowless sample boreholes (WS01-WS04) were formed to a maximum depth of 4.0mbgl across the proposed development area, to assess the nature and strength of the underlying ground conditions.

KEY:

Window Sample Location

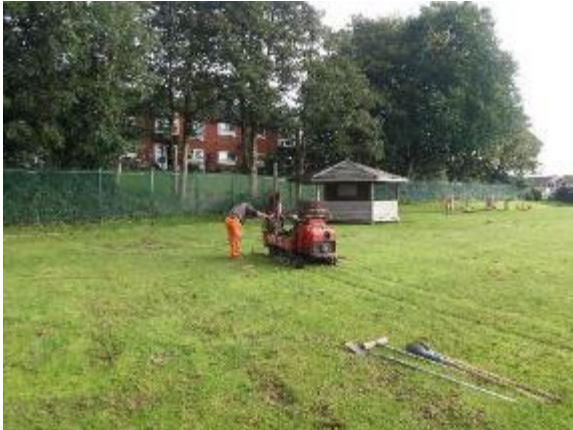
| Photo 1: Rig in location of WS01. | Photo 2: Rig in location of WS02. |

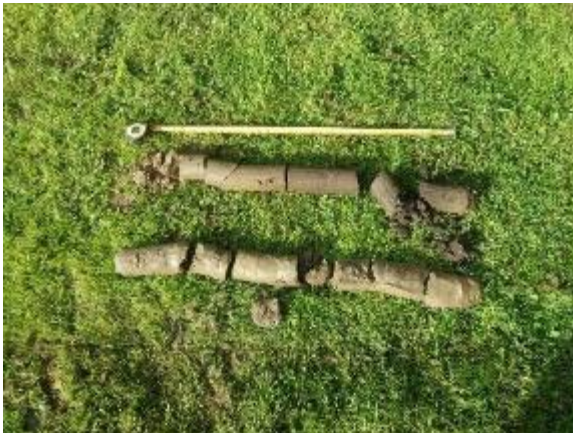
Within WS01 and WS02, the soils were recorded as medium dense to dense, but occasionally loose, silty, clayey sands with some silts and gravels occurring in weak lenticular structures.

| Photo 3: Soils recovered from WS01. | Photo 4: Soils recovered from WS04. |

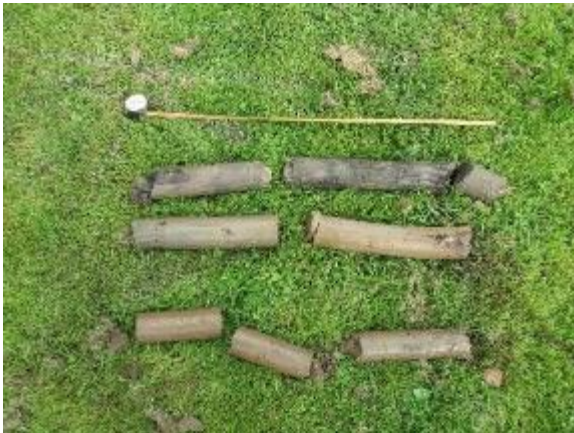
Within WS03 and WS04, the soils were recorded as firm to stiff sandy clays, again with some variability in silt and gravel content; generally increasing with depth, including a more distinguishable section of silt in WS04 between 1.1m and 1.3m. The silt was otherwise generally observed as grey veining, thought to be historic rootlet structures.

Towards the base of WS04, some orange/beige fragmented sandstone was recovered, interpreted to be weathered top surface of the Pennine Lower Coal Measures. Some fragments of anthracitic coal were noted within the SPT at the base of the hole.
