## Phase 1 GeoEnvironmental Desk Study

Parr Hill

Whitefield

**Report No. A6988/25/FDS/V2**

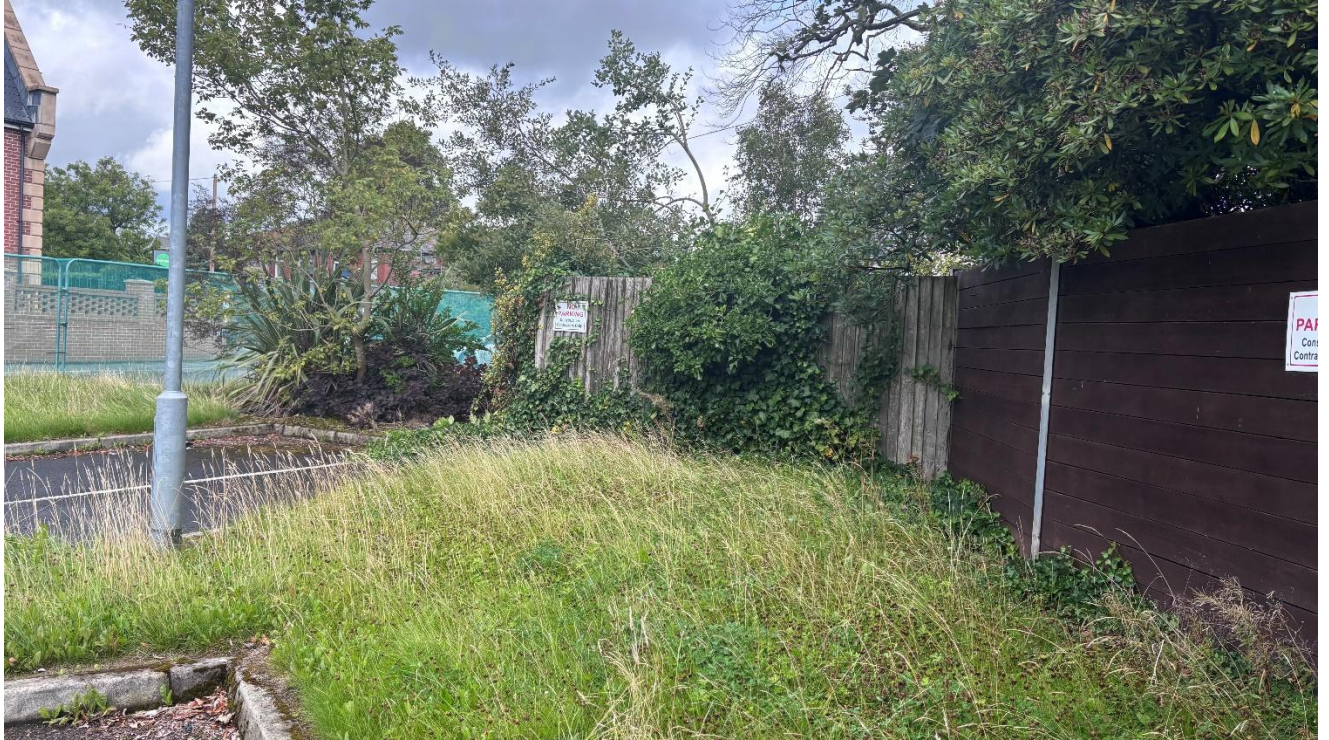
**Figure 3: Site Photograph**

- 2.3 Access to the site is gained via a Heras fence to the southern end of the site off the A665 Road and Parr Hill Road.
- 2.4 The site is relatively flat and is mainly covered in hardstanding due to the old car park; however, a small area of the site is a grassland at the northeastern point of the site.

- 2.5 A Heras fence and a wooden fence along the eastern boundary of the site bound the site.
- 2.6 The site is surrounded by residential buildings to the north and west, commercial buildings to the south and a large parcel along with a used building to the east.

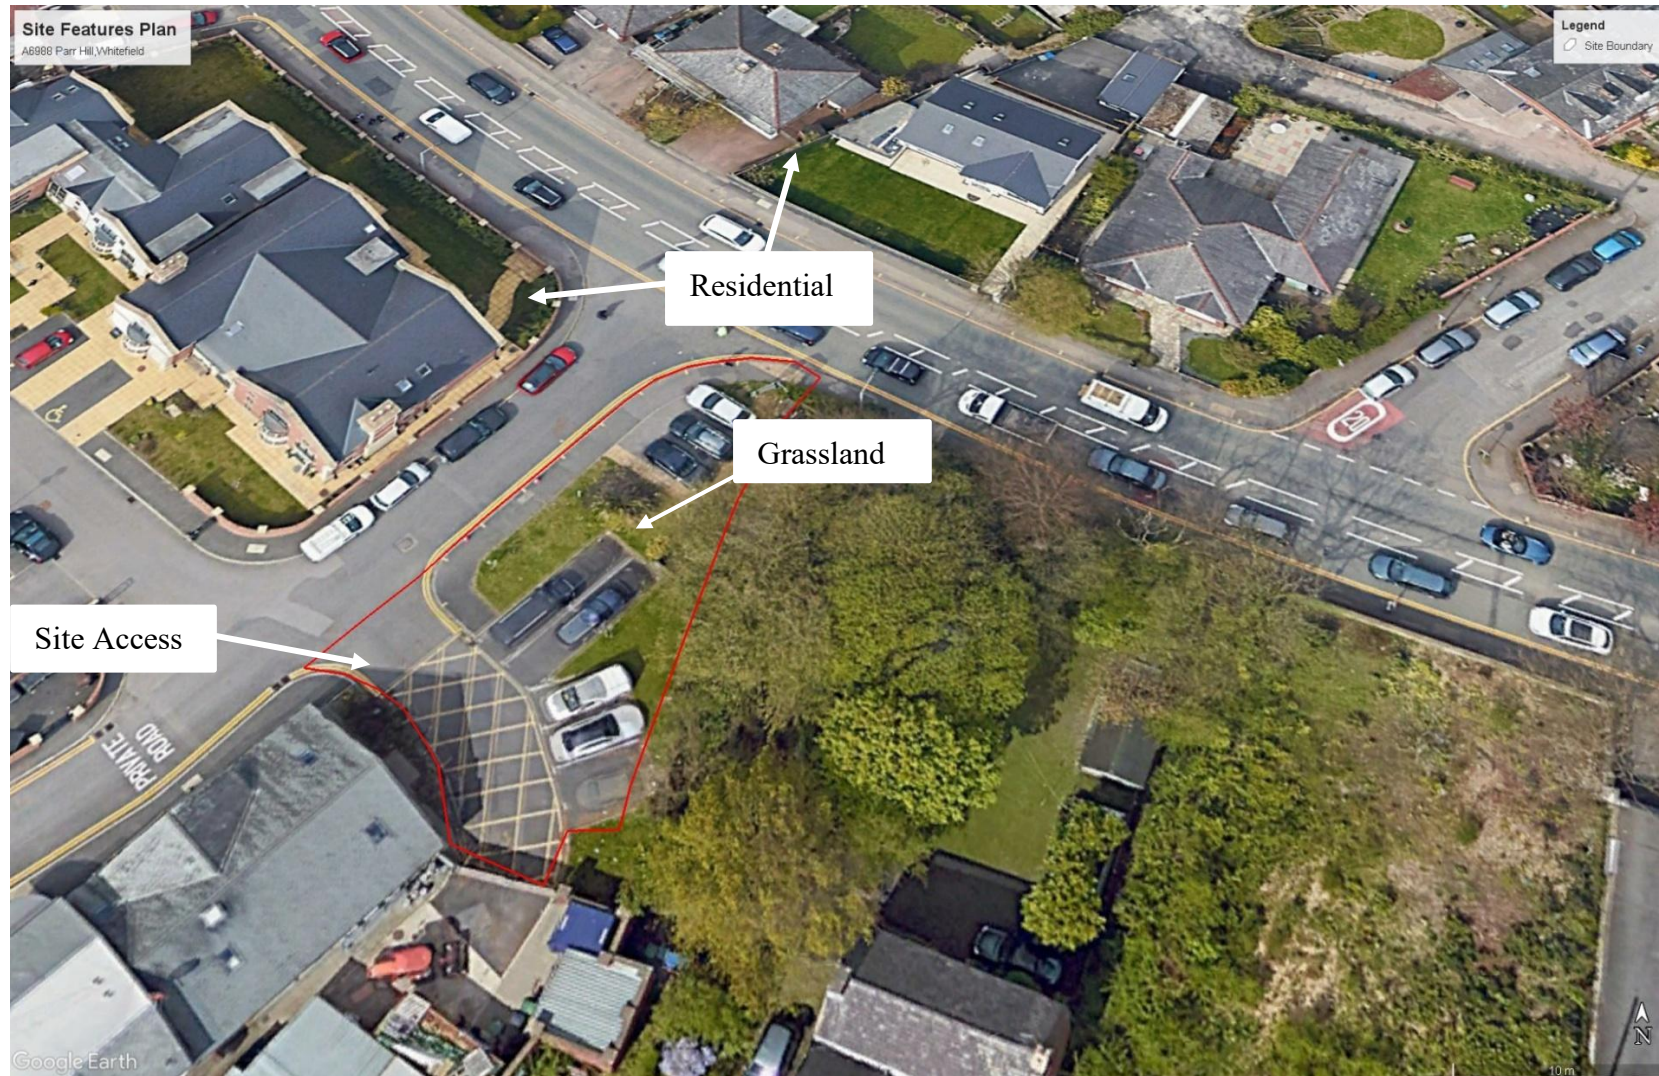
**Figure 8 Site Features Plan**

- 5.1 A walkover survey was completed on 7<sup>th</sup> August 2025. The photographs and notes from this survey are appended to this report as Appendix 2 and Appendix 3, respectively.
- 5.2 Access to the site is gained via a Heras fence to the southern end of the site off the A665 Road and Parr Hill Road.
- 5.3 The site is relatively flat and is mainly covered in hardstanding due to the old car park; however, a small area of the site is a grassland at the northeastern point of the site.
- 5.4 A Heras fence and a wooden fence along the eastern boundary of the site bound the site.
- 5.5 The site is surrounded by residential buildings to the north and west, commercial buildings to the south and a large parcel along with a used building to the east.

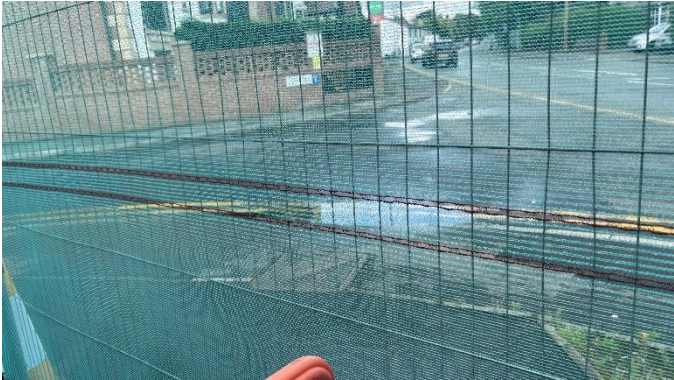
| <p><b>Plate 1 View showing the entrance to the site</b></p> | <p><b>Plate 2 View showing the light pole in the middle of the site</b></p> |

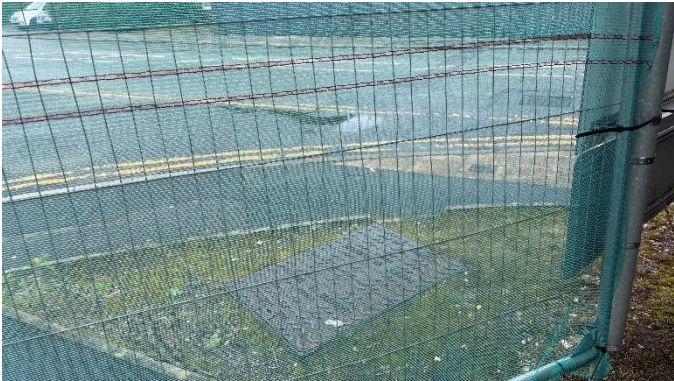
| <p><b>Plate 3 View showing drainage at the northwestern boundary of the site</b></p> | <p><b>Plate 4 View showing the trees to the east</b></p> |

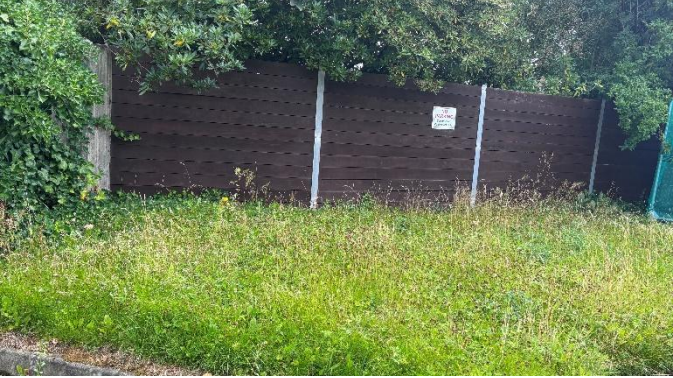
| <p><b>Plate 5 View showing the grassland on the site</b></p> | <p><b>Plate 6 View showing the condition of the hardstanding</b></p> |

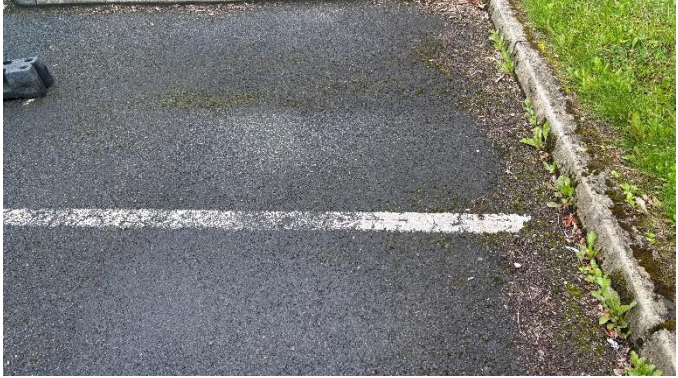
| Desk Study features checked during site visit | Feature and Information required | Present | Description / Comments |
|---|---|---|---|
| Ground Surface | <p>Are there areas of hardstanding and estimate the split between hard and soft cover? (If yes describe locations, types, and conditions).</p> <p>Is there any evidence of any spillages or staining?</p> | <p>Yes/<del>No</del></p> <p><del>Yes</del>/No</p> | 75% of the site has hardstanding due to the car park. |

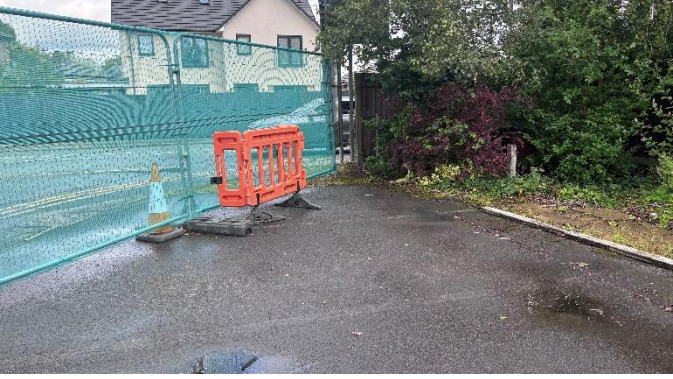
| <p><b>Plate 7 View showing Heras fencing</b></p> | <p><b>Plate 8 View showing the wooden fence to the east</b></p> |
