HOLLYMOUNT FARM, HOLLYMOUNT LANE, TOTTINGTON,  
BURY, BL8 4HP

## **BRIEFING NOTE – PRELIMINARY BAT ROOST ASSESSMENT**

## **Bat Survey of Buildings at Holly Mount Farm, Greenmount.**

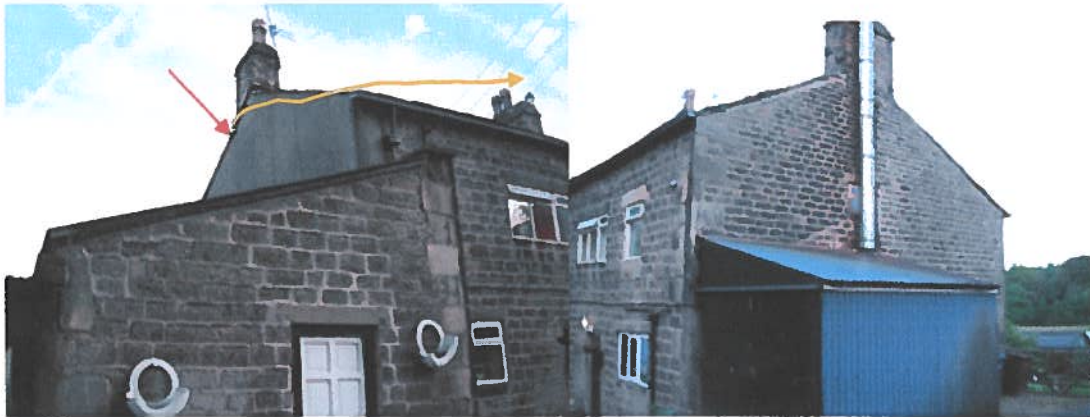
Building 1 and 2, The House, see photos 1, 2 and 8.

The house was of stone and there many gaps suitable for at access such as under end slates, under stone tiles and under lead flashing at the chimneys.

The house was considered to have high bat roosting potential.

The first bat recorded was a Common Pipistrelle, emerging from the east gable of the house at 21.51. See photo 1.

**P1 House (2) and building 3, bat exit point    P2 House, building 2 and building 1**

**5.1** It must be ensured that any work likely to cause vibration near the roost, such as demolition and building, is carried out when the bat is unlikely to be present, November to mid-March inclusive.  
Any structure, such as scaffolding, must not obstruct the roost area outside these times.  
It is recommended that extra bat roosting potential is created in the new build by reproducing the gap in the eventual east gable.

**5.6** The gap under the slates around the bat exit point must be retained. If there is any proposed repair work on the roof, advice from Natural England must be sought; contact the local bat group (South Lancashire or the Bat Conservation Trust).

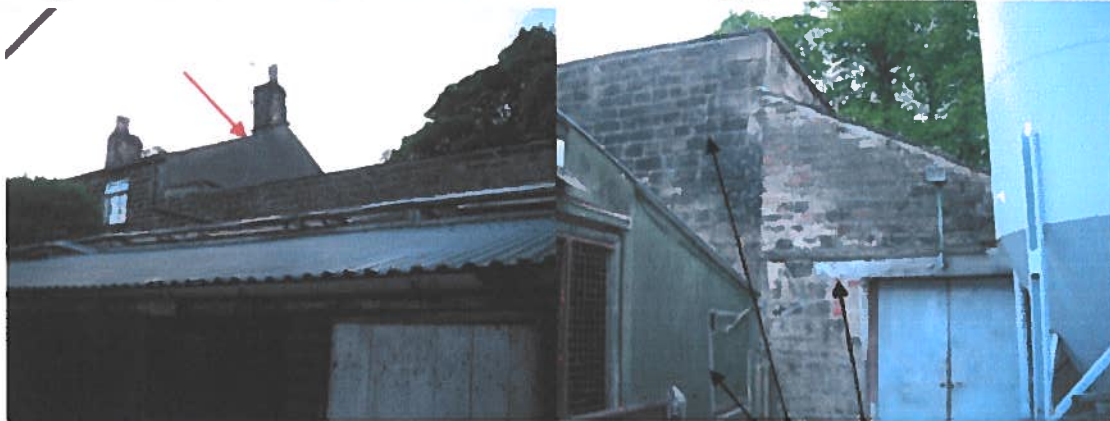
Buildings 4, 8 and 9, see photos 3, 4 and 7

These three buildings had walls and roofs of corrugated sheeting, board-lined in parts. They were considered to have minimal bat roosting potential.

**P3 Building 8 and house. Bat exit point    P4 Buildings 8, 4 and 5.**

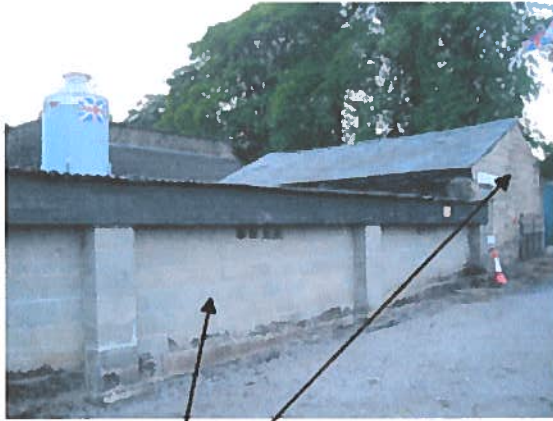
Building 6, see photos 5, 6 and 7

This small barn was of stone with a pitched slate roof lined with planking. It was considered to have low bat roosting potential.

Building 7, see photo 5

This building was of breeze block walls with a corrugated sheeting roof. It was considered to have very low bat roosting potential.

**P5 Buildings 7 and 6**

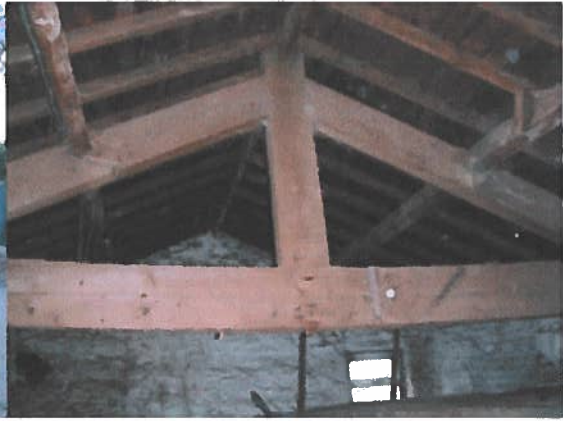
There were nesting Swallows in the building 6 and many other suitable nesting sites throughout the outbuildings.

**P6 Plank-lined roof, building 6**

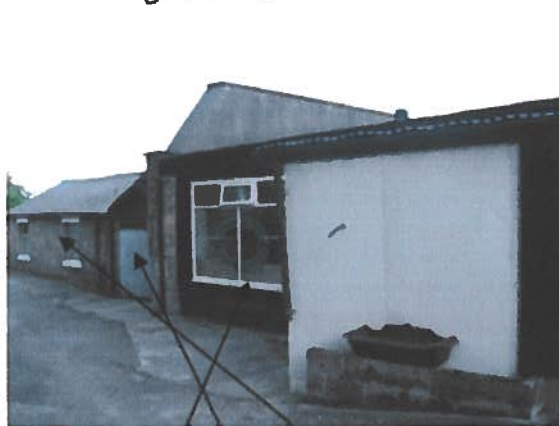
**P7 Buildings 4, 5 and 6**

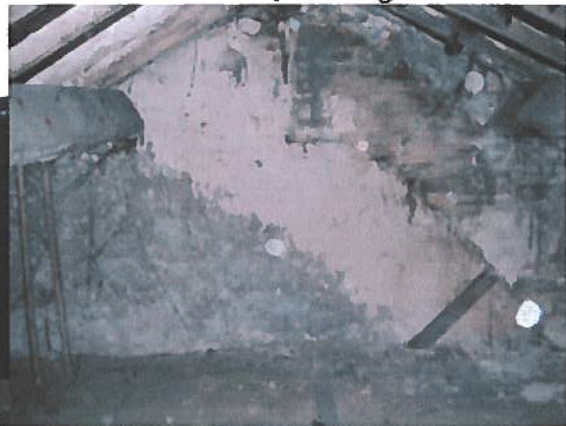
The roof void of the house was insulated at floor level and the roof was felt lined.

No signs of roosting bats were found. A scattering of mouse droppings was found in the attic.

**P8, House loft, building 2**

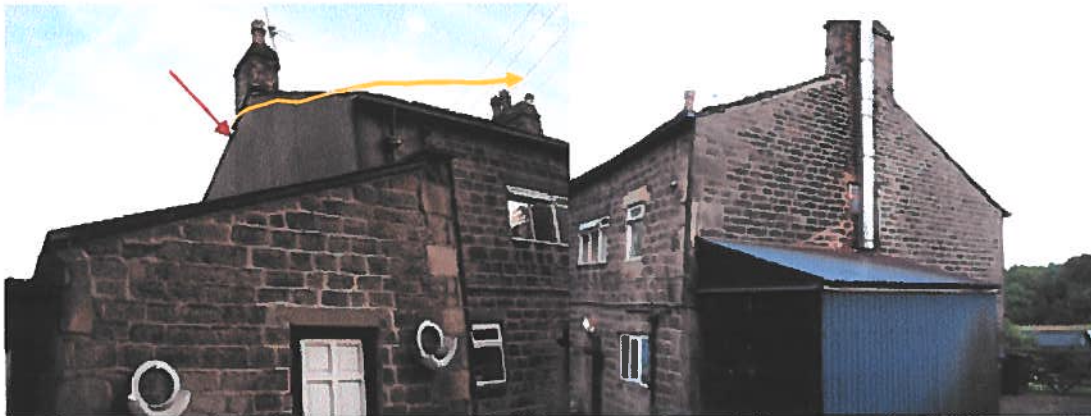
**P1 House (2) and building 3, bat exit point**    **P2 House, building 2 and building 1**

**5.6** The gap under the slates around the bat exit point must be retained. If there is any proposed repair work on the roof, advice from Natural England must be sought; contact the local bat group (South Lancashire or the Bat Conservation Trust).

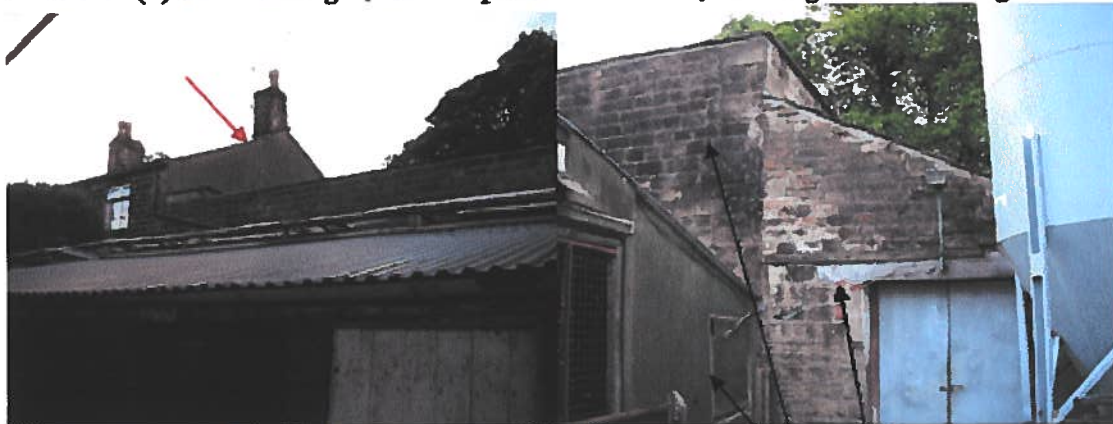
**P3 Building 8 and house. Bat exit point**    **P4 Buildings 8, 4 and 5.**

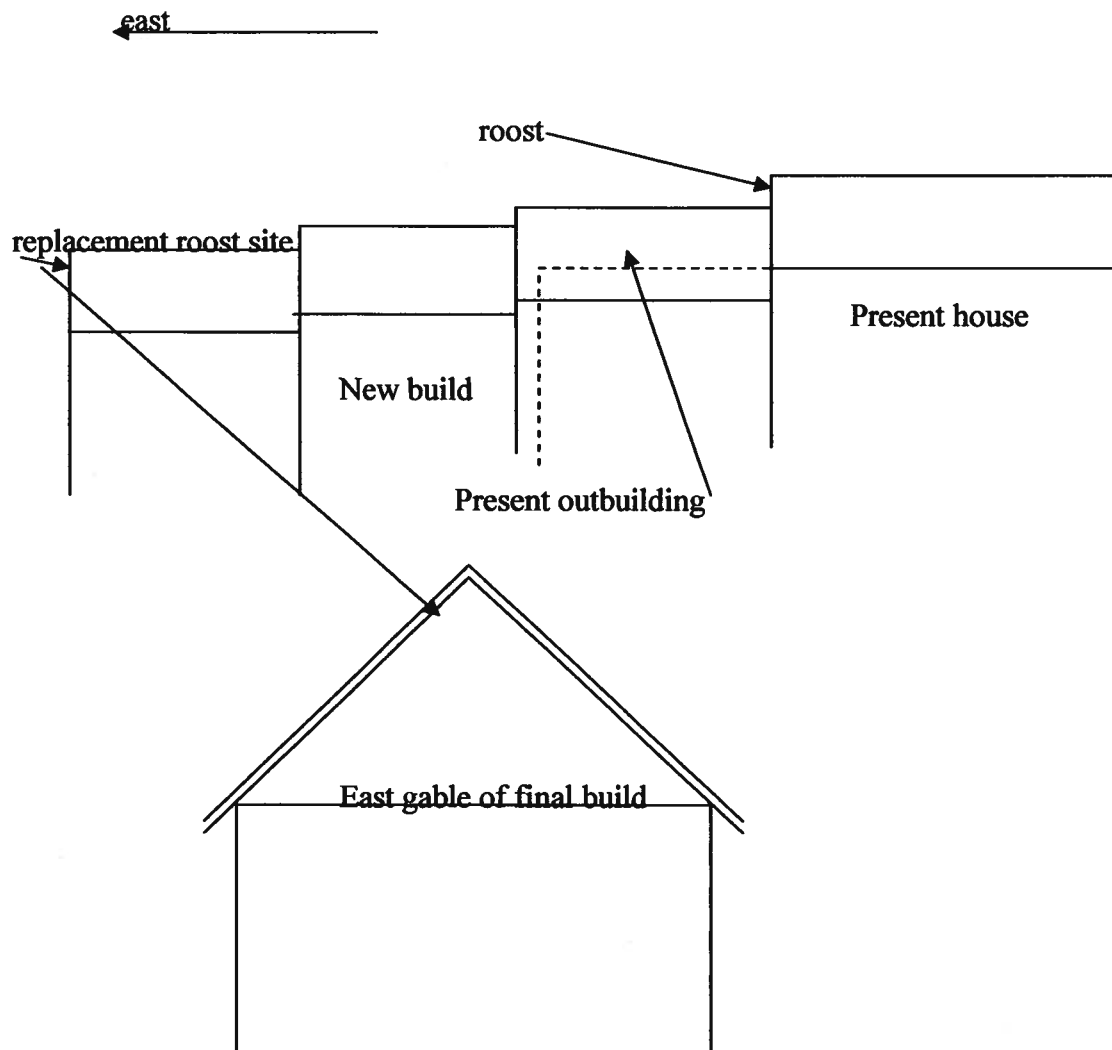
Plan 2, illustrative only

The gap should be about 5cms long and no more than 2cms wide, and be high on the gable under the eaves. The felting at this point must be of the traditional bituminous type at modern fibrous types tangle bats causing harm to the bats and damage to the felting. The site of the gap must not be obstructed or directly lit. See plans 2 and 3.
