## **PROPOSED RESIDENTIAL DEVELOPMENT AT 68 RINGLEY ROAD, WHITEFIELD, MANCHESTER**

### **PHASE 1 SITE INVESTIGATION REPORT**

**Report No 3358/01 Issue 2**

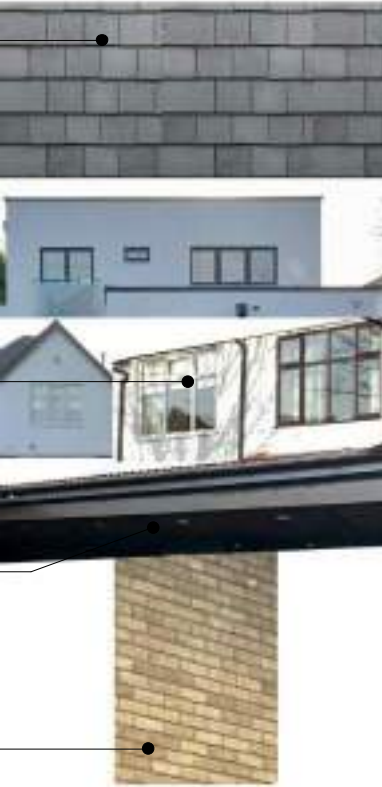
3. Existing materials  
1 : 1

Existing horizontal band/canopy in dark brown/black to be retained and overclad to match the contemporary aesthetic

The existing facing brick ground floor wall is to be retained. This will match the prevailing aesthetic in the area but when stained a darker colour it will introduce a more modern design in line with the rest of the proposed aesthetic

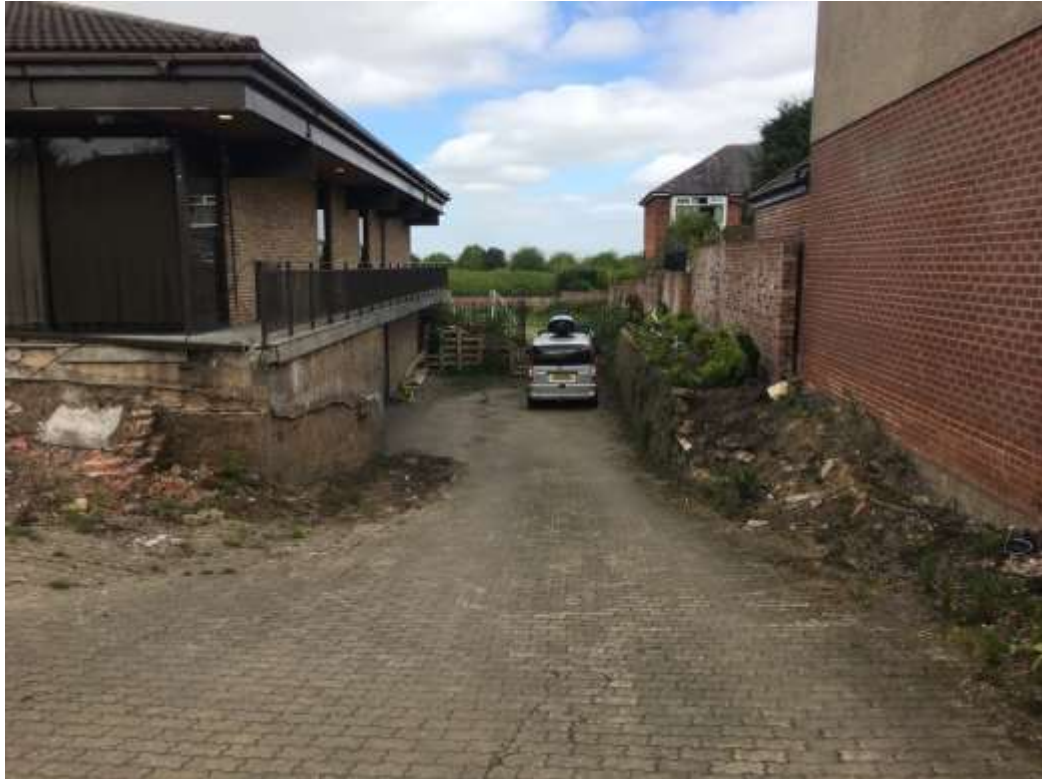
**Photograph 1: View northwest – Along eastern side of the existing property**

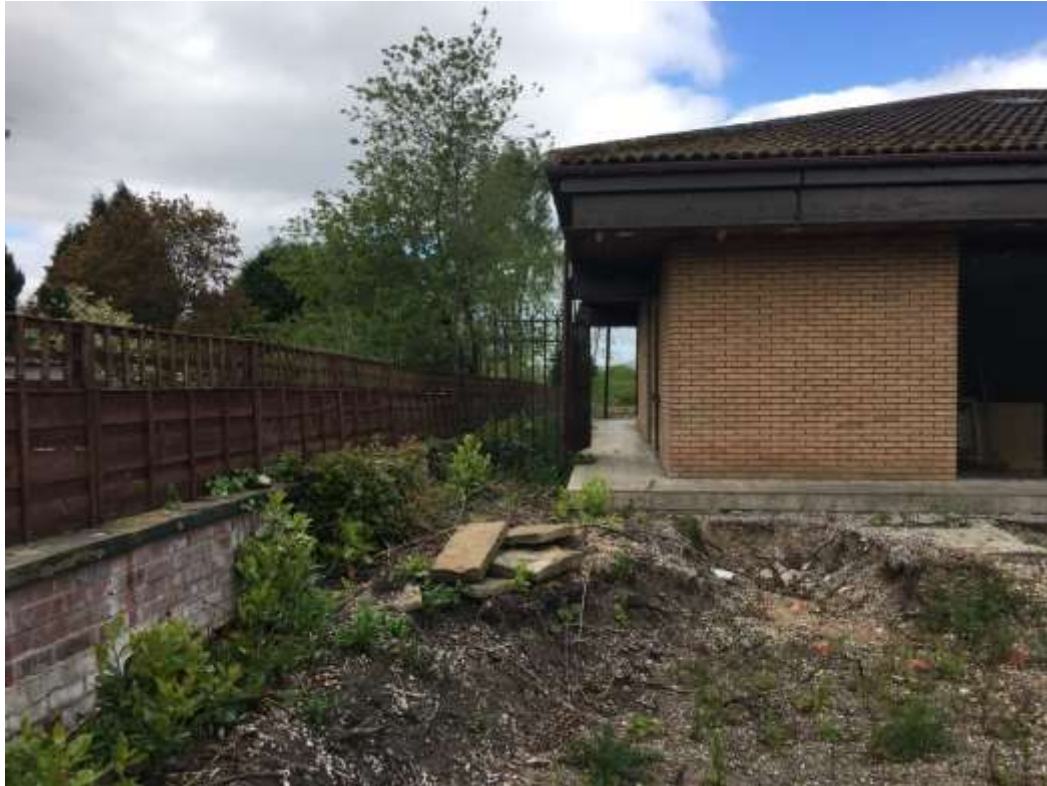
**Photograph 2: View northwest – Along western side of the existing property**

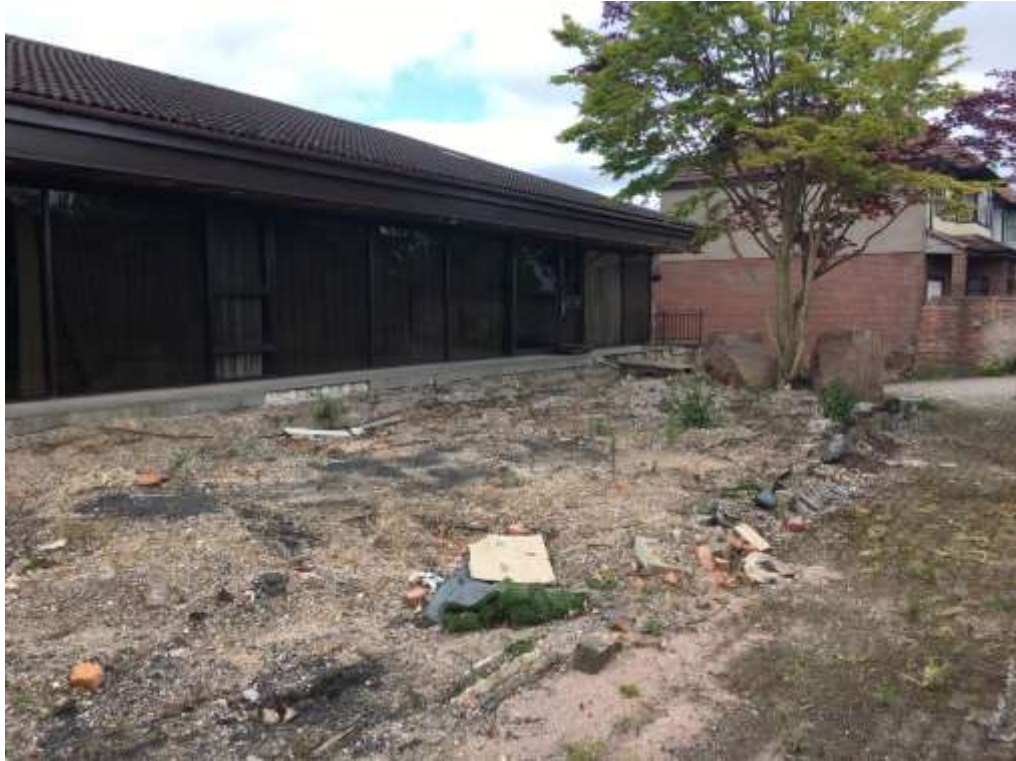
**Photograph 3: View northeast along the front /southern side of the exiting property showing the area where the trees once were**

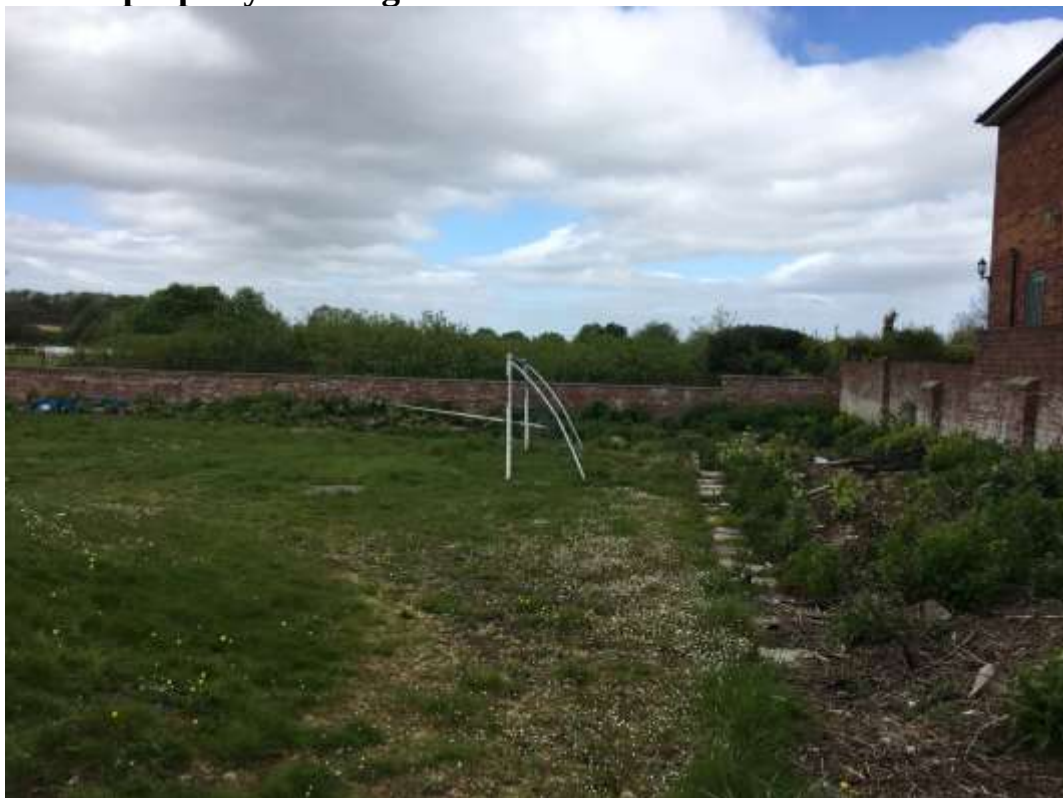
| <b>Table 2: Summary of Description of the Site and its Environs</b> | |
|---|---|
| <b>Services</b> | Several service covers were noted in the grassed back garden, a further cover was noted adjacent to the underground garage on the eastern side of the site. It is likely that most of the services are located on the southern side of the site from the main road, but this cannot be confirmed at this stage. |

**Photograph 4: General view north of the rear garden area. Note service cover near the goalposts in the picture**

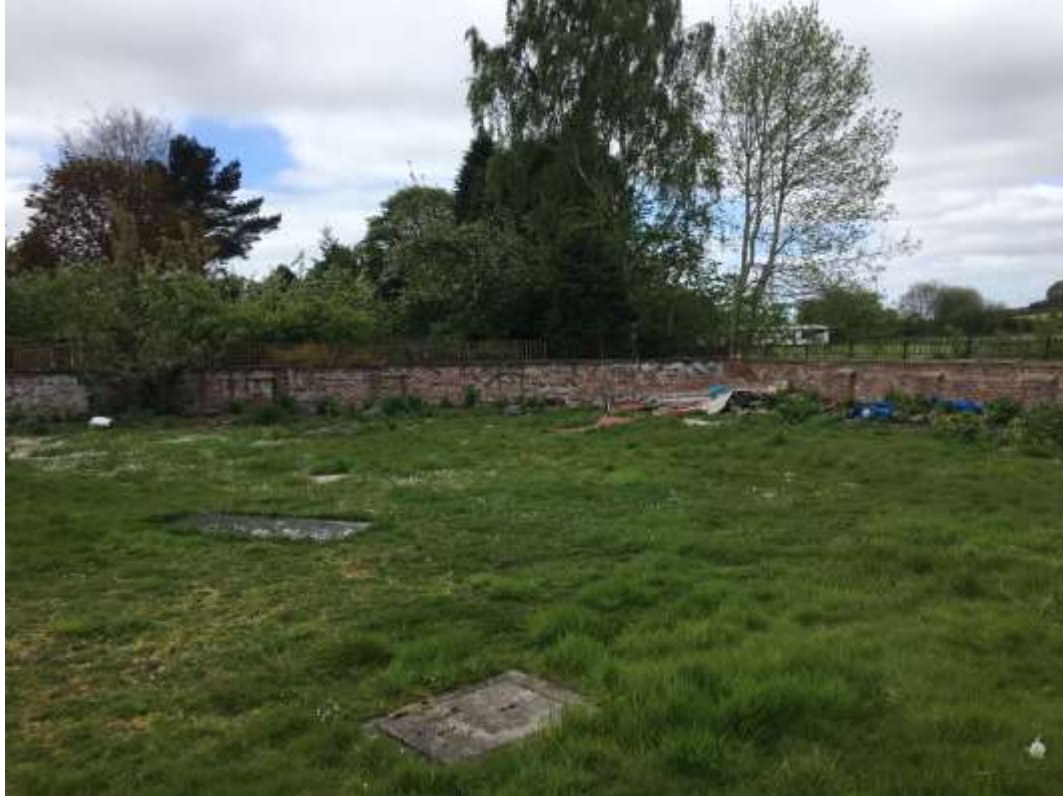
| <b>Table 2: Summary of Description of the Site and its Environs</b> | |
|---|---|
| <b>Waste Disposal/ Materials Storage</b> | A pile of demolition rubble was noted in the north-western corner of the site, at the site of a former structure (possibly a shed). Several blue plastic bags were also noted on the northern border near the pile of demolition waste. Along the south side of the building, there was an area where there had been some demolition next to the house. |

**Photograph 5: View northwest across the garden area, note former demolished structure in the background and service cover in the foreground**

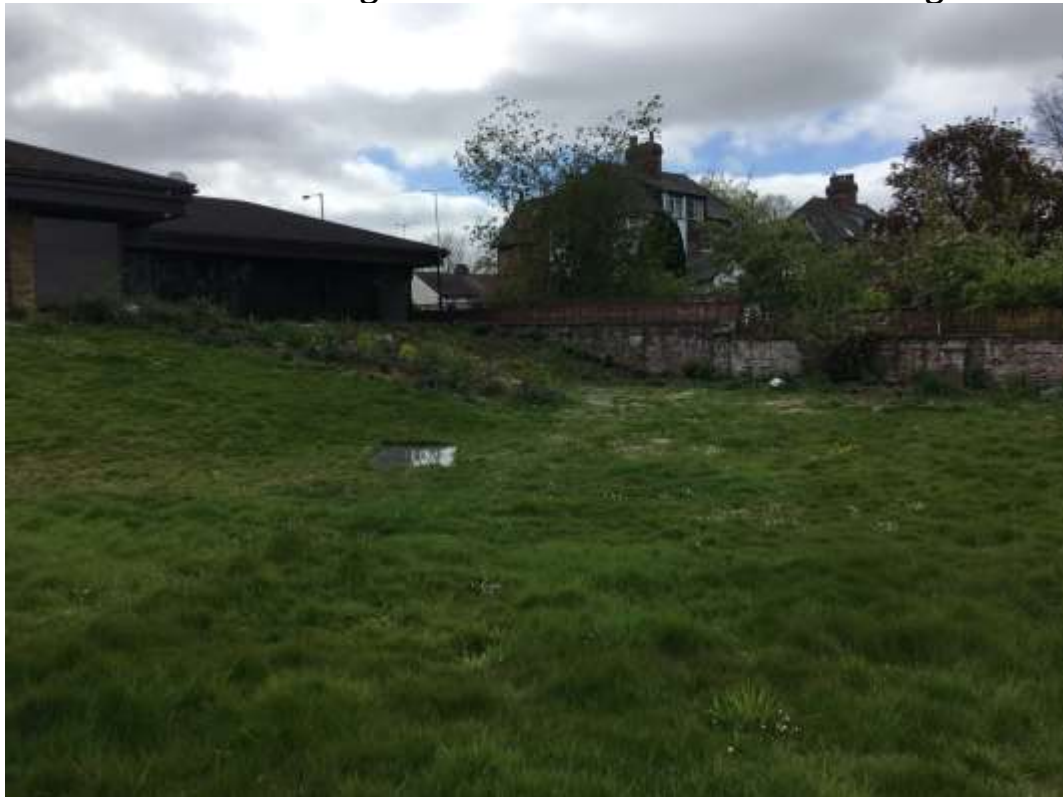
| <b>Table 2: Summary of Description of the Site and its Environs</b> | |
|---|---|
| <b>Vegetation</b> | Grass and weed covered borders were noted to the north of the site in the former back garden area. A vegetated rockery was noted to the immediate north of the residential property. The majority of the trees noted on google mapping had been cut down prior to the walkover. |

**Photograph 5: View southwest from garden towards existing structure, also showing rockery area**

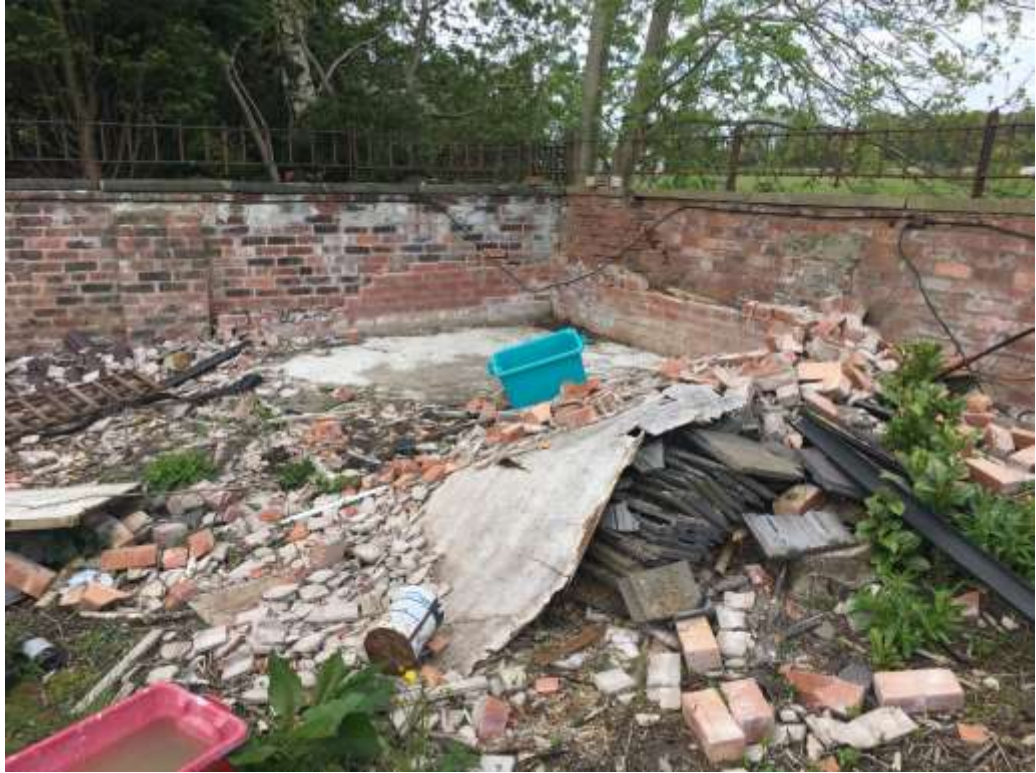
**Photograph 6: Close up view of demolished structure in the northwest corner of the site**

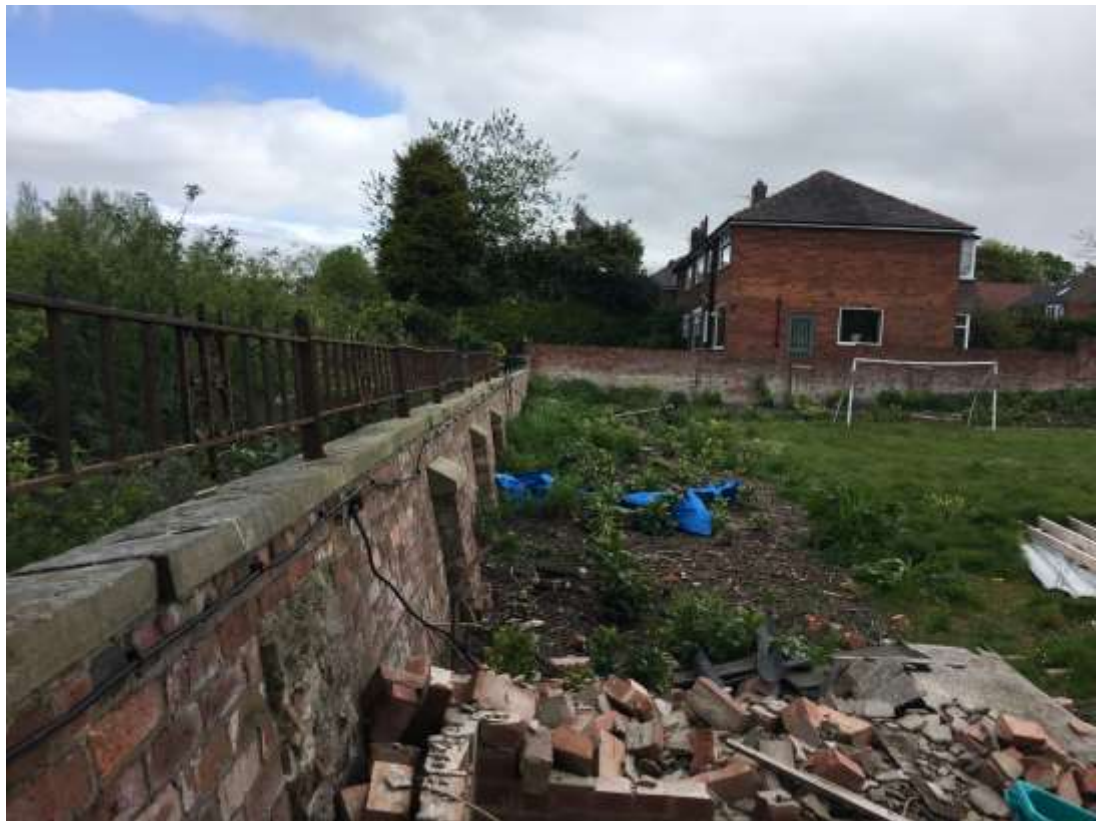
**Photograph 7: View east along northern boundary of the site**

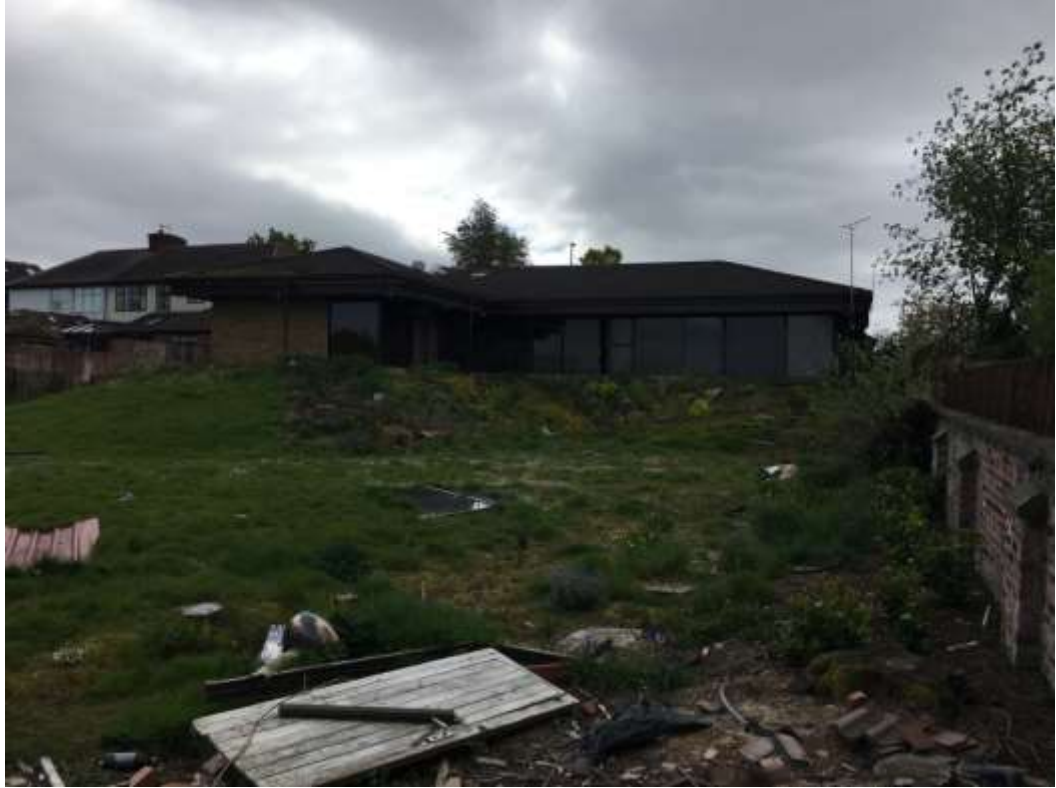
**Photograph 8: General view south from northwest corner of the site showing existing property**

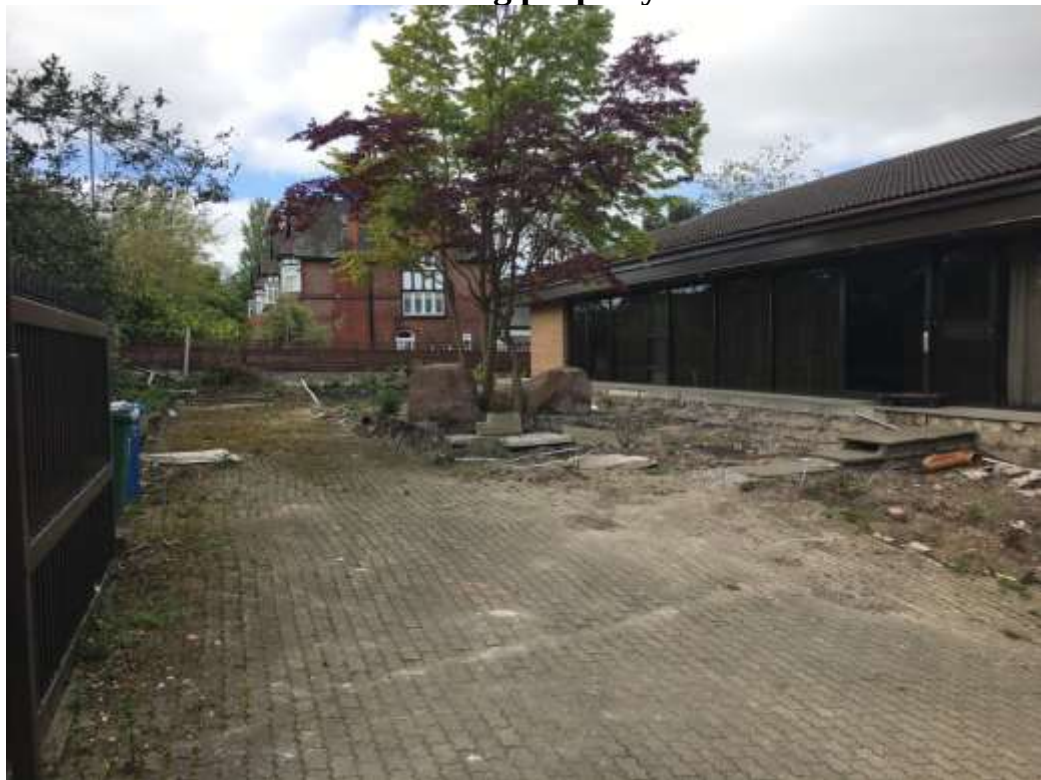
| <b>Table 2: Summary of Description of the Site and its Environs</b> | |
|---|---|
| <b>Site Surface</b> | Block paving hardstanding was located on the southern half of the site along the southern, eastern, and part of the western sides of the site. There was evidence of settlement as the surface was uneven and the brick alignments were locally out of alignment. This suggested poor construction of the paving. There were some large ornamental sandstone boulders.<br><br>A grass covered area was noted to the north of the site (back garden), other areas of soft cover/ Made Ground were noted to the south and western side of the site where vegetation used to be located. |

**Photograph 9: View southwest along southern side of the site where the trees used to be**
