**Bevis Green Works (Tetrosyl)  
Mill Road, Bury, BL9 6RE**

**Vapour Risk Assessment (Plot 48)**

**For: Barratt Homes Ltd.**

**Report Ref: R2174-R13-v1**

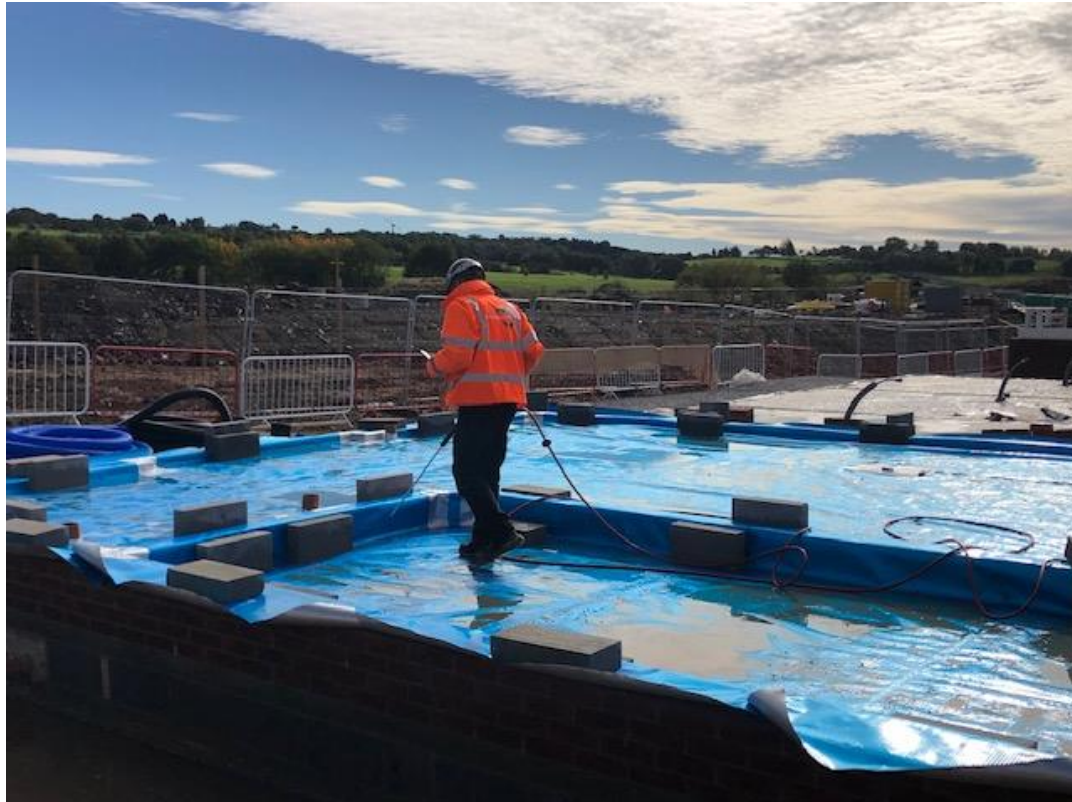
On the 6<sup>th</sup> October 2021 from 12:30 to 13:30 the installation of Visqueen Gas Barrier Proprietary Membrane on plot 48 (Detached) was inspected and found to be in an excellent condition. 100% Air-Lancing of the plot was conducted.

Barratt Bury Photograph 2: VISQUEEN GAS BARRIER Membrane:

| slab/membrane condition | ✓ | 10. Good condition, minimal traffic marks and no stress points observed during inspection. | | | | |
| laps and joints | ✓ | 11. Laps >150mm with taped seam seals. | | | | |

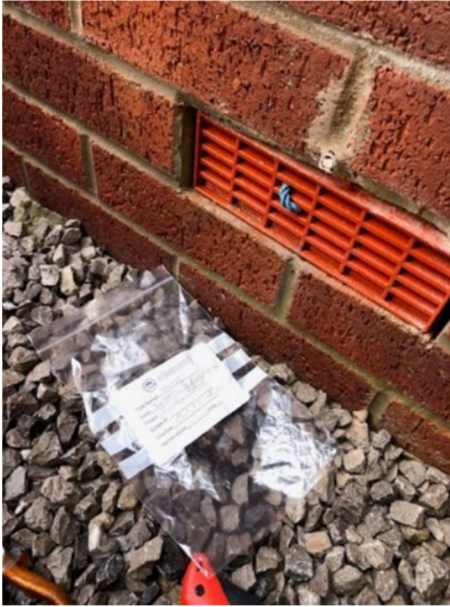
1.

- 2.4.2. The front cover of an airbrick along the gable end of the property was partially removed and a diffusion tube secured to a copper wire was inserted through the airbrick and down the telescopic vent. It is acknowledged that there are limitations to this method, as outlined within CL:AIRE TB16, in that the angle of the venting typically limits any monitoring device from entering into the void

Plot 48 sub-floor void monitoring.

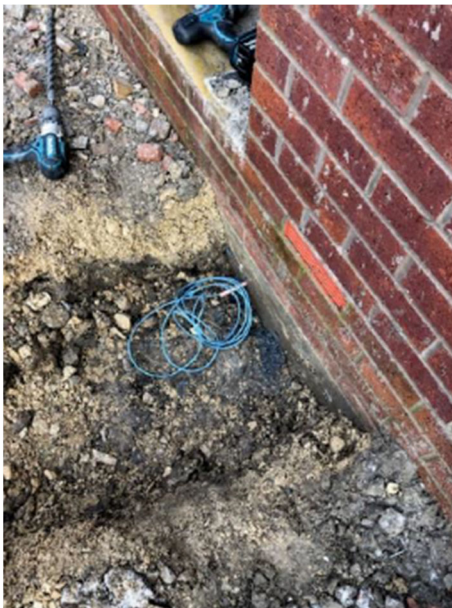
3.

Installation of diffusion tube attached to metal rod into void space. Rope secured for recovery

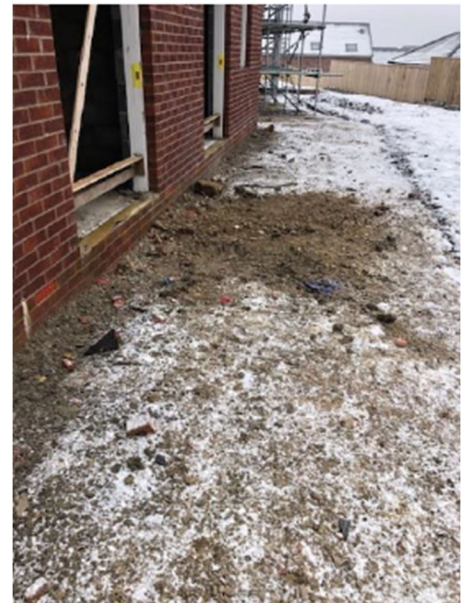
4.

Monitoring location temporarily backfilled to avoid destruction during site works
