**Job title:** Tetrosyl Bevis Green Works,  
Bury

**Report type:** Verification Report (Phase 1B)

| Document Control Form | | |
|---|---|---|
| REPORT NAME | VERIFICATION REPORT, GAS ASSESSMENT & BUILD PHASE REMEDIATION (PHASE 1B) | |
| REPORT REFERENCE | GRO-21459-3559 | |

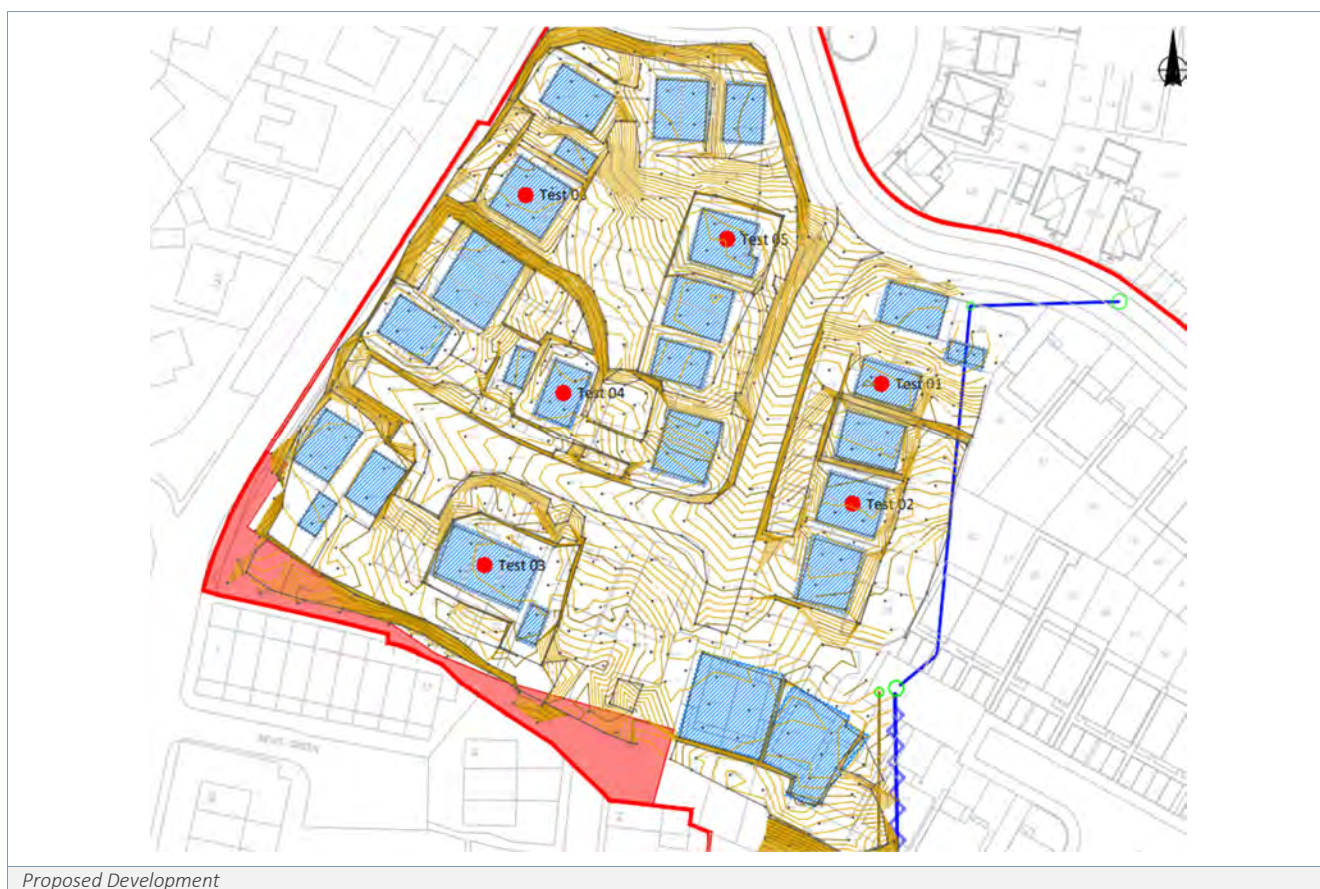
Phase 1B is to be developed by a different housebuilder for the same residential end use, it is intended to handover with the pre-construction remediation measures already completed and ready to commence construction. A developable platform levels plan is presented in the table below.

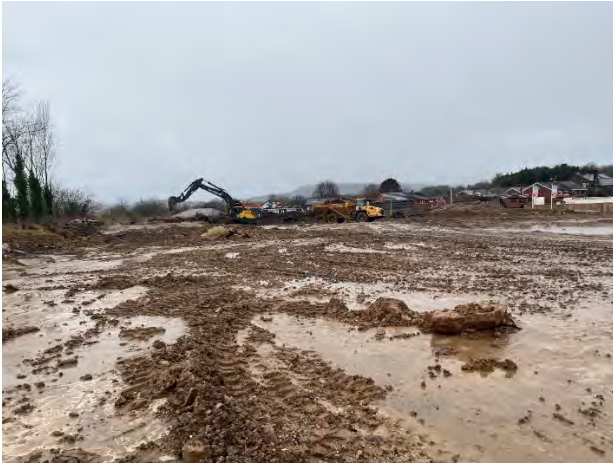
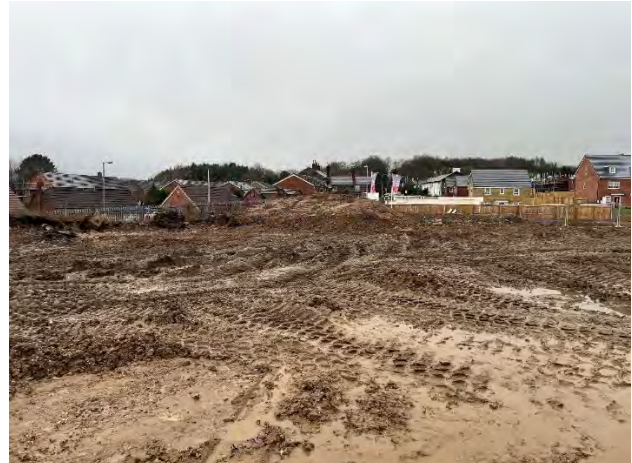
Photograph 1 – Western extent of reduced level dig.

The topsoil and spoil heaps were removed to Phase 2 prior to the reduced level dig and stockpiled for reuse as part of the residential development onsite.

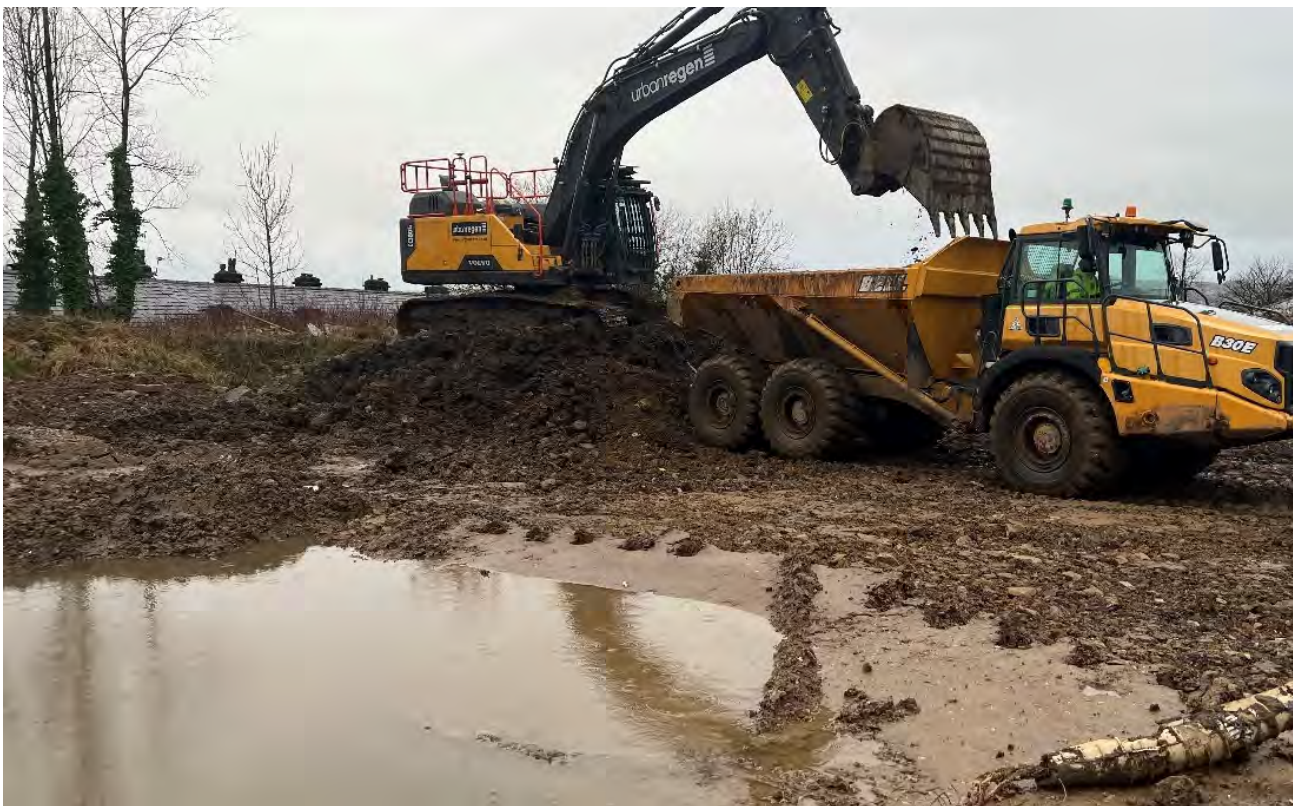
Photograph 2 – Stockpile/vegetation clearance at former car park area.

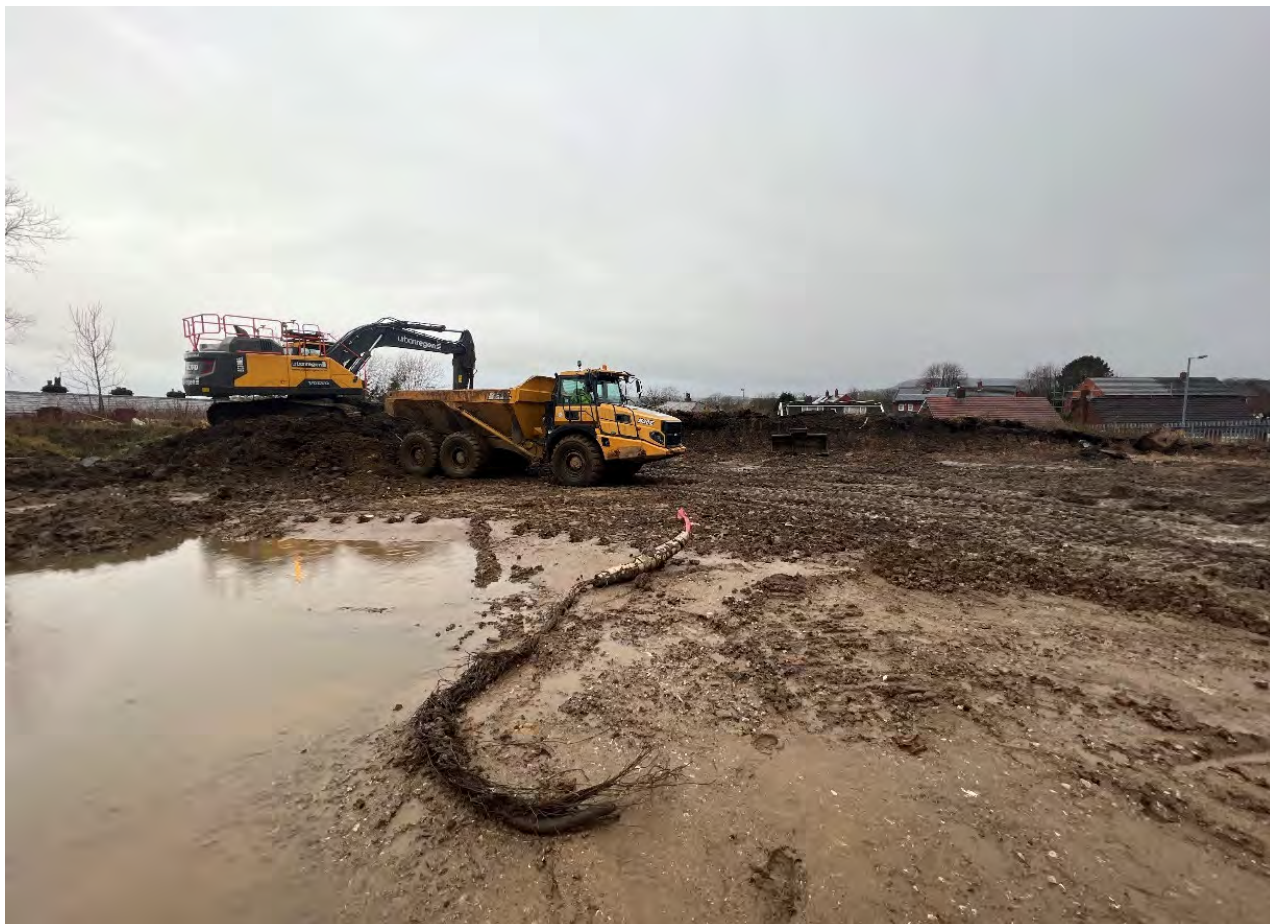
The following visit was undertaken to observe the initial excavations at the western extent of site for any sources of permanent ground gases. Natural soils were encountered with no evidence of organic contamination at this position.

Photograph 3 – Stockpile/vegetation clearance at former car park area.

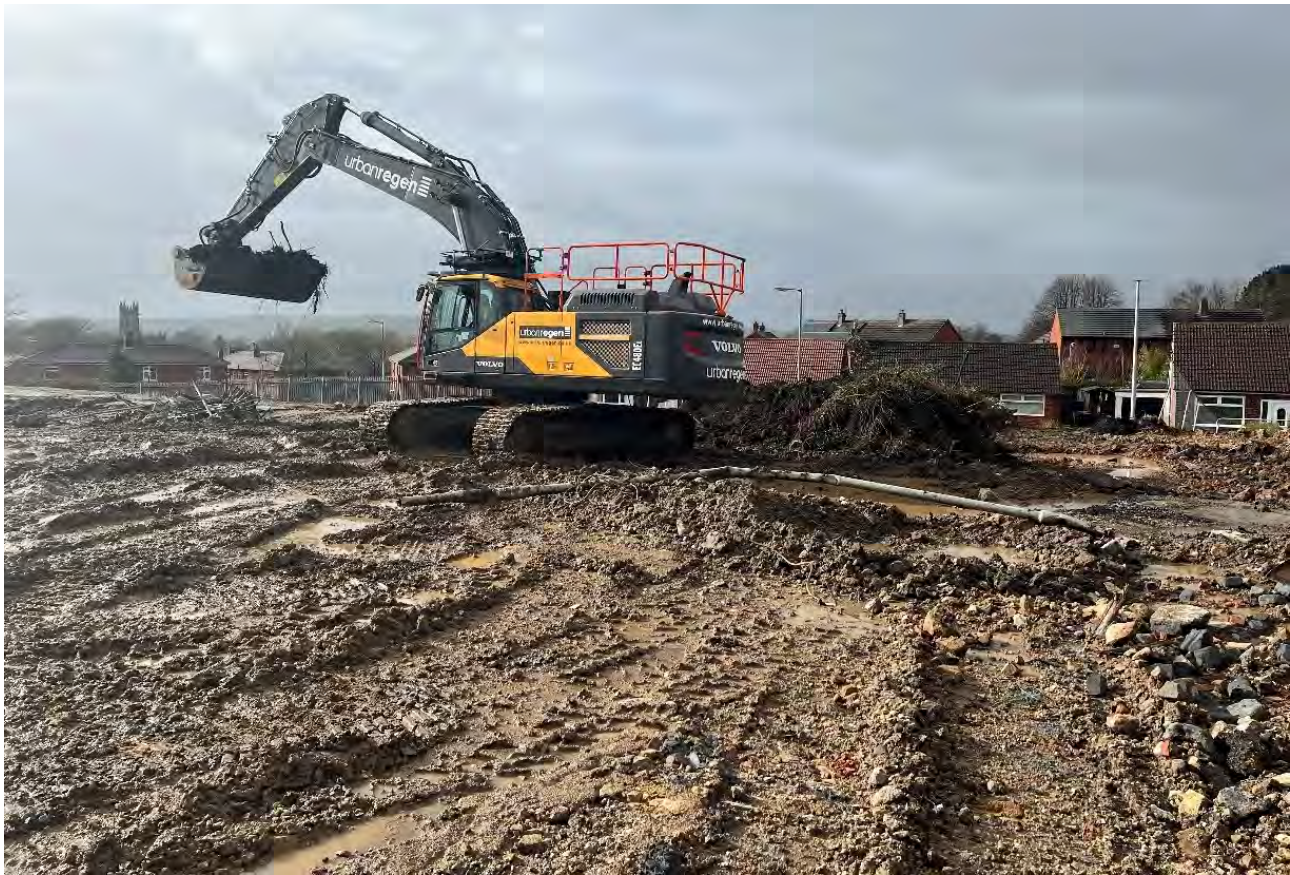
Photograph 4 – Excavation of overlying vegetation at western site boundary.

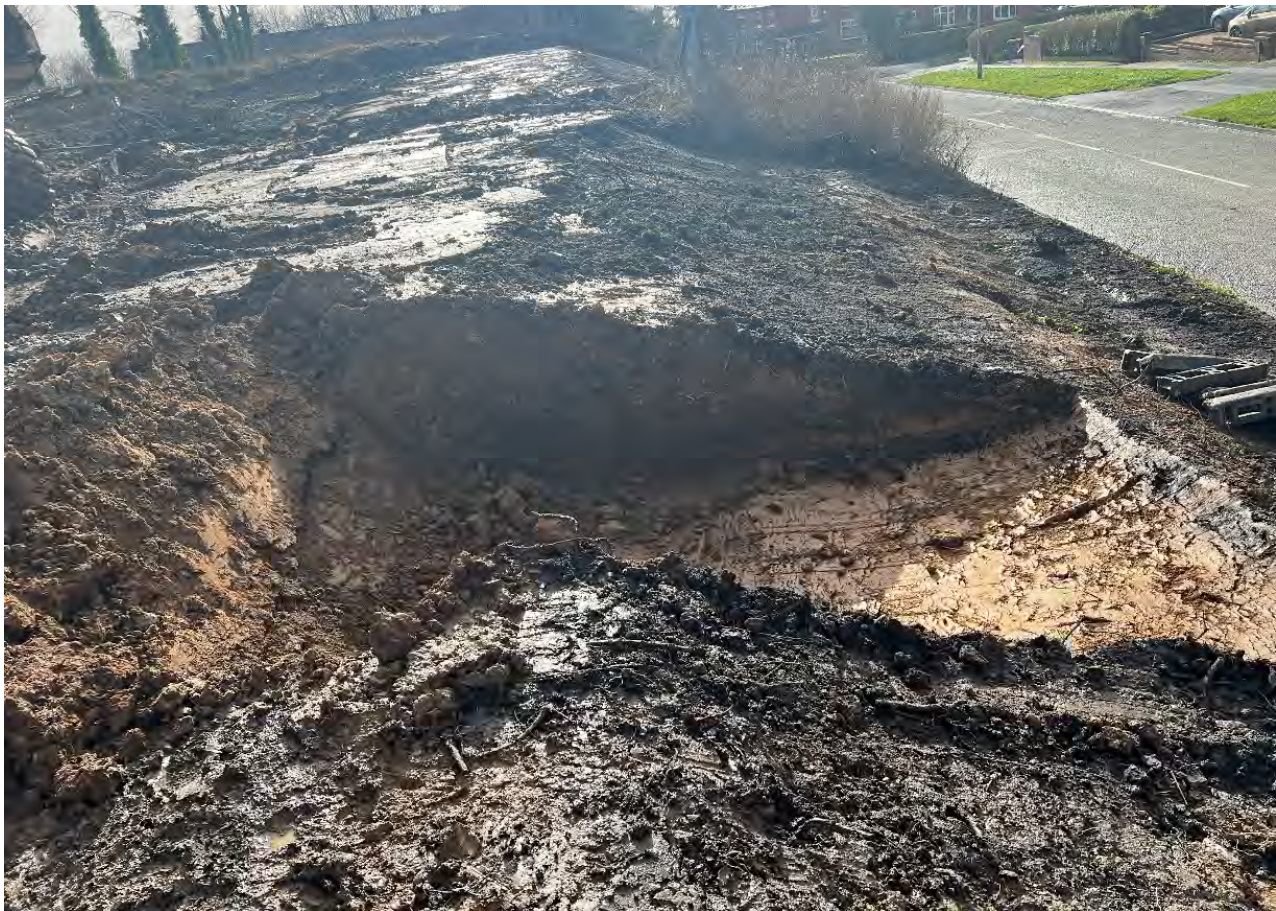
All soils excavated from the ground were inspected for evidence of a ground gas source, no evidence of a was noted at the extreme western end of site within the Made Ground or reworked clay to formation level (circa 4m bgl).

*Photograph 5 – Excavation into reworked clay at western extent.*

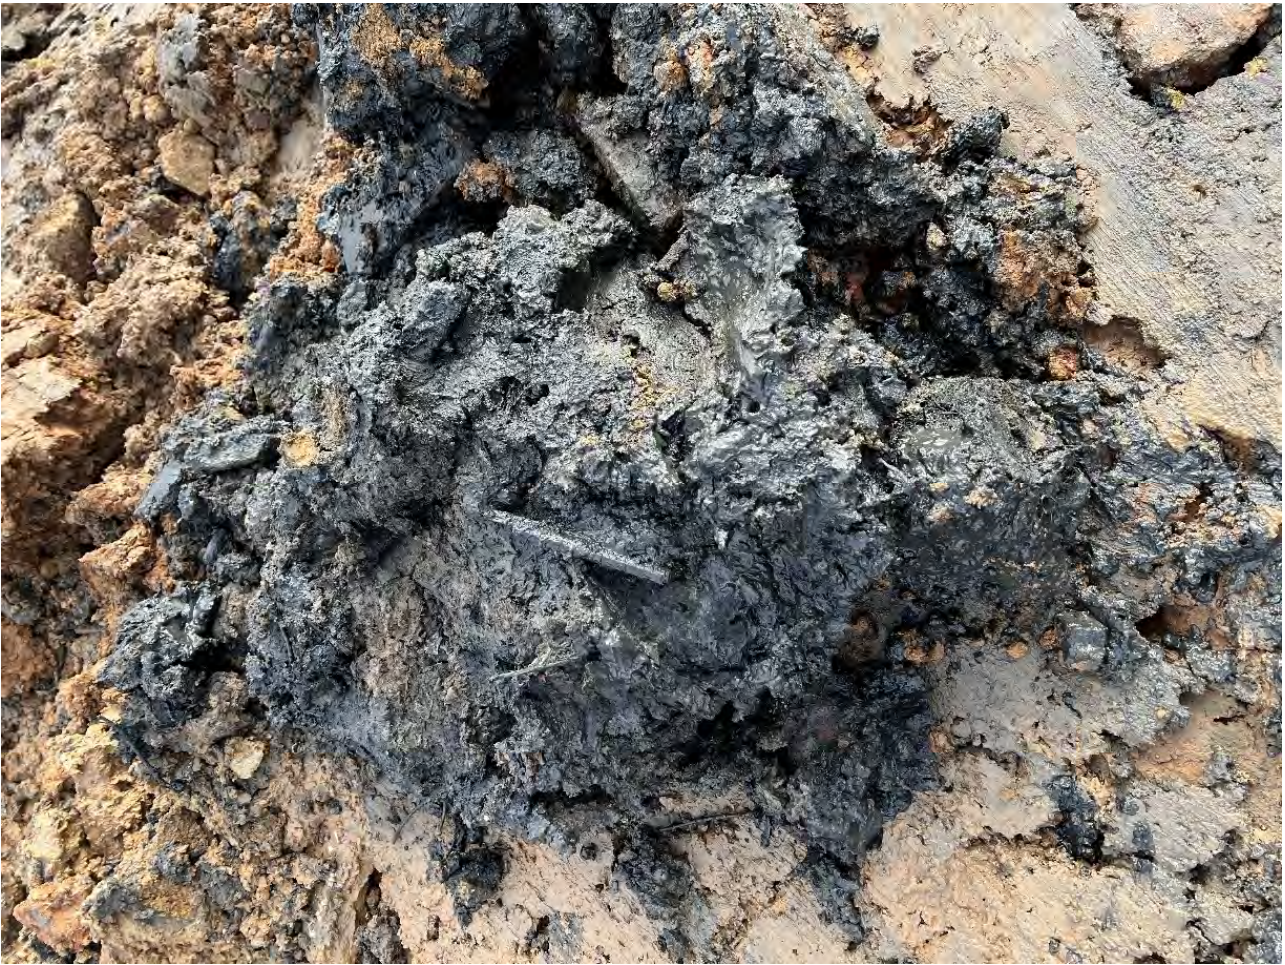
Several trial pits were undertaken to determine the source of contamination and a potential source was noted within the Made Ground in the form of slightly clayey silty slightly gravelly sand with minor constituents of wood and a mild organic odour.

*Photograph 6 – Possible evidence of source of methane located within Made Ground.*

All soils which contained putrescible or organic material and posed a potential source of ground gas generation were segregated, removed from Phase 1 and stockpiled at a secure position in the Phase 2 area separate to the 'clean' material identified for reuse within the earthworks exercise, as agreed with Urban Regen. Site personnel were made aware of the material to be removed and additional visits were arranged to ensure the correct material is being removed and for any further evidence of a ground gas source.

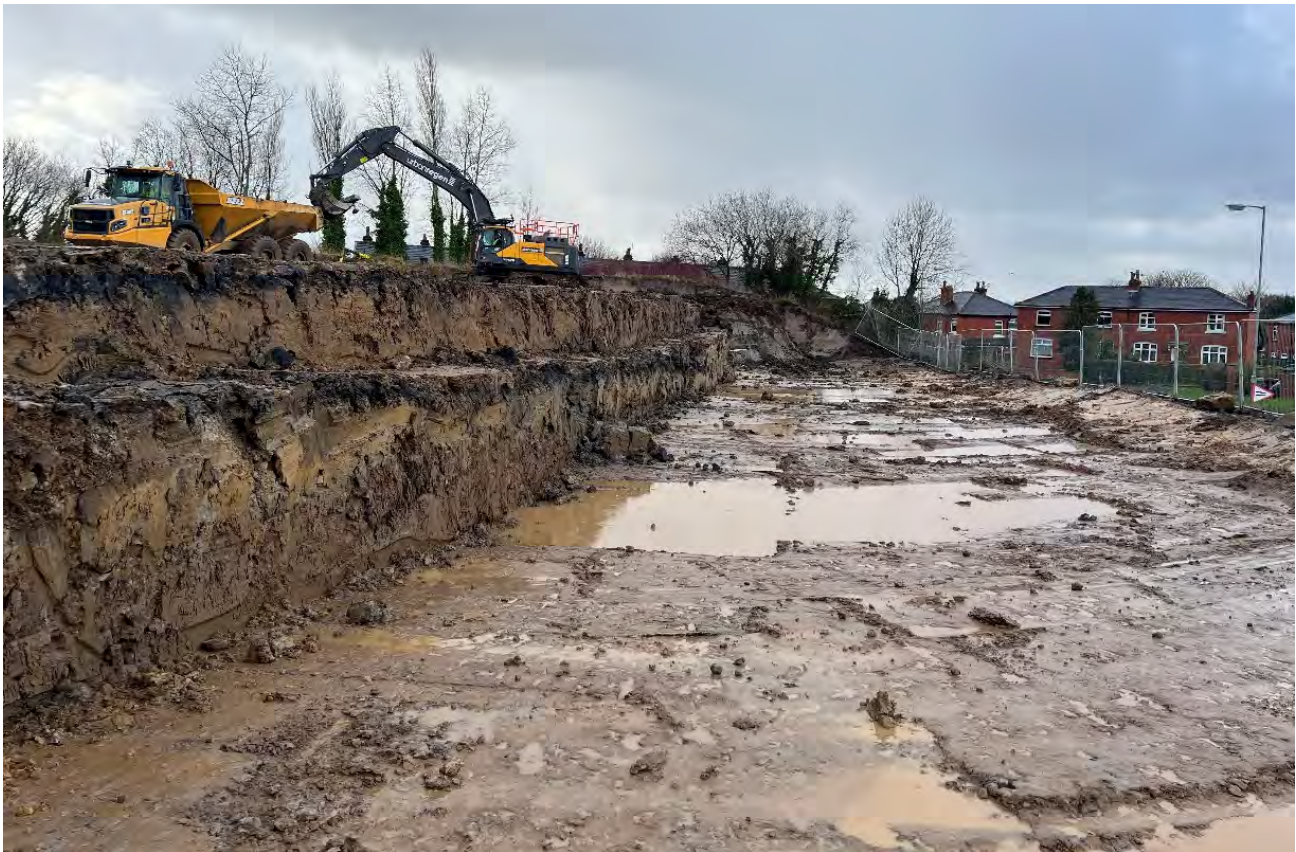
*Photograph 7 – Progress of reduced level dig.*

The majority of the western area had been excavated down almost to formation level as shown in the photograph above, reworked clay is present at this depth with no evidence of organic materials/silt present. Visual and olfactory evidence of possible permanent ground gas sources were noted within the Made Ground in the form of high organic content and a mild organic odour. These soils were stockpiled separately in Phase 2 for evaluation on reuse dependant on the results of additional geo environmental testing.

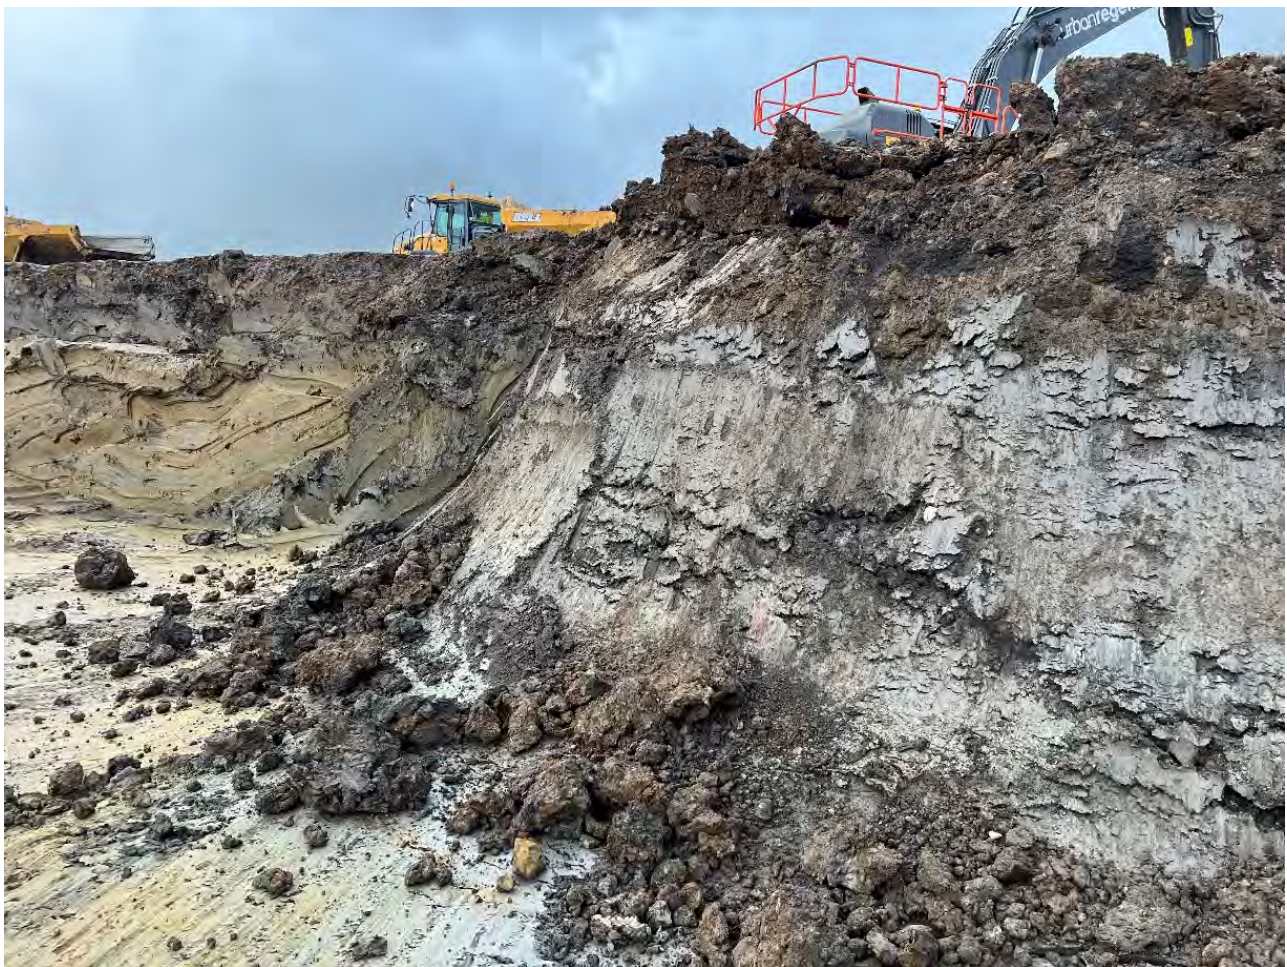
*Photograph 8 – Cross profile from existing level to formation.*

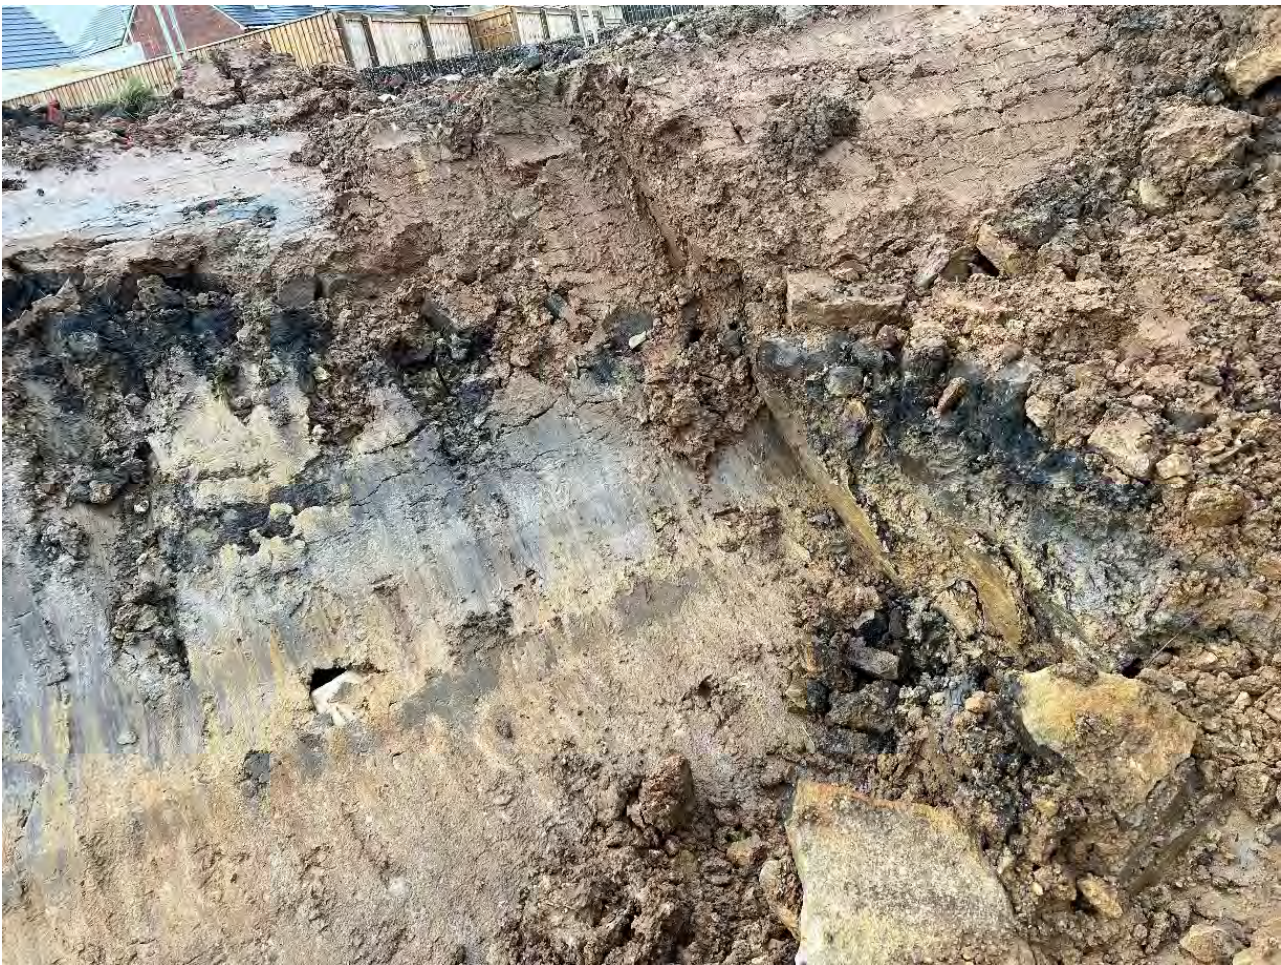
Photograph 9 – Excavation at western extent.

Thin bands of organic material show near the surface bands of organic material (photograph 9) which was removed from Phase 1B and stockpiled in Phase 2 as the reduced level dig was progressed down to formation level.

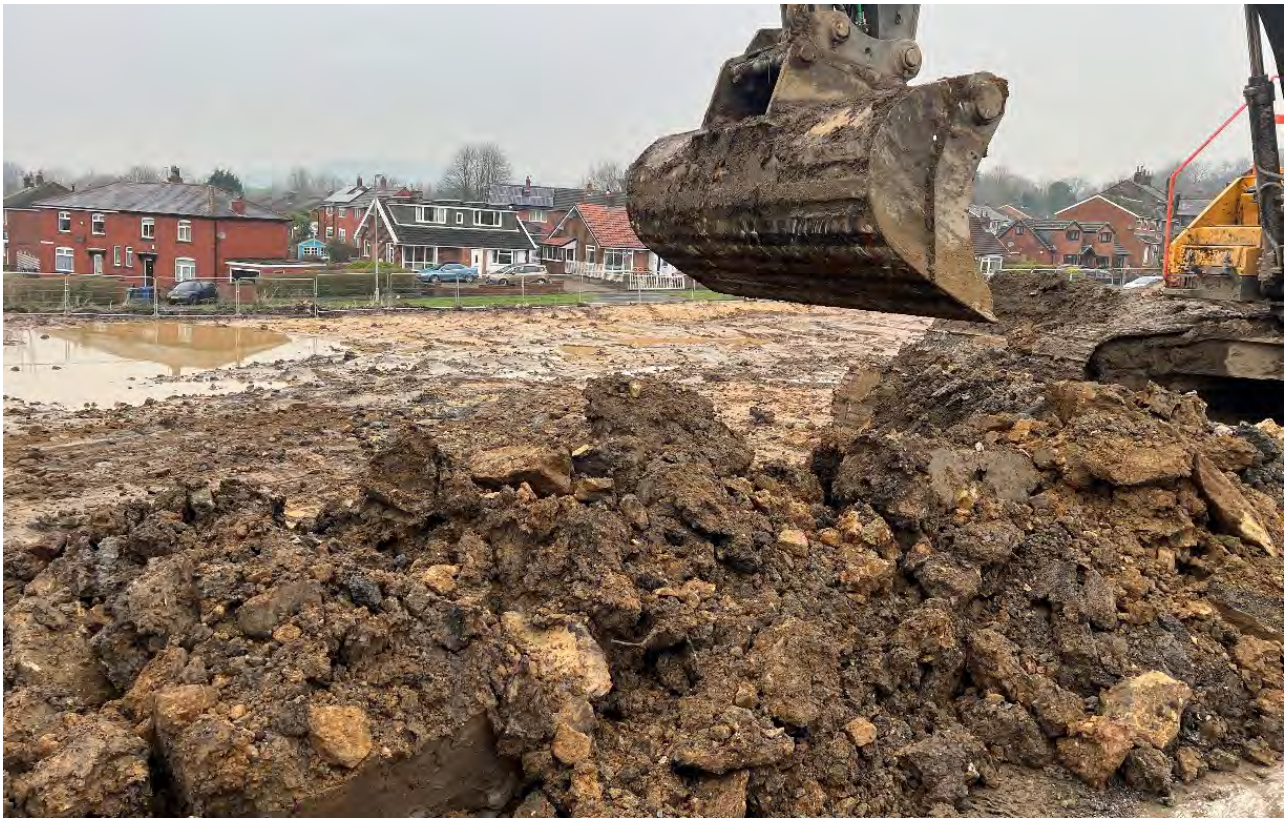
Photograph 10 – Excavation of reworked clay and reduced level dig progress west.

No evidence of sources of ground gases such as silt/organic material was identified as part of the excavation with the exception of some evidence of relict topsoil present at circa 2m bgl within the Made Ground likely to be associated with the former reservoir. The areas of relict topsoil were observed across centre west of site near the position of WS316 which has been previously classified as CS2/Red. The soils containing the organic material were removed from Phase 1B and stockpiled separately in Phase 2 alongside the other soils which contained potential sources of ground gas generation. The above is presented spatially on the Groundtech Excavation Progress Plan which outlined the postulated extent of the former reservoir and locations of the previously installed Gas monitoring wells.

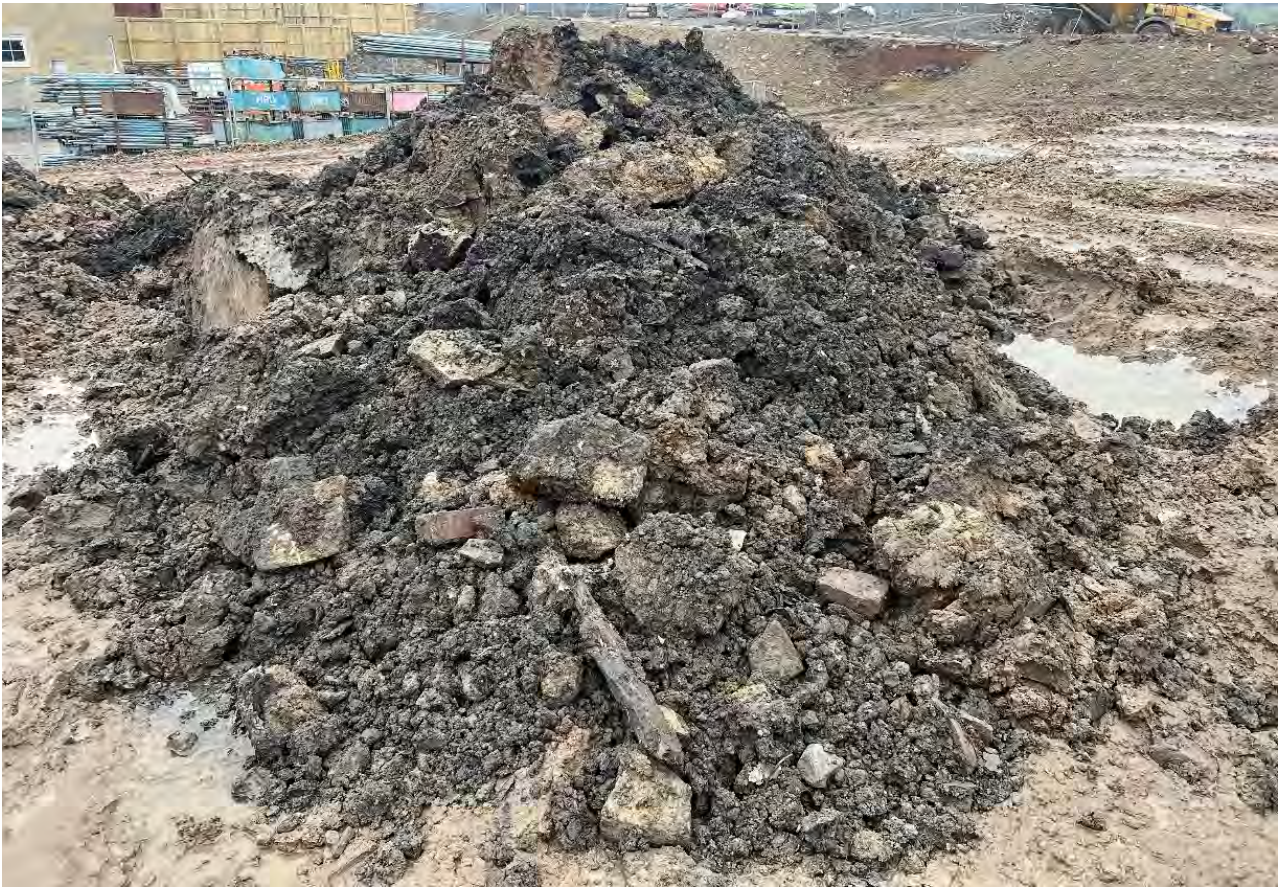
*Photograph 11 – Evidence of possible sources of methane contamination.*

Additional evidence of organic containing material was observed within the deeper areas of Made Ground and is presented in *Photograph 11* above which was taken prior to stockpiling the material in Phase 2. The organic material is considered to be a source of ground gases associated with the former reservoir and the subsequent backfill prior to the development of the car park.

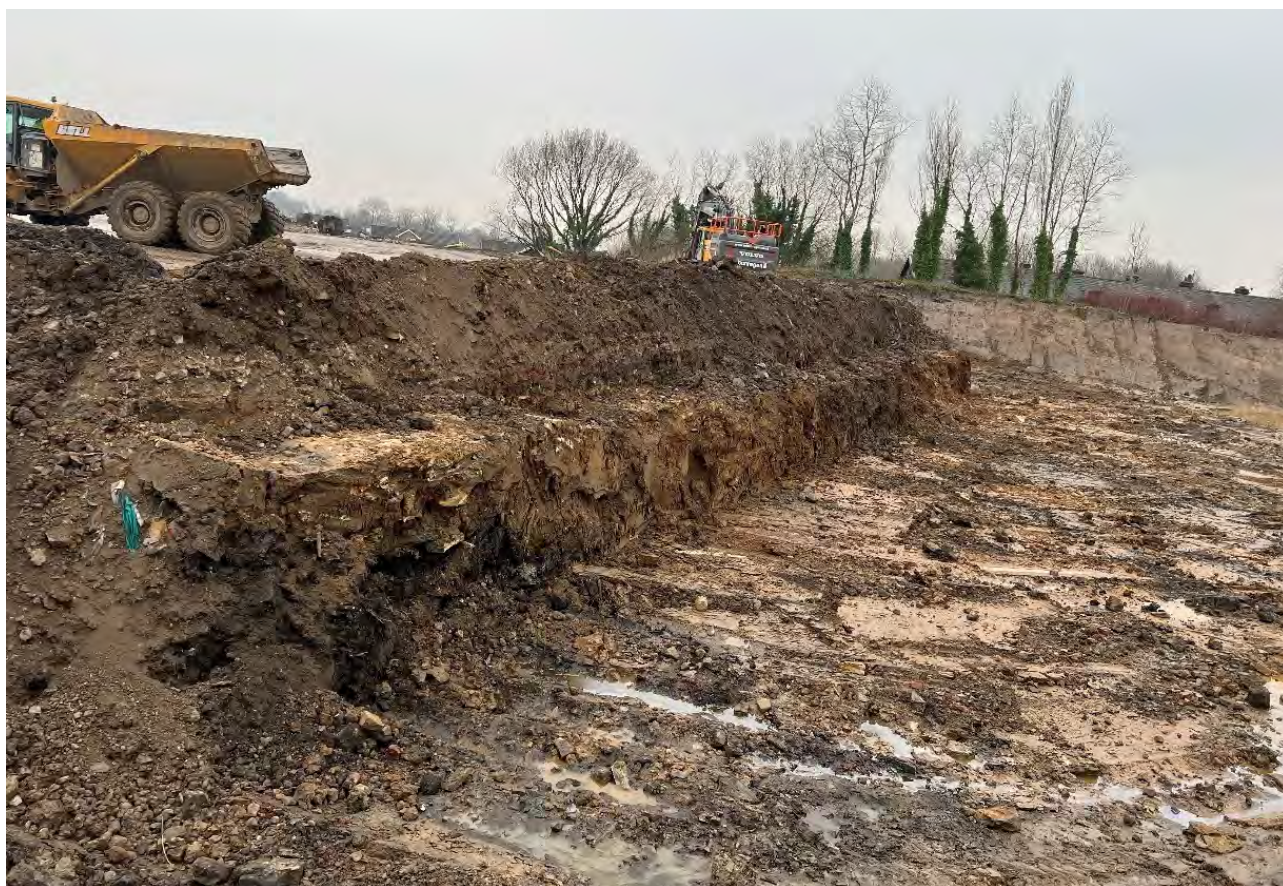
Photograph 12 – Reduced level dig progress.

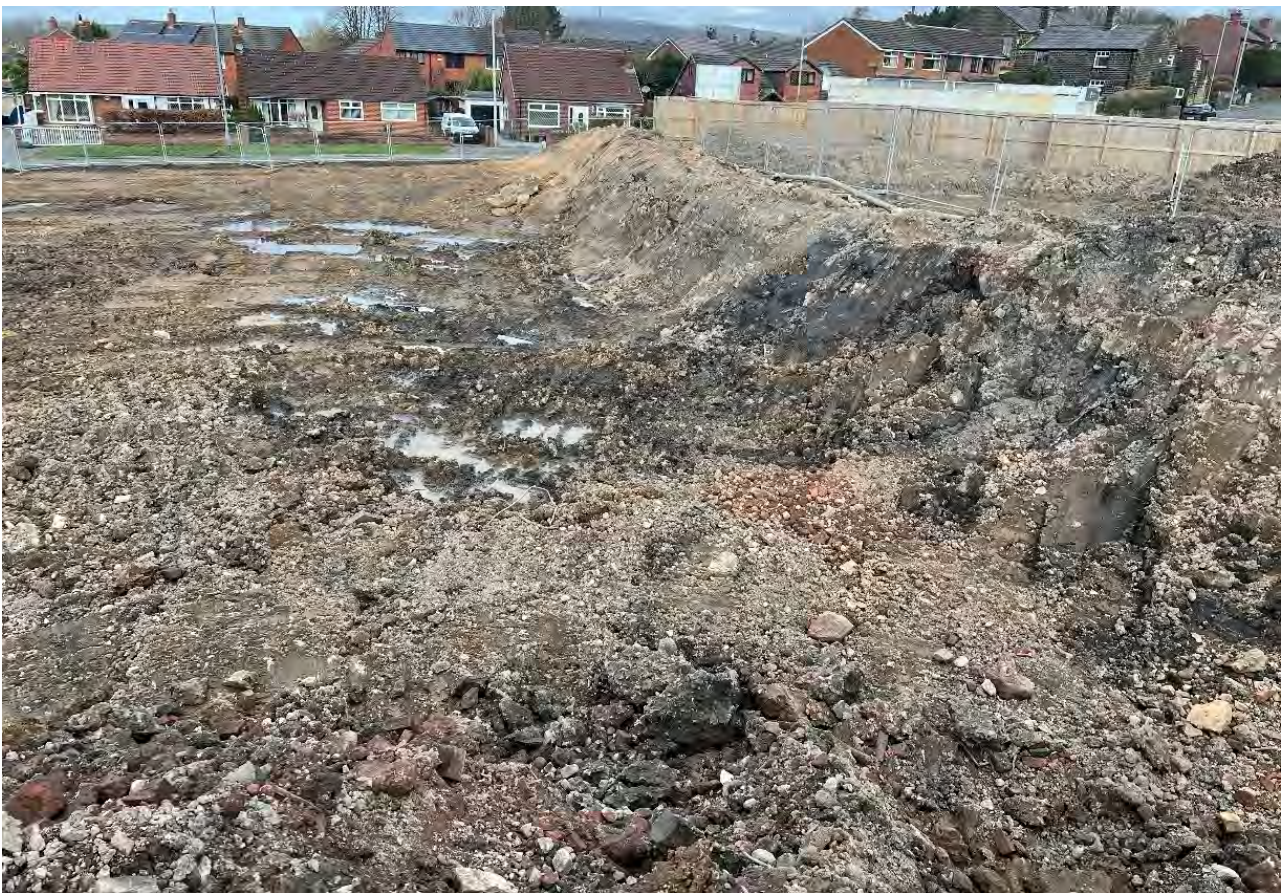
Photograph 13 – Northern extent of reduced level dig including area of hydrocarbon contamination.

The locations where hydrocarbon contamination was encountered is presented on Groundtech *Excavation progress Plan GRO-2149-P02*. No wells are indicated to directly overlie the area of hydrocarbon contamination however WS306, WS316 and WS315a are all situated very close to the affected areas and did not indicate elevated VOCs implying non-volatile fractions.

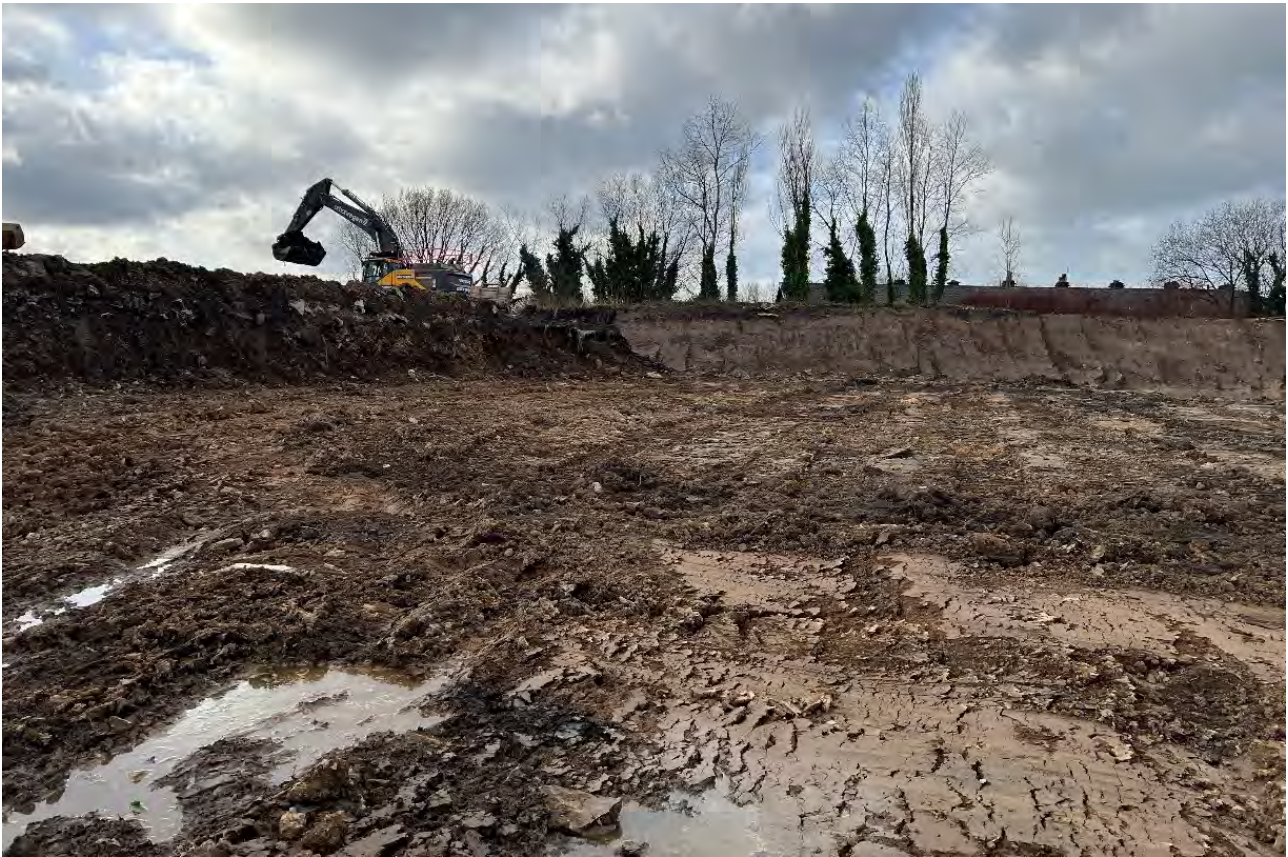
*Photograph 14 – Natural clay present at formation level (possibly reworked).*

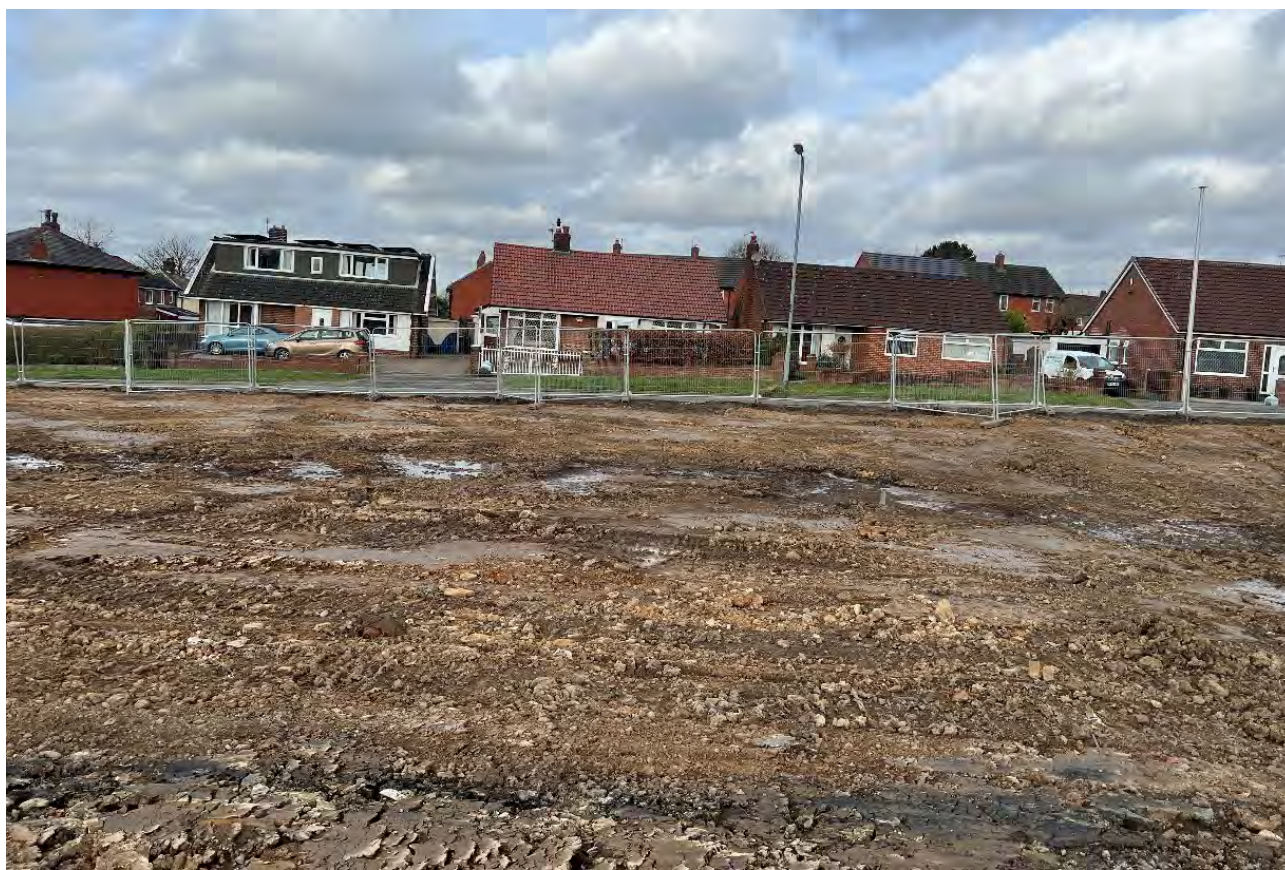
The majority of soils had been excavated laterally from the western boundary near to the east, however formation depths vary across the Phase 1B, and some minor areas of further excavation were still required. Furthermore, areas with deeper Made Ground have been excavated and removed to Phase 2 to ensure natural strata is present at the formation depth. In areas where this is not possible, the remaining in-situ Made Ground is reworked Clay with no evidence of organic contamination.

*Photograph 15 – Western site boundary with soils at near proposed formation level, some small areas of Made Ground still present at surface level.*

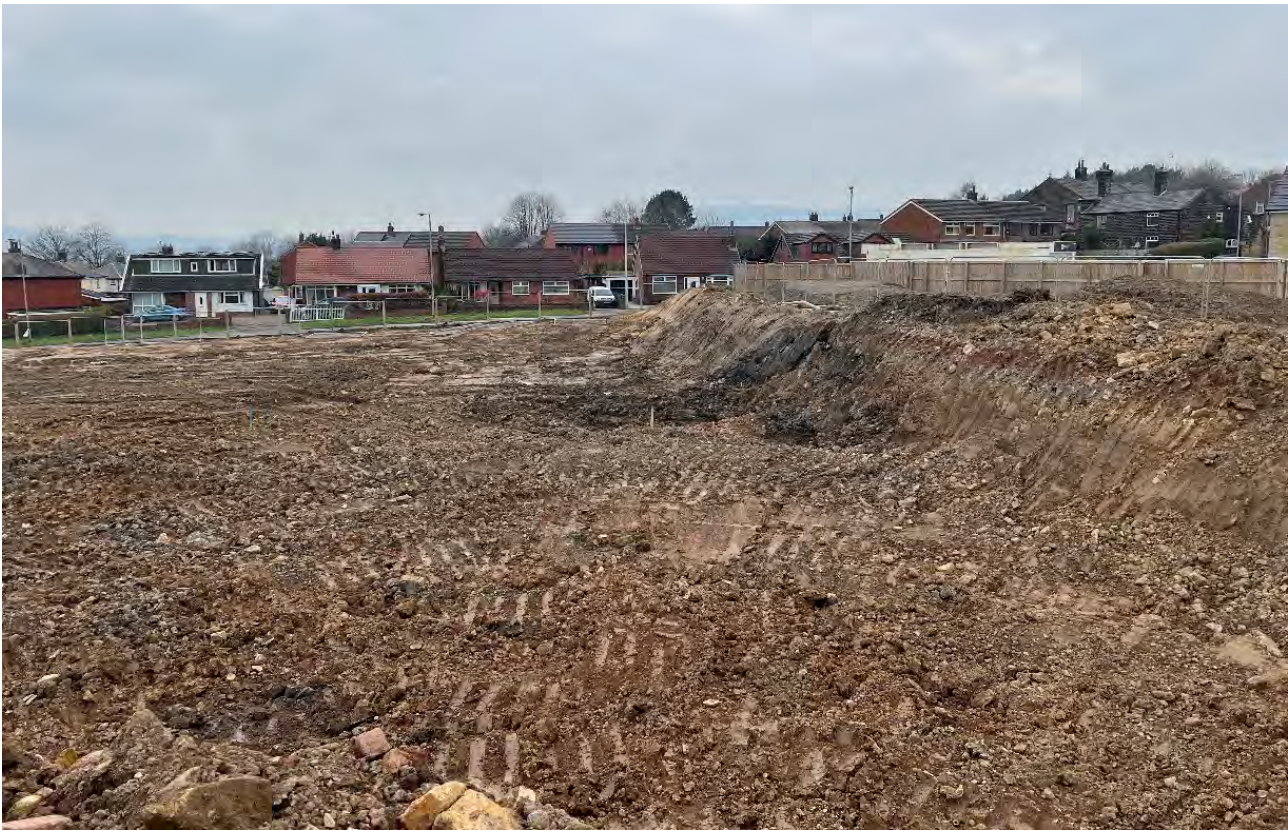
*Photograph 16 – Northern extent of reduced level dig.*

The reduced level dig has progressed further to the north since the previous visit, no additional evidence of ground gas sources had been recorded at the site within the natural Clay. Some evidence of silt bands and relict topsoil have been observed beneath the reworked Clay, these soils have been removed and stockpiled separately to the clean material as discussed with Urban Regen.

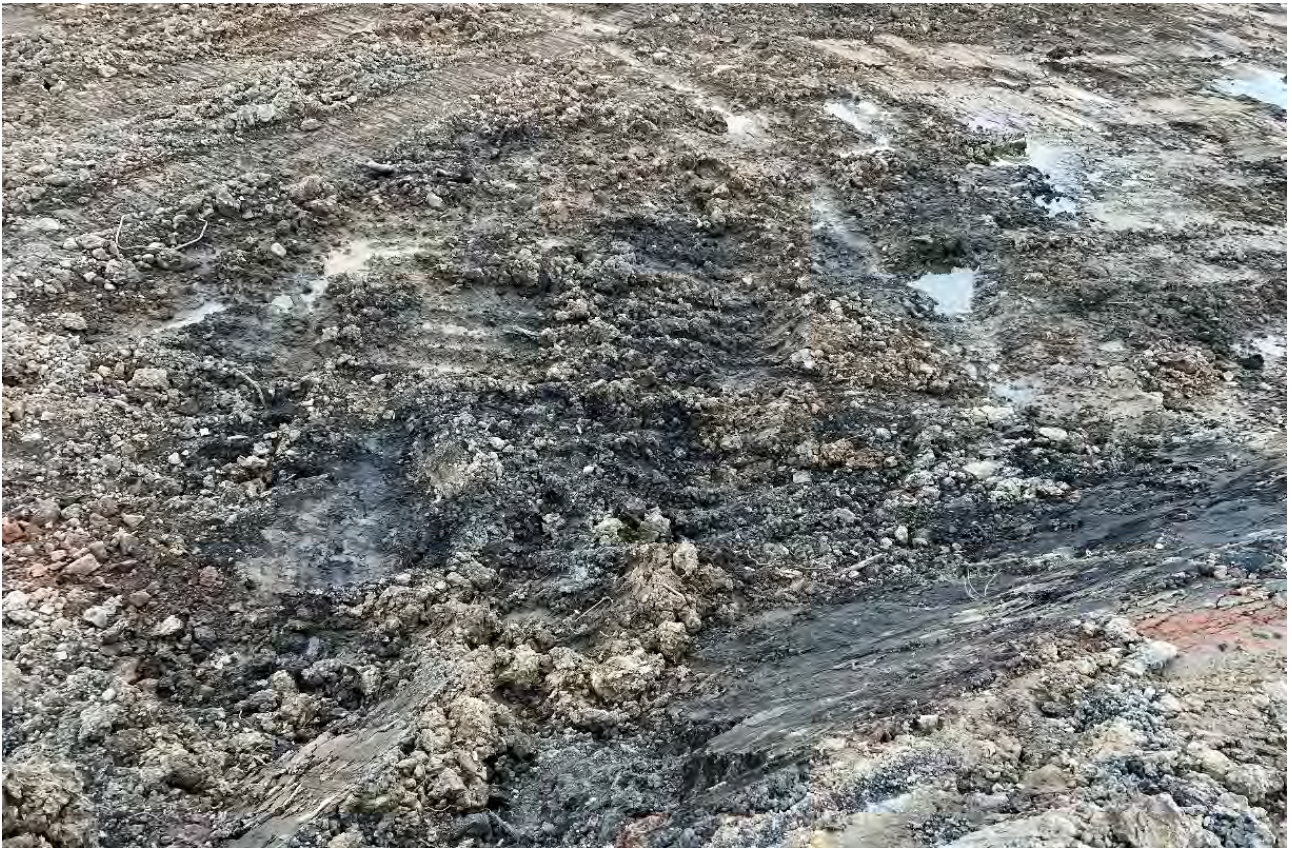
Photograph 17 – Evidence of hydrocarbon contamination.

Made Ground has been identified at areas of formation level including in the area of hydrocarbon contamination which may have migrated into the underlying natural Clay. Trimming of this area was undertaken to ensure natural ground with no organic content/silt is present at the proposed formation level due to its proximity to WS306 which has recorded high methane levels during previous ground gas monitoring.

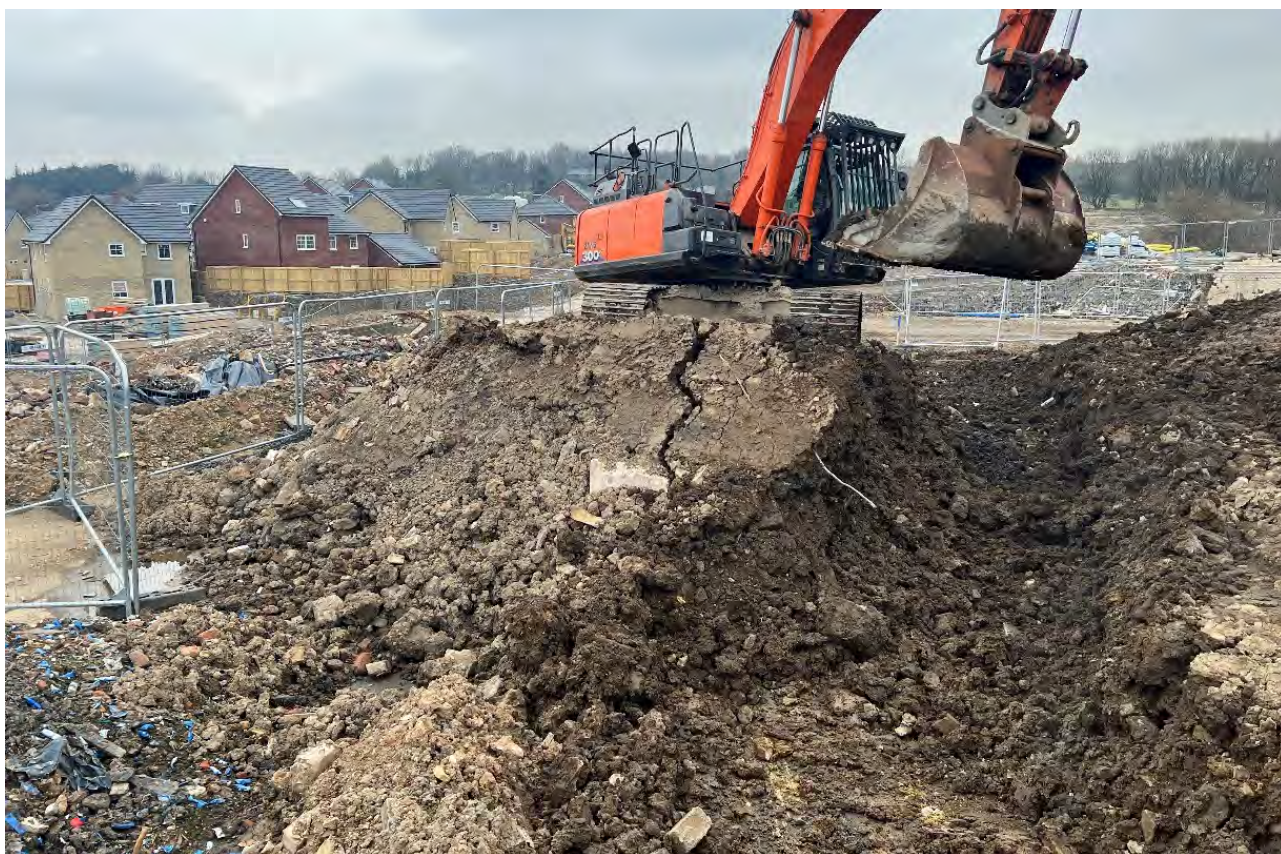
Photograph 18 – Possible sources of methane stockpile.
