**Job title:** Tetrosyl Bevis Green Works,  
Bury

**Report type:** Verification Report (Phase 1B)

| Document Control Form | | |
|---|---|---|
| REPORT NAME | VERIFICATION REPORT, GAS ASSESSMENT & BUILD PHASE REMEDIATION (PHASE 1B) | |
| REPORT REFERENCE | GRO-21459-3559 | |

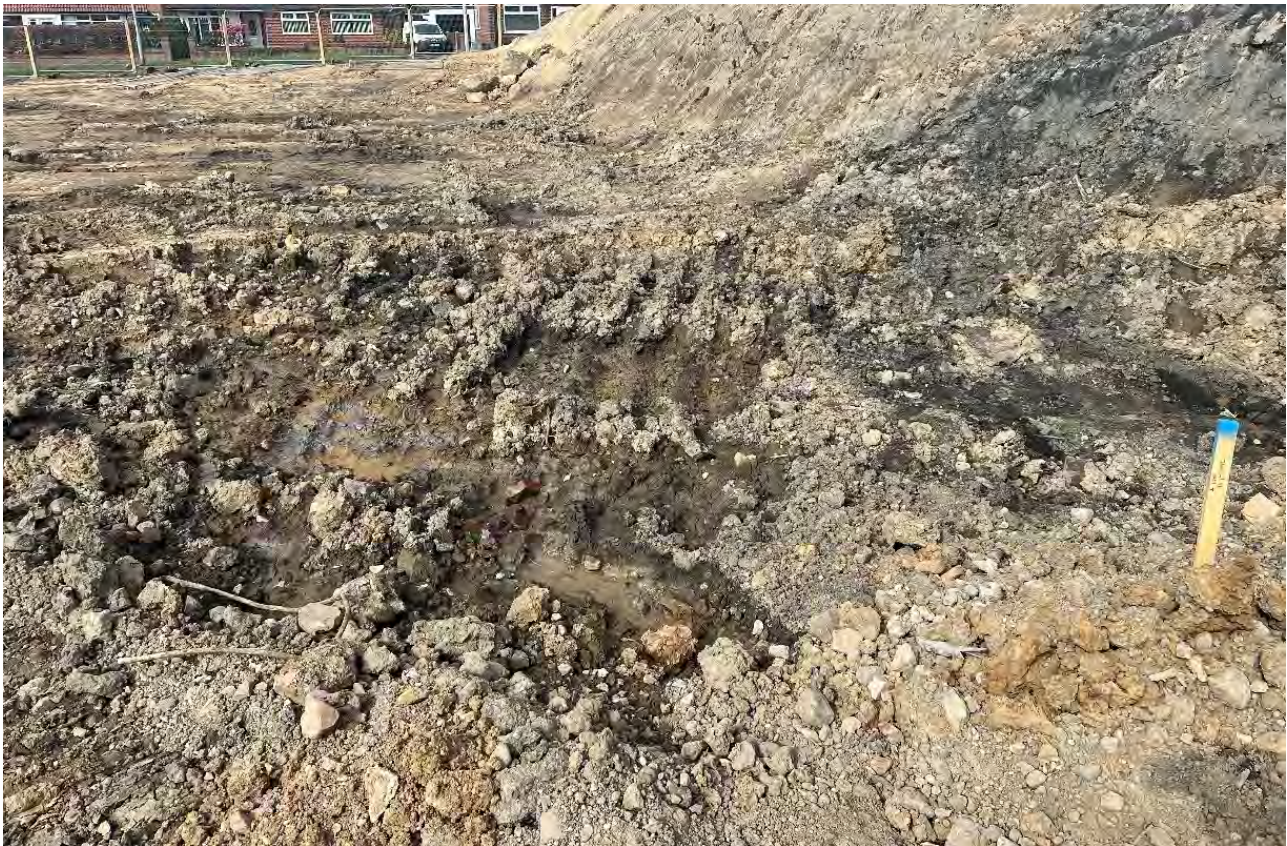
Photograph 19 – Pocket of deeper Made Ground.

Instances of Made Ground and silt were identified at the proposed formation level. This visit included removing any remaining areas of silt or deeper Made Ground/reworked ground to natural soils.

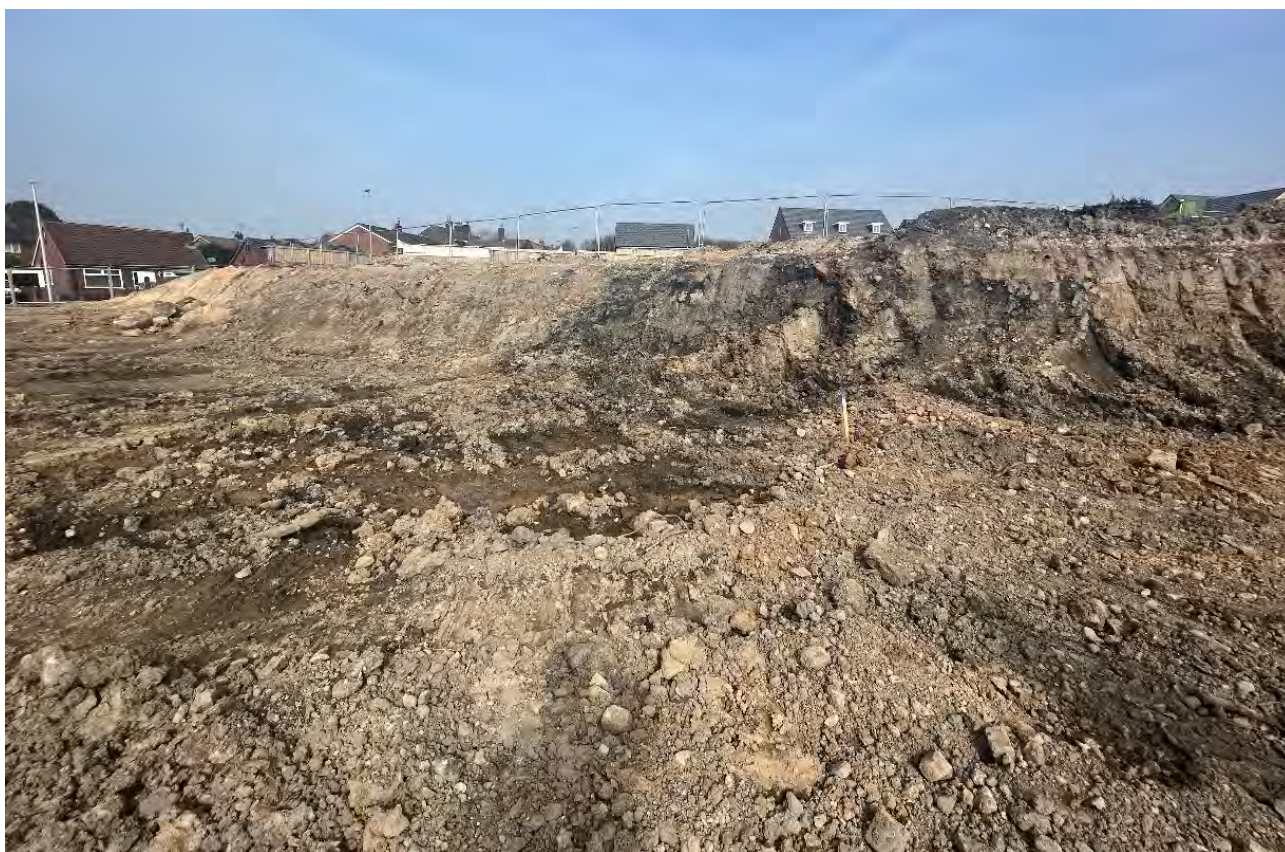
*Photograph 20 – Pocket of deeper Made ground & northern area (background) still to be excavated.*

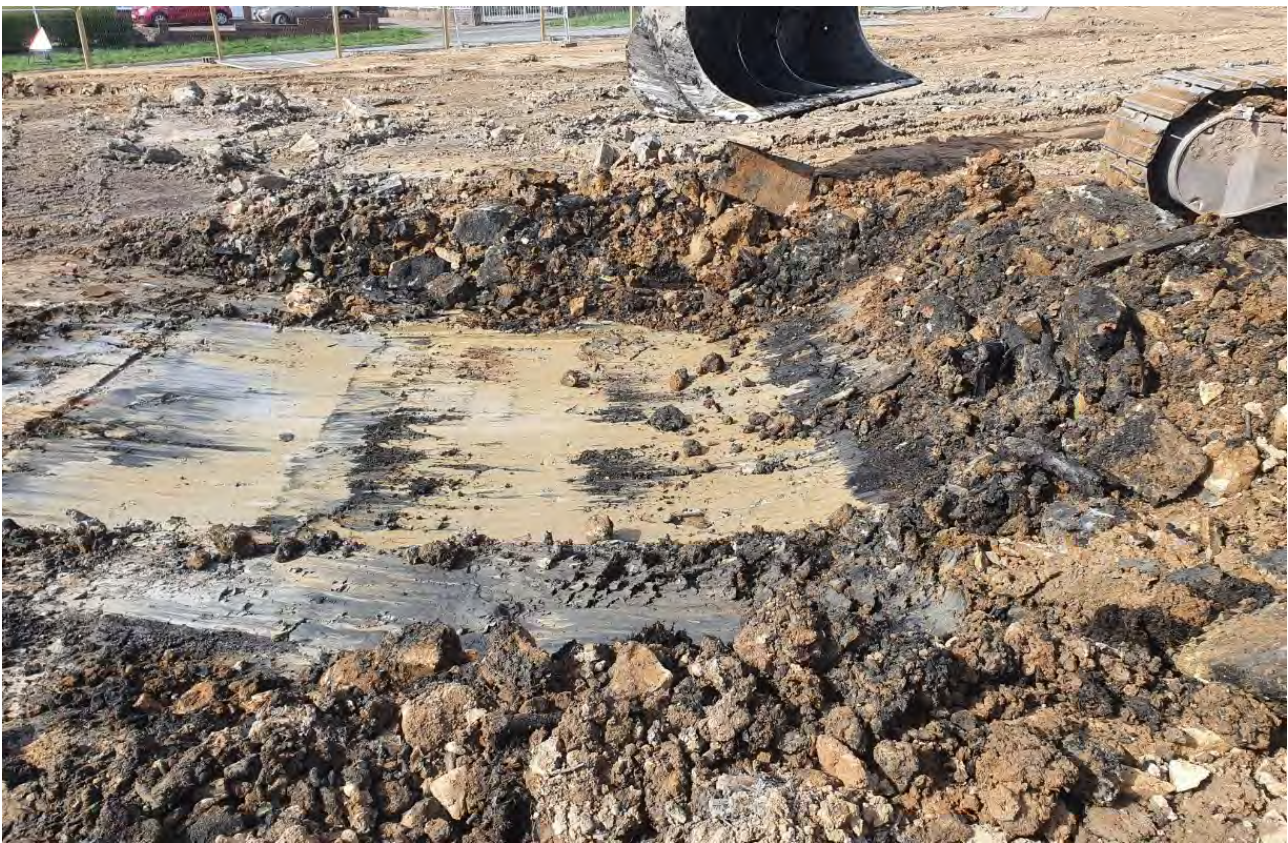
*Photograph 21 – Natural (possibly reworked) clay beneath containing some bands of silt (black material)*

ToC testing is required to confirm the suitability of this material for reuse as part of the development on the site at Phase 2 and additional testing at the hydrocarbon stockpile is required when treated.

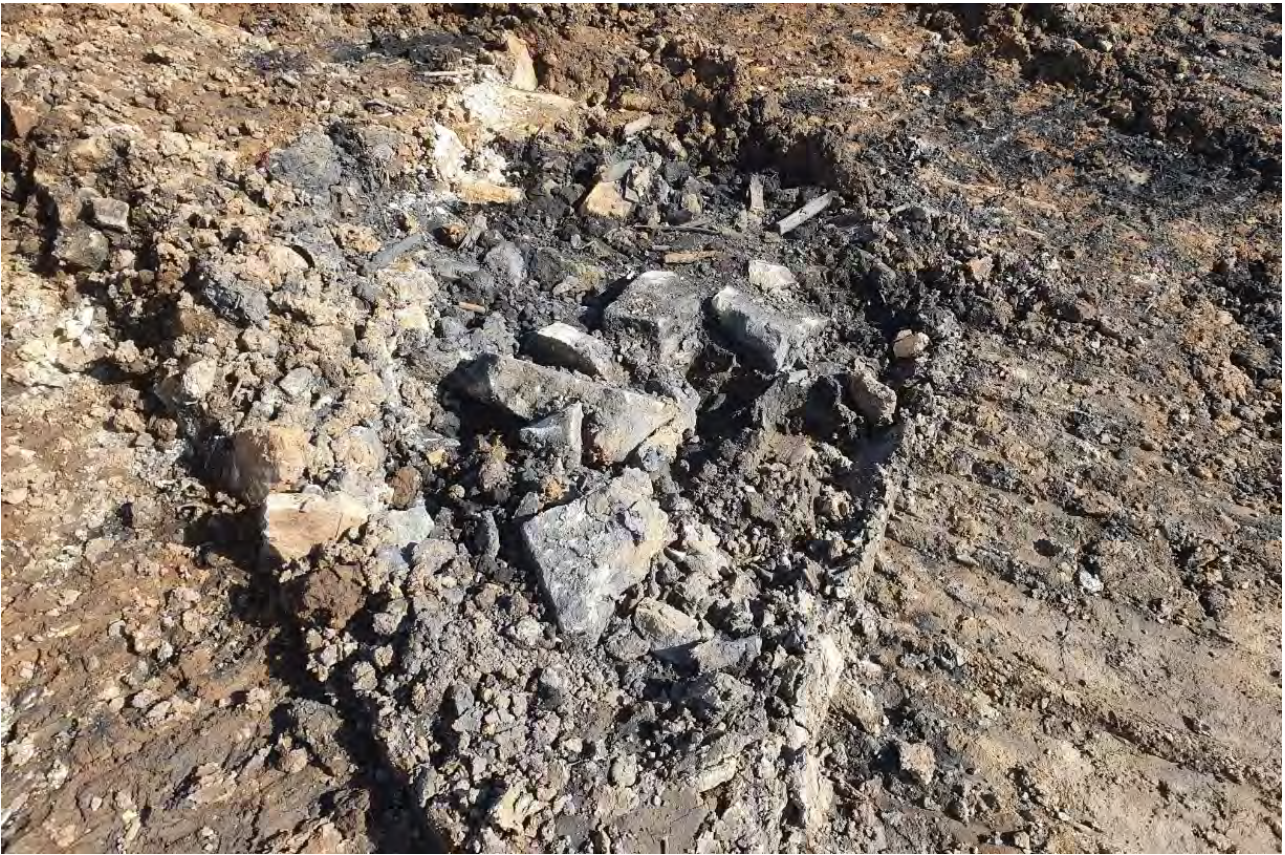
*Photograph 22 – Made Ground present at proposed formation level.*

No evidence of organic contamination was noted during the trimming of Made Ground to formation level. This material was chased out in the deepest area to determine the depth and influence on the high methane levels recorded by the previous Ground Investigation. The remaining silt bands/relict soil layers are thin and not considered to be the identified gas source or a viable gas source. CS2/Amber 1 gas precaution measures present as part of the development will be sufficient to mitigate the low risk.

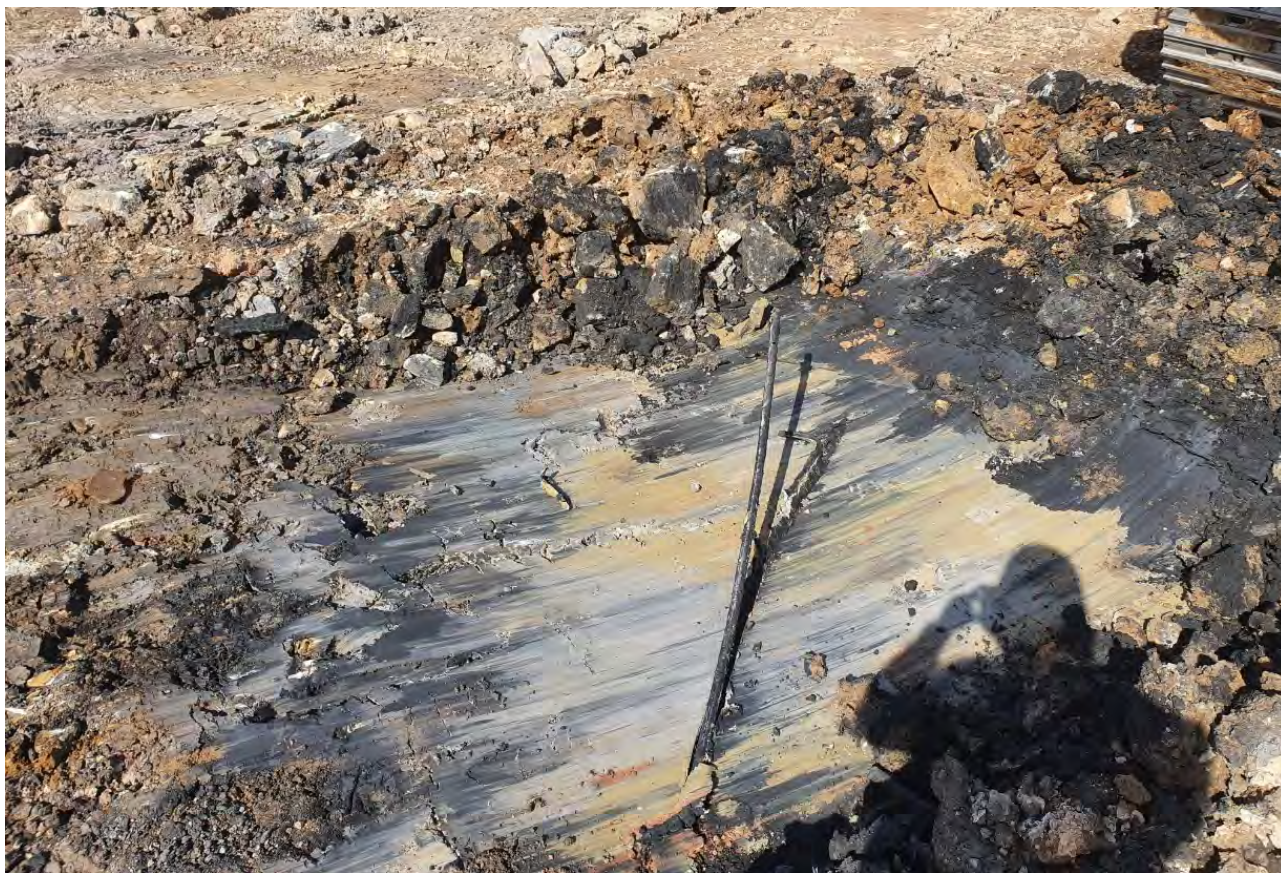
*Photograph 23 – Reworked clay and some areas of silt indicated at formation level.*

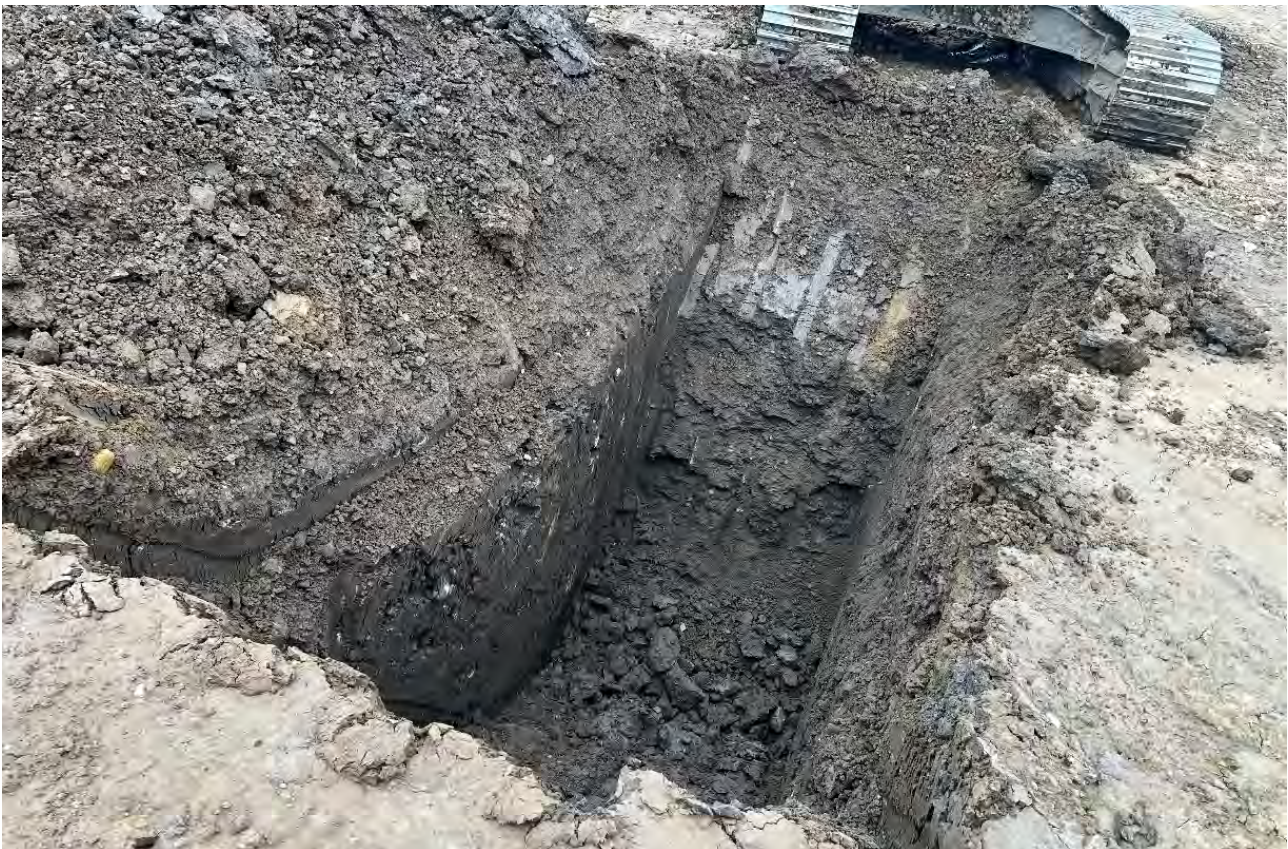
Eight trial pits were undertaken across the area to depths of between 3.0m and 4.0m bgl and any evidence of potential organic/silt contamination was excavated from Phase 1 and stockpiled in Phase 2.

Photograph 24 – Trial Pit at western extent of site, no evidence of organic contamination recorded.

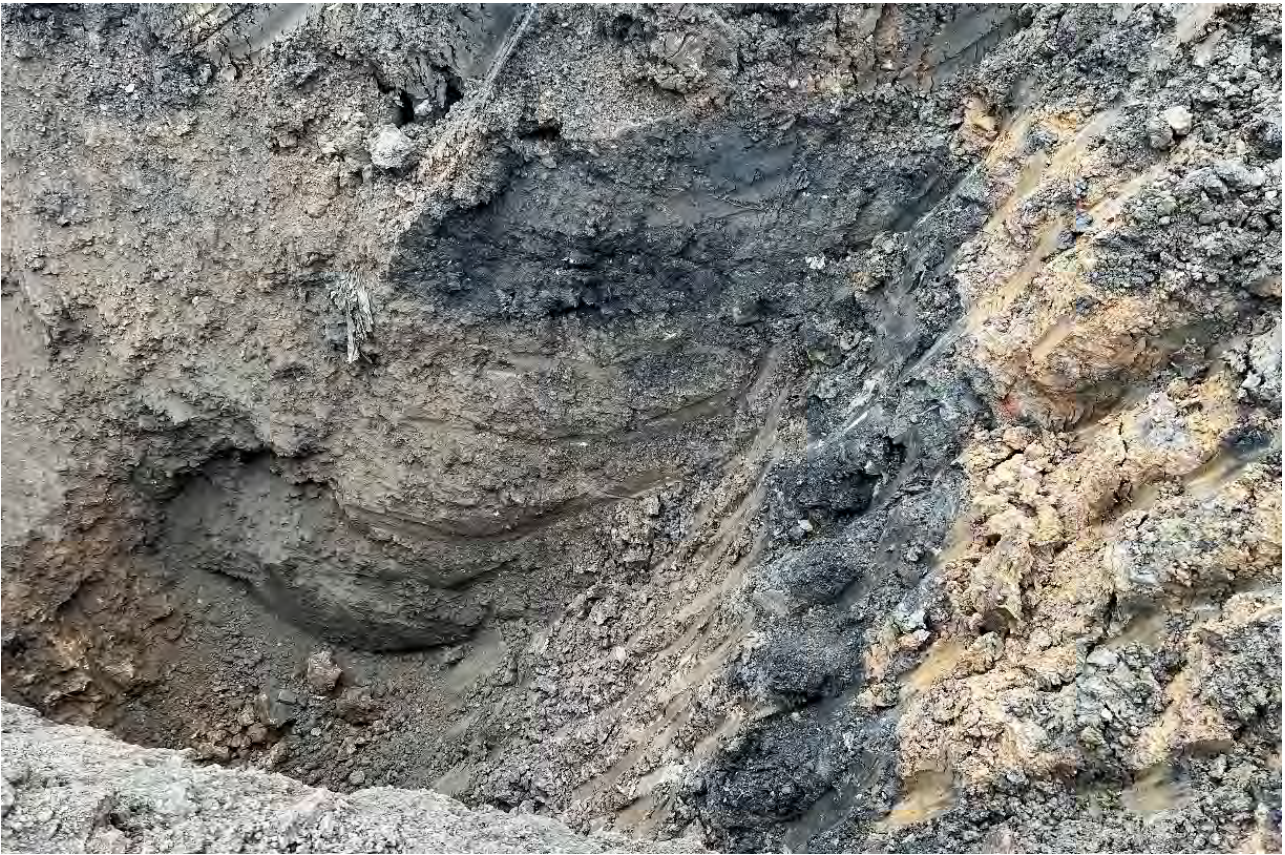
Evidence of potential ground gas sources was observed at shallow depths beneath the current site level in the form of a circa 200mm silt band which thins out to the east and west. This band is present below (circa 4.5m) the previous ground level prior to the reduced level dig and was not noted during the original visits. This material was excavated and stockpiled in Phase 2 with the previously excavated organic material.

The previous monitoring wells recording elevated concentrations are not present within the vicinity of the silt band and therefore it is not considered to be the likely source of methane production recorded in the monitoring wells.

*Photograph 25 – Band of silt beneath reworked clay at centre of site.*

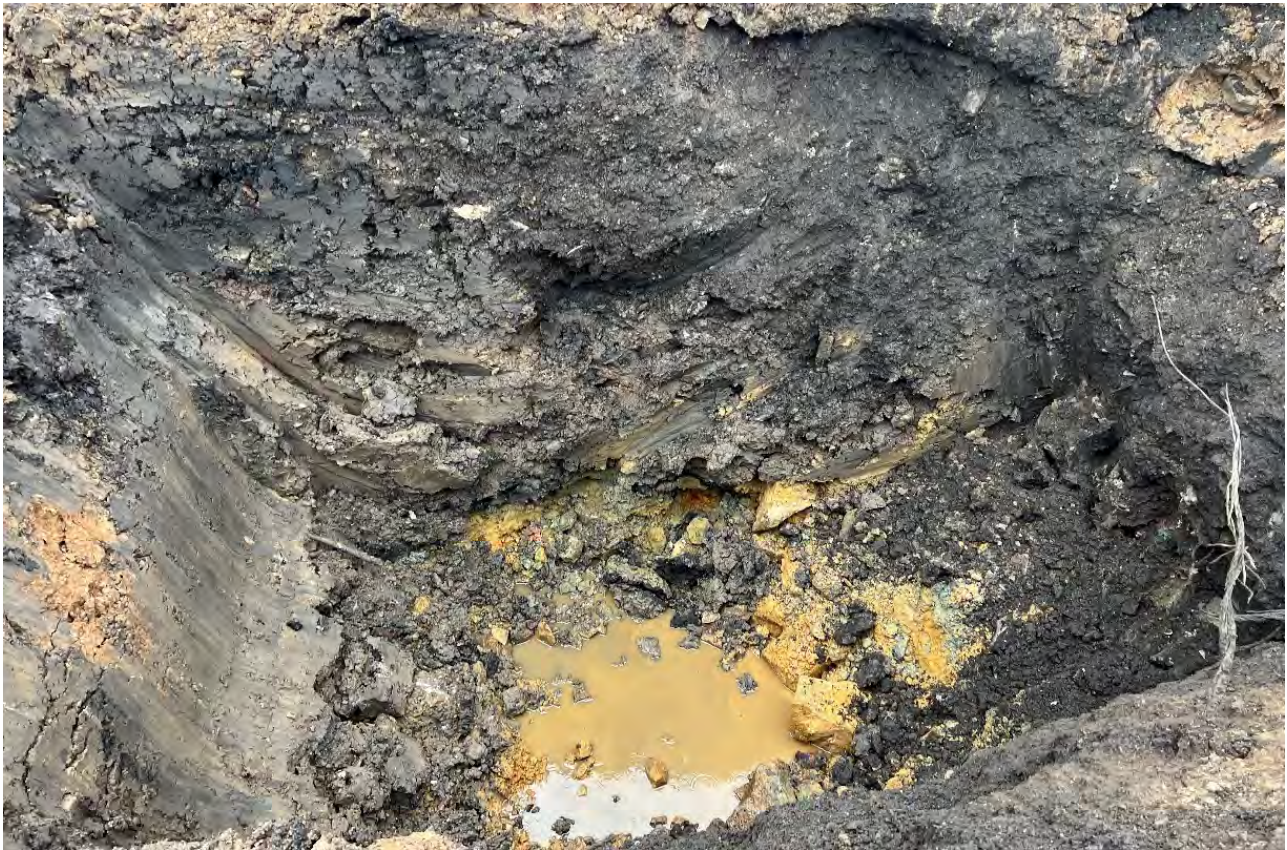
Deep Made Ground was also indicated in the eastern section of site at the position of the former pile foundations for the historic building, however a lack of organic material was observed in this area and no source of ground gas generation was identified.

*Photograph 26 – Area of deep Made Ground in northern extent of site (to be excavated to formation level)*

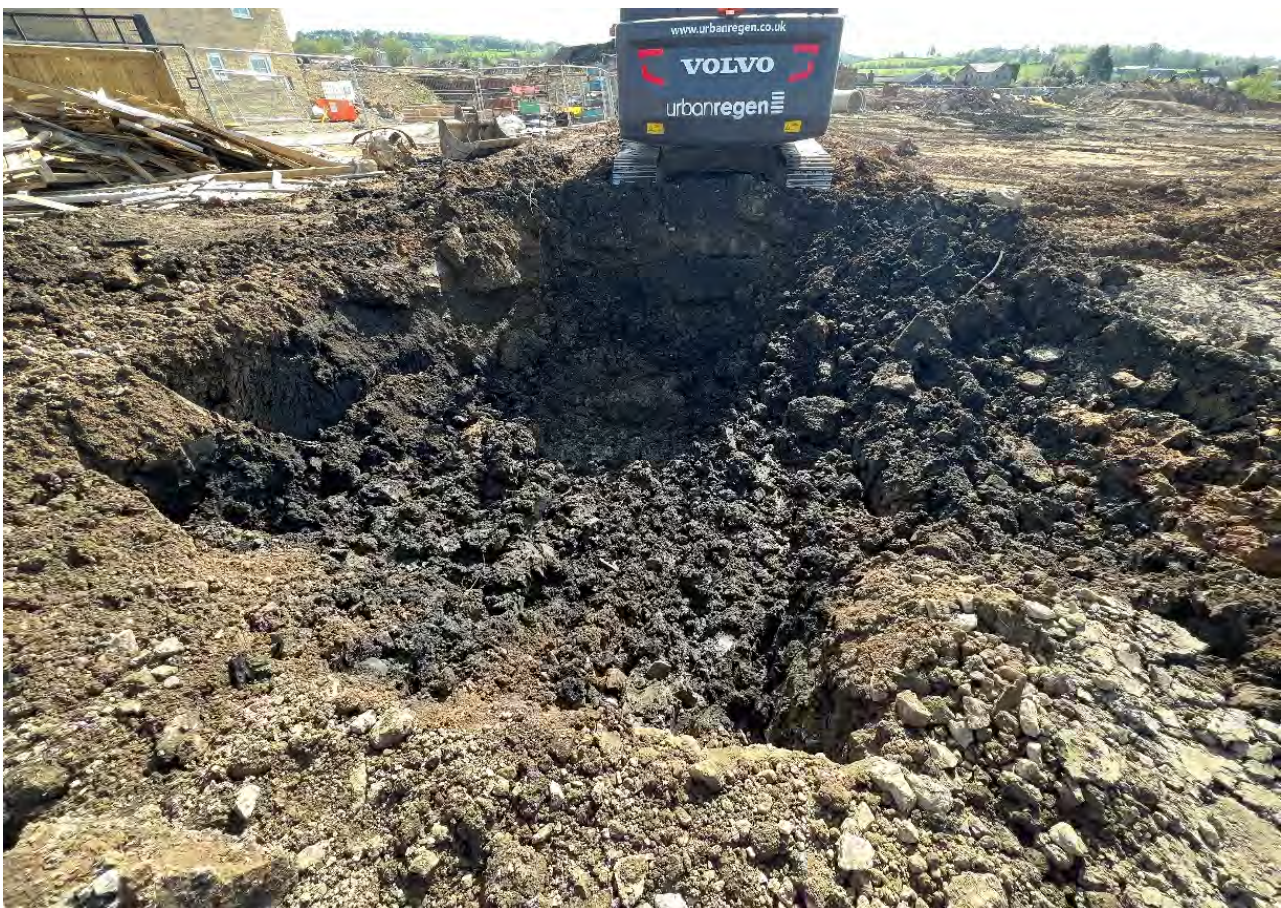
This visit was carried out on 20<sup>th</sup> April 2022 to excavate the remaining areas of deep Made Ground, specifically the central western section comprising evidence of hydrocarbon and organic sources of contamination. The final extent of the hydrocarbon contamination was identified and a trench was undertaken to excavate the remaining hydrocarbon contaminated soils to remove the potential source of permanent ground gases. All soils excavated were transported and stockpiled in Phase 2. This excavation was targeted at the north western area of site which is located near WS306 where high methane levels were recorded and therefore is considered to be the source.

Photograph 27 – Area of deep Made Ground comprising hydrocarbon contaminated soils at northern extent.

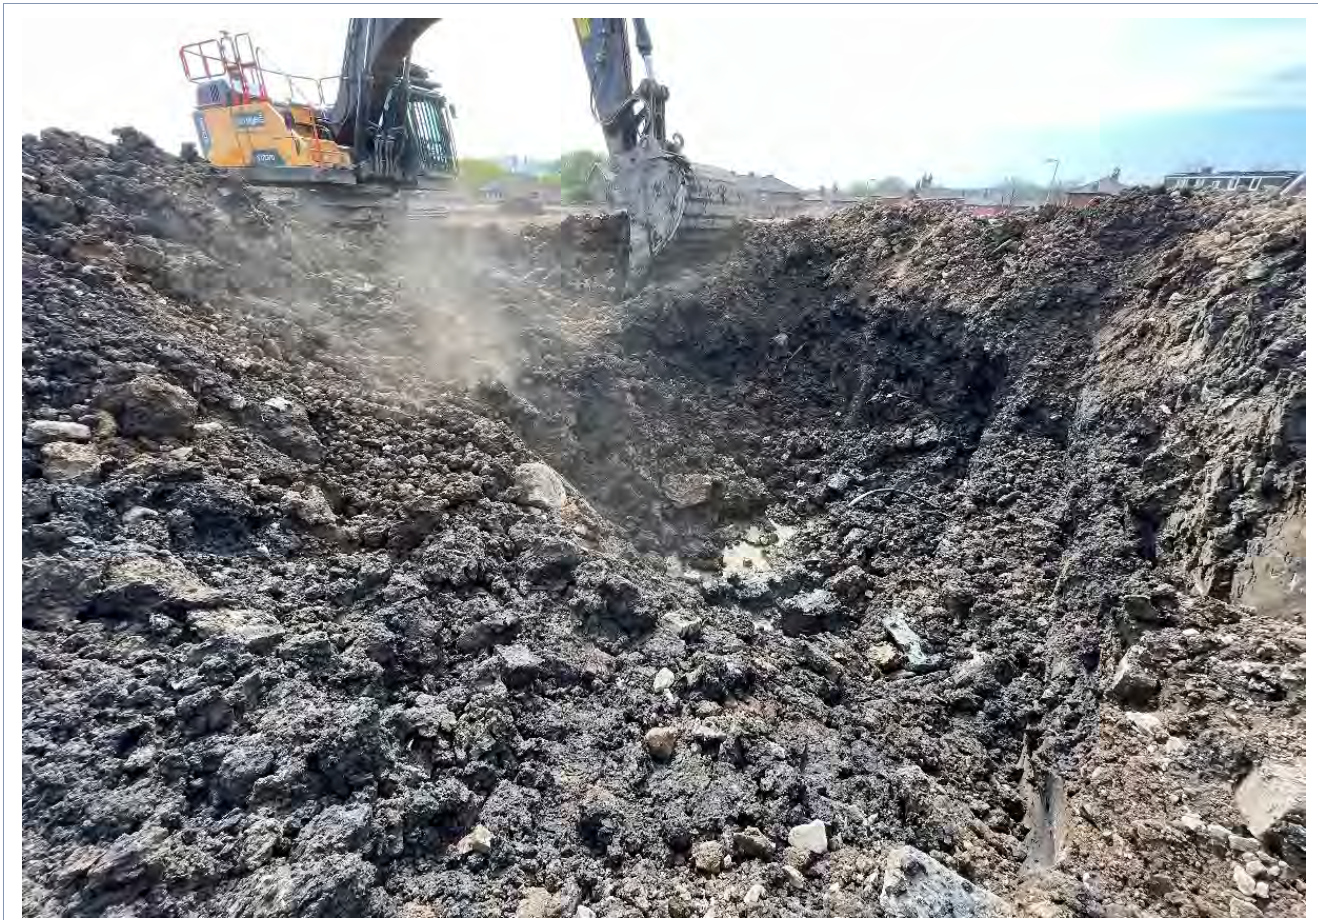
Organic contamination present immediately south of the hydrocarbon soils were excavated and removed to Phase 2, with thin sporadic bands of silt still present in-situ at shallow depths. As discussed previously, the remaining silt bands/relict soil layers are not considered to be a viable gas source, CS2/Amber 1 gas precaution measures will be sufficient to mitigate the low risk.

*Photograph 28 – Area of deep Made Ground comprising hydrocarbon contaminated soils at northern extent.*

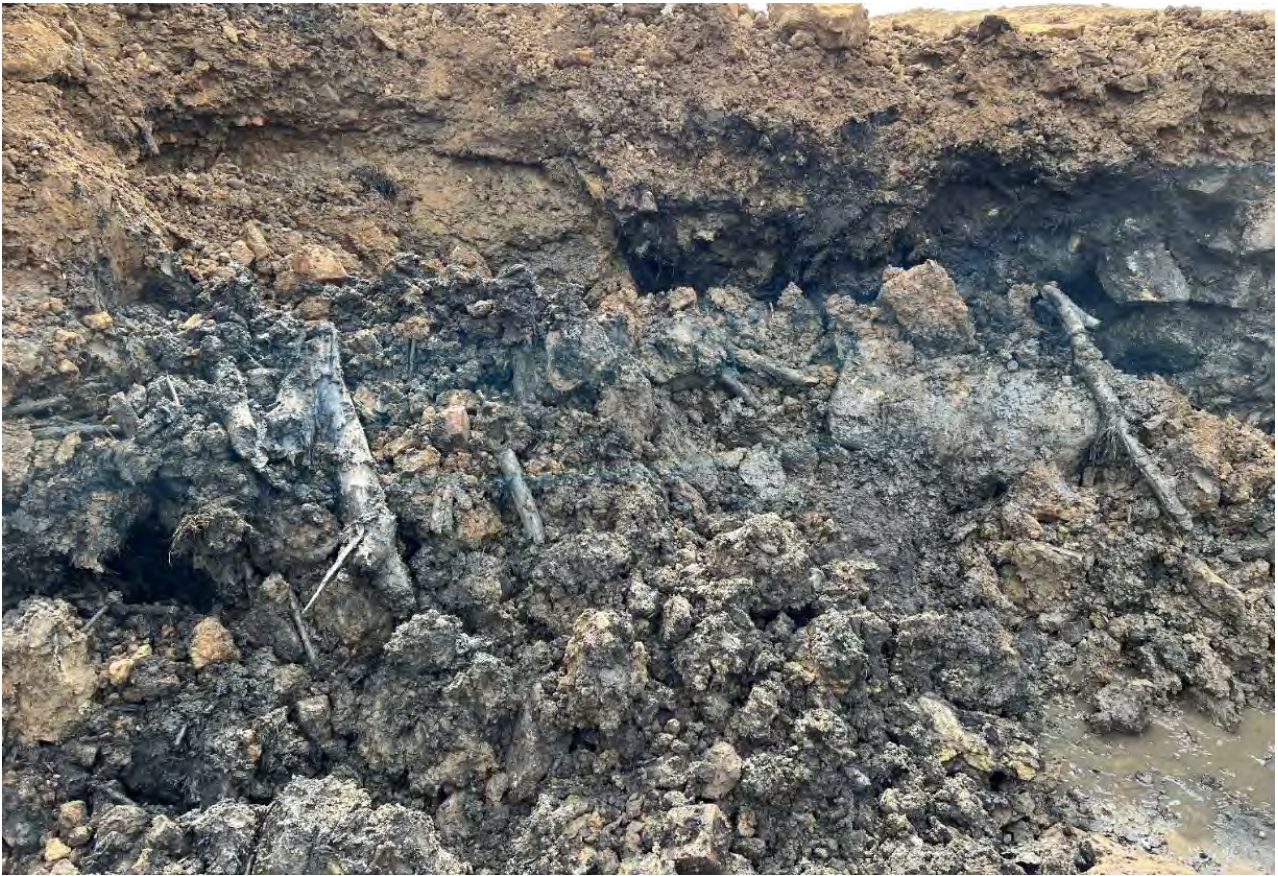
The small amount of silt recorded is at depths just below formation level in this area, the thickest extent of silt has been removed to Phase 2 and the remaining thin bands are not considered to be a significant source of methane. Furthermore, the silt in this area is not present within close proximity to the two monitoring wells (WS306 & WS316) which recorded high methane levels and therefore is not considered to be a major source of ground gas.

Photograph 29 – Deeper Made Ground with organic properties at the northern area of site – silt band thins out southwards.

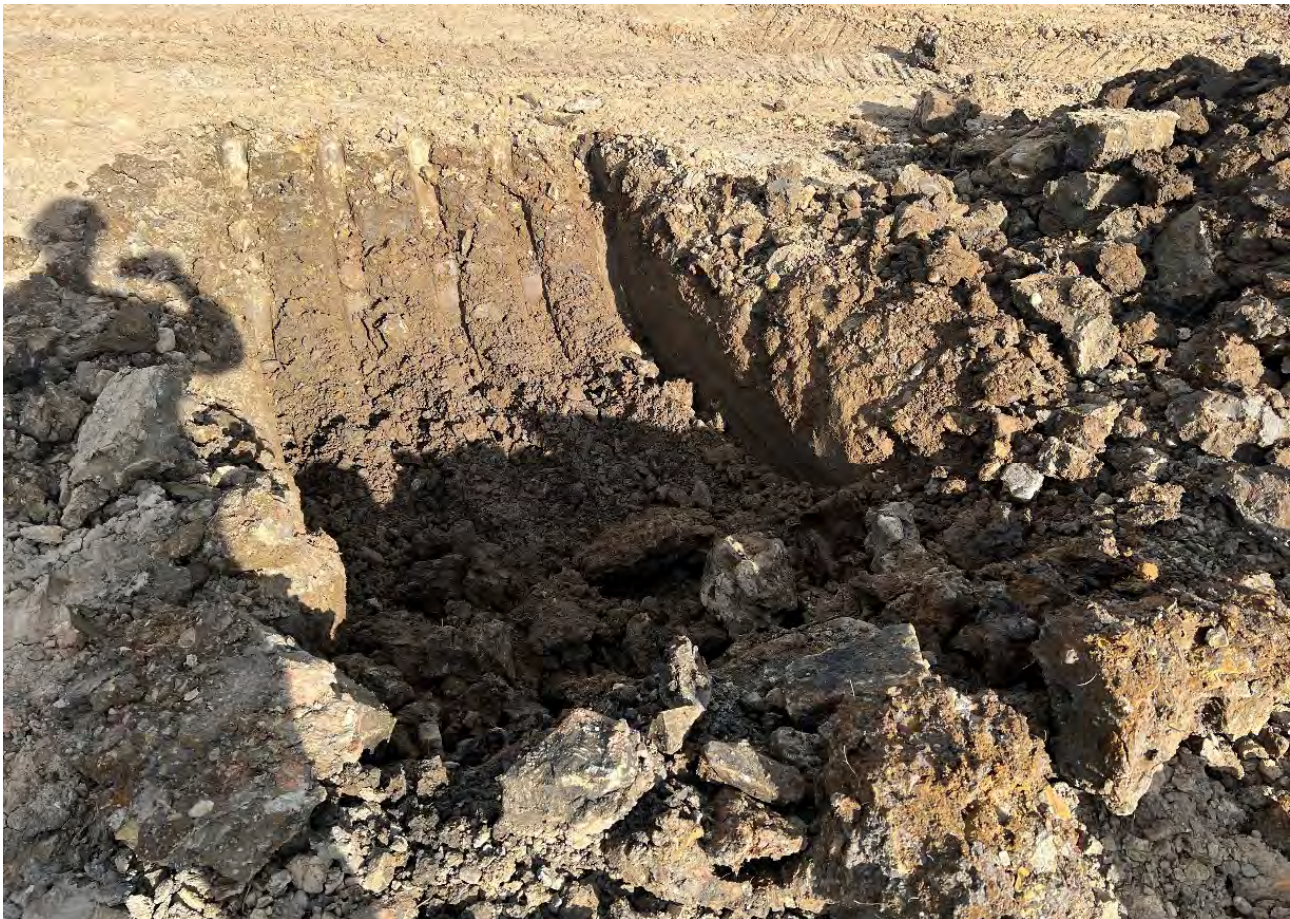
Photograph 30 – No evidence of organic material in pit to west.

Four trial pits were excavated within the centre of site spanning from the western boundary to the former pile foundations to the east. No evidence of possible organic contamination was indicated within the pits at the east and west, however localised areas of silt (circa 400mm to 600mm bgl) were indicated at the trial pits to the centre, and thins near the area of WS316 where high methane levels were recorded. The silt bands were excavated and removed during this exercise to the stockpile of organic material in Phase 2.

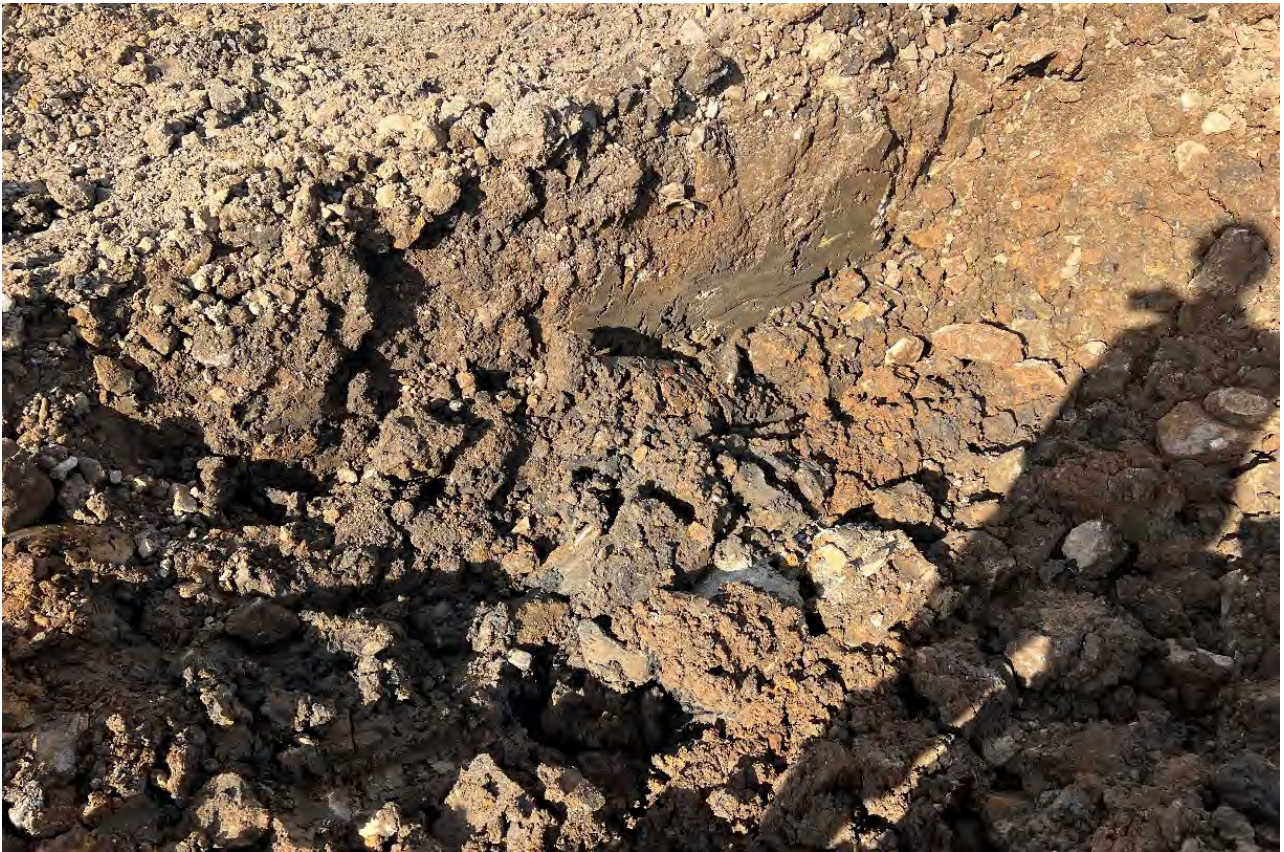
*Photograph 31 – Trial pit to centre with limited silt detected.*

The trial pit photographed above (*Photograph 31*) was excavated overlying the position WS316 where the highest methane concentrations were recorded, no direct source of organic contamination was recorded in the natural soils in this area, indicated that the likely source of the Ground gas was the overlying Made Ground (removed to Phase 2), the hydrocarbon impacted Made Ground to the south (removed to Phase 2) and the thicker silt band to the northeast (removed to Phase 2).

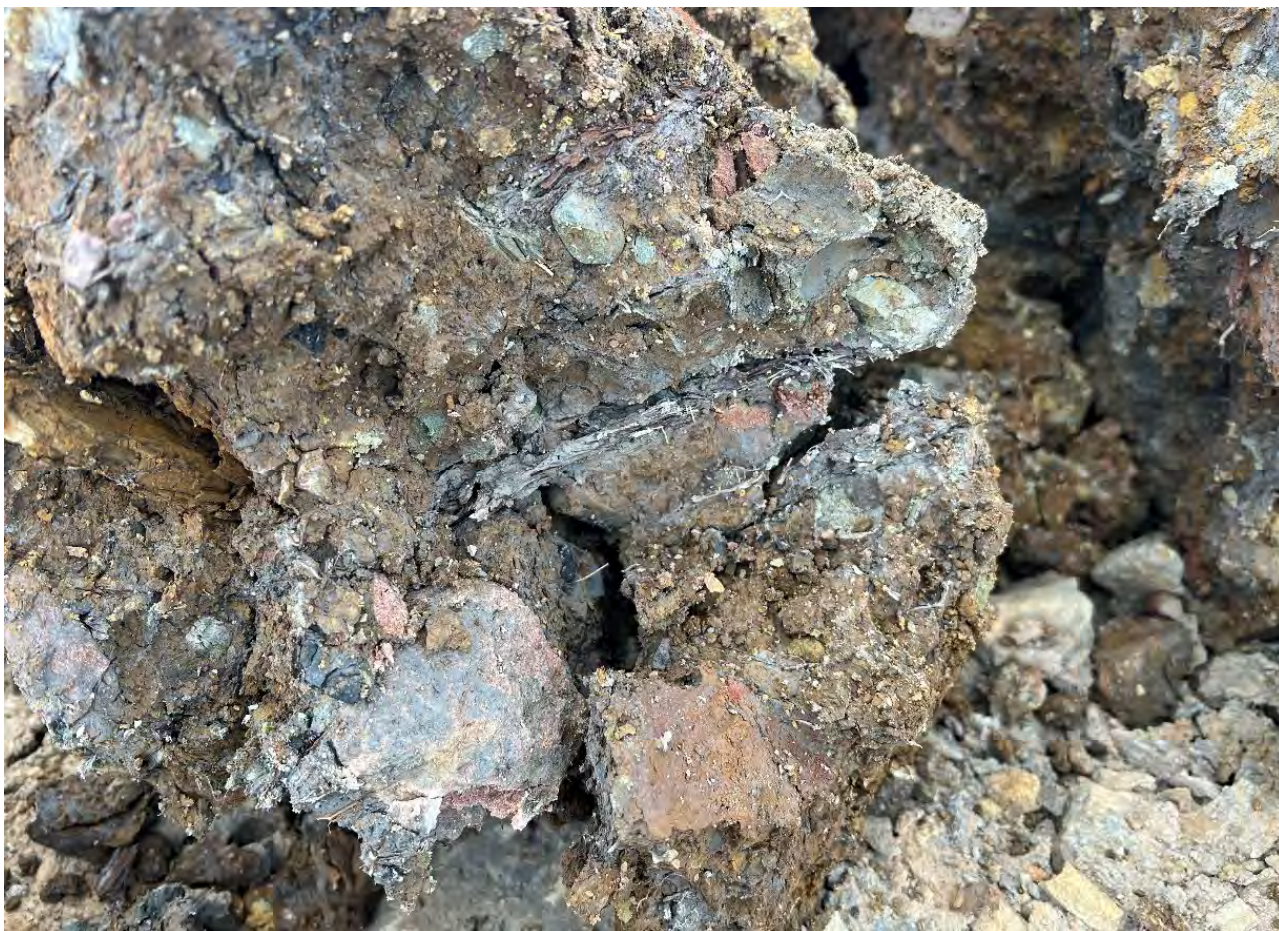
*Photograph 32 – Rare sections of organic content present within reworked clay.*

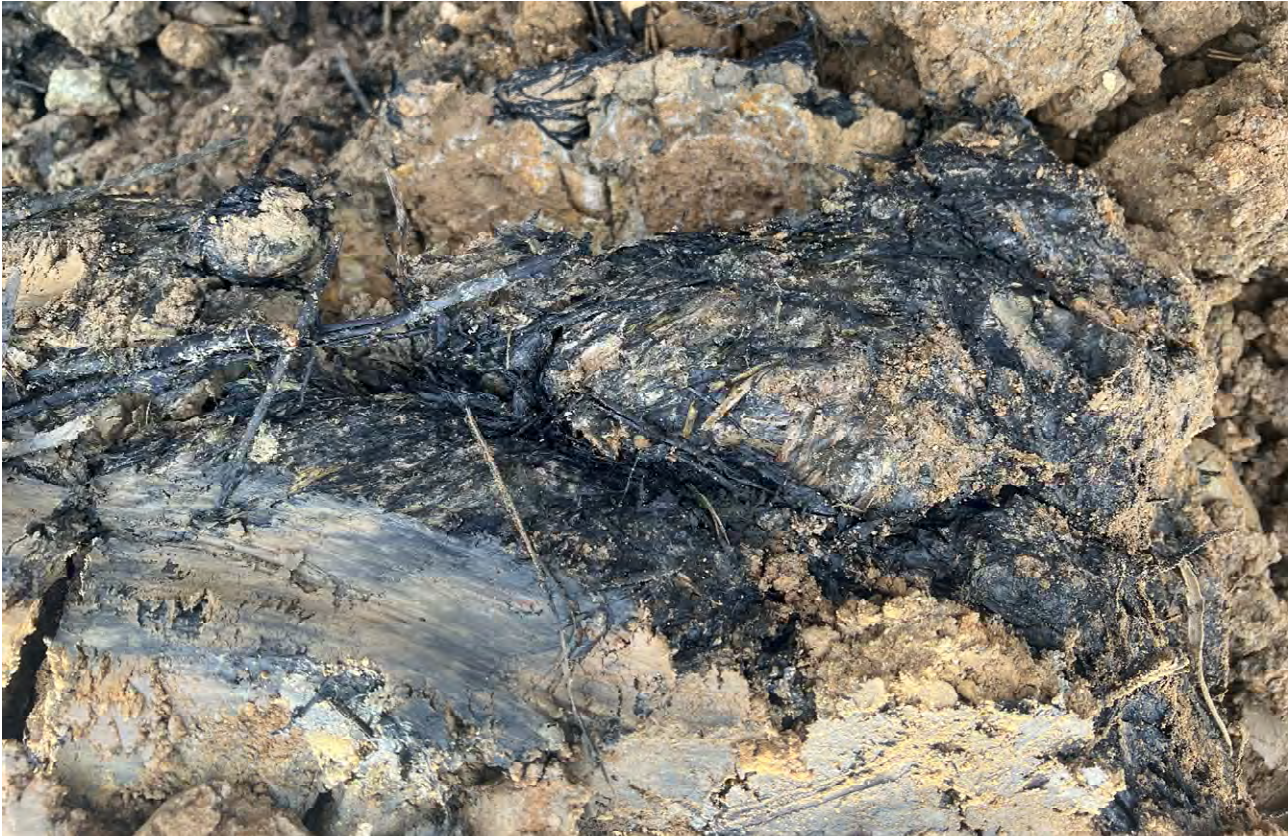
Photograph 33 – Pockets of silt/organic content within reworked clay.

Some organic material was recorded along the northern extent of the area in the form of silt pockets alongside organic material and is assumed to be associated with the backfill of the historic reservoir, this material is located circa 0.1 to 0.3m below current formation level and not considered to be the source of ground gas. Any material which was considered to be a significant source of ground gas generation based on composition and thickness was excavated and removed to the stockpile in Phase 2.

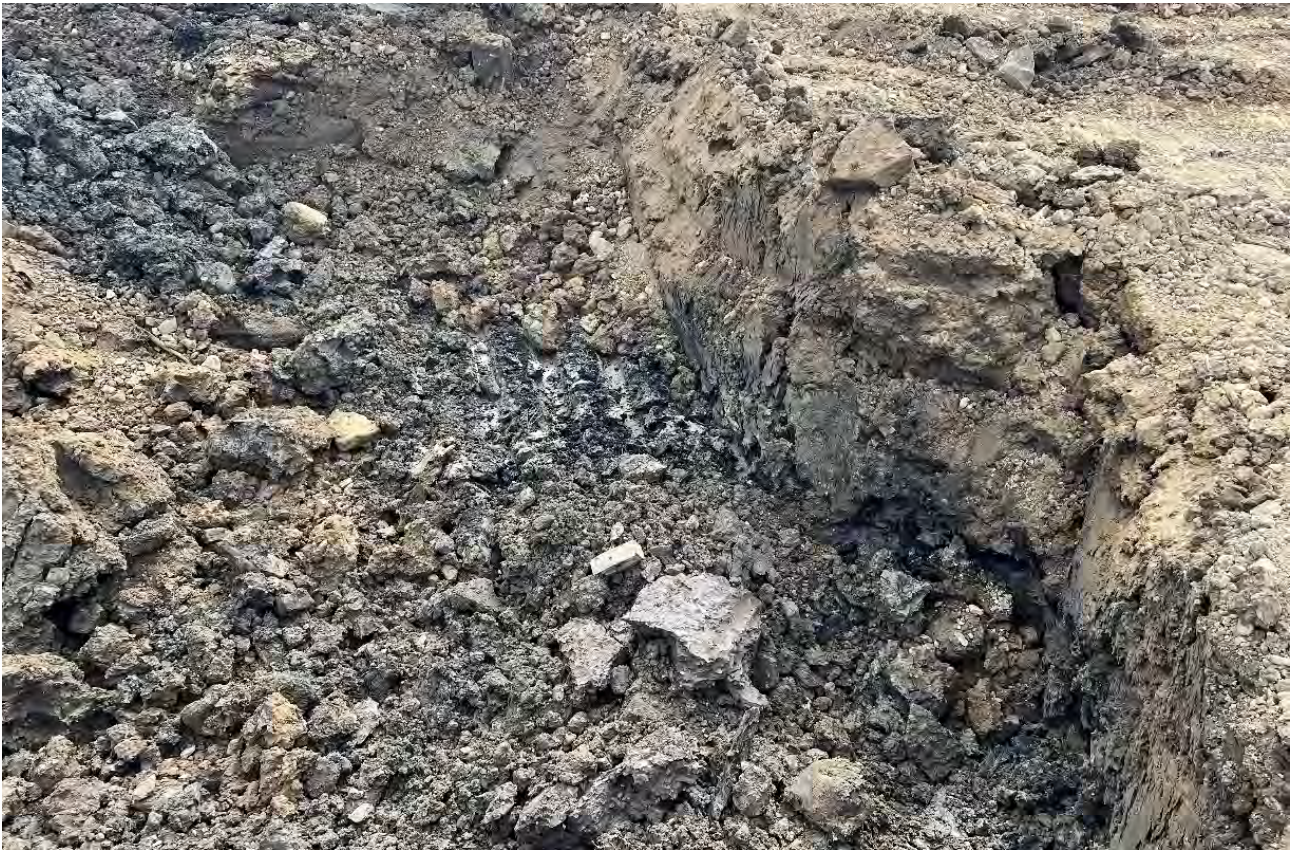
*Photograph 34 – Small silt band chased out towards centre of site.*

The remaining hydrocarbon contamination was excavated and placed with the hydrocarbon stockpile at Phase 2 and the organic material was stockpiled separately in Phase 2. Further evidence of a significant ground gas source was not observed with the only the localised smaller bands of silt beneath the reworked clay at the centre section of site being observed, these soils were largely removed but some small pockets may remain in-situ underlying the reworked clay in this area, as discussed the thin bands of Silt are not considered to be the source of ground gas and CS2/Amber 1 site wide precautions will mitigate the low risk.

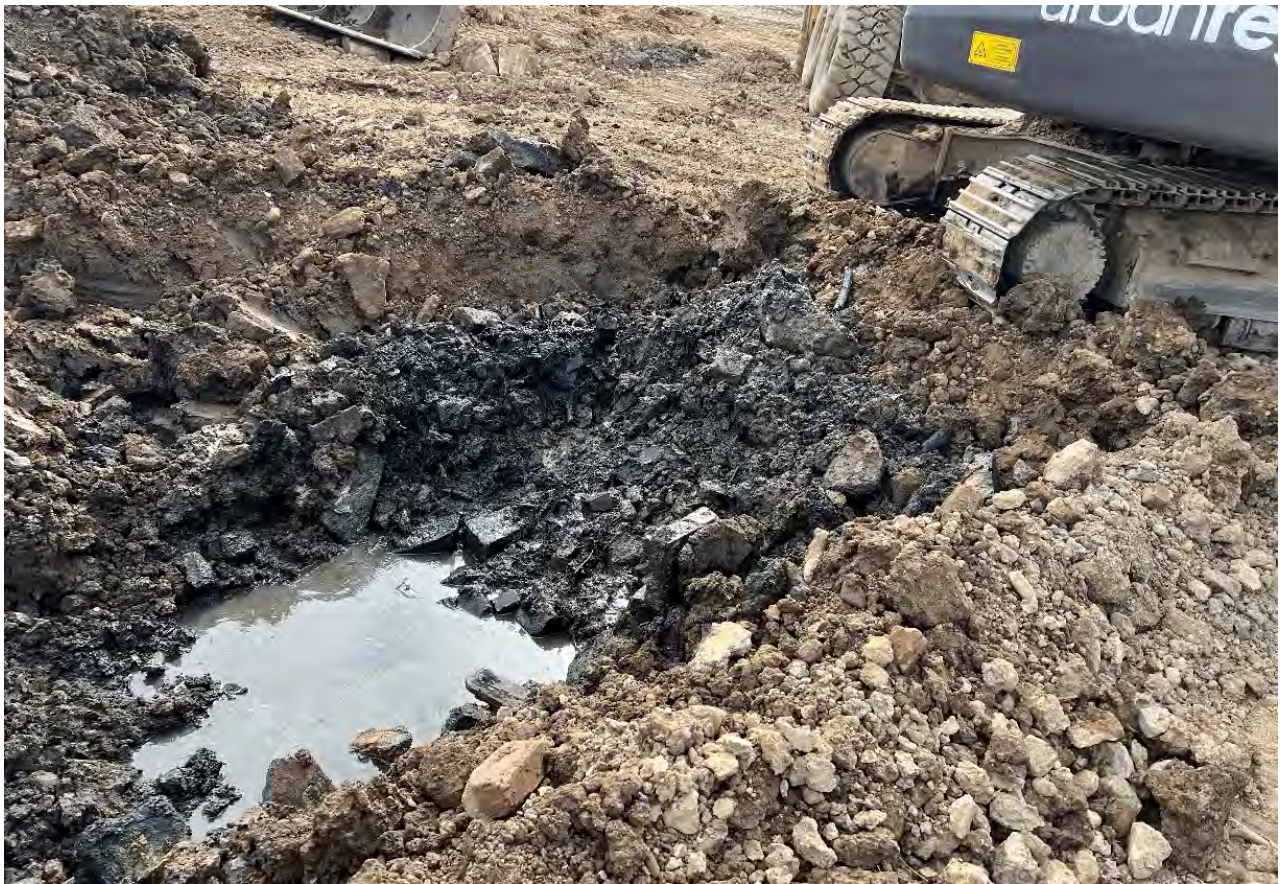
Photograph 35 – Deeper Made Ground removed from ground along the northern boundary.

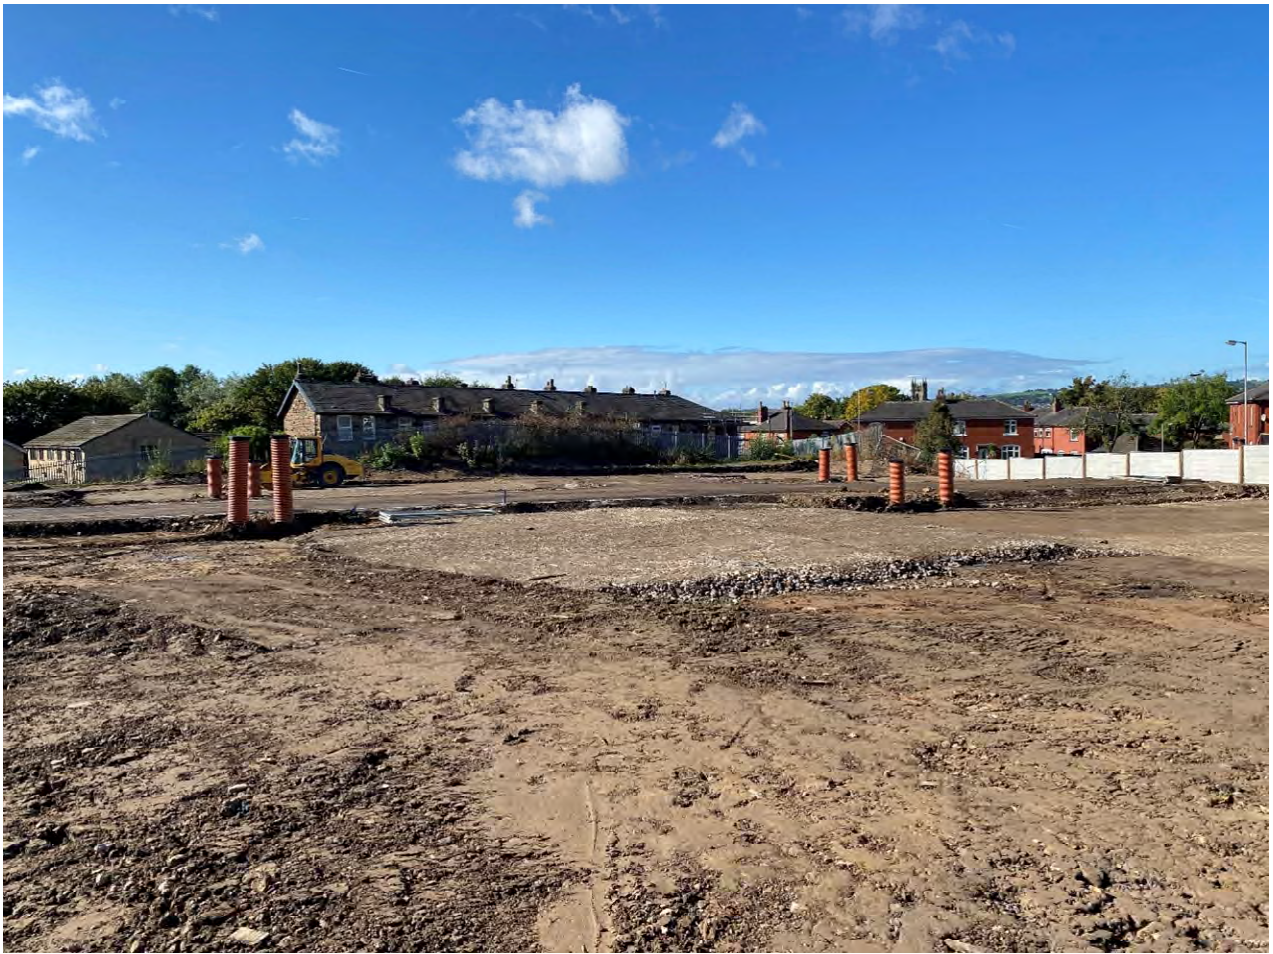
*Photograph 36 – Roadway at centre of site and imported 6F2 material (piling mat) beneath.*

The photograph above illustrates the site formation level on completion of the excavation of the Made Ground and organic deposits. It can be seen that the piling mats have been constructed beneath the position of the plots and the central roadway has been civilised. No evidence of organic/hydrocarbon contamination is present, the ground gas sources have been removed and natural cohesive soils are at the surface of the site.
