**Job title:** Tetrosyl Bevis Green Works,  
Bury

**Report type:** Verification Report (Phase 1B)

| Document Control Form | | |
|---|---|---|
| REPORT NAME | VERIFICATION REPORT, GAS ASSESSMENT & BUILD PHASE REMEDIATION (PHASE 1B) | |
| REPORT REFERENCE | GRO-21459-3559 | |

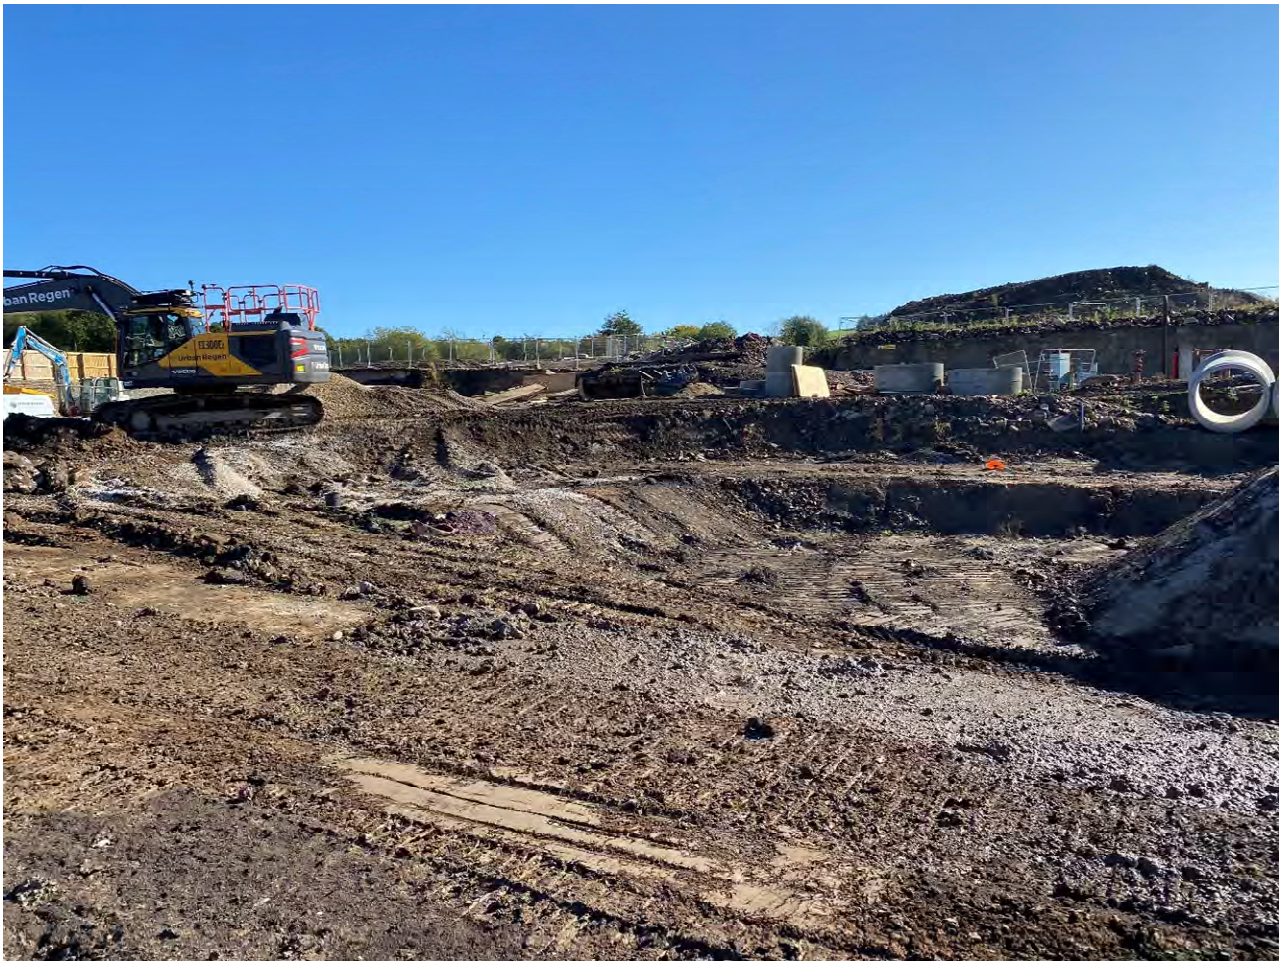
Photograph 37 – Eastern end of Phase 1B.

The eastern section of Phase 1B has yet to be completed to formation and the crushing of onsite 6F2 is ongoing for this position. It should be noted that no evidence of organic materials or Made Ground is visible including silt bands in this area.

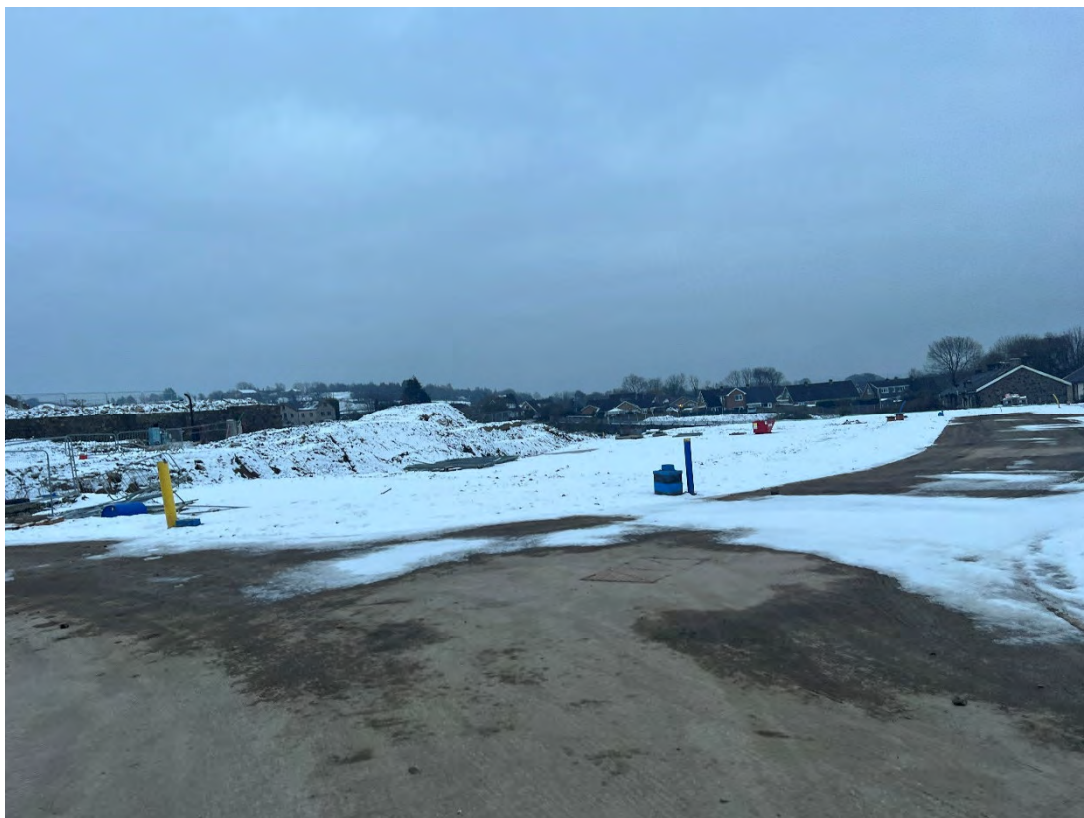
The final visit was carried out to observe the final level changes prior to the commencement of the build phase. The photographs below display the current level post excavation of the soils in the eastern area which have reduced the level to formation. Approximately 1060m<sup>3</sup> of 6F2 material has been crushed onsite and placed at the position of the proposed plots and roadways.

Photograph 38 – Eastern section of Phase 1B.

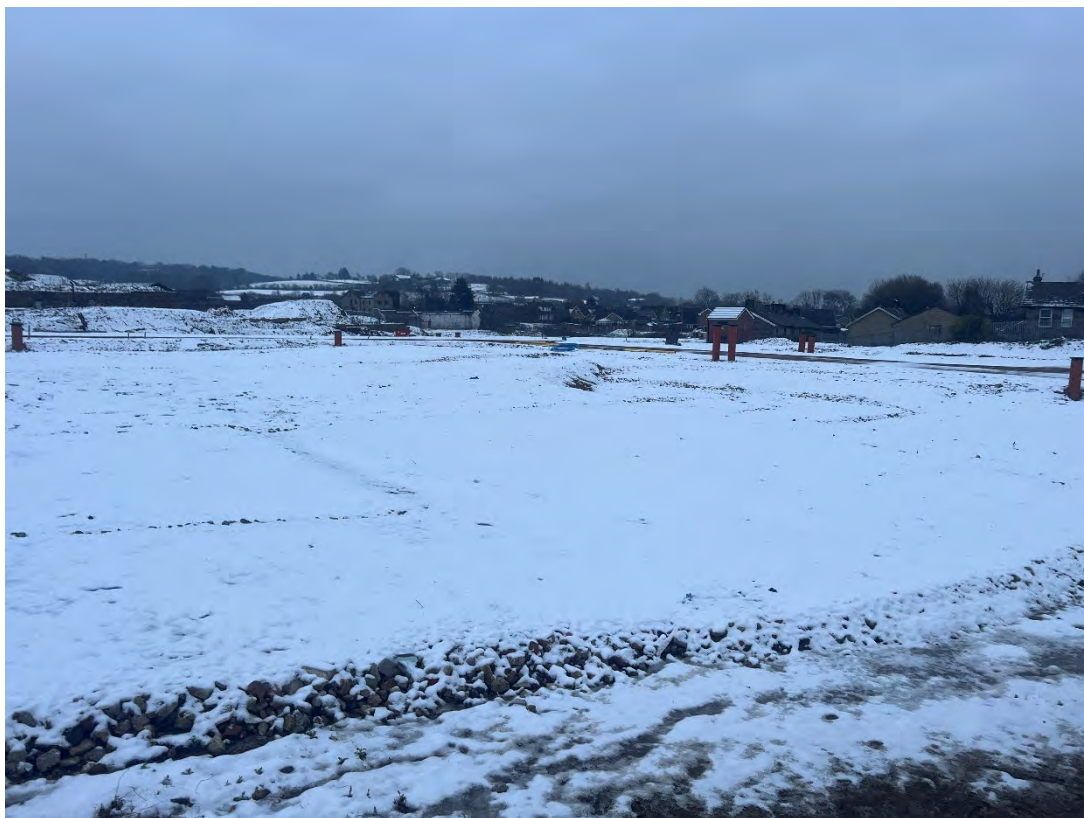
Photograph 39 – Formation level.
