## **GeoEnvironmental Desk Study**

**Meadowcroft Farm**

**Bury**

**August 2020**

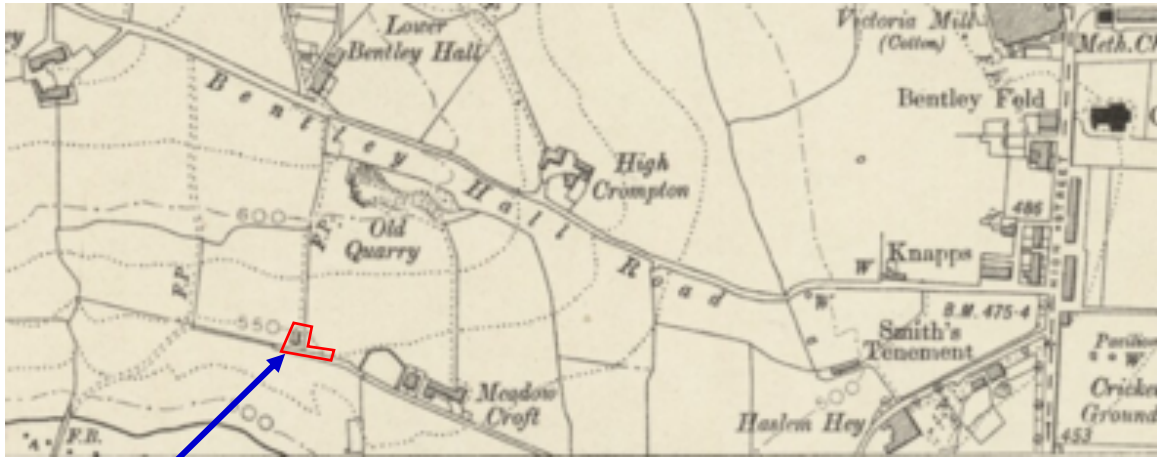
Figure 5 OS Map Extract 1911

| Date | On-Site History | Surrounding Land Use History |
|---|---|---|
| 1911<br>1:10,560 | No significant change. | <p>Sandstone quarry now old quarry to the northeast.</p> <p>Butts located between and around 2 large reservoirs to the south.</p> <p>An infectious diseases hospital is located 500m south of the site.</p> |

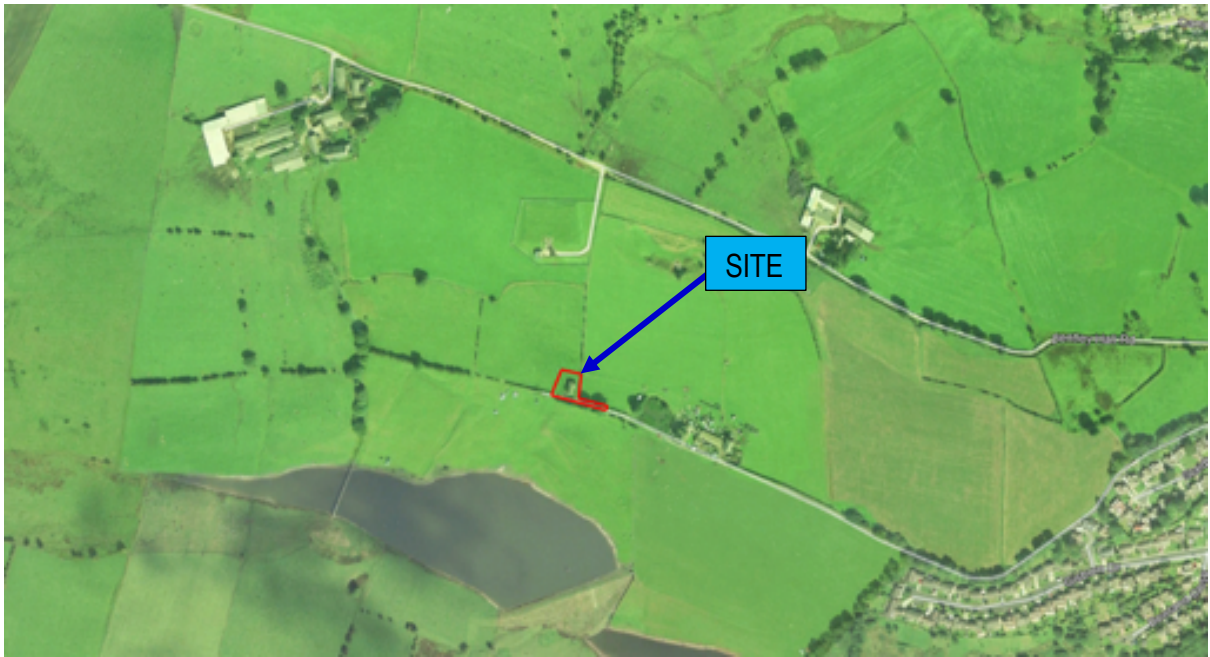
**Figure 7 Aerial Photograph 2000**

| Date | On-Site History | Surrounding Land Use History |
|---|---|---|
| 2000<br>Aerial<br>Photograph | No significant change. | A large housing estate is located 400m east of the site. |
