# Unexploded Ordnance Risk Mitigation

Explosive Ordnance Desk Top Study for:  
**BURY INTERCHANGE, BURY, GREATER MANCHESTER**  
**PROJECT 24321**  
On behalf of  
**Tier Environmental**

**16012-EOD-BRY-XXX-RP-HS-000001**

## Bury Interchange, Bury, Greater Manchester

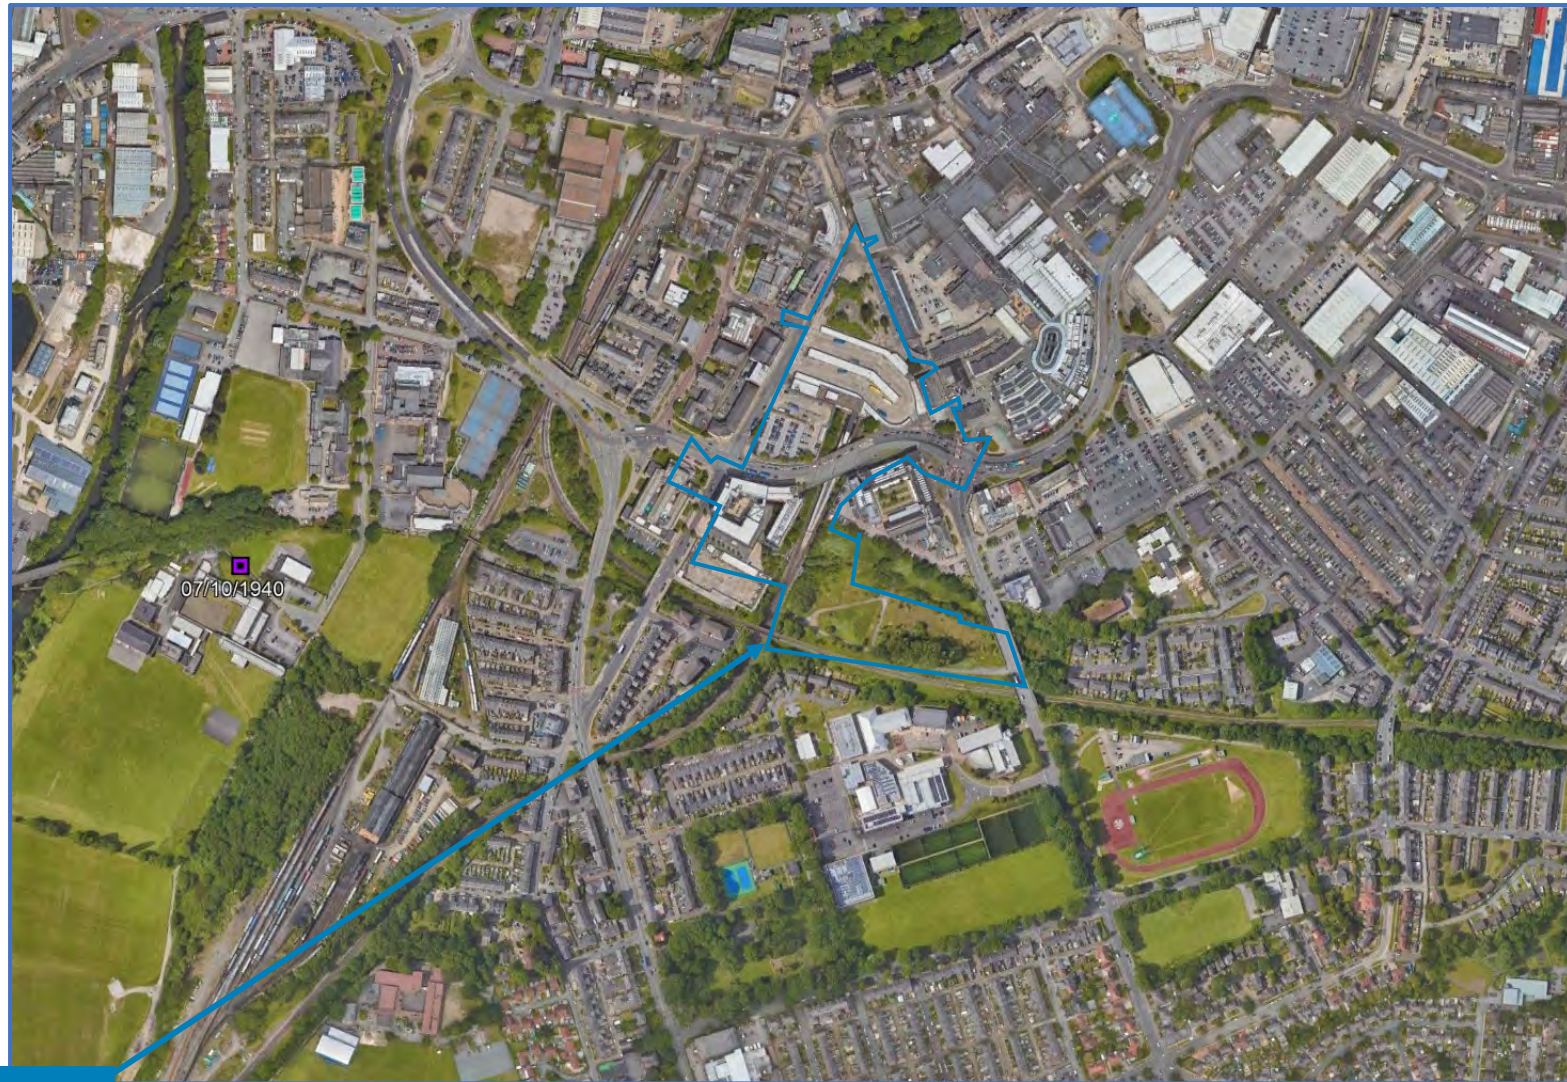
Site

## EXPLOSIVE ORDNANCE CONTAMINATION ROUTES

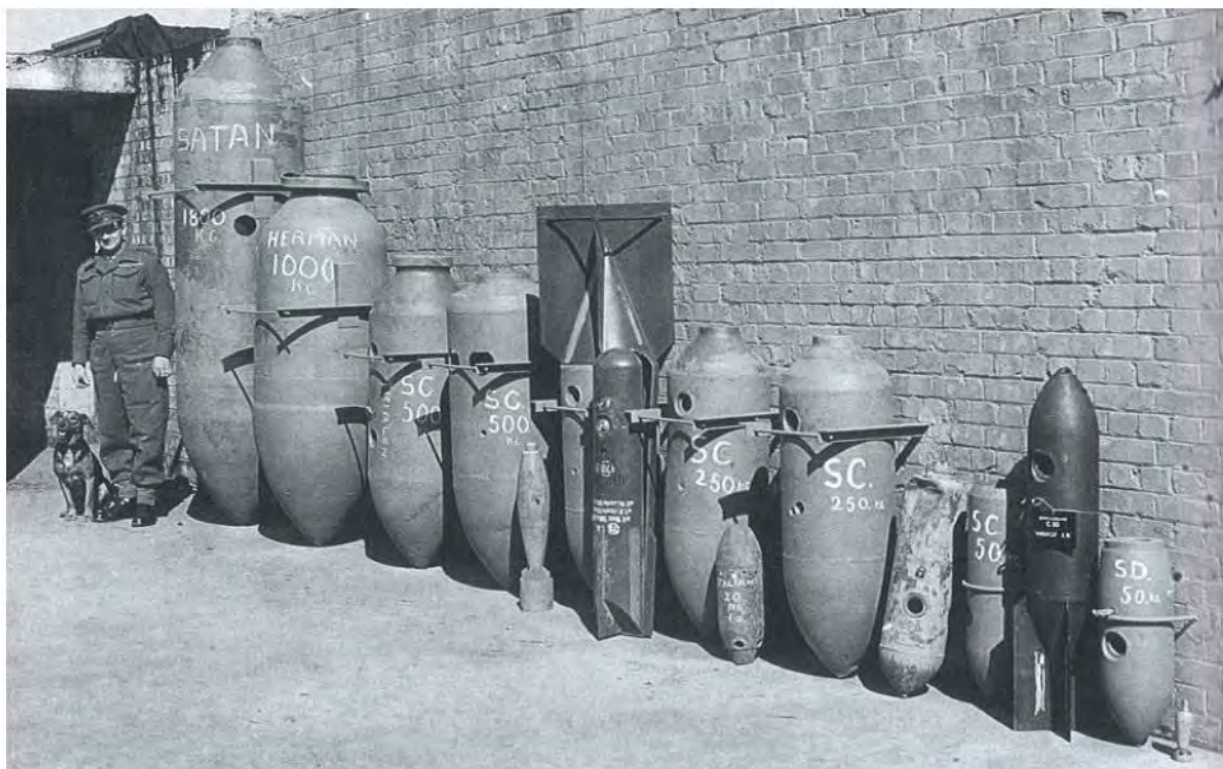
Figure 4: Range of HE bombs dropped on the United Kingdom.

NOTE: The smaller sub-munitions (Bomblets) seen to the right, ranged in size between 1 and 3kg, were dropped in large numbers and were intended as incendiary bombs, anti-personnel bombs or as bombs filling both roles. The smaller bomblets were dropped in larger container bombs designed to hold between 360 and 620 of the bomblets. The containers were designed to burst open at a predetermined height above ground level, dispersing the bomblets over a wide area. Air raid damage was far greater by using both incendiary, and HE bombs on a single raid. The fires started by the incendiaries being rapidly spread by the blast waves from the HE bomb. This scenario was shown to devastating effect on the 14<sup>th</sup> February 1945 in the German city of Dresden. Where fires started and spread by the bombing increased to a point where the oxygen was being sucked into the flames at such a high speed that the fire became a "Fire Storm". At the time the city's population had increased due to a high number of refugees fleeing the Russian advance to the east, the exact civilian death toll from fire and suffocation will never be known, but is considered to be somewhere between 25,000 and 100,000.

**High Explosive (HE) Bomb.** Some of the most common type of ordnance to be dropped on the United Kingdom, HE bombs are often the type encountered as UXBs. Relatively thick cased, they are still recovered in remarkably good condition. Ranging in size from 50 to 1700 kg, their typical release height (1,500m) allowed them to penetrate deep into the ground as a result of design or flaw. Towards the end of the bombing campaign, as steel became scarce the German Engineers produced a range of bombs that used steel reinforced concrete as the bomb body. Figure 4 shows the range of steel HE bombs dropped on the UK.

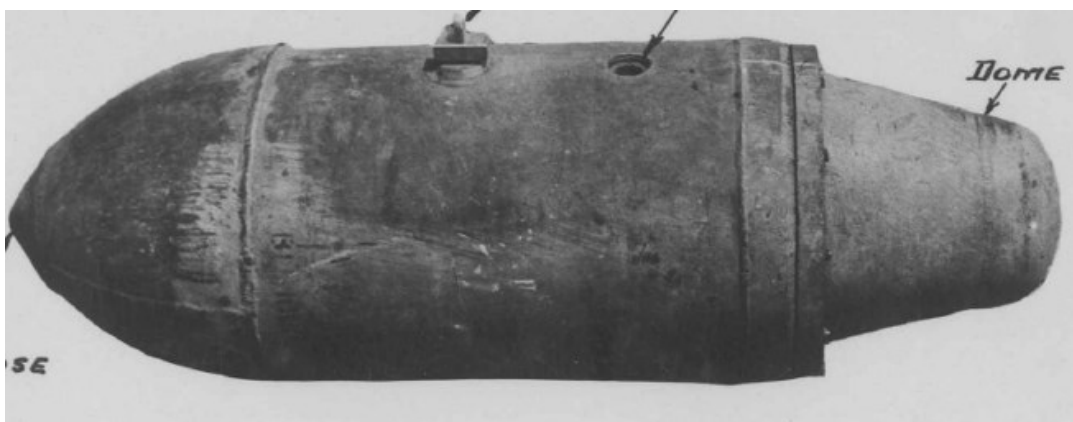
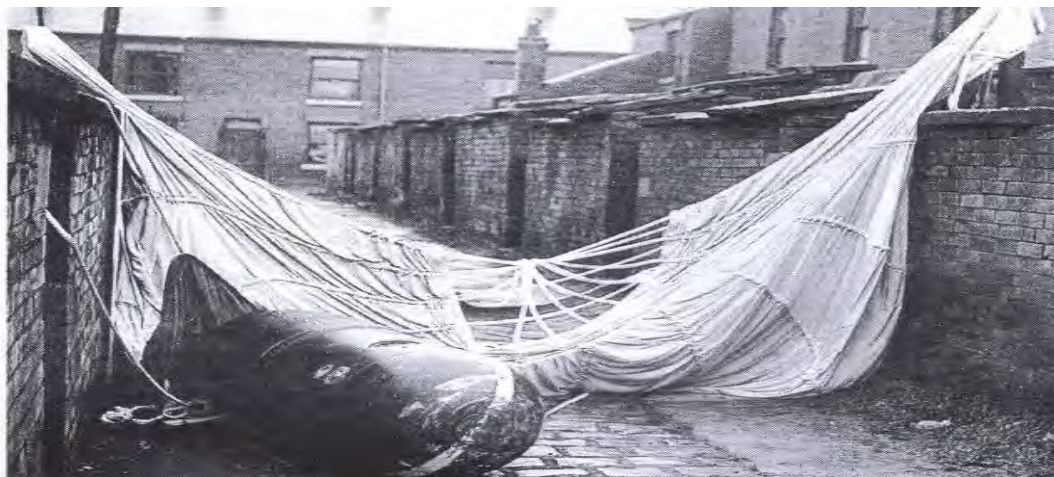
Figure 6: Common Airdropped Mines.

#### Parachute & Ground Mines

Note; all mine fuzes were designed to arm after deployment from the ship, submarine or aircraft, some fuze designs incorporated anti-removal booby traps. Unexploded mines found today are the result of a failure within the arming mechanism or procedure whereby the mine never fully armed. Sudden shock or jarring of a weapon in this state has the potential to complete the arming sequence and could result in the mine detonating with lethal consequences.

**Blast Bomb / Parachute Mine.** The parachute mine was extensively used on land and at sea and was fitted with specialist fuzes designed to trigger the weapon at a predetermined altitude, water depth or to switch on other magnetic influence mechanisms to trigger the weapon when a ship approached (Magnetic or Acoustic influence). While early versions were based on the standard 1000kg SD Bomb case others were specially designed and manufactured with an aluminium body, making them extremely difficult to detect using magnetometers. The thin cased versions would normally disintegrate on impact on land and are normally considered to pose little threat to work on land based projects, but the risk increases significantly on projects over water or in marshland. Thicker cased versions however will survive impact and pose a significant risk regardless of the local ground conditions. (See Figure 6)

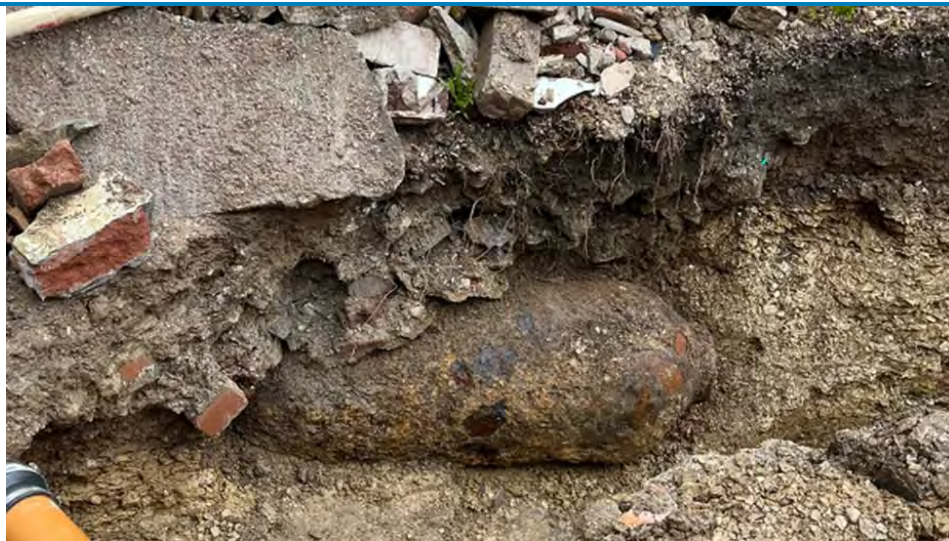
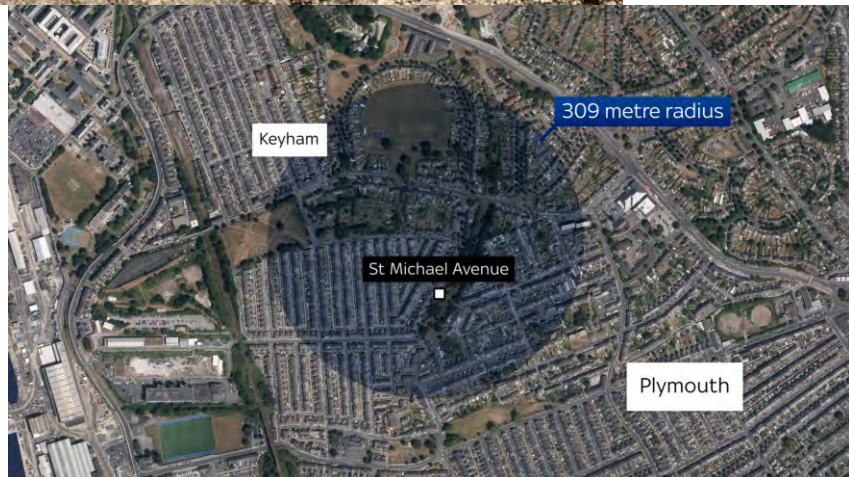
| <b>Description:</b> | <p>A 500kg (1,102lb) German World War Two bomb that forced the evacuation of thousands of people in Plymouth has been detonated at sea.</p> <p>The unexploded device was found in a garden on St Michael Avenue on Tuesday, sparking four days of disruption.</p> <p>On Friday police closed roads and rail and bus services were stopped as the bomb was transported 1.4 miles (2.3km) through the city's streets.</p> <p>The device was taken by boat beyond the breakwater and detonated at 21:51 GMT.</p> <p>No further details of the disposal have been given.</p> |

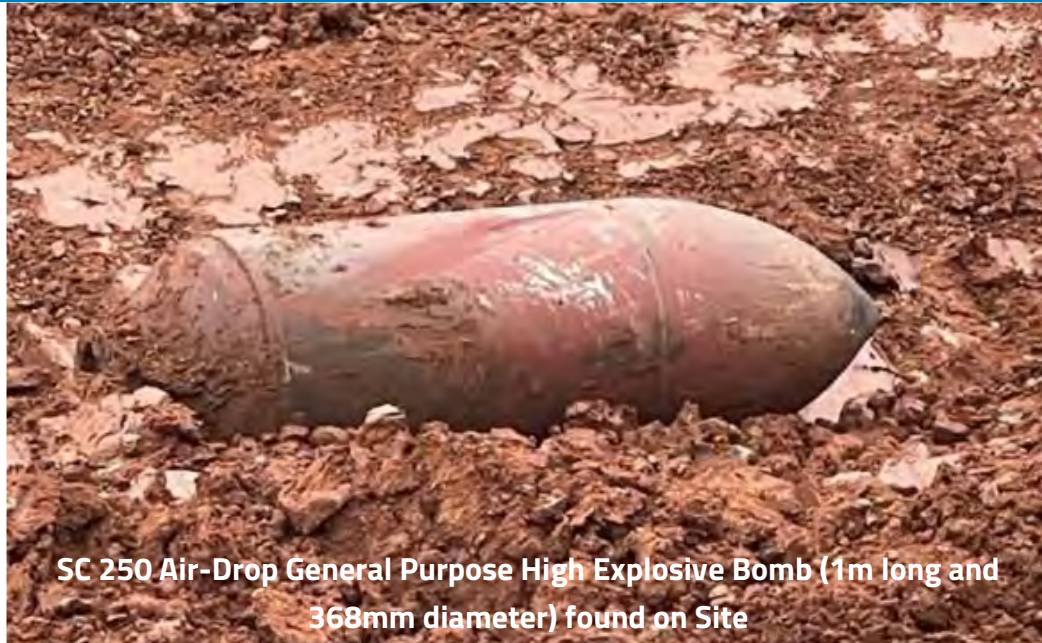
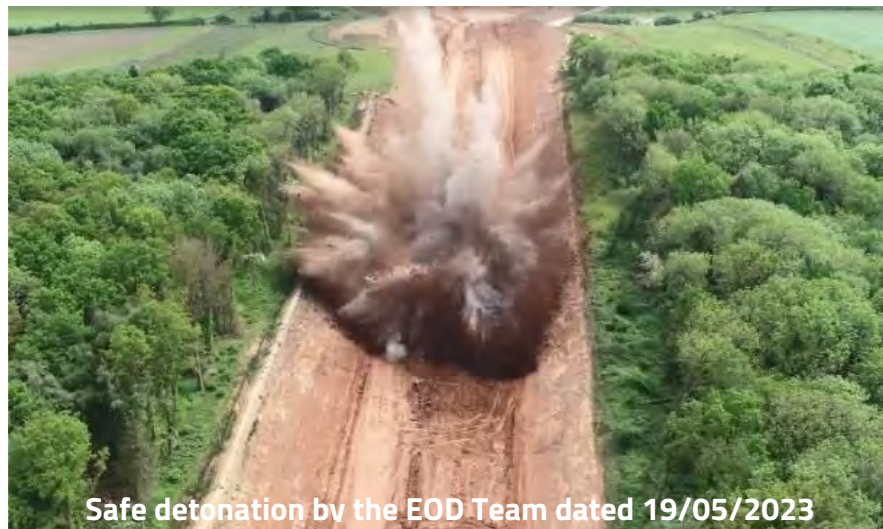
| Description: | <p>When carrying out earthworks activities at Cubbington Cut. An Unexploded Bomb (UXB) was reported. The UXB was picked up in the bowl of the Scraper and was immediately placed onto the ground by the Operator. The Operator instantly raised the alarm.</p> <p>The Police and Explosive Ordnance Disposal (EOD) Team were contacted to control the area. The surrounding work areas were immediately evacuated. Public houses adjacent to the Woods (aligned with the UXB) were evacuated when the bomb was detonated successfully by the EOD at 1330 hrs 19/05/2023.</p> |

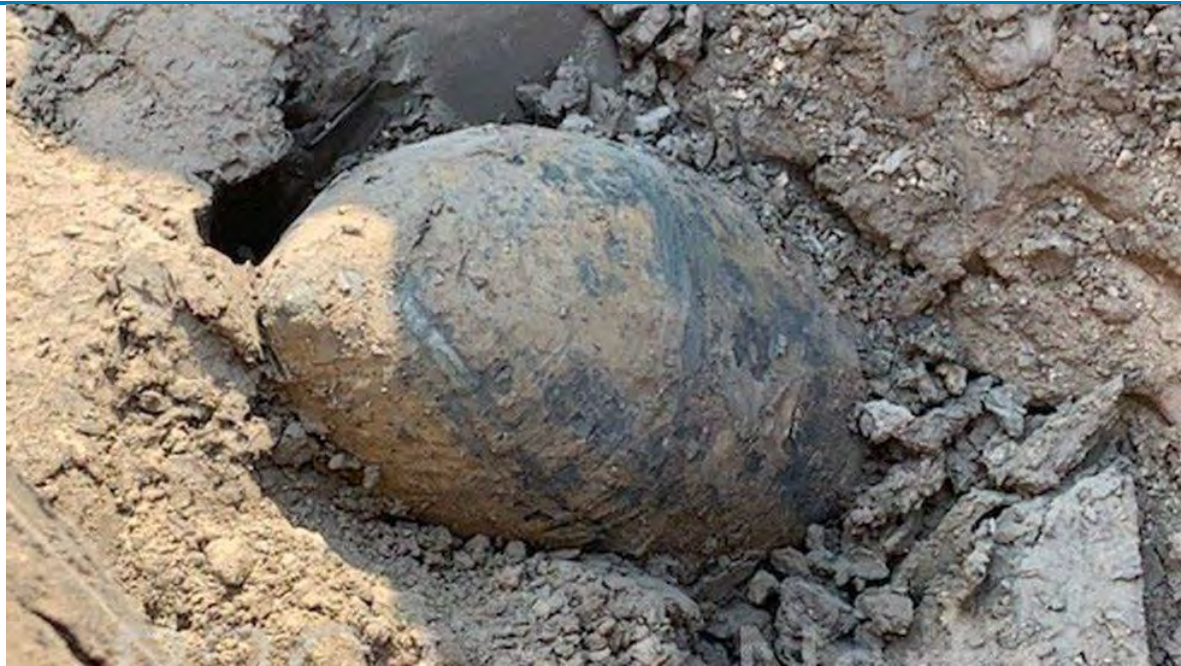
| <b>Description:</b> | <p>A live World War Two bomb unearthed by builders on a housing development has been destroyed in a controlled explosion. The 500lb (227kg) device was found on the new-build estate in Goole, East Yorkshire, on Thursday. Eight homes were evacuated and the M62 was shut between junctions 35 and 37 as a safety precaution.</p> <p>Humberside Police said the device was successfully detonated at 16:22 BST on Saturday. All residents have been able to return to their homes and local business are no longer being asked to remain closed. The force also said a no-fly zone and the closures of the M62 and other roads nearby had since been lifted.</p> <p>John Sharpe, site manager of the Beal Homes development, said he received a call from workers just after midday on Thursday.</p> <p>"They didn't know what they'd dug up at first and a guy went down into the hole because we thought it was a metal pipe.</p> <p>"As he uncovered it he realised it was a bomb and got out pretty quickly," he said.</p> |

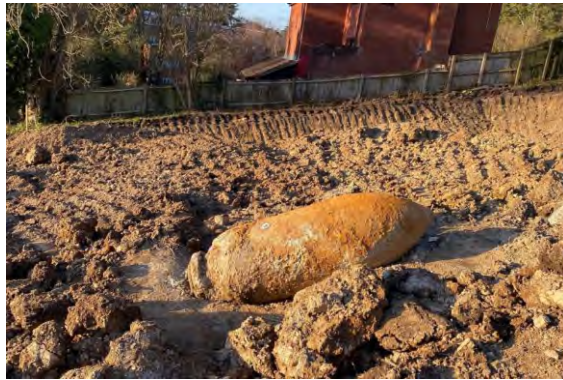
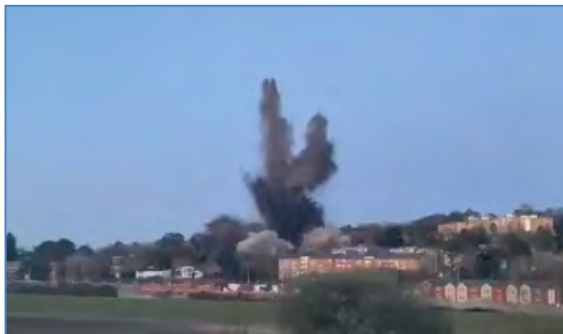
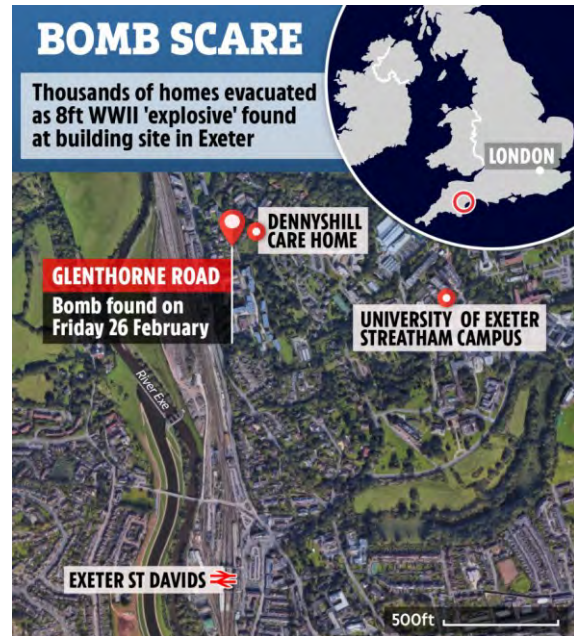
| <b>Description:</b> | <p>A WORLD War II bomb which sparked a mass evacuation in Exeter has been detonated by army experts leaving a crater the "size of a double decker bus." The noise from the huge blast - which sent debris flying more than 250 metres - could be heard five miles away with some residents claiming the aftershock rattled their windows.</p> <p>Personnel from the Army's Royal Logistics Corps took over from Royal Navy bomb disposal experts this morning.</p> <p>They used 400 tonnes of sand to create an enclosing "box" before it was "made safe" at around 6.10pm.</p> <p>He added: "Around 400-tonnes of sand was transported to the site of the device, which is at a building site on private land, and walls were erected... to mitigate the impact of the detonation.</p> <p>"Trenches were also dug to prevent ground shock. Despite these mitigation measures, the impact of the blast has been significant and debris has been thrown at least 250-metres away.</p> <p>"The crater is around the size of a double decker bus.</p> |
