## Land off Stopes Road, Little Lever

### Mineworking Treatment Validation Report

For: Taylor Wimpey (Manchester)

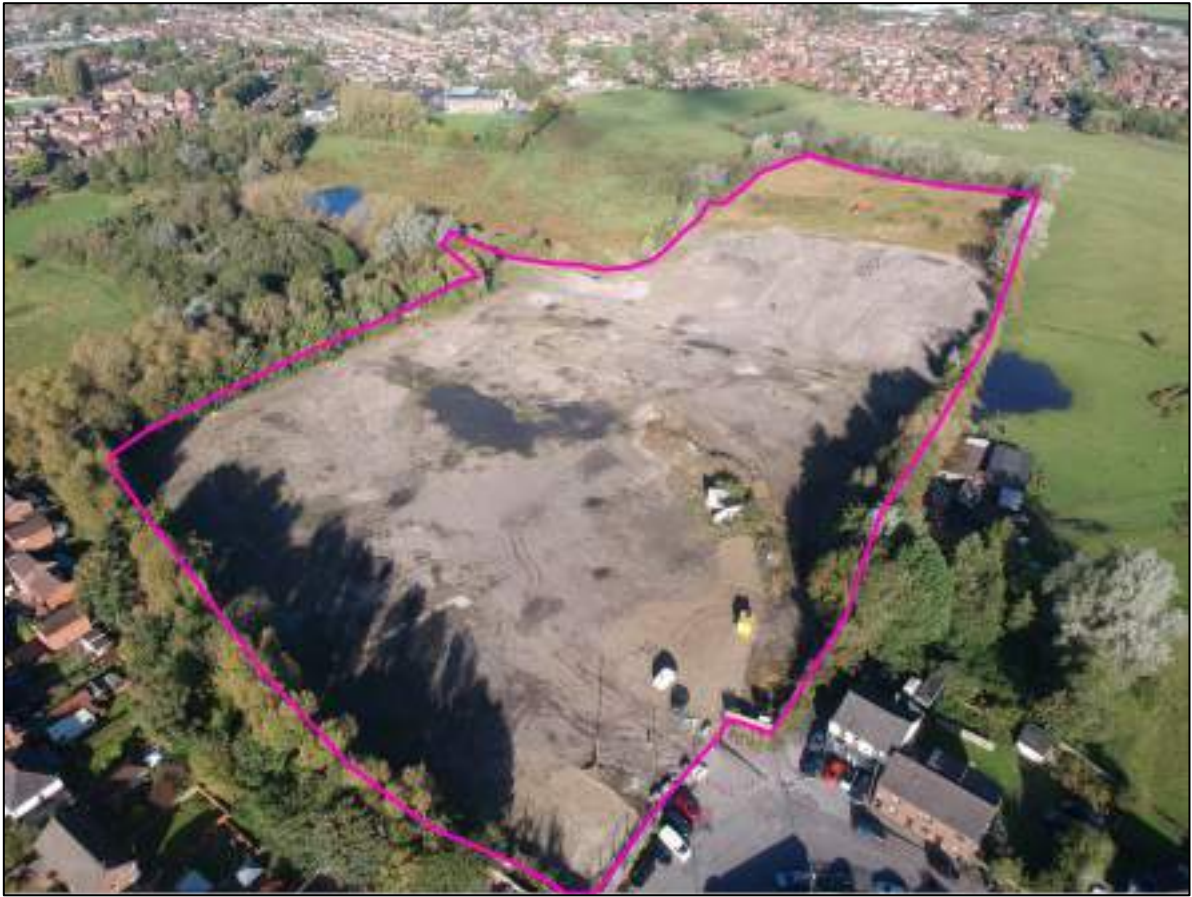
Figure 1: Aerial image of the site dated October 2024.

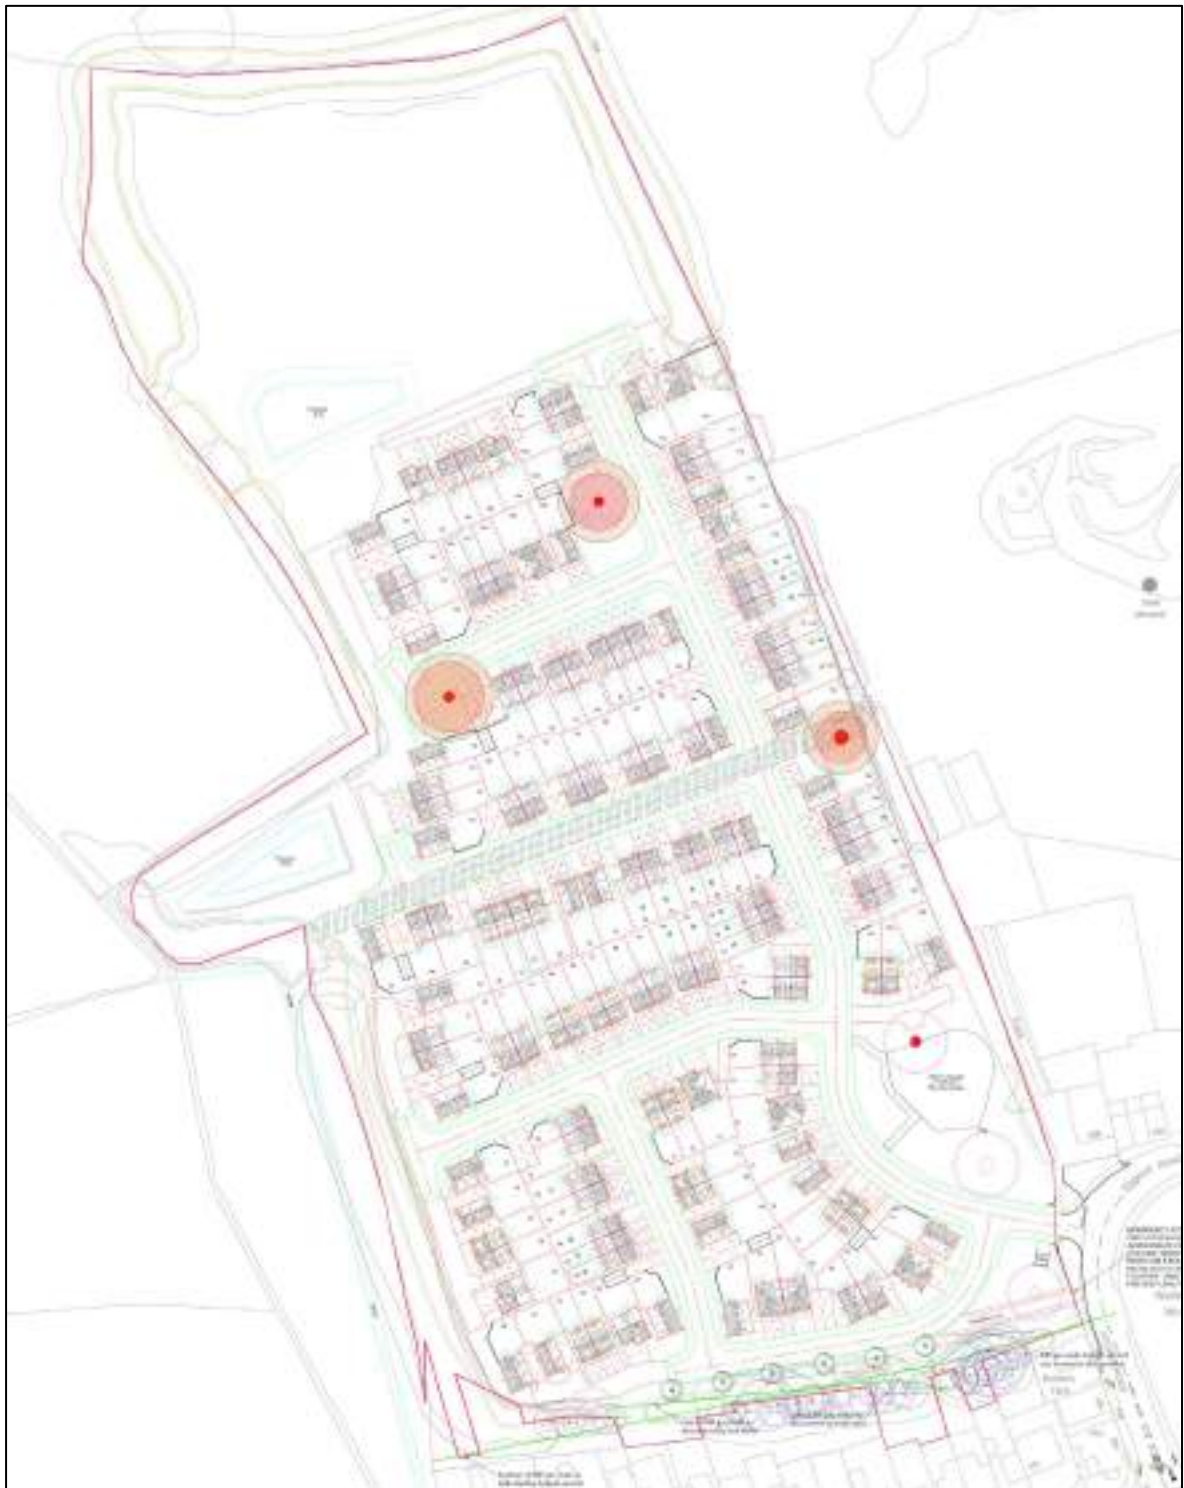
*Figure 1: Extract of the proposed development plan rev AG – the layout also illustrates the three previously unrecorded mine entries in the north and eastern site sections (noted with a red dot and shading)*

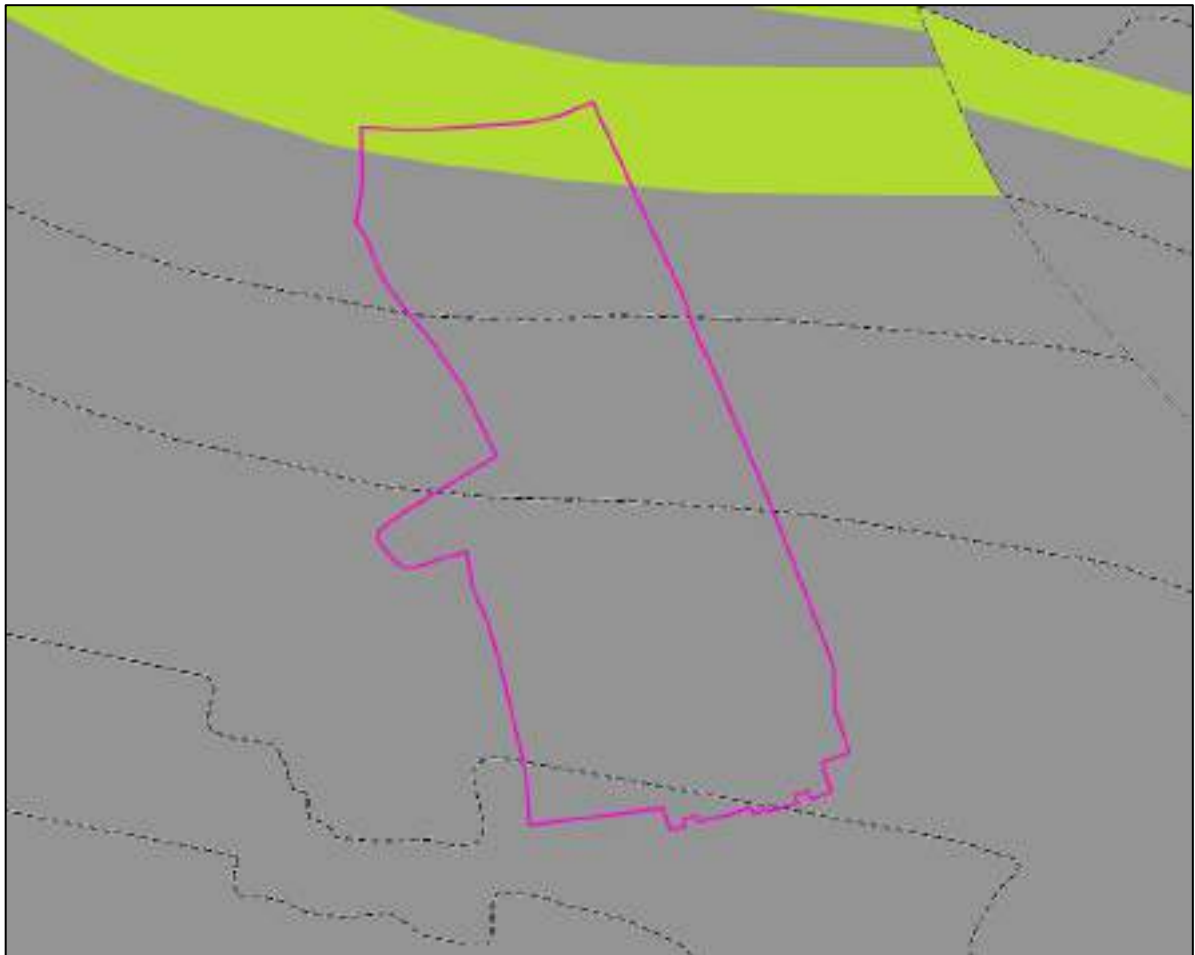
The BGS geological maps indicate that 3 No. coal seams subcrop on the site. The geological maps suggest a bedrock dip of 15° to the south. The coal seam subcrop to the south west of the site is recorded to 'bend' which is indicative of opencast workings that have artificially displaced the coal subcrop down-dip. Mudstone, siltstone and sandstone are recorded across the majority of the site. The northern site section (outside of the proposed development area) is recorded to be underlain by sandstone. An extract of the BGS 1:50,000 scale bedrock geological map is shown below:

Figure 2: Extract of the BGS 1:50,000 scale bedrock map. Sandstone (green), mudstone, siltstone and sandstone (grey) and coal seams (black dotted lines).

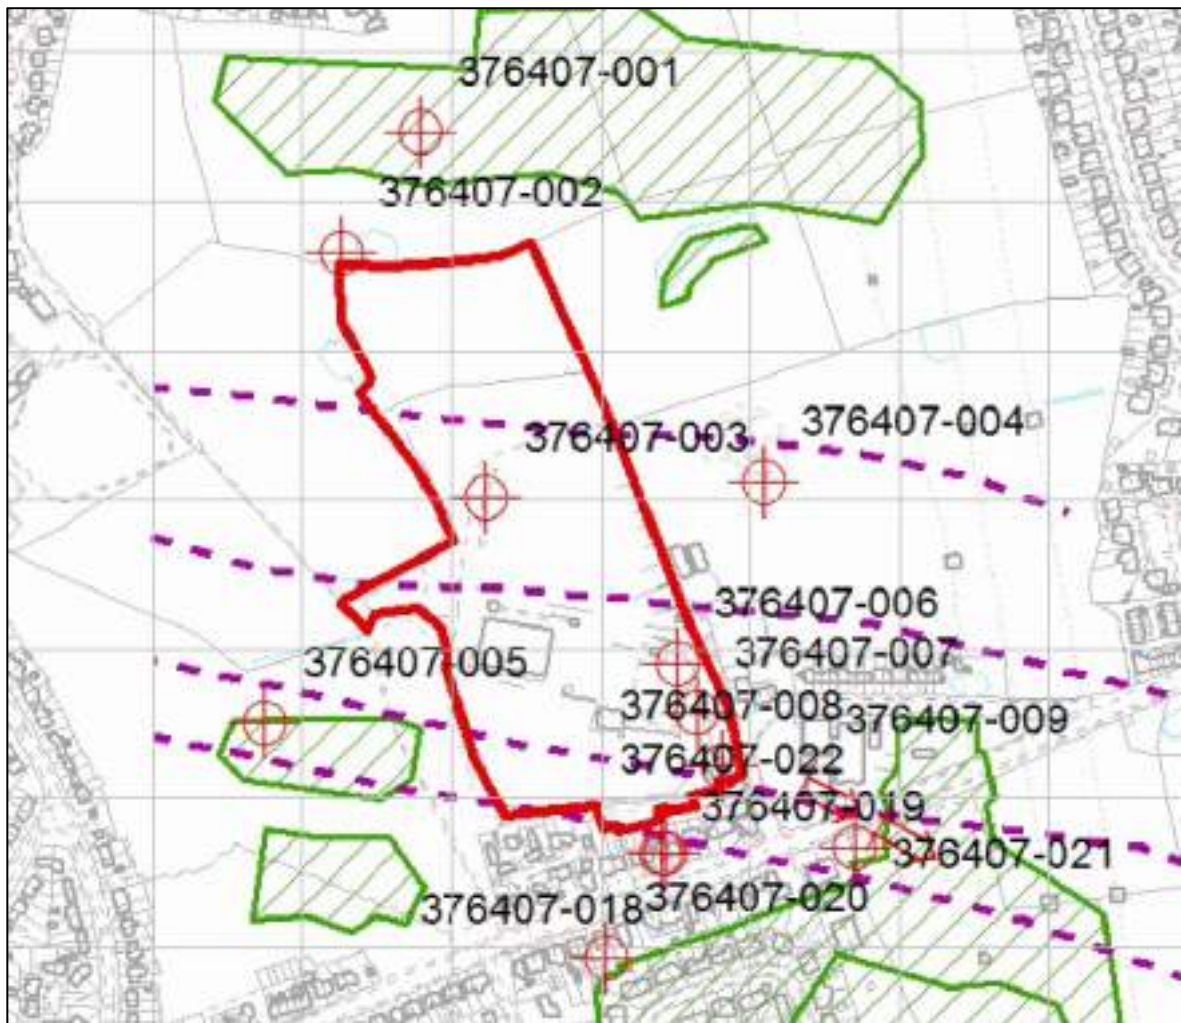
The Coal Consultants Report identified 3 No. coal seam subcrops on the site and a subcrop is also recorded to run parallel with the southern site boundary. The Rams coal seam subcrops in the northern site section, the Top Furnace coal seam subcrops in two partings / leaves (also known as the Lower Florida (upper parting) and Top Shuttle (lower parting) in the central site section, and the Roger coal seam subcrops in the south western corner of the site. The subcrop locations recorded on the coal consultant's report are broadly similar to the BGS geological map records. The MRA report indicates that workings within the underlying coal seams had a recorded bedrock dip of 14 to 16° to the south or south west.

Figure 4: Extract from the Coal Authority Consultants Coal Mining Report Ref: 51002283067001 contained within the Hydrock Coal Mining Risk Assessment Report

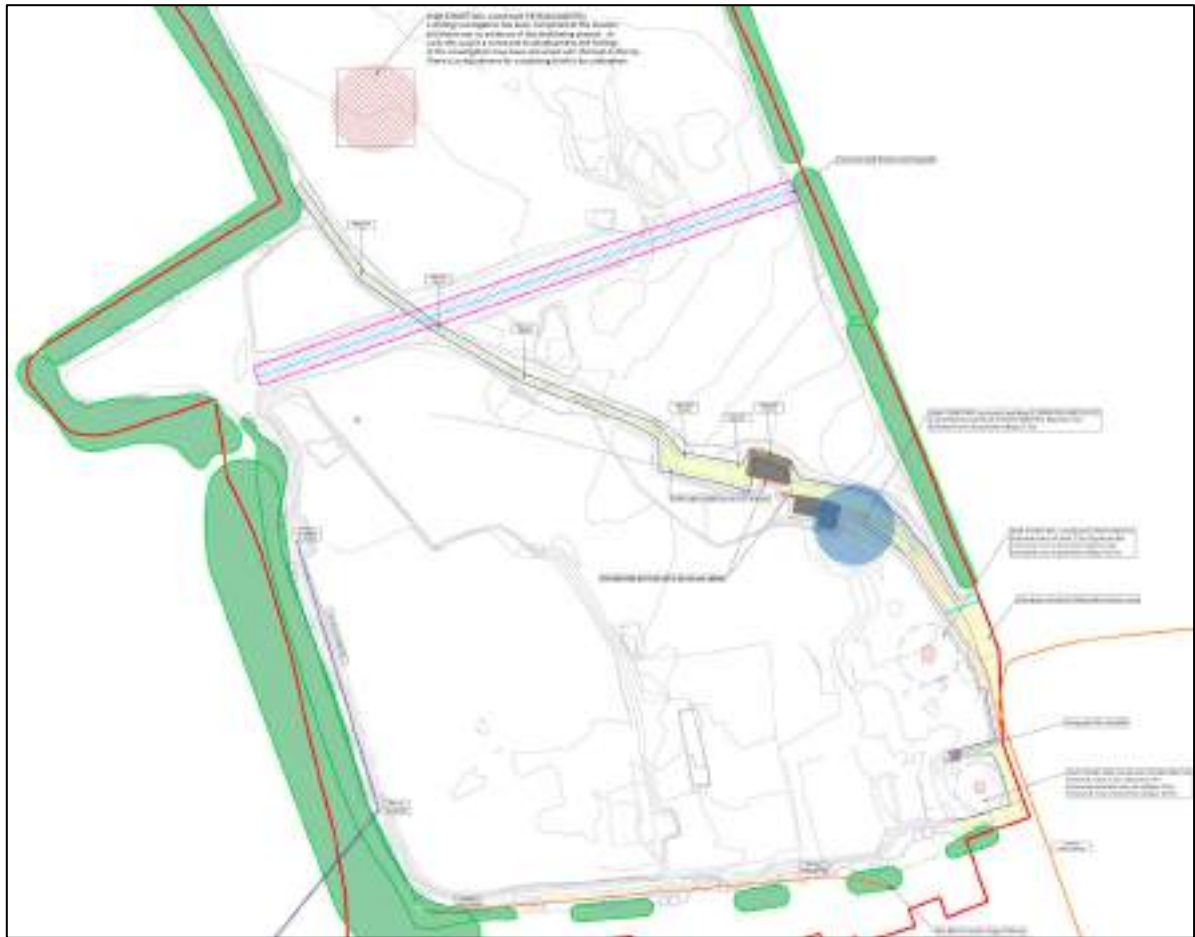
This Hydrock technical note summarised the further investigation works undertaken to locate or confirm the absence of 4 No. recorded mine shafts that are recorded on site based on MRA records. The works were undertaken over two investigation phases. The initial shaft investigation was undertaken in September 2021 and the second phase undertaken in May 2022. A plan is included below showing the locations of the 4 No. targeted mine shafts:

Figure 5: Extract of Hydrock drawing 15220-HYD-XX-XX-DR-GE-1023

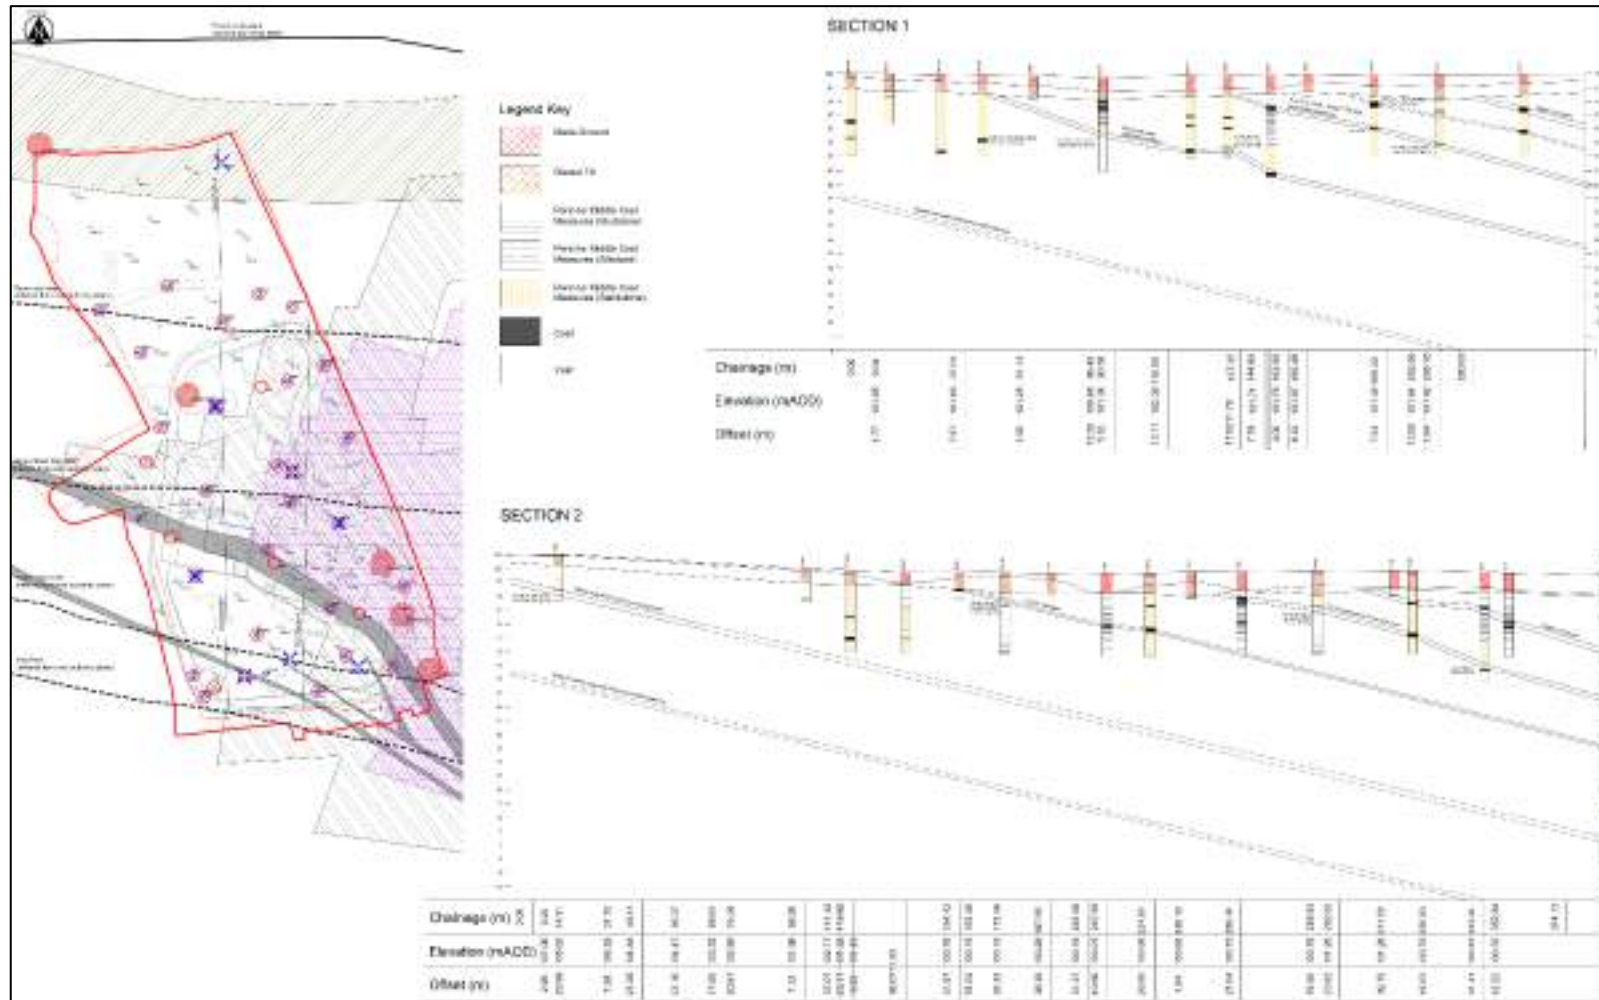
The initial ground model was produced by Hydrock following their works. This ground model highlights the 4 No. coal seams that subcrop on or in close proximity to the site.

Figure 6: Hydrock initial conceptual ground model.

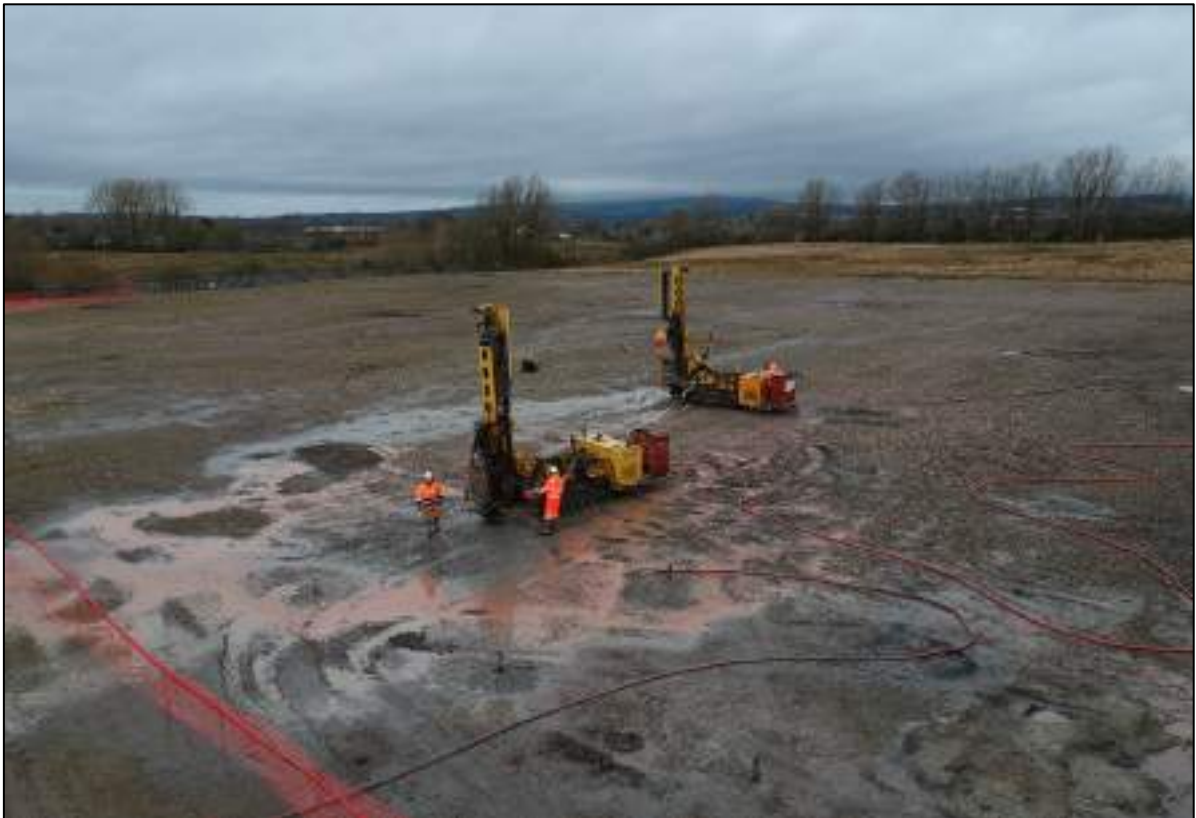
*Figure 7: Rotary drilling rigs undertaking drilling in the northern site section in February 2025.*

The drill and grout works were undertaken by 2 No. Klemm 802-2 rotary drilling rigs utilising water flush as a drilling medium. Temporary 101mm diameter steel casing was installed into the bedrock to allow grout to be injected at target depths and prevent the overlying Made Ground and Glacial Till from collapsing into the holes.

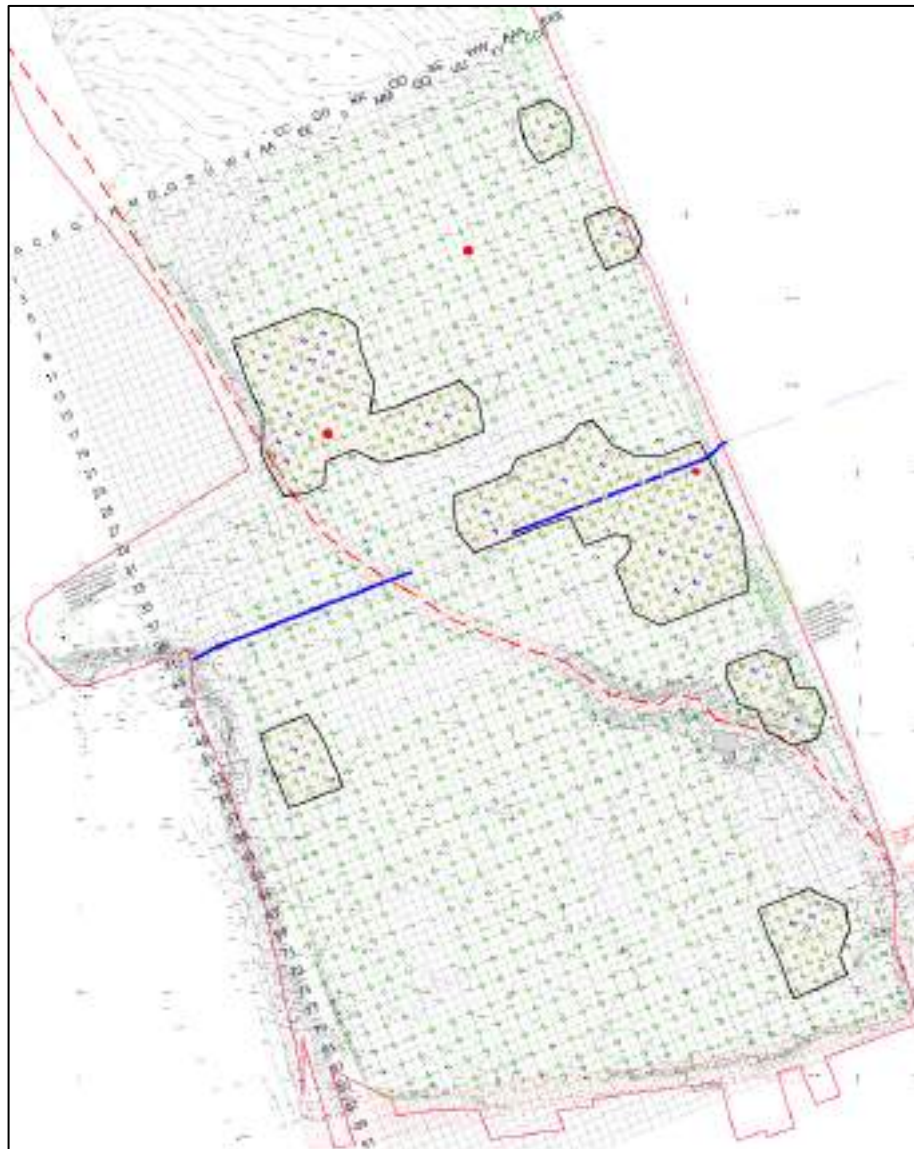
Areas of broken ground and loss of flush were encountered during the drilling works which were attributed to historical workings. These areas would typically require secondary grout holes due to grout takes in excess of 5T. The central site section typically required a greater proportion of secondary holes which suggests that there may have been more shallow workings in this area. Low grout takes were recorded in the northern and south western site areas. An extract of the completed grouting grid drawing with areas requiring secondary drill and grout holes highlighted, is shown below. This drawing is also included in Appendix 2:

Figure 8: Extract of the completed drill and grout grid with areas requiring secondary holes outlined and highlighted in orange.

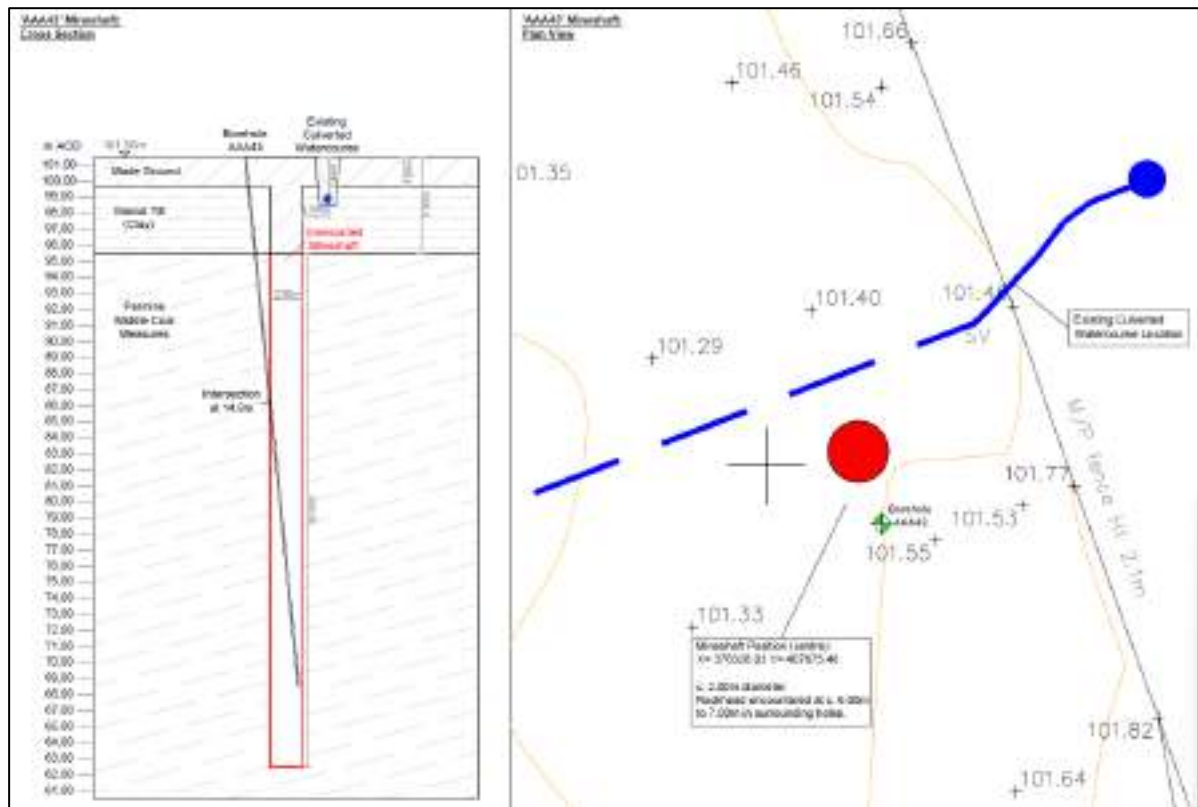
A further 21 probe holes were undertaken in and around the mine shaft to confirm the diameter, depth and 5m past the base of the feature. Whilst undertaking the probes, soft drilling was noted, which suggest the mineshaft may have been partly backfilled. The shaft had a confirmed depth of 38m below ground level and an estimated diameter of c. 2.00m. The coordinates for the centre of the shaft are: 376328.03E, 407675.46N. Mineshaft AAA43 is located c. 1.5m south of an existing surface water culvert.

Figure 9: Cross section and location plan of mineshaft AAA43.

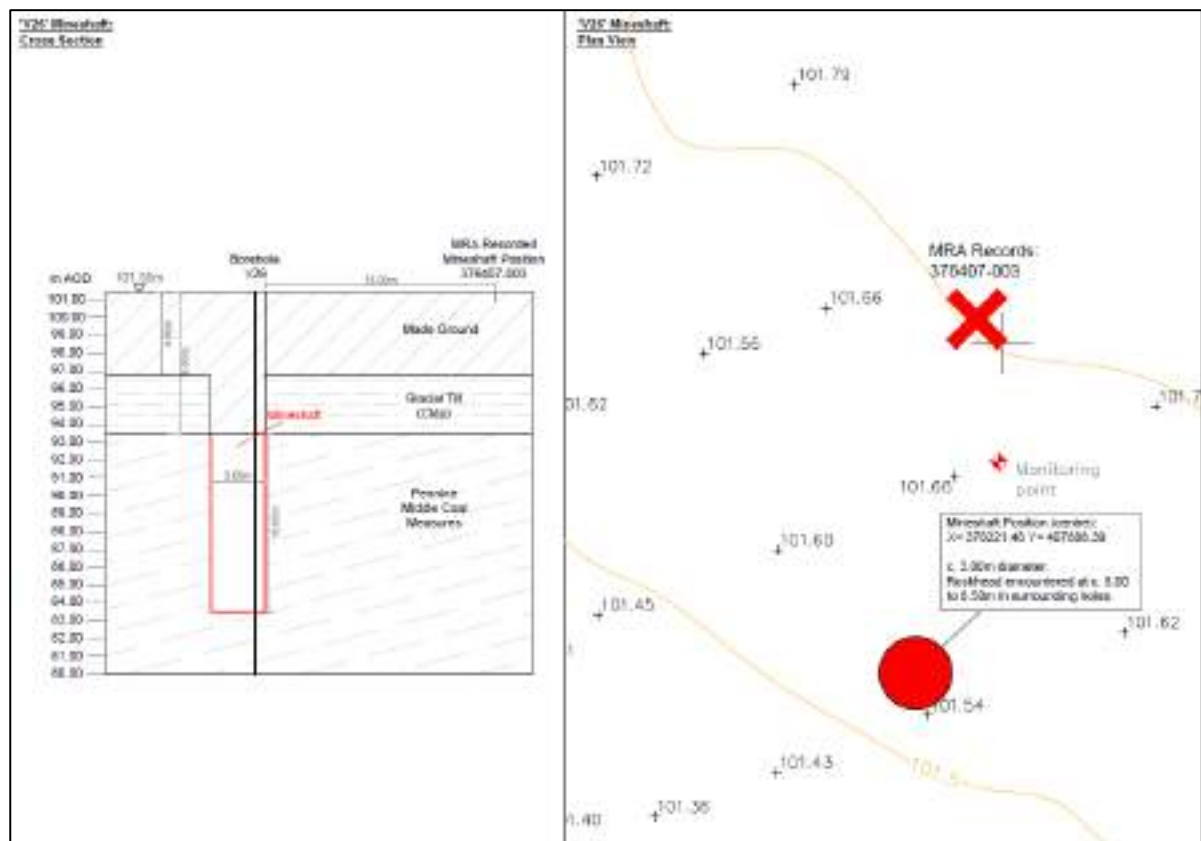
Based on MRA records a mineshaft (376407-003) was recorded to be present on the site in the north eastern site area. Previous investigation works (summarised in Section 3.3.1) were undertaken by Hydrock in 2022 to attempt to locate the shaft but were unsuccessful. Therefore, it was recommended that a watching brief was undertaken for drill and grout holes in this area. All drilling operatives were made aware of the risk of encountering the mineshaft in this area as well as any other unrecorded shafts prior to drilling. The mineshaft encountered in borehole V26 was located c. 13m south of the MRA recorded position of 376407-003, outside of the Hydrock investigation 10m search area. The shaft at borehole V26 is anticipated to correspond with the MRA record referenced as 376407-003. For consistency between the drill and grout logs, investigation, grouting and validation report, this mineshaft shall be referred to as V26.

Figure 10: Cross section and location plan of mineshaft V26.

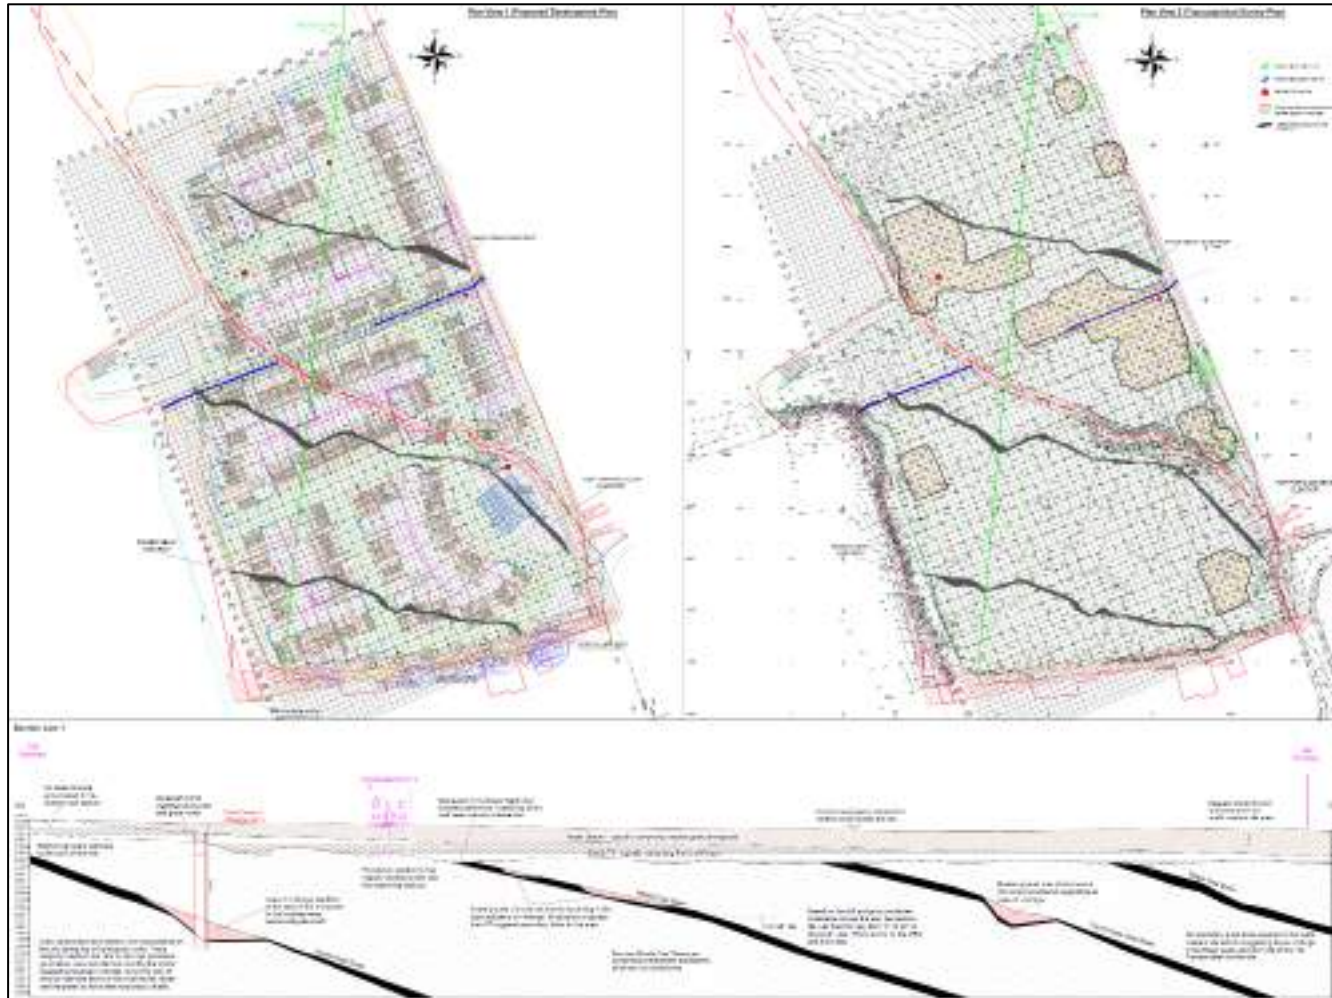
Figure 11: Extract of the conceptual ground model for the site.

The drill and grout works identified 3 No. coal seams subcropping on the site which are interpreted to represent the Rams, Top Furnace and Roger coal seams (from north to south). The Stubbs coal seam is interpreted to subcrop off site to the north and is present at shallow depth in the northern site section. Based on the drill and grout works, the coal seams were recorded to range in thickness from 0.20m to 3.50m with a mean thickness of 0.95m and a median thickness of 0.70m. The recorded seam thicknesses should be treated with caution given the method of drilling does not provide sample recovery and can therefore be misinterpreted.

Grout takes greater than 5T indicative of potential workings / broken ground were recorded in the Stubbs, Rams and Top Furnace coal seams. No workings / broken ground were encountered in the south western site section associated with the Roger coal seam.

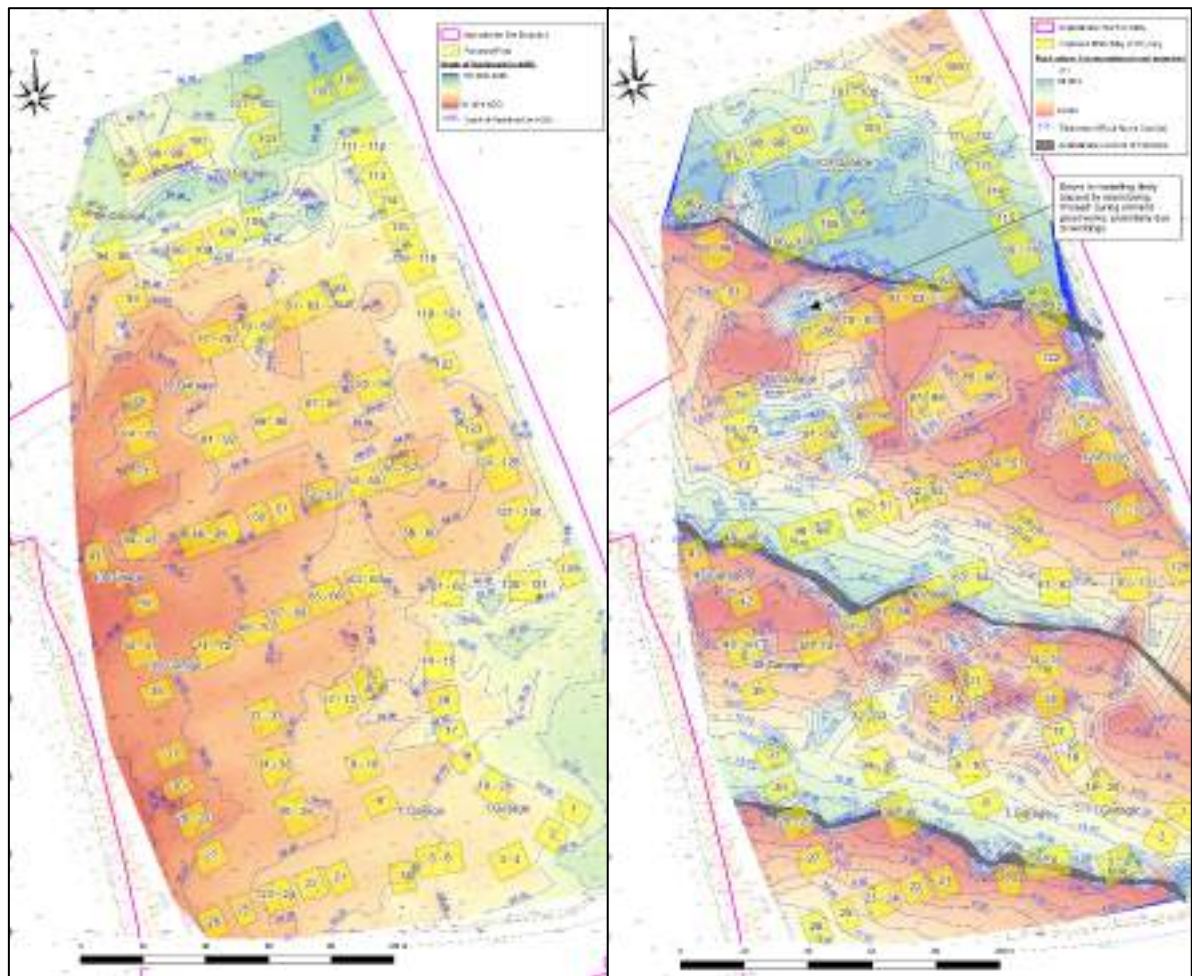
The depth of coal seams was recorded during the drill and grouting works which identified the location of subcrops on the site. By assessing the level of the coal seams and rockhead, the thickness of rock above the shallowest coal seam across the site can be calculated. Further information regarding the strength of the underlying bedrock is included in the IGE Consulting *Ground Investigation Report* (Ref. 3524-07, dated May 2025). This information should be submitted to specialist piling contractors and can be used when completing their detailed designs and determining appropriate pile lengths.

Figure 12: Depth of rockhead (m AOD) (left). Thickness of bedrock above coal seams and coal seam subcrop locations (right)

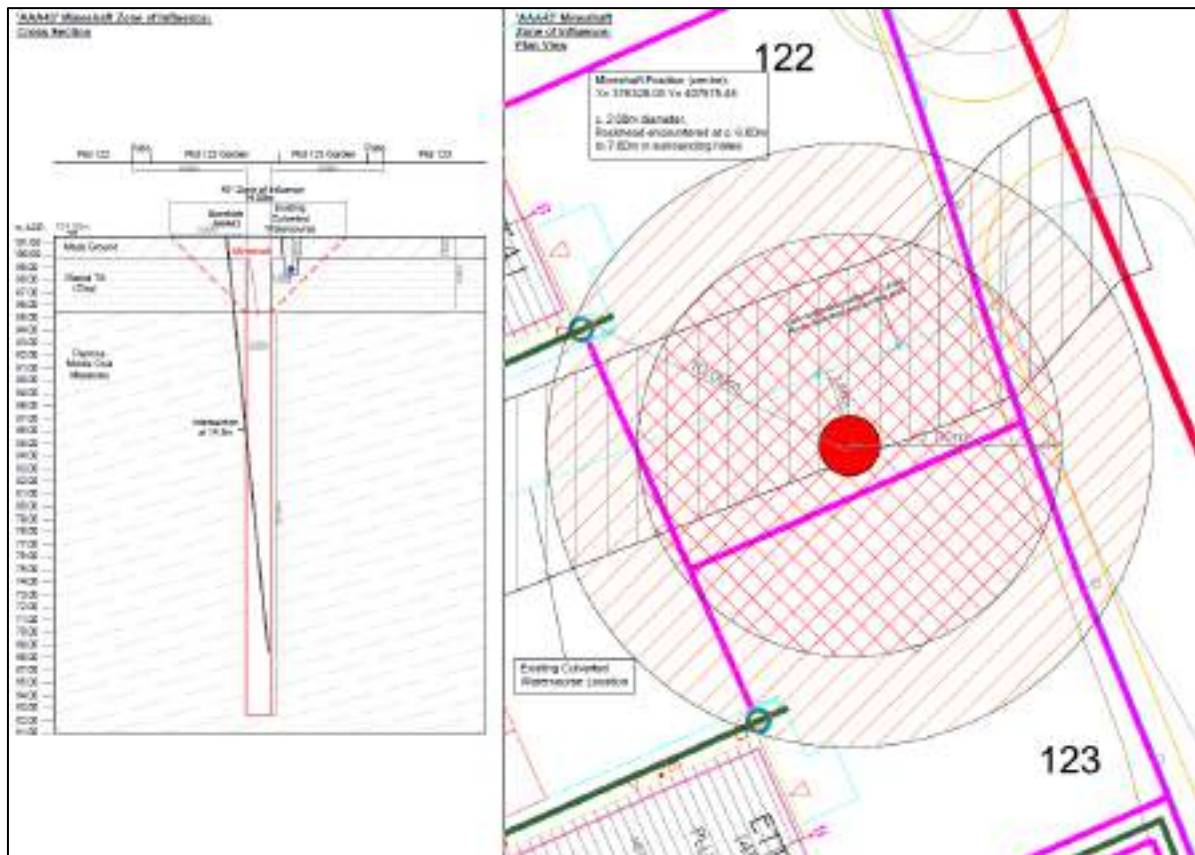
Based on the ground conditions encountered, a safe standoff zone of 45° from where the mineshaft edge intersects rockhead is considered appropriate. This would give a radius from the mineshaft edge of 6.00m.

Based on the proposed layout, accounting for the zone of influence of the shaft, mineshaft AAA43 would be located in the rear garden of plot 122. The proposed zone

of influence extends into plot 123 garden. The locations of proposed plots are shown on the mineshaft zone of influence drawing contained in Appendix 2 and an extract shown below:

Figure 13: Zone of Influence of mineshaft AAA43.

The preferred option for the treatment of mineshafts would be to install a reinforced concrete cap at the top of the shaft to mitigate the risk of future failure in line with CIRIA C758. However, given the presence of the existing culverted watercourse c. 1.5m north of the mineshaft and the close proximity to the western boundary of the site, alternative solutions for mitigating the risk of the shaft are proposed.

Alternatively, the risk of the mineshaft could be mitigated using other means that negate the requirement for a reinforced mineshaft cap. By enforcing a 'no build' stand off zone surrounding the mineshaft, the risk of damage to infrastructure through mineshaft subsidence is reduced. The proposed development plan has been designed to account for this and mineshaft AAA43 is currently positioned within a private garden (plot 122) with no infrastructure (proposed plots, garages, driveways or highway) within the zone of influence. This vastly reduces the risk to buildings of mineshaft collapse and does not increase the likelihood as the shaft or its zone of influence will not be subject to structural loads.

By using a geogrid as reinforcement, the culvert can remain in-situ. If access to the culvert was required in this area in the future, the geogrid could be excavated and replaced with relative ease.

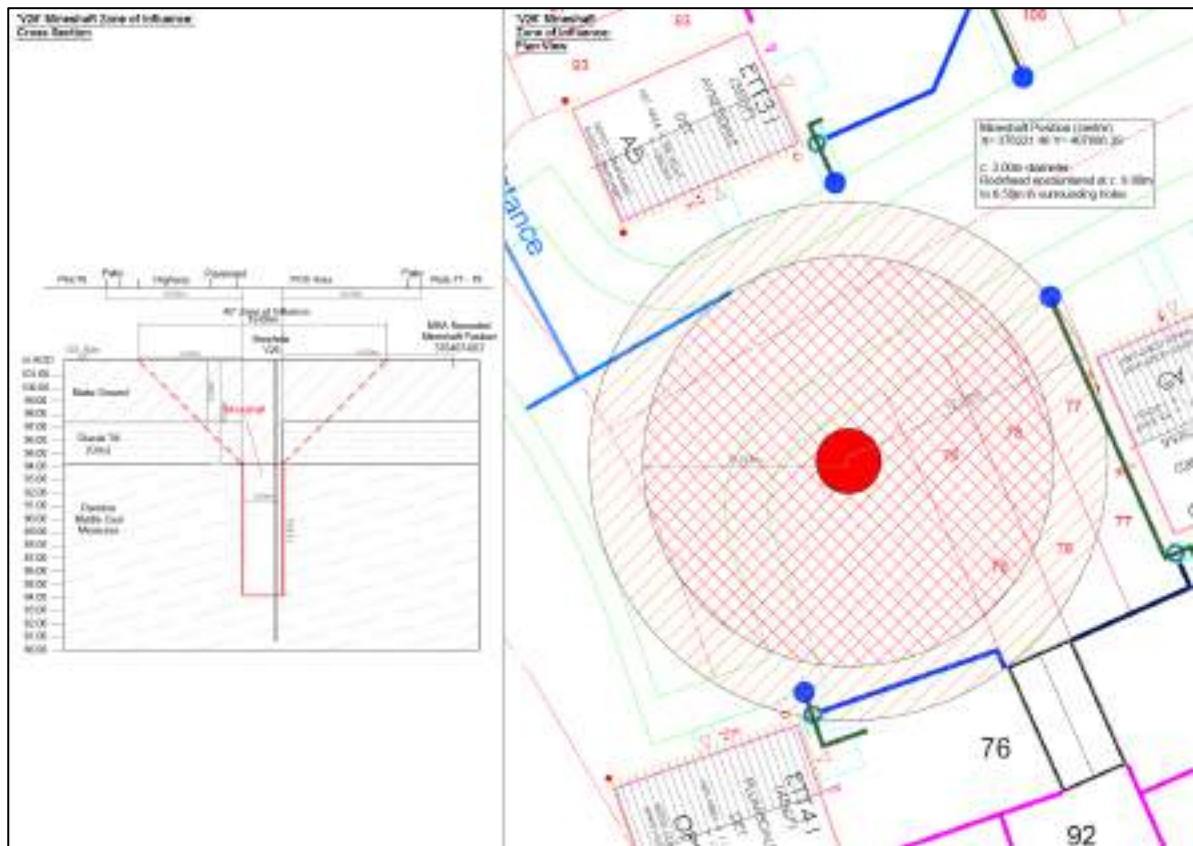
The probe holes confirmed a shaft diameter of 3.00m. Based on the ground conditions encountered, a safe standoff zone of 45° from where the mineshaft edge commences at rockhead is considered appropriate. This would give a radius from the mineshaft edge of 8.00m.

The mineshaft is located in an area of proposed public open space (POS). The zone of influence of the shaft extends over as proposed highway and car parking area. The proposed zone of influence and locations of proposed plots are shown on the mineshaft zone of influence drawing contained in Appendix 2 and an extract shown below:

Figure 14: Zone of Influence of mineshaft V26.

Mineshaft V26 is not restricted by existing services or access. Therefore, it is recommended that the mine entry is capped at bedrock in line with CIRIA C758.

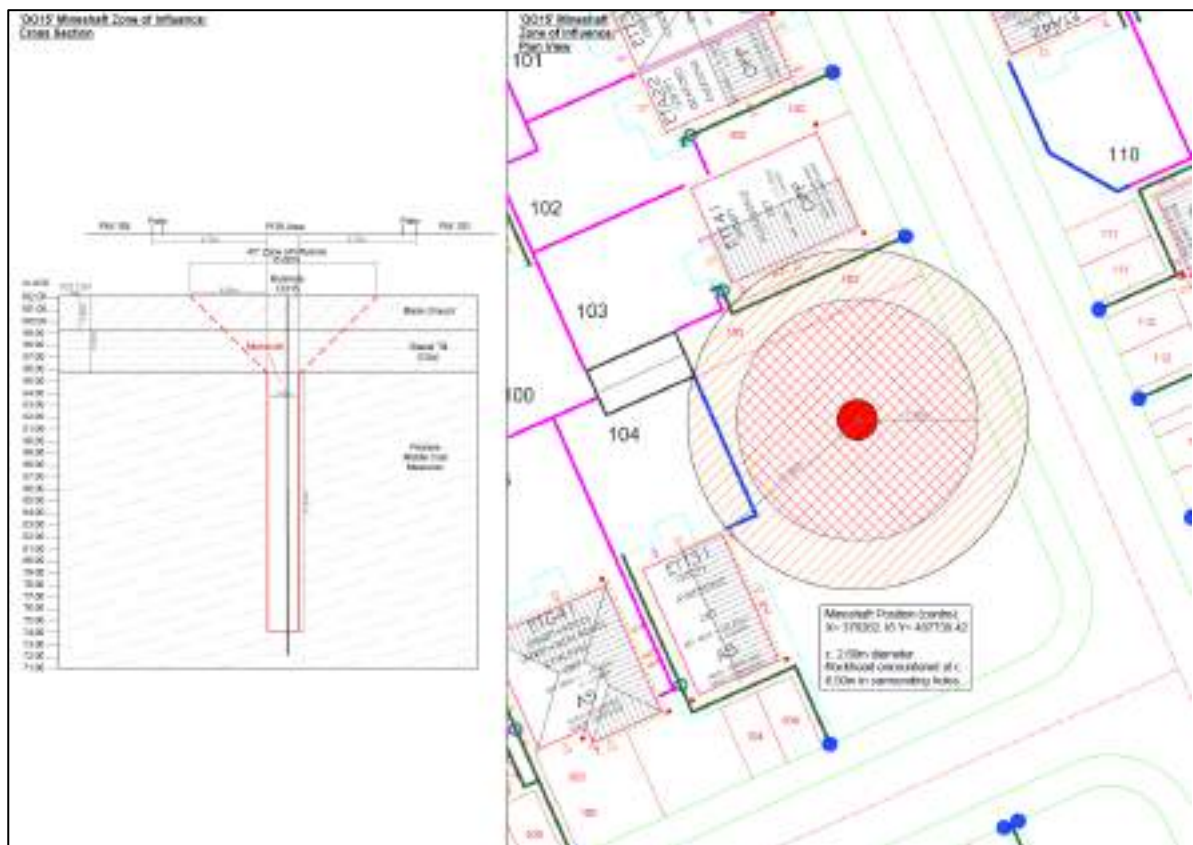
The probe holes confirmed a shaft diameter of 2.60m. Based on the ground conditions encountered, a safe standoff zone of 45° from where the mineshaft edge commences at rockhead is considered appropriate. This would give a radius from the mineshaft edge of 6.50m.

The proposed zone of influence and locations of proposed plots are shown on the mineshaft zone of influence drawing contained in Appendix 2 and an extract shown below:

Figure 15: Zone of Influence of mineshaft OO15

No access or service restrictions are present surrounding mineshaft OO15. Therefore, it is recommended that the mine entry is capped with a reinforced concrete cap as per the outline specification detailed above for mineshaft V26. It is proposed that the mine entry would be located within the proposed POS area.
