## RECORD OF INSITU DENSITY OF FILL MATERIALS

| Project Reference: | Stopes Road, Bolton |

# Appendix C VHE Addendum Validation Report (JMS/SR/JP/47366- RP006 Rev A)

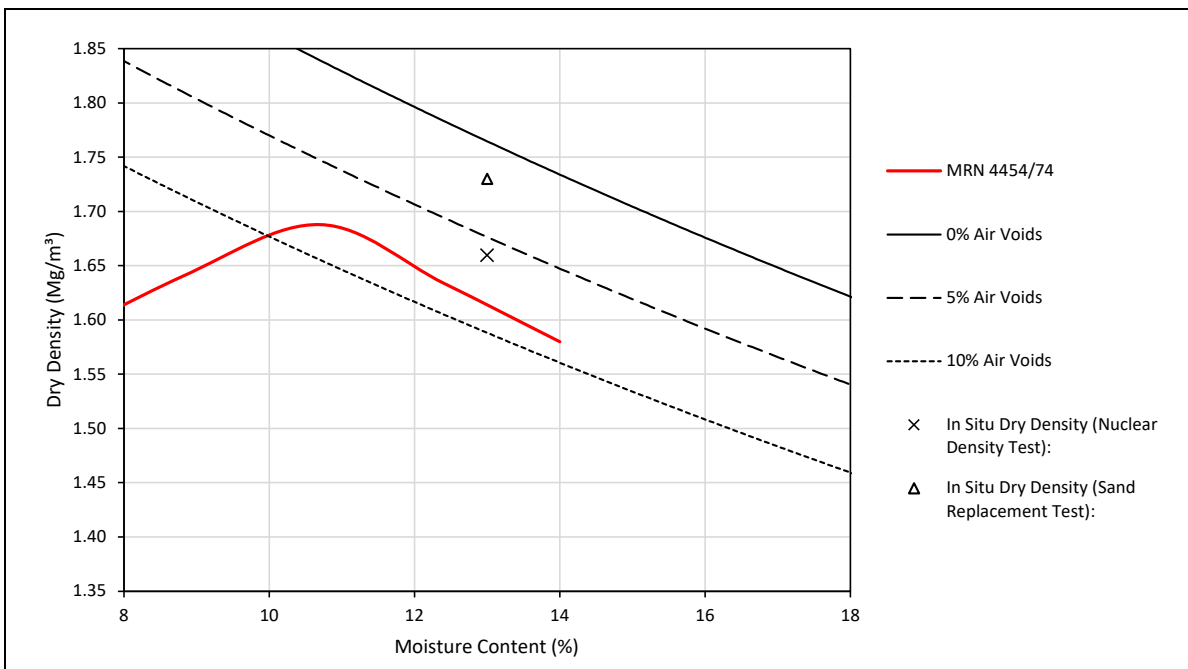
| In Situ Dry Density (Nuclear Density Test): | 1.66 Mg/m <sup>3</sup> |
| In Situ Dry Density (Sand Replacement Test): | 1.73 Mg/m <sup>3</sup> |
| Average Dry Density: | 1.70 Mg/m <sup>3</sup> |
| Degree of Compaction: | 100 % |
| Air Void Content: | 3.9 % |

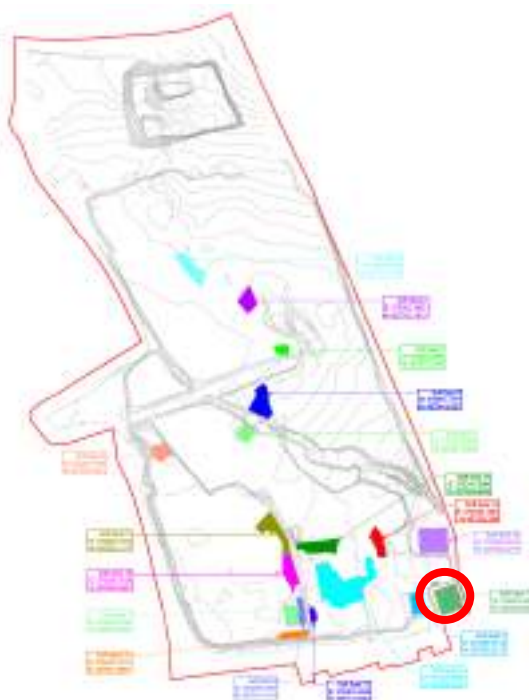
| <b>Comments / Details of soft spot:</b><br>Clays at the base of the dig were observed to be very soft, these were excavated further until suitable clays were encountered. A starter layer of imported 6F5 was used at the base of the dig for filling. | |

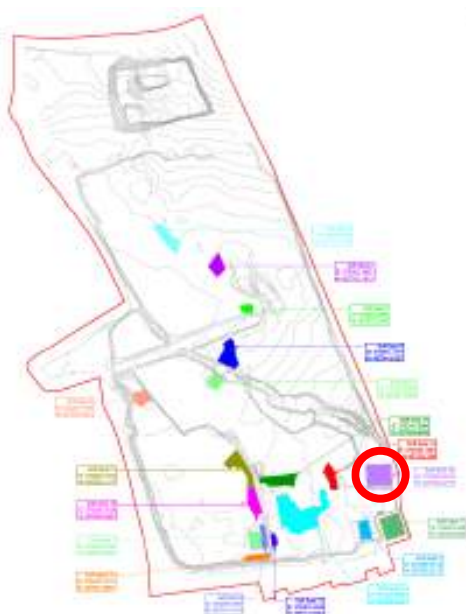
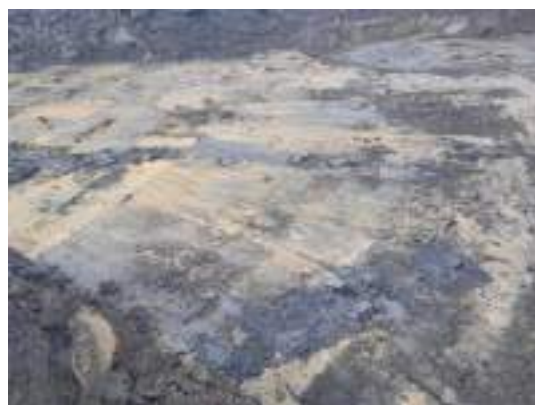
| <b>Comments / Details of soft spot:</b><br>Clays at the base of the dig were observed to be very soft, these were excavated further until suitable clays were encountered. A starter layer of imported 6F5 was used at the base of the dig for filling. | |

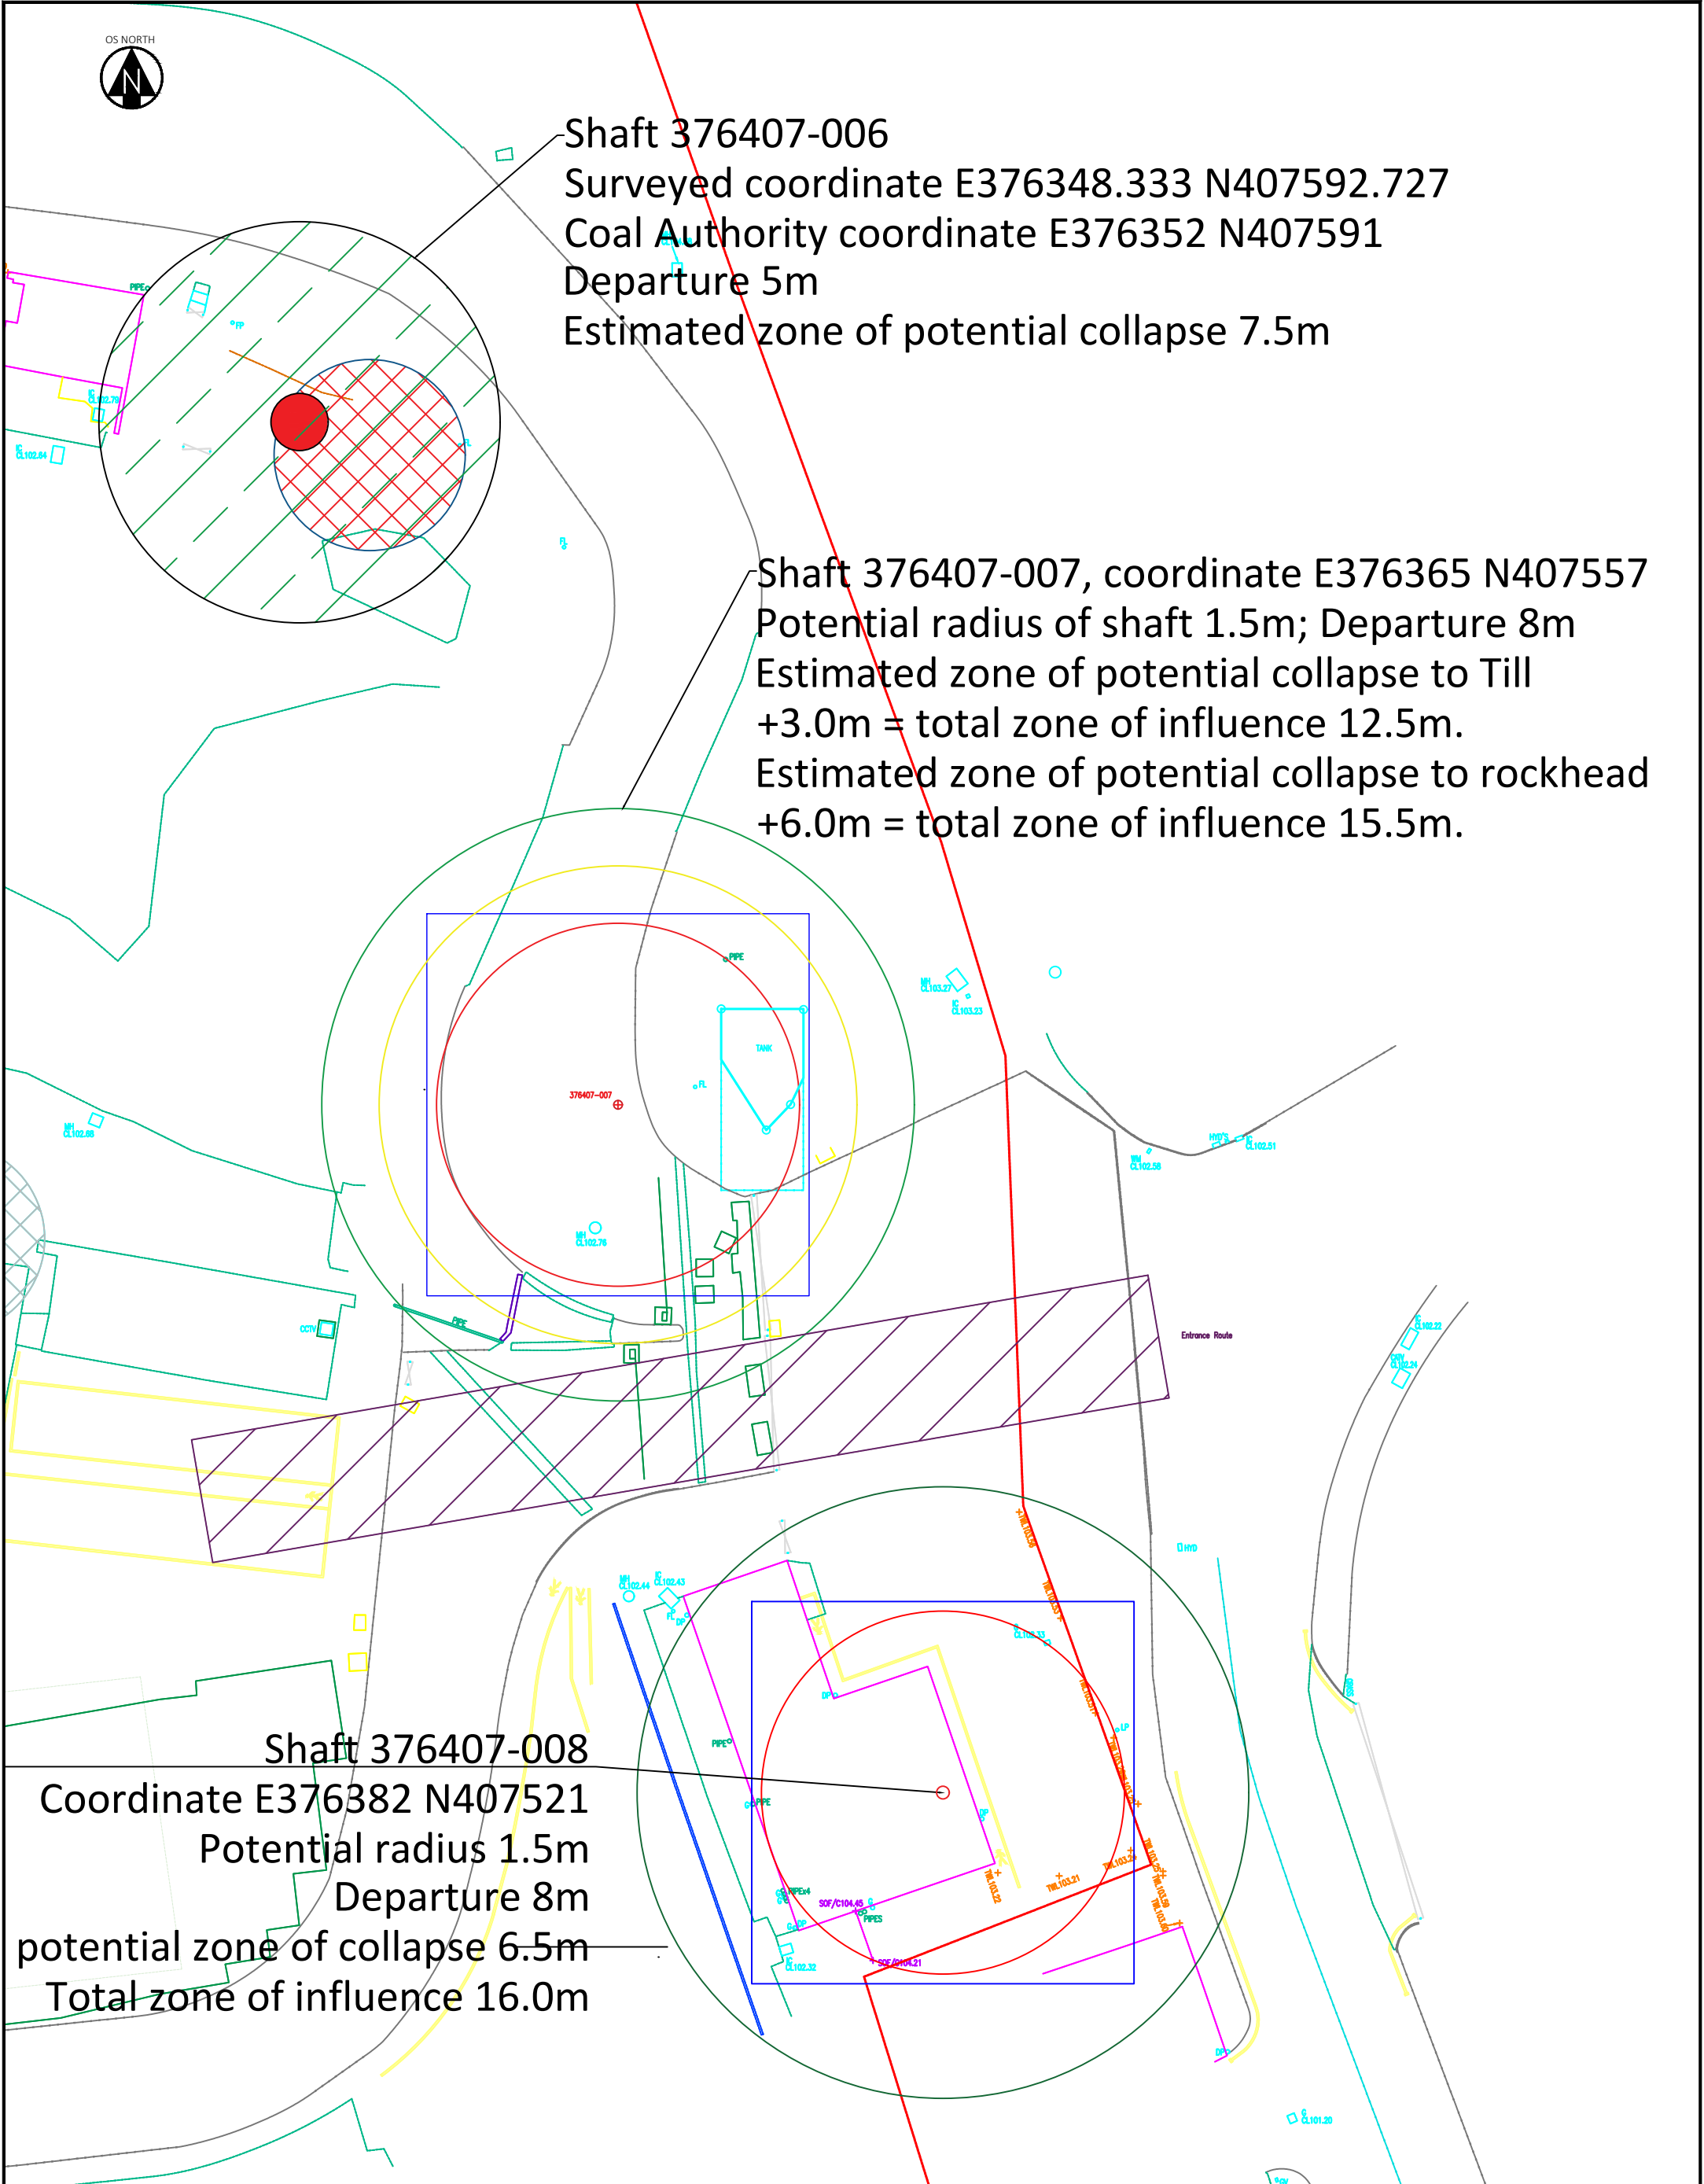
Shaft 376407-006  
Surveyed coordinate E376348.333 N407592.727  
Coal Authority coordinate E376352 N407591  
Departure 5m  
Estimated zone of potential collapse 7.5m

Shaft 376407-007, coordinate E376365 N407557  
Potential radius of shaft 1.5m; Departure 8m  
Estimated zone of potential collapse to Till  
+3.0m = total zone of influence 12.5m.  
Estimated zone of potential collapse to rockhead  
+6.0m = total zone of influence 15.5m.

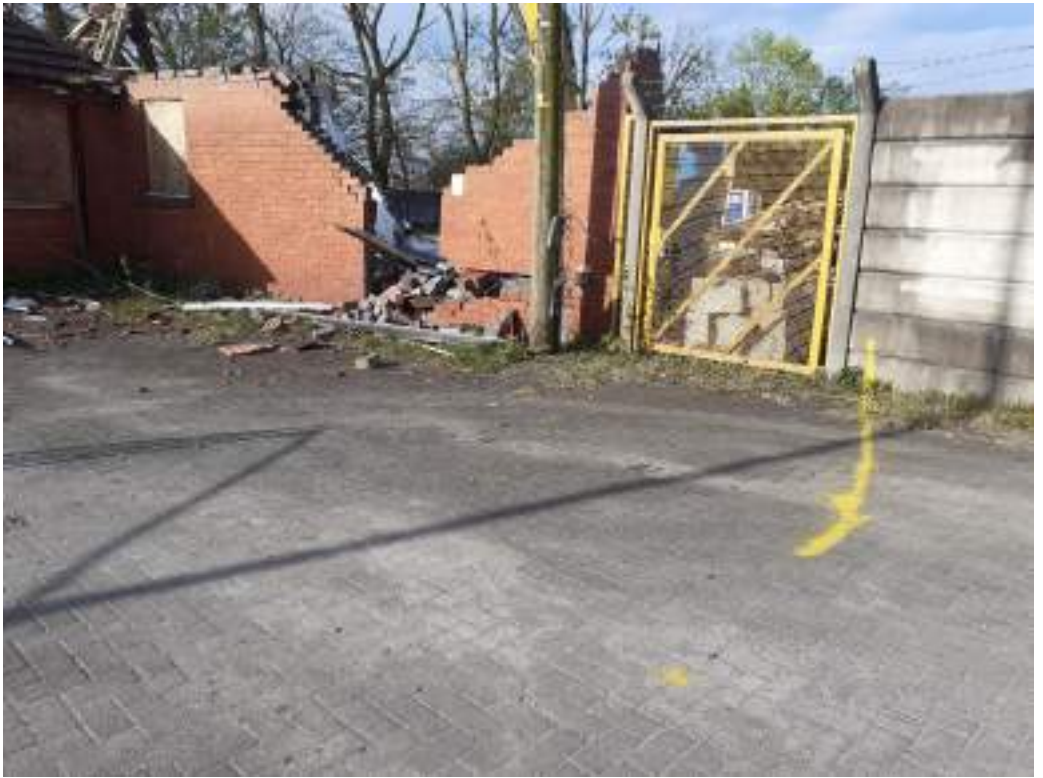
| <b>Photograph 3</b> | |

| <b>Description:</b><br><br>'Building 1' demolished down to slab level | |

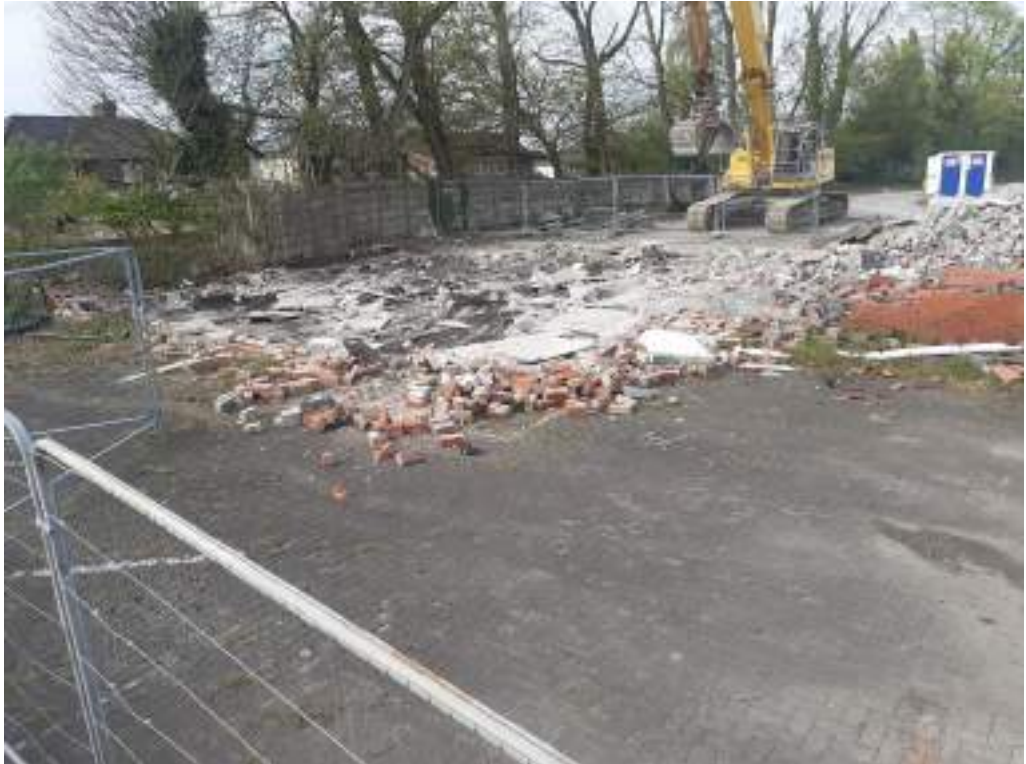
| <b>Photograph 5</b> | |

| <b>Description:</b><br><br>Slab being broken and removed by long reach excavator. | |

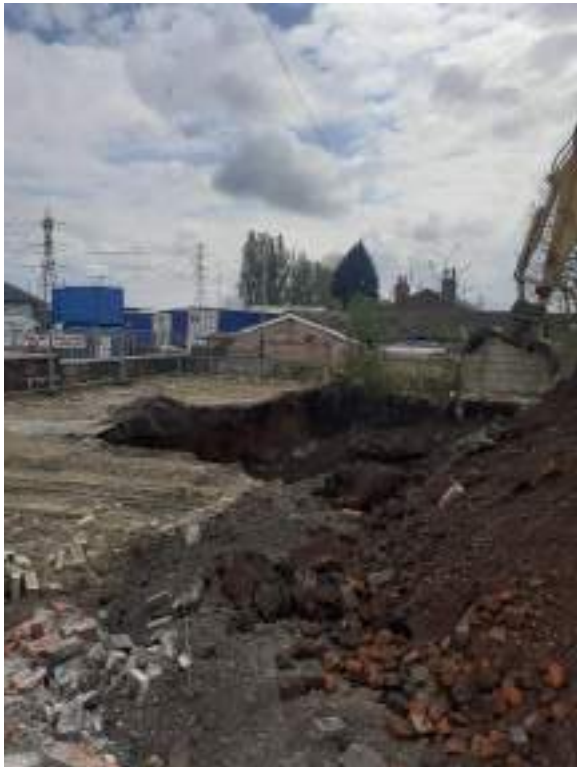
| <b>Photograph 8</b> | |

| <b>Description:</b><br><br>Excavation of the foundations of 'Building 1'. | |

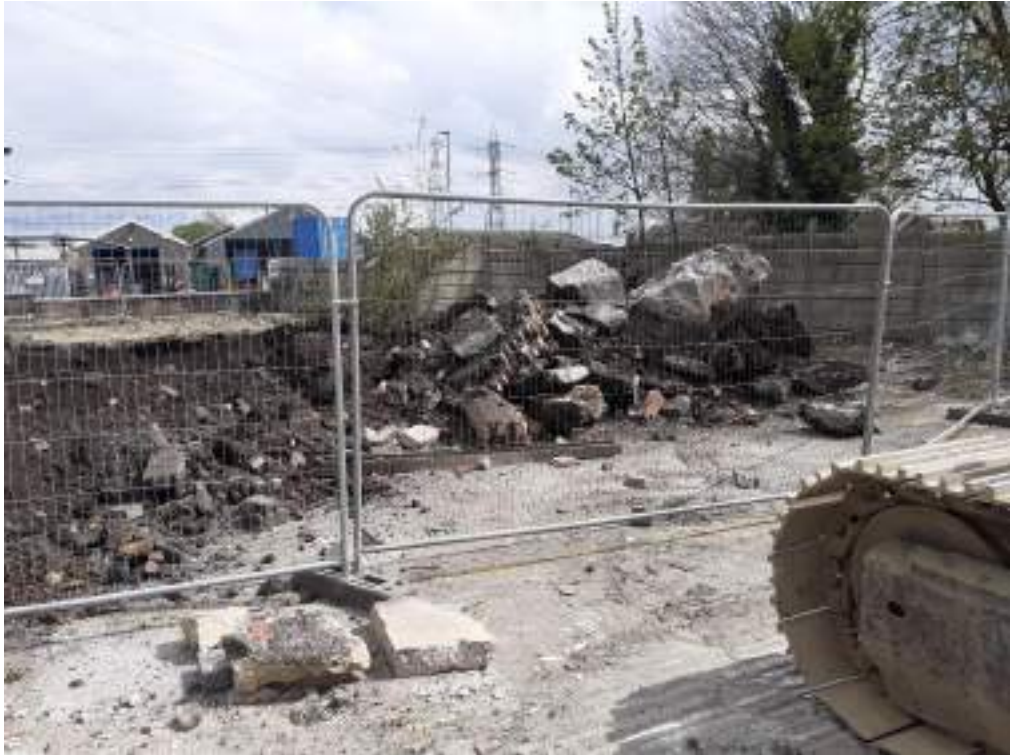
| <b>Photograph 9</b> | |

| <b>Description:</b><br><br>Removed concrete<br>and brick<br>foundations | |

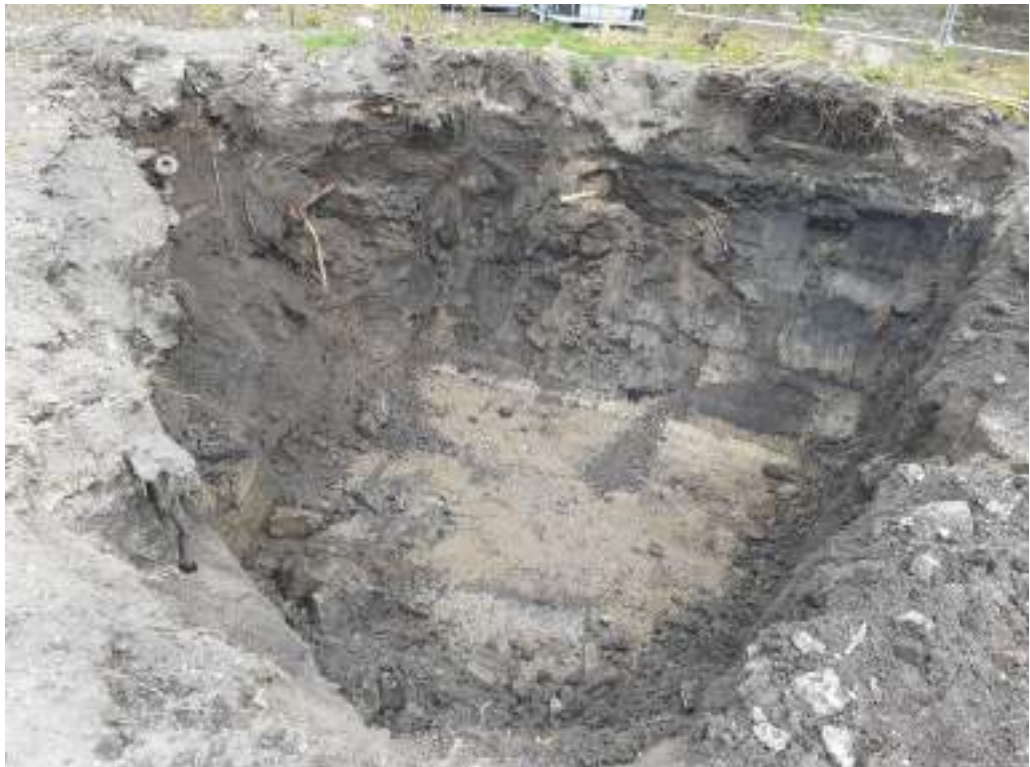
| <b>Photograph 14</b> | |

| <b>Description:</b><br><br>Natural Glacial Till<br>clay below the tanks<br>position. | |

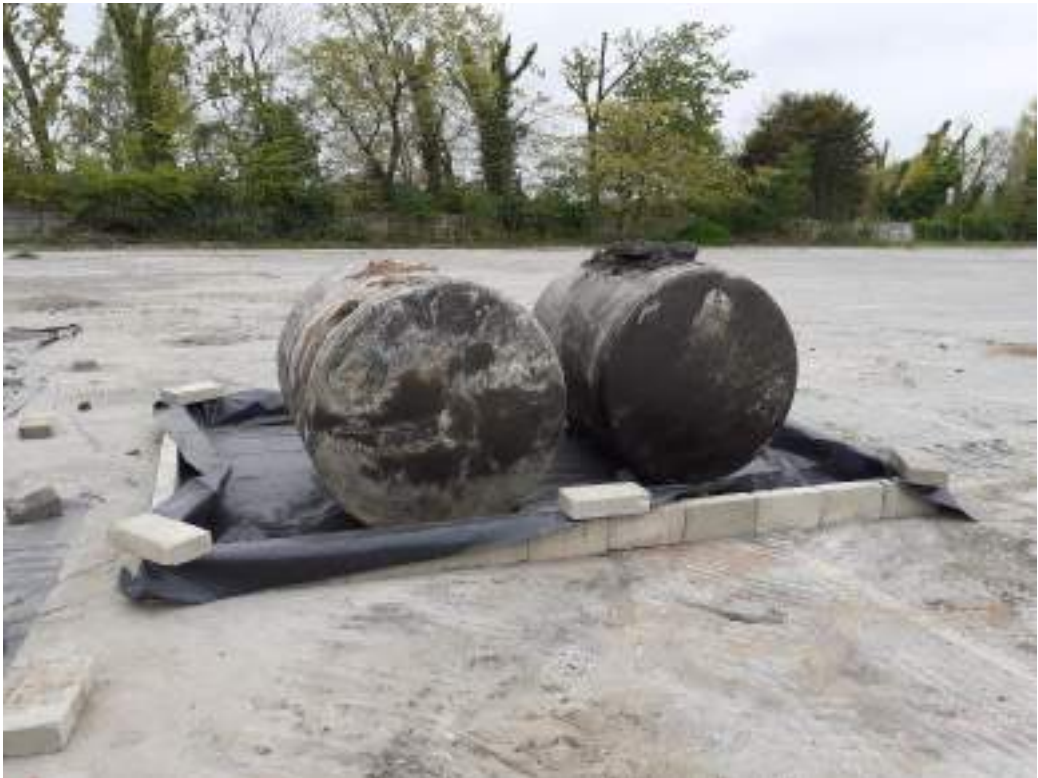
| <b>Photograph 15</b> | |

| <b>Description:</b><br><br>Removed tank in<br>block and visqueen<br>bund. | |
