# ROAVR | GROUP

**Project:** 23\_PRA\_10\_75  
**Site:** 21 Church Street East, Radcliffe, Manchester, M26 2PG  
**Client:** Robert Heaton

| Report Type: | Preliminary Roost Assessment Report [PRA]<br>Daytime Bat Walkover (DBW) |

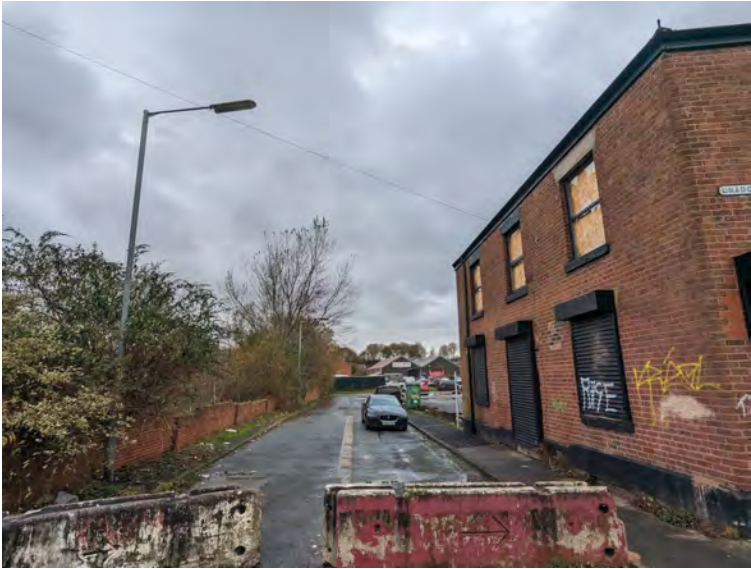
| Detail | Photograph |
|---|---|
| <p><i>Photo showing the southern elevation of B1</i></p> | |

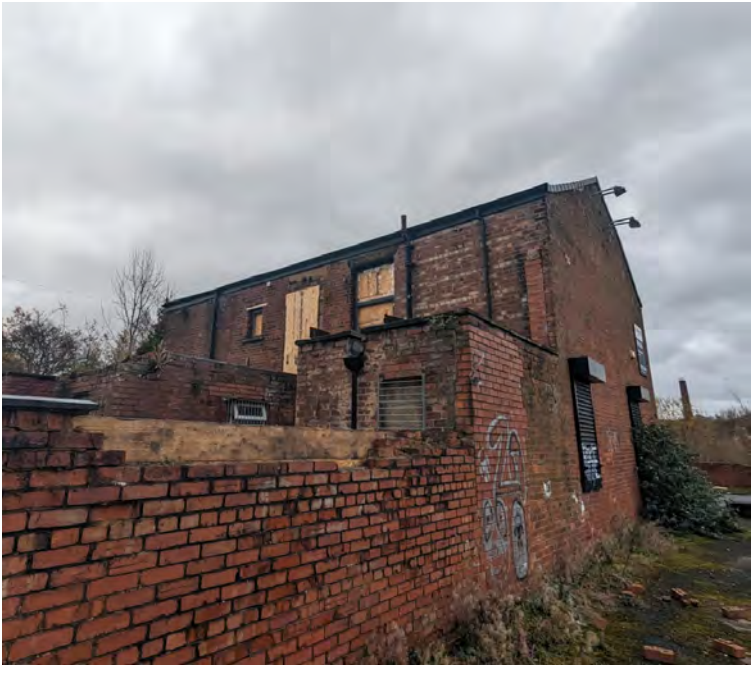
| Detail | Photograph |
|---|---|
| <p><i>Photo showing the northern and eastern elevations of B1</i></p> | |

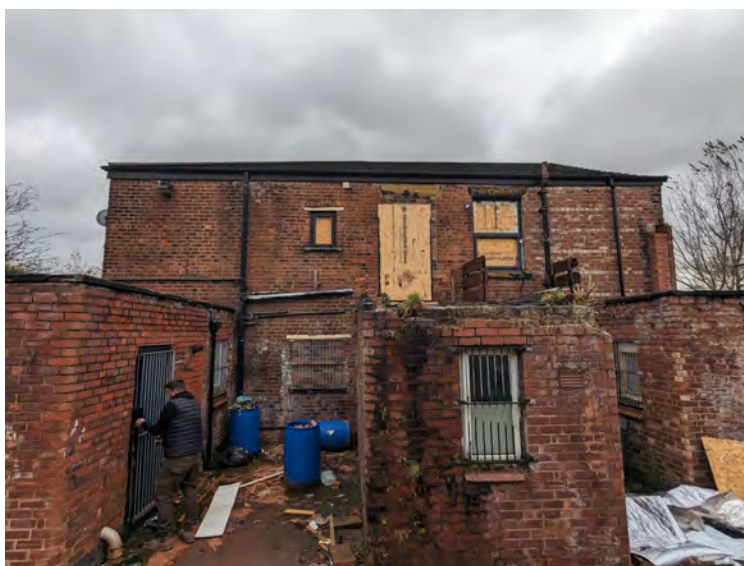
There are three small flat roof extensions to the northern elevation which are planned for demolition.

The flat roof extension had numerous PRFS in the form of gaps in brick work, fly in access through smashed windows and missing mortar although these are considered to be of very low value to bats due to the low height <2m.

| External | Feature of value to bats | Notes |
|---|---|---|
| External Stonework | Yes | Damaged brickwork and missing mortar on the three northern extensions although this is of very low value to bats. |

Photo showing the northern elevation of B1

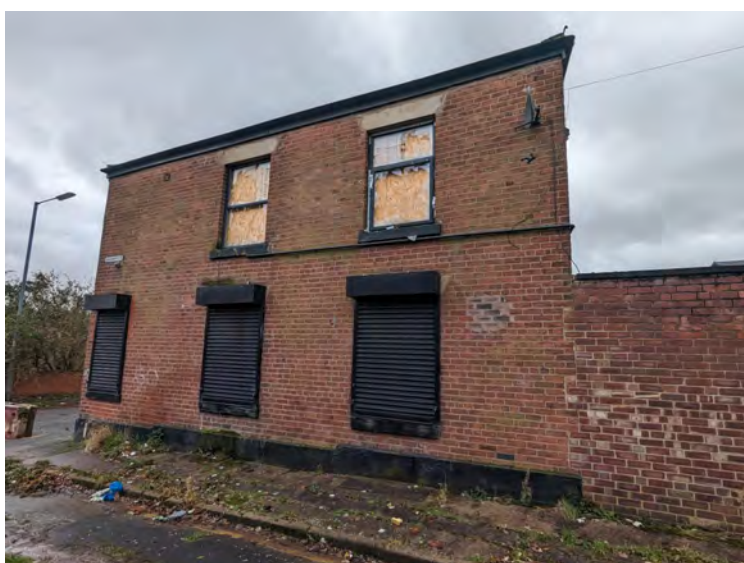
Photo showing the eastern elevation of B1

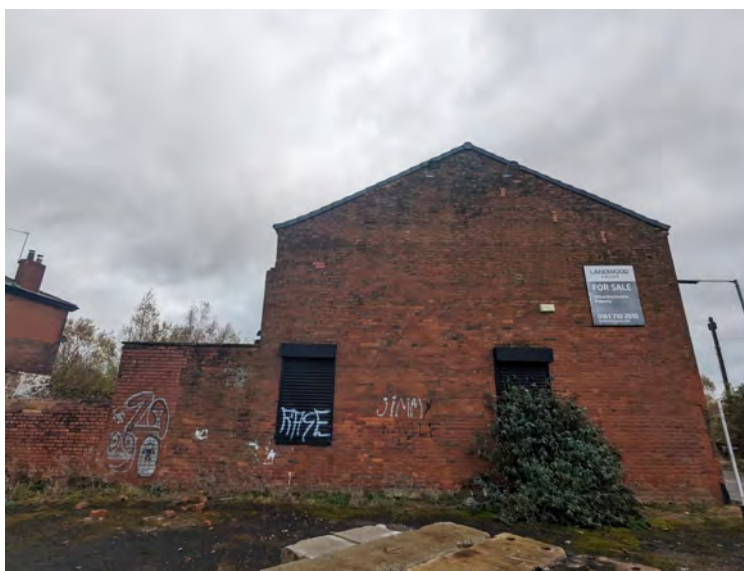
Photo showing the western elevation of B1

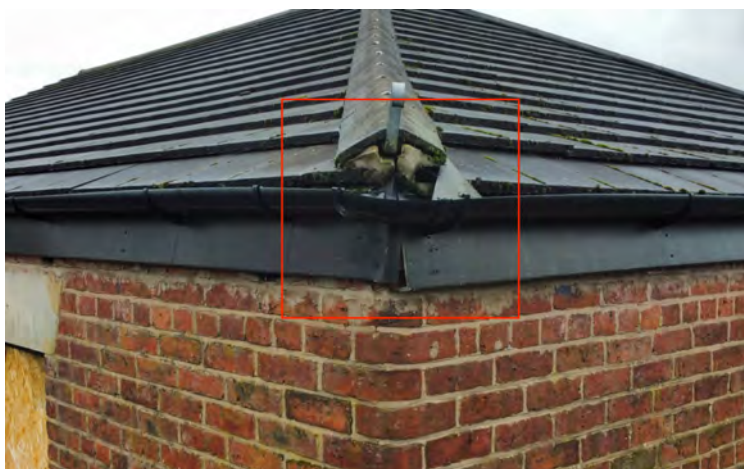
identified in the form of missing mortar from the ridge on the eastern elevation.

| External | Feature of value to bats | Notes |
|---|---|---|
| Eaves Coverings | Yes | Missing mortar from one of the ridges on the eastern elevation. |

*Photo showing the PRF on the eastern elevation (missing mortar and raised barge board)*

- 5.3 The missing mortar beneath the eave and ridge provide roosting potential for crevice dwelling bats species such as Common and Soprano Pipistrelle species which are known to be present in the local area. Therefore, based on this information and the guidance outlined by the Bat Conservation Trust, the building has been assessed as having low suitability for roosting bats.

- 7.3 The features present at the property are suitable for crevice dwelling bats species which are present in the local area. These features amount to one area of missing mortar on the ridge and eaves of the property and as such the property has been classified as having low suitability for bats.

- 7.4 It is recommended that one bat presence/absence survey be carried out. The survey should be carried out between May and September (with September considered to be sub-optimal).

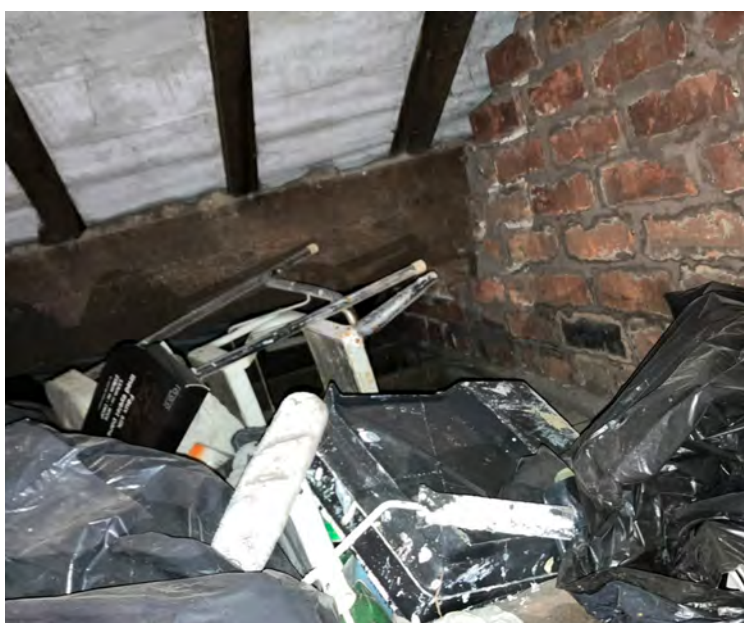
Imagery provided by the customer following the site visit by ROAVR highlights the void space that covers most of the floor plan of B1. There was evidence of mice/rats though-out the loft in the form of droppings. The void appears to be lined with a roofing membrane which is torn in places and there is a large amount of dumped rubbish in the void.

*Customer photo showing the interior of the roof void*

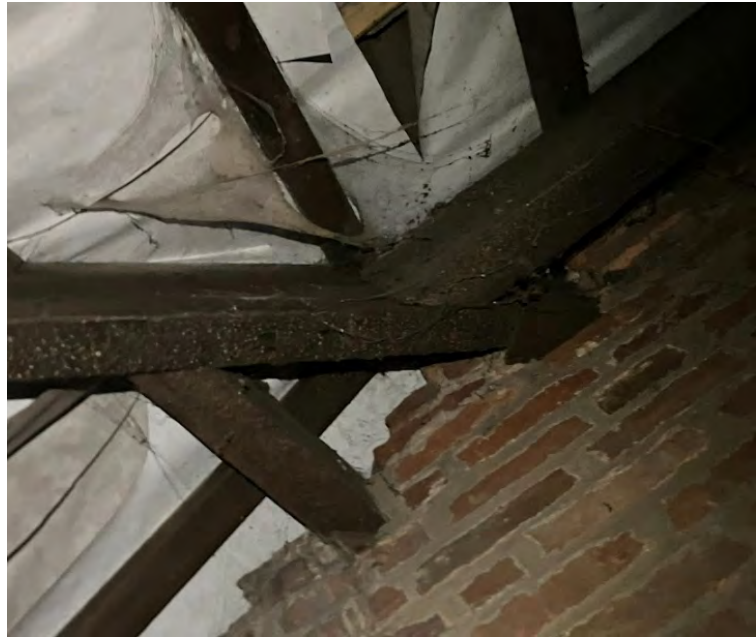
| External | Feature of value to bats | Notes |
|---|---|---|
| Membrane Coverings | Yes | The customer photos appear to show ripped and torn roof lining. |

*Customer photo showing the interior of the roof void which shows torn roof membrane*
