## Preliminary Geotechnical Appraisal

Proposed School Extension

Our Lady of Lourdes RC Primary School, Bury

Document no.: STV6181-R01 Rev A

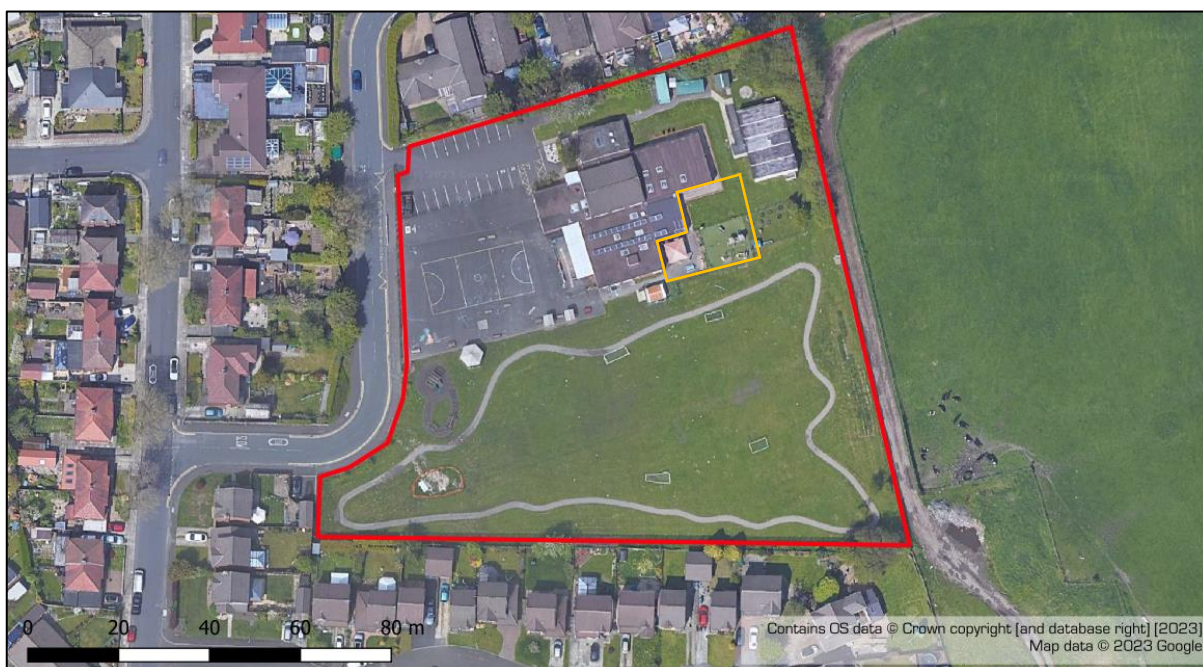
Figure 2-A: Aerial photograph and approximate site boundary (red) and extension (orange)

- 2.1.1 The proposed development lies within the grounds of Our Lady of Lourdes RC Primary School, approximately 2.3km northwest of the Bury town centre. The post code for the site is BL8 1YA and the site is accessed from Rudgwick Drive, which lies adjacent to the schools western boundary.
- 2.1.2 The area of the extension is located in south-eastern part of the school, which comprises of children's activity areas, open space and perimeter access routes. A retaining wall some is also present in the footprint of the proposed extension.
- 2.1.3 An aerial image showing the approximate wider site boundary is presented below. A Site Plan is provided within Appendix A.

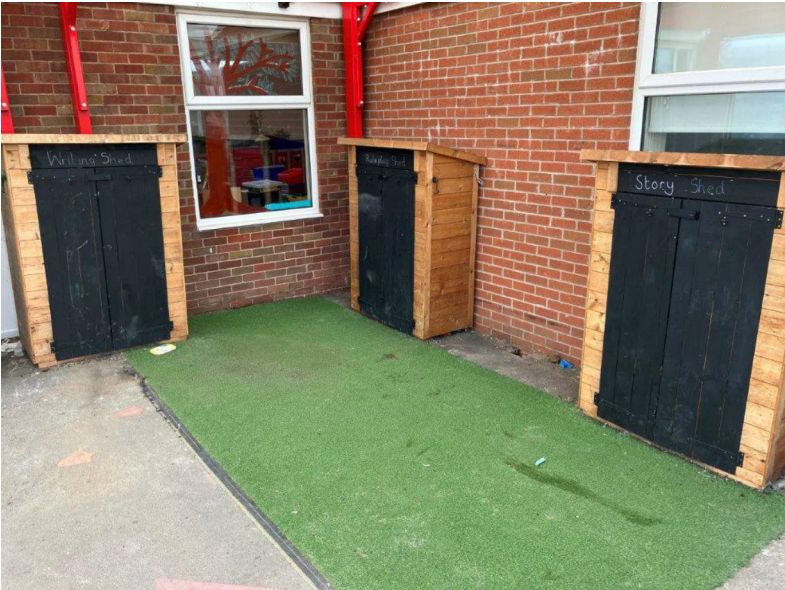
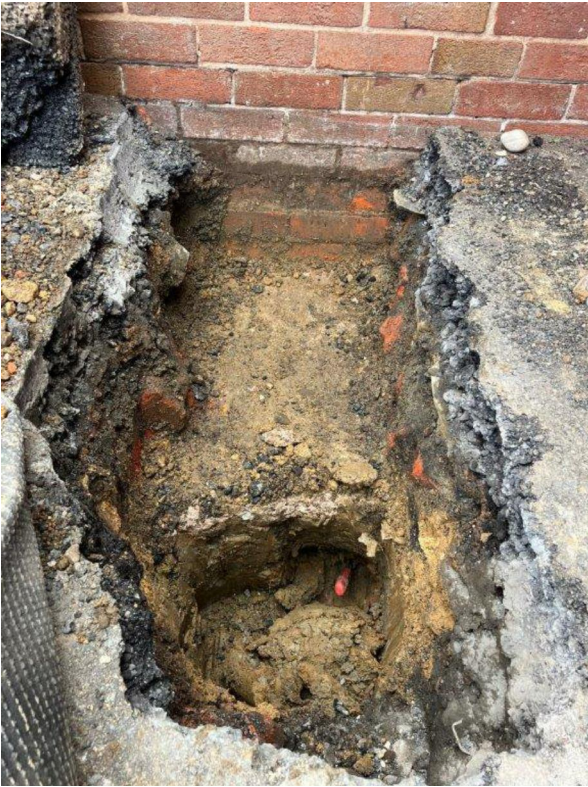
| Foundation Pit | Findings |
|---|---|
| TP01 | Brick wall extended to 390mm bgl, located directly on a concrete foundation which projects 650mm from the brick wall at the top of the foundation. The foundation was 350mm thick and tapers to a width of 450mm at the base. Base depth was 740mm bgl and founded on the Devensian Till. |

- A. ASPHALT.
- B. Brownish grey sandy clayey fine to coarse angular GRAVEL with medium cobble content of half and whole brick. Gravel is concrete, asphalt and brick. (MADE GROUND)
- C. Soft to firm brown slightly gravelly sandy CLAY. Gravel is fine to medium angular to subangular sandstone and quartzite. (DEVENSIAN TILL)

- TP01 – 450-600mm projection from wall recorded therefore assume 1200mm wide foundation at 0.74m depth.
  - TP04 – 250mm projection from wall recorded therefore assume 900mm wide foundation at 1.00m depth.

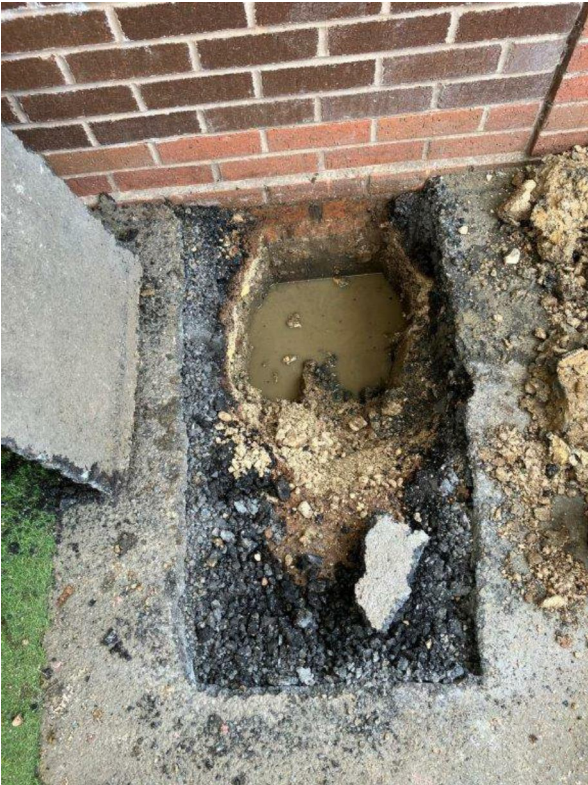
| Foundation Pit | Findings |
|---|---|
| TP02 | Unable to determine foundation arrangements due to groundwater ingress. |

- A. ASPHALT.
- B. Black fine to coarse angular GRAVEL of bituminous surfacing. (MADE GROUND)
- C. Greyish white fine to medium subangular GRAVEL of limestone. (MADE GROUND)
- D. Soft brown mottled grey slightly sandy gravelly CLAY. Gravel is fine to medium subangular sandstone and brick. (MADE GROUND)

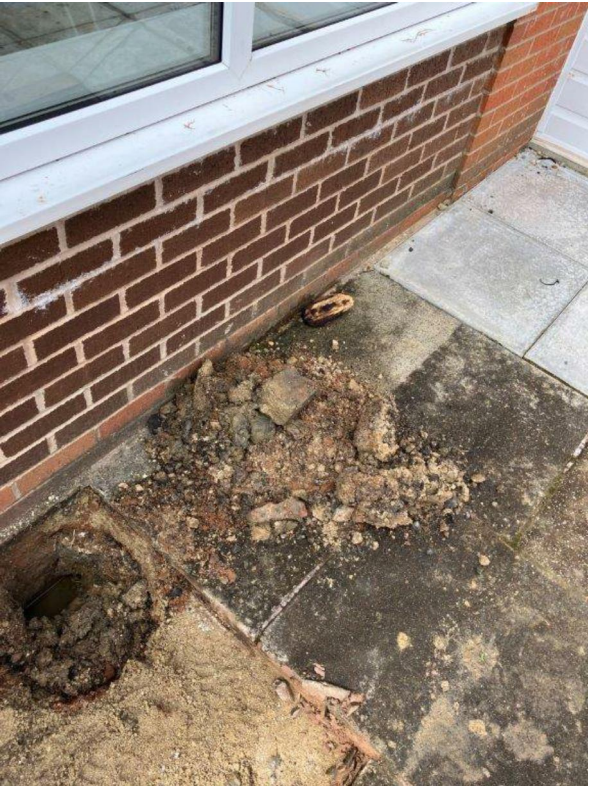
- A. PAVING SLAB.
- B. Fine GRAVEL of mortar.  
(MADE GROUND)
- C. Soft to firm brown slightly sandy gravelly CLAY. Gravel is fine to coarse angular to subangular sandstone.  
(DEVENSIAN TILL)

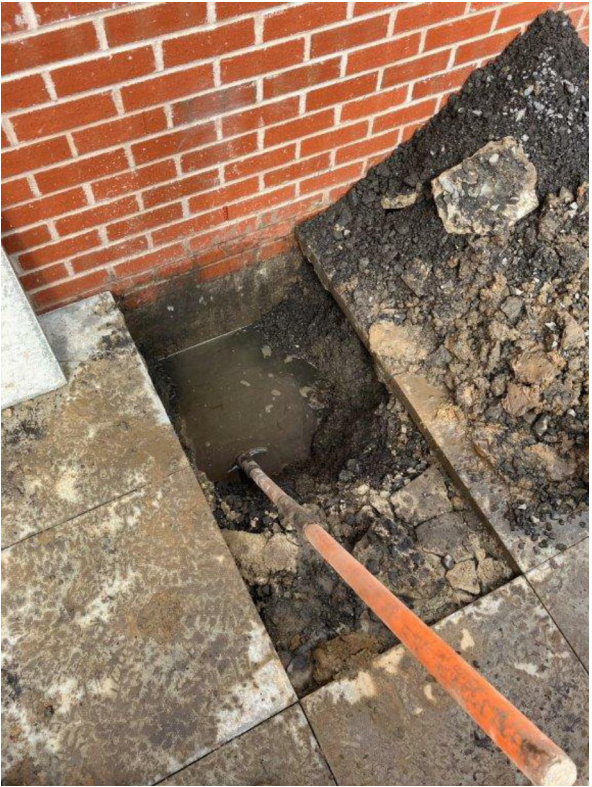
| Foundation Pit | Findings |
|---|---|
| TP04 | Brick wall sits directly on concrete (wall?) below surface level.<br>Although the concrete footing could not be visually exposed beyond 600mm due to water ingress, a breaker bar was advanced to a depth of 850mm bgl at which point a horizontal obstruction projecting ~250mm from the wall was noted. The breaker bar was then driven at an angle to intersect the underside of the obstruction – the obstruction was noted to be approximately 100-200mm in thickness. This is likely to represent the projection of a concrete strip foundation, founded on the Devensian Till. |

- A. PAVING SLAB.
- B. Black fine to coarse angular GRAVEL of shale. (MADE GROUND)
- C. Soft to firm brown slightly sandy gravelly CLAY. Gravel is fine to coarse angular sandstone. (DEVENSIAN TILL)
