# ROAVR | GROUP

**Project:** 25\_PRA\_06\_10  
**Site:** 299 Middleton Rd, Prestwich, Manchester M8 4LY  
**Client:** Subhan Saleem

| Report Type: | Preliminary Roost Assessment Report [PRA]<br>Daytime Bat Walkover (DBW) |

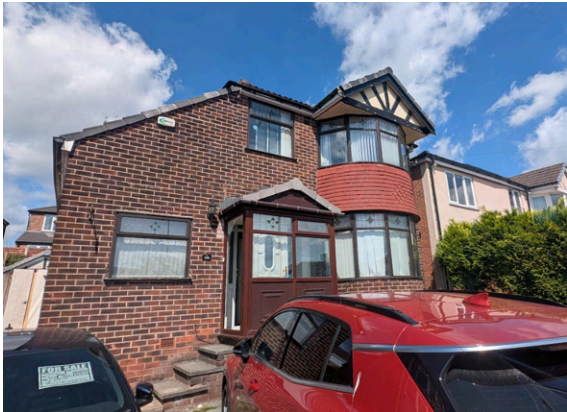
The eastern elevation includes a projecting bay window on the ground floor, featuring clay hanging tiles above, several of which are slightly displaced or exhibit minor gaps. These hanging tiles present potential niche roosting opportunities, particularly for solitary bats such as *Pipistrellus* species. Above this, gaps in the soffit and under roof tiles contribute to the building's overall moderate bat roost suitability. The shaded, recessed structure of this elevation may offer favourable microclimatic conditions for bats.

| Detail | Photograph |
|---|---|
| <p><i>Plate 1 - Front (eastern) elevation of B1.</i></p> | |

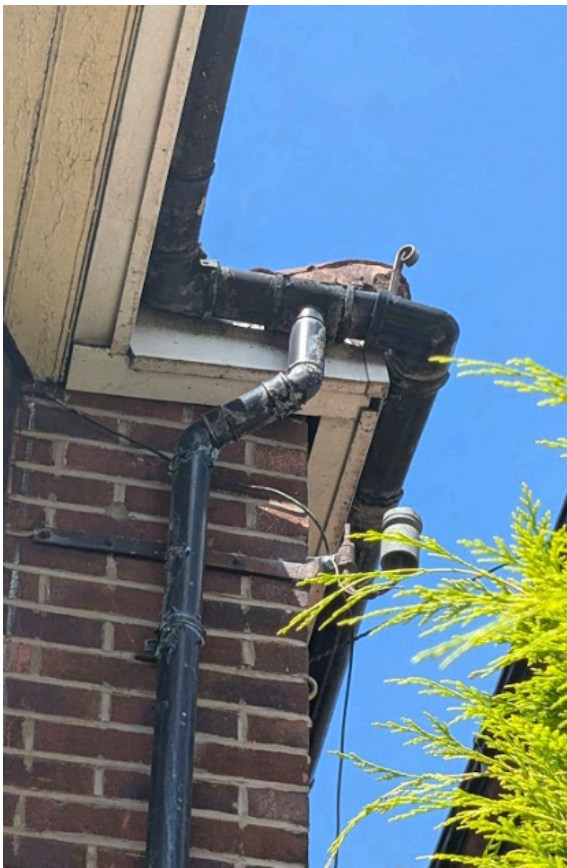
| Detail | Photograph |
|---|---|
| <p><i>Plate 2 - B1 external - PRF 1. Gap below soffit box where it meets the brick wall, north east corner.</i></p> | |

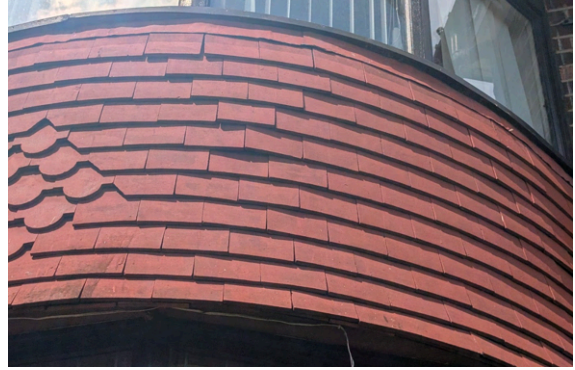
*Plate 3 - B1 external - PRF 2. Hanging tiles in bay window area, several gaps under slipped tiles.*

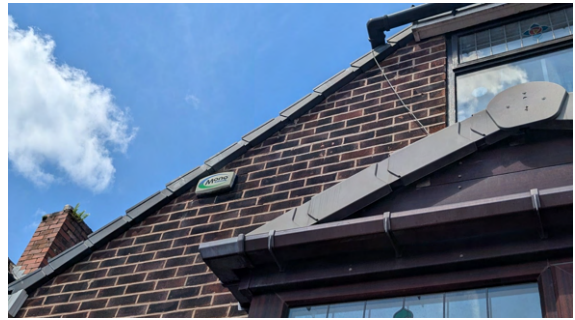
*Plate 4 - B1 external - PRF 3. Gaps along barge board and soffit box at the top.*

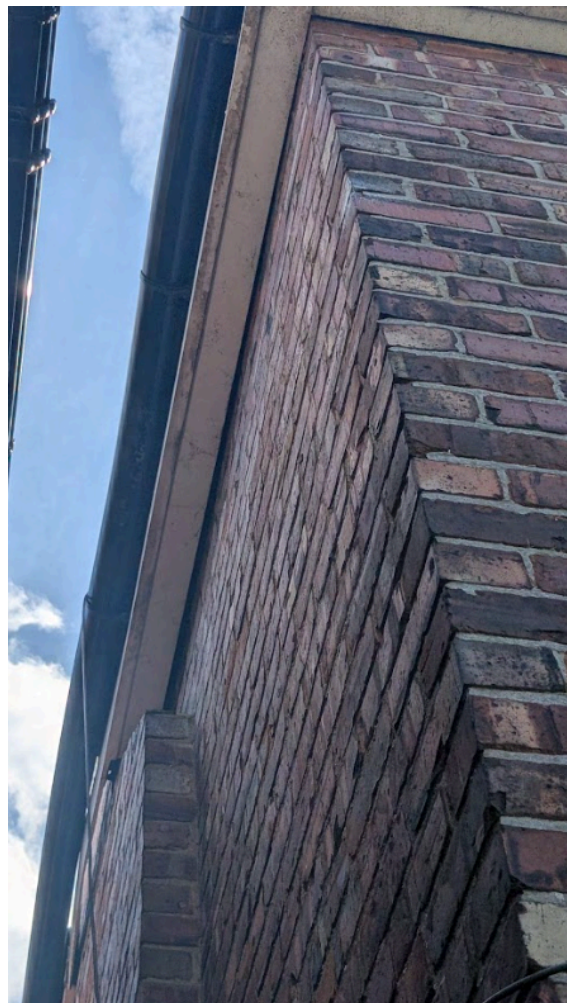
*Plate 6 - B1 external - PRF 5. Several gaps along the soffit box on the northern eaves. However, this is a very cluttered location.*

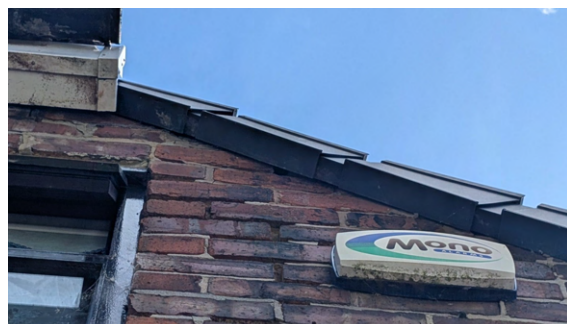
*Plate 7 - B1 external - PRF 6. Gap all along soffit box at the western eaves and at the top of the barge board on sloping section to the south.*

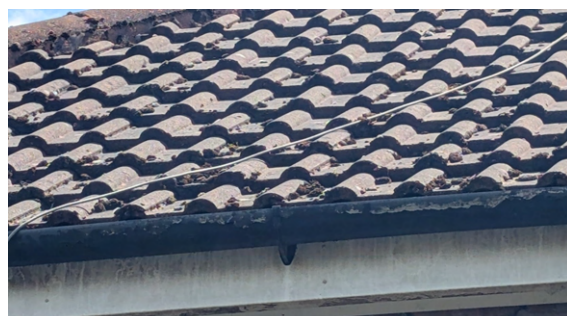
*Plate 8 - B1 external - PRF 7. Gaps at the eaves of the roof, under interlocking tiles.*

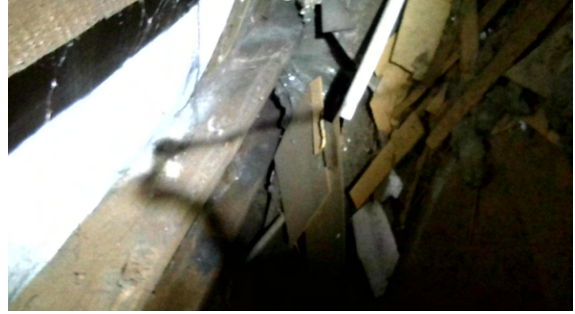
*Plate 9 - B1 internal - PRF 8. Small section of the loft space to the east above bay window is inaccessible (outside of the boarded storage area). Exposed rafters and roofing felt (no wool insulation as in the other areas of the roof). This area of the roof void could be suitable for roosting bats if there is access from the exterior.*

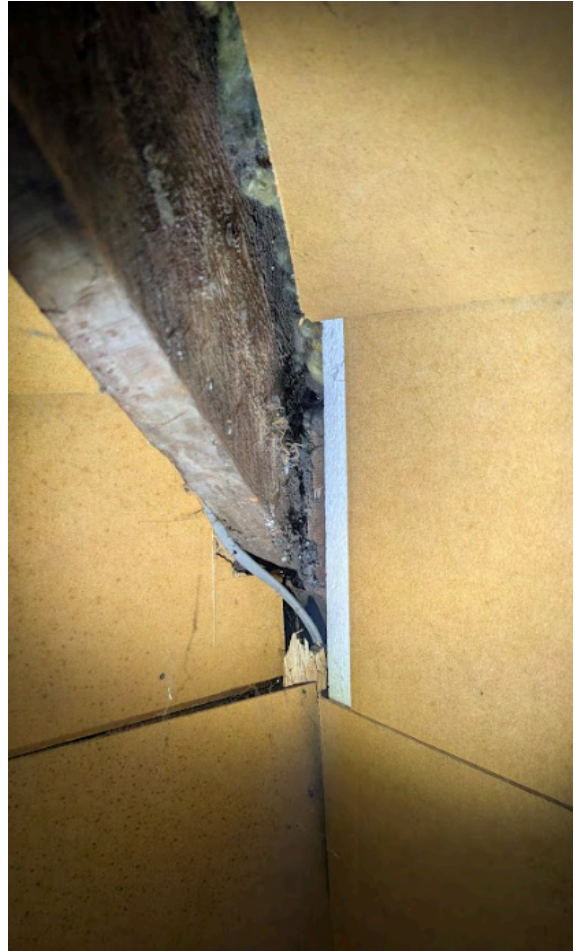
*Plate 10 - B1 internal - PRF 9. Small gap in boards where exposed joists with no wool insulation are visible. Potential roosting feature if access available from the exterior.*

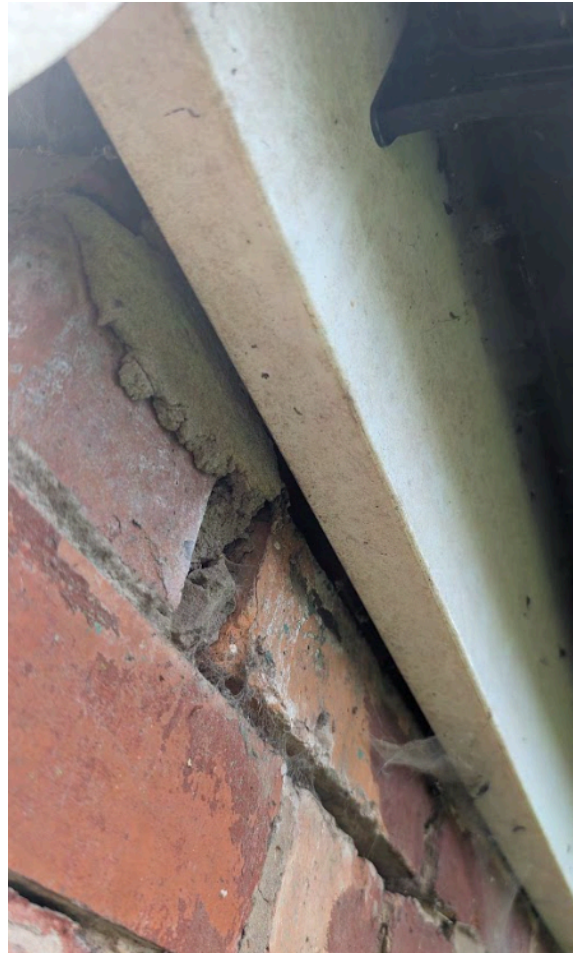
*Plate 12 - One of three PRFs identified externally on B2.*

TN2 - The outbuilding (B2) presents three external PRFs. These include a linear gap running along the eastern barge board that was inspected using a torch; although no bats or signs were noted, the feature is suitable for solitary roosting. A second PRF is located in the form of gaps between vertical timber cladding next to the main door, which leads into a narrow void between the cladding and underlying structure. While the void was partially inspected from both interior and exterior vantage points, it was not fully visible and presents potential for use by individual bats. The third PRF identified is a gap along the soffit box on the north-facing eaves. This feature may offer access into the internal void of the building and remains suitable for transient or temporary roosting behaviour.
